# **Accident Investigation Report**

# Fall from Fixed Ladder at Building 830at Brookhaven National Laboratory on June 29, 2012

August 2012

Brookhaven Site Office U.S. Department of Energy Upton, New York

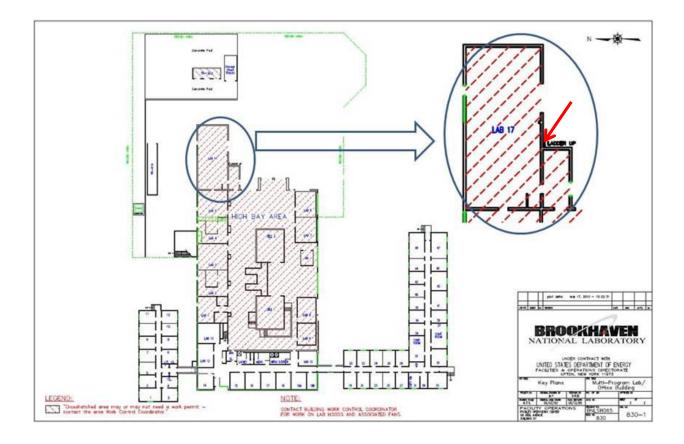
Figure 1: Fixed Ladder Location at Building 830

The fixed ladder involved in this accident is located on the exterior of the northeast portion of Building 830, near the center of the south wall of "Lab 17" (see the red arrow on Figure 1). The fixed ladder from which the MMW fell is the single permanent access point to all Building 830 roof levels.

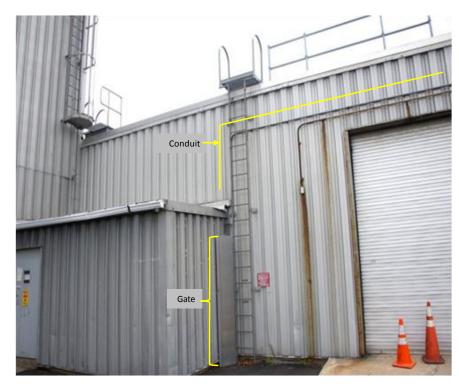
Figure 2: Current Location of the Fixed Ladder on Building 830, Lab 17

During the 1980's or 1990's, a lockable side-hinged gate was installed onto the left rail of the fixed ladder to prevent accessing the roof above Lab 17. This gate is made of ¼ inch thick aluminum plate. The gate is attached directly to the ladder by hinges fixed to its left rail. A hasp is installed on the right rail of the ladder to permit the gate to be locked. When closed, the gate

laps over both side rails and covers the first eight rungs; thus likely preventing inadvertent access to the roof if padlocked. This was done as a radiological control measure when it was realized there was a possibility of unexpected radiation exposure to persons on the roof at a time when samples were being loaded into or removed from the GIF pool. The radiation exposure for which the gate was installed no longer exists.

Finally, during the early 1990's, for the purpose of providing power to a nearby storage area, a run of 1 inch rigid metal conduit was attached to the exterior of the south wall of Lab 17. The conduit runs up vertically and immediately adjacent to the left rail starting at approximately the mid-point of the 18-1/2 foot fixed ladder. It then turns to the right and runs horizontally at a level of the same height of the fourth rung down from the grated step-off platform of the fixed ladder. (Figure 2) The distance between the conduit and the fourth ladder rung is less than seven inches.
