U.S. DEPARTMENT OF
ENERGY

2015 Annual Site Inspection and Monitoring Report for Uranium Mill Tailings Radiation Control Act Title II Disposal Sites

November 2015

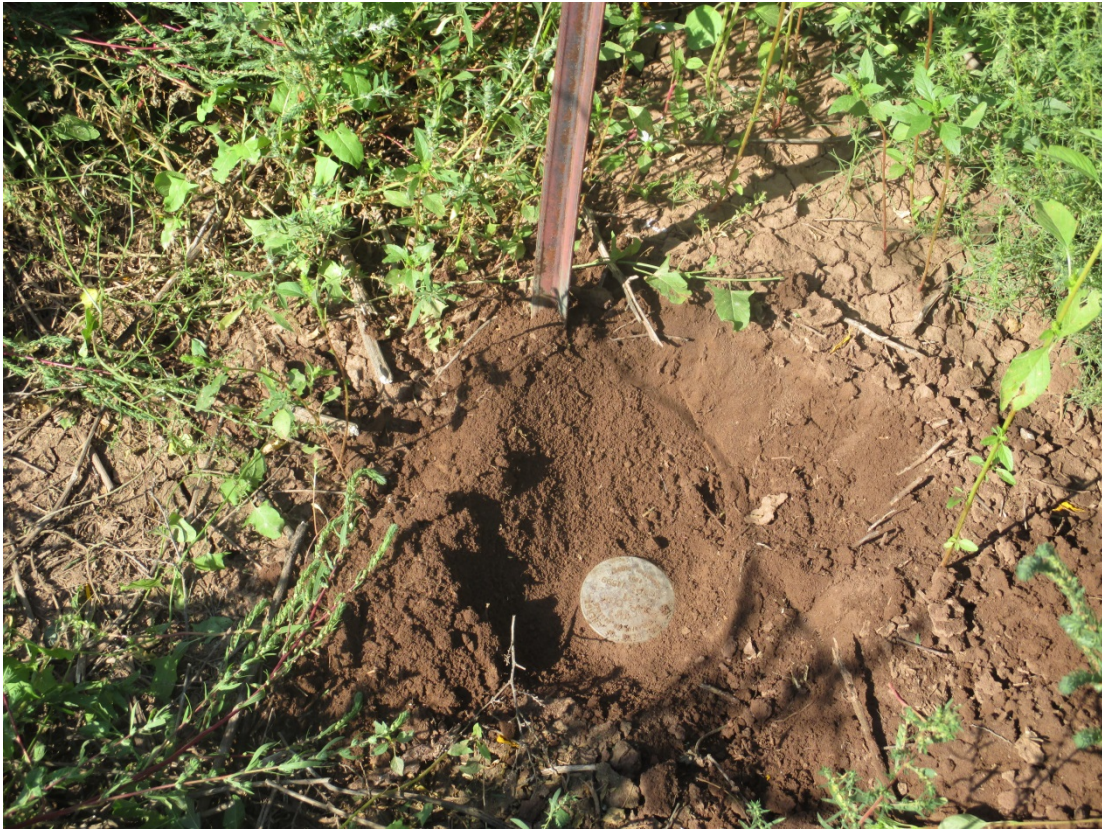
Twenty-four boundary monuments define the site boundary. These monuments are typically inside the perimeter fence and several feet inside the true corner or boundary line. The boundary monuments observed during the inspection were in good condition. Some monuments tend to get covered by drifting sand, and metal t-posts have been driven at those locations to help inspectors find them (PL-1).

BLU 8/2015. PL-1. Boundary monument BM-21.

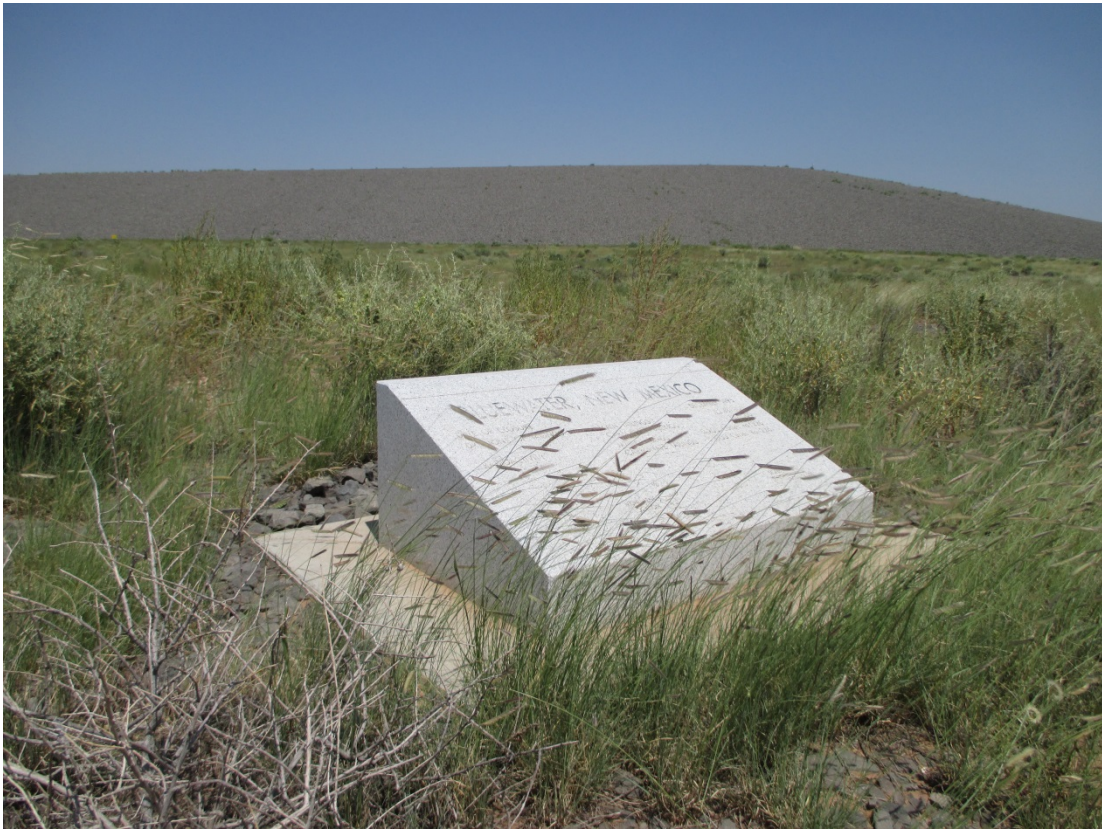
A granite site marker is between the southwest corner of the main tailings disposal cell and the northwest corner of the carbonate tailings disposal cell. The site marker was in excellent condition (PL-2).

BLU 8/2015. PL-2. Site marker.

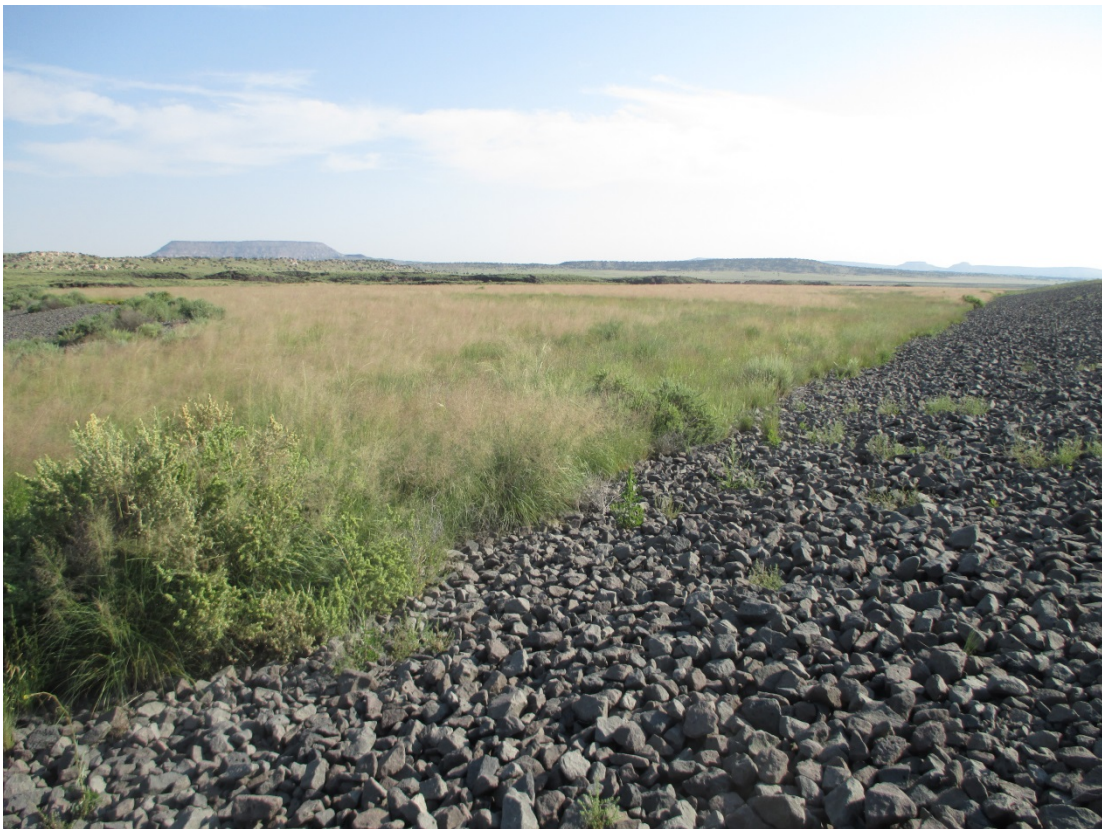
grade is 3 to 4 percent at the south end and decreases to less than 0.5 percent at the north end. The top slopes of the acid tailings (PL-4) and the south bench (PL-5) disposal areas are essentially flat and covered by healthy grass. Basalt riprap protects the side slopes of the three disposal structures. The riprap was in excellent condition.

BLU 8/2015. PL-4. Acid tailings bench of main tailings disposal cell.

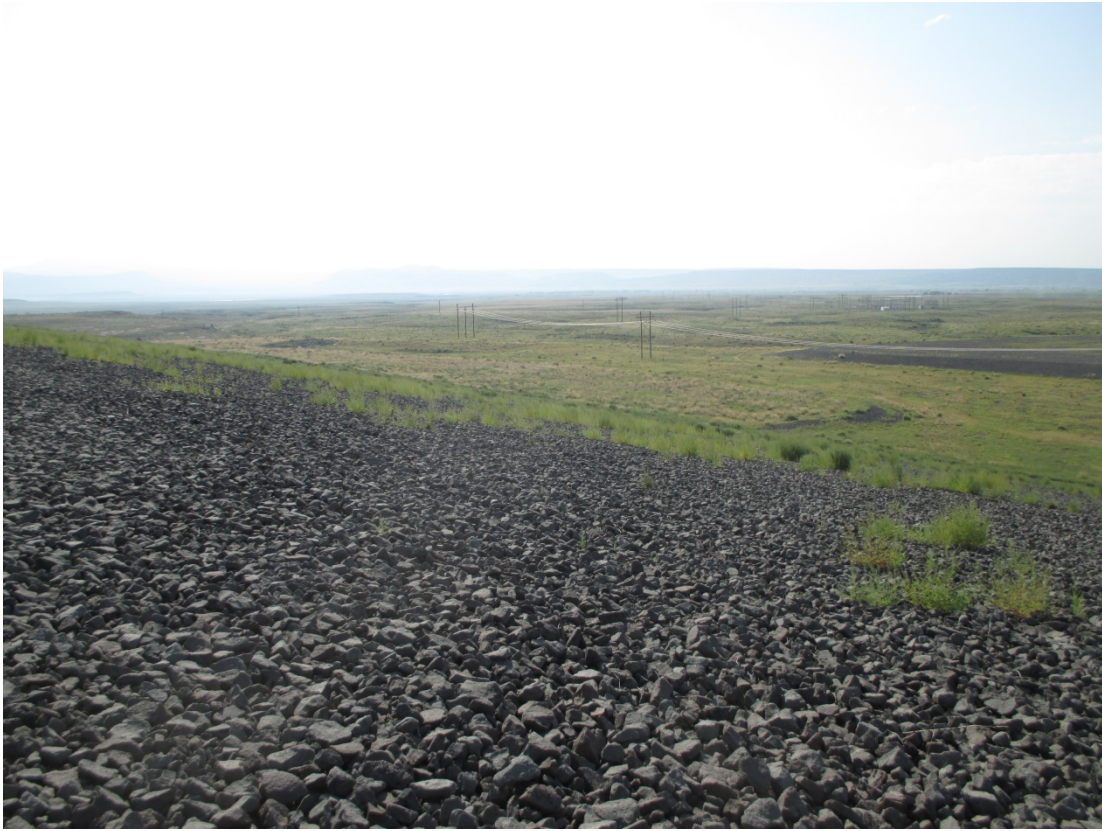
BLU 8/2015. PL-5. South bench of main tailings disposal cell.

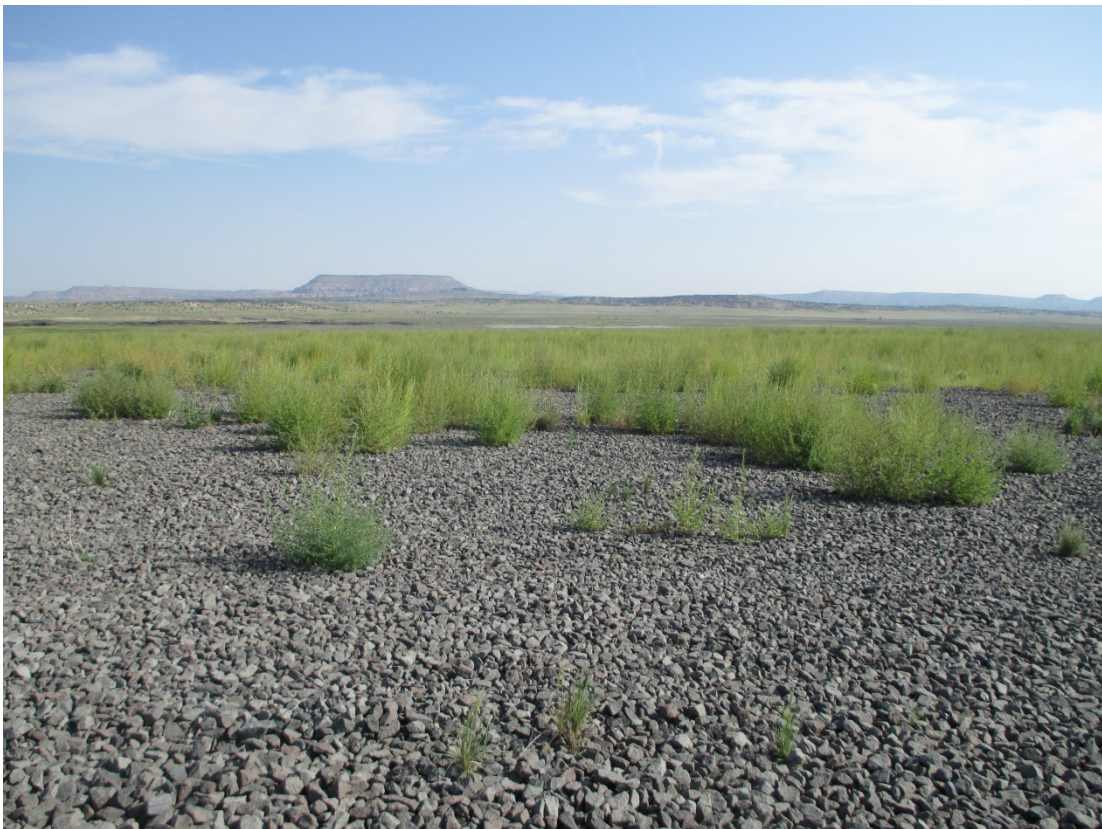
Plant encroachment (annual weeds, perennial grasses and forbs, and scattered perennial shrubs) continues on the cell cover (PL-6) and side slopes (PL-7). Saplings of Siberian elm have been present on the disposal cell covers and are managed to prevent the establishment of trees that could damage the cell covers; several saplings were observed during the inspection. The elm saplings will be cut and treated with herbicide in 2016.

BLU 8/2015. PL-6. Vegetation on main tailings disposal cell top slope.

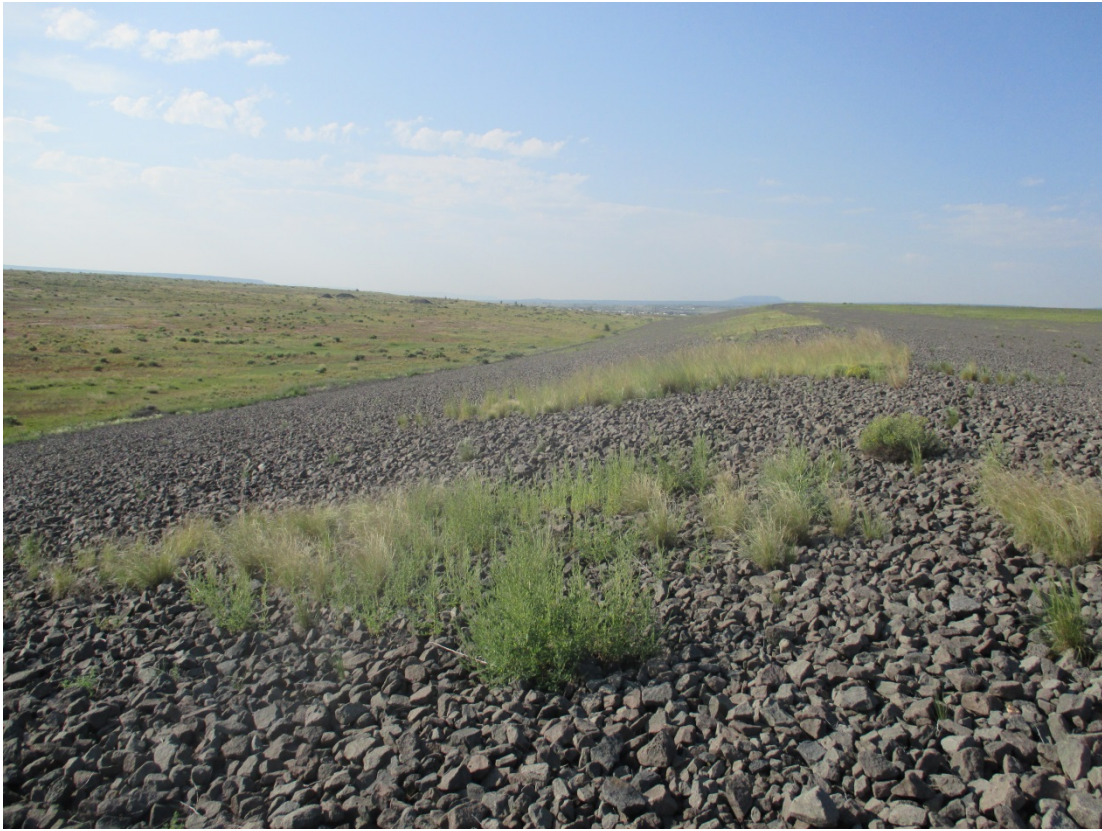
BLU 8/2015. PL-7. Vegetation on east side slope of main tailings disposal cell.

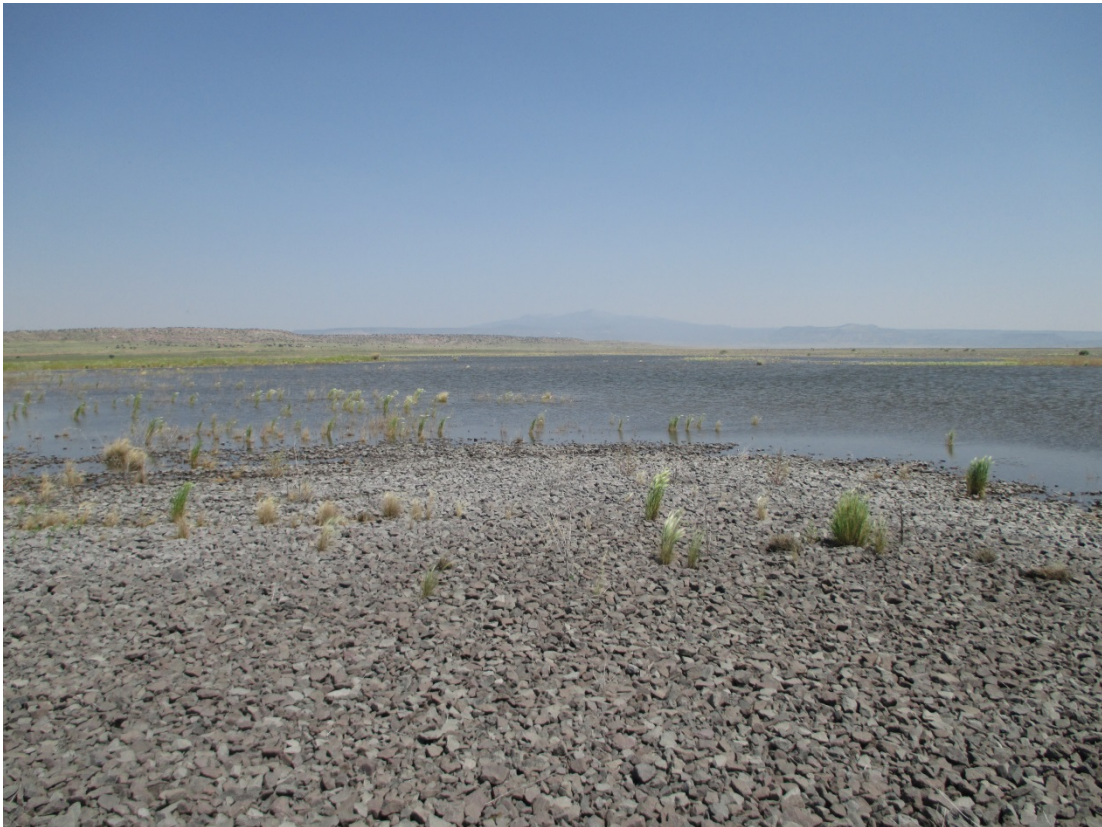
NRC requested DOE to evaluate the performance of the low-permeability radon barrier to determine if the ponded water was degrading disposal cell performance through (1) release of radon to the atmosphere or (2) infiltration of water through the cover and into the encapsulated tailings.

DOE measured radon flux on top of the radon barrier in the area of the depressions in July 2013. All radon measurements were less than the detection limit. On the basis of the radon monitoring results, there do not seem to be gross defects in the low-permeability radon barrier that would result in elevated radon flux, indicating that the radon barrier in that portion of the disposal cell was performing as designed.

DOE noted that ponded water accumulates after precipitation events and does not dissipate rapidly, and that evaporation far exceeds precipitation in the Bluewater region. Water levels in point-of-compliance (POC) wells have been dropping steadily since 1995, when the cell was covered, which suggest insignificant seepage from the tailings. Based on the integrity of the radon barrier, the persistence of ponded water, and lack of evidence of seepage, dissipation of the ponded water is most likely due to evaporation rather than infiltration.

BLU 8/2015. PL-8. Ponded water on north end of main tailings disposal cell top slope.

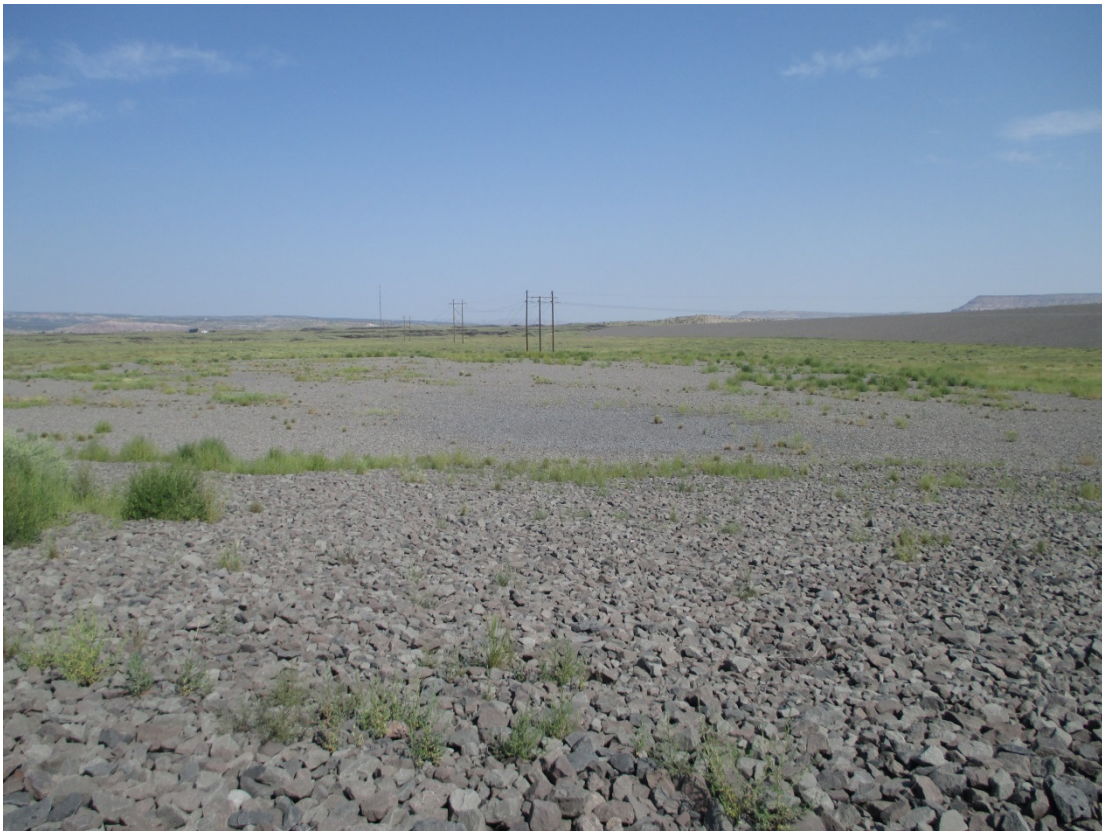
BLU 8/2015. PL-11. Shallow depression on northwest extension of carbonate tailings disposal cell (dry).

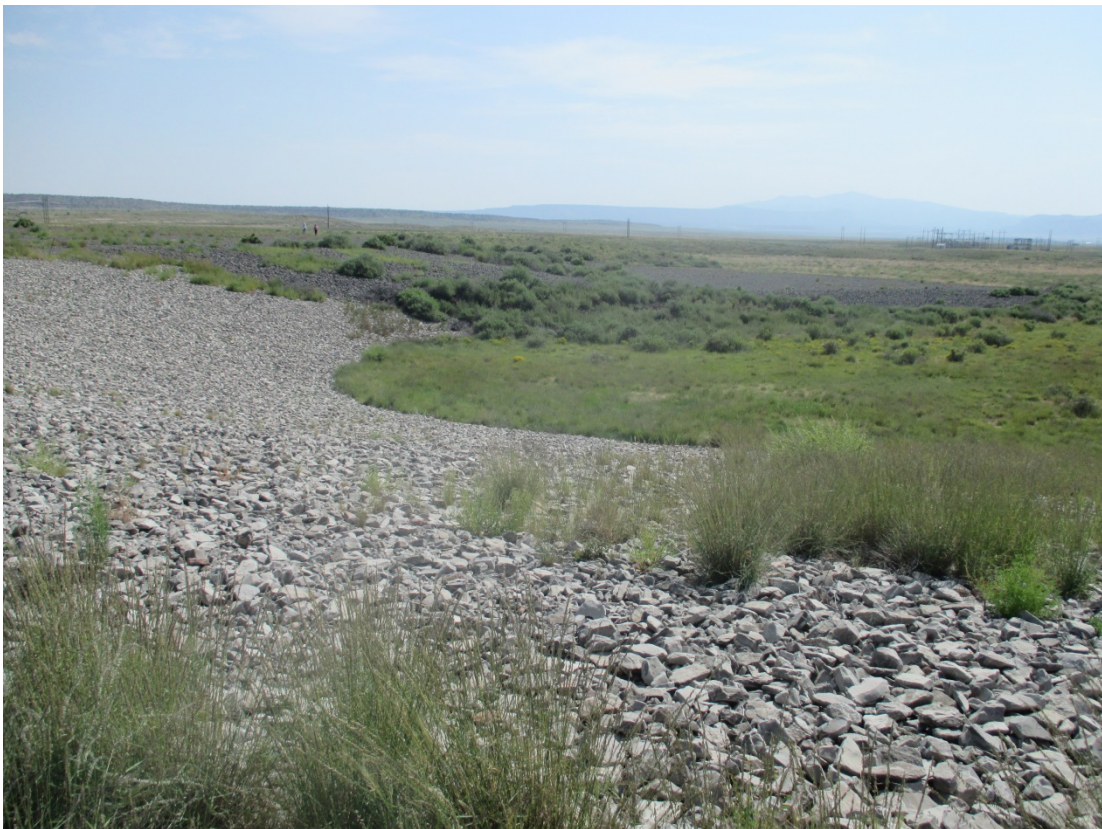
The 2-acre asbestos disposal area is a bowl-like feature just south of the carbonate tailings disposal cell (PL-12). The north, west, and south side slopes of this feature are covered by limestone riprap; the bottom of the bowl (the asbestos cell cover) is grass-covered. The asbestos disposal area was in excellent condition.

BLU 8/2015. PL-12. Asbestos disposal area.

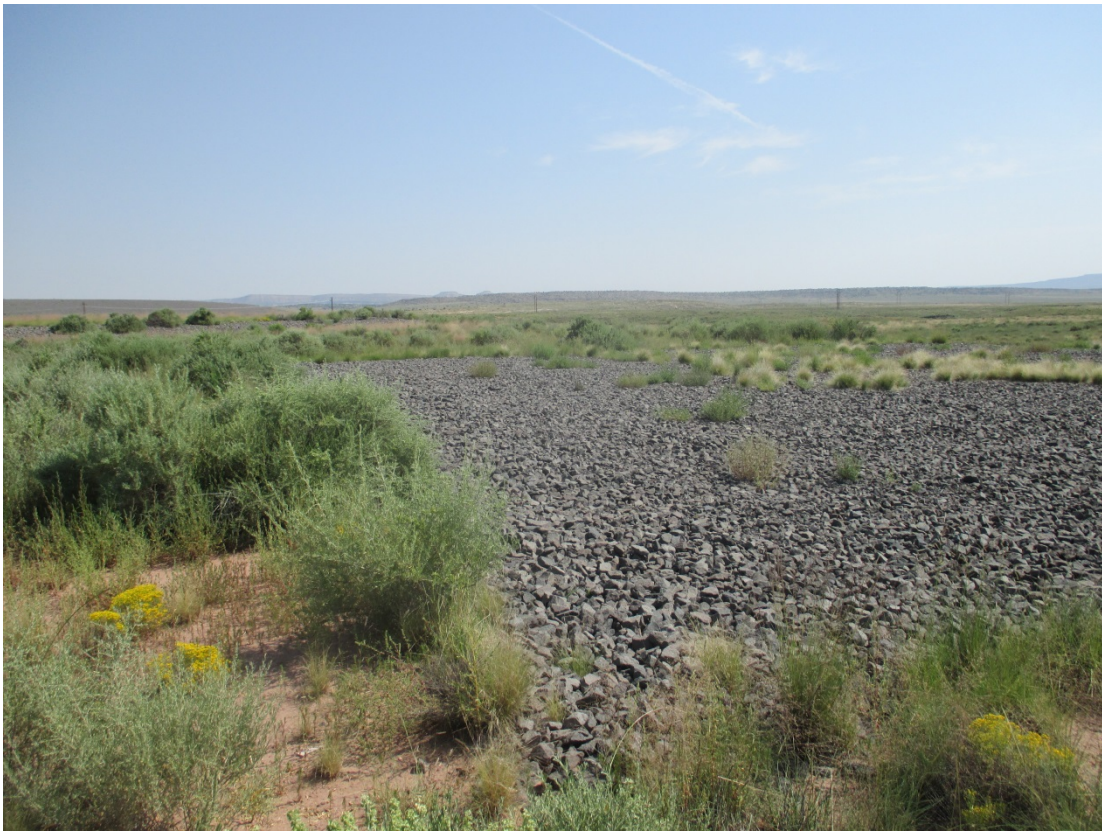
The 11-acre grass-covered Disposal Area Number 1 south of the asbestos disposal area was in excellent condition, as was the small riprap-covered PCB cell located within that disposal area (PL-13). The two grass-covered landfills east of the carbonate tailings disposal cell, totaling about 2 acres, were not checked during this inspection.

BLU 8/2015. PL-13. PCB disposal area.

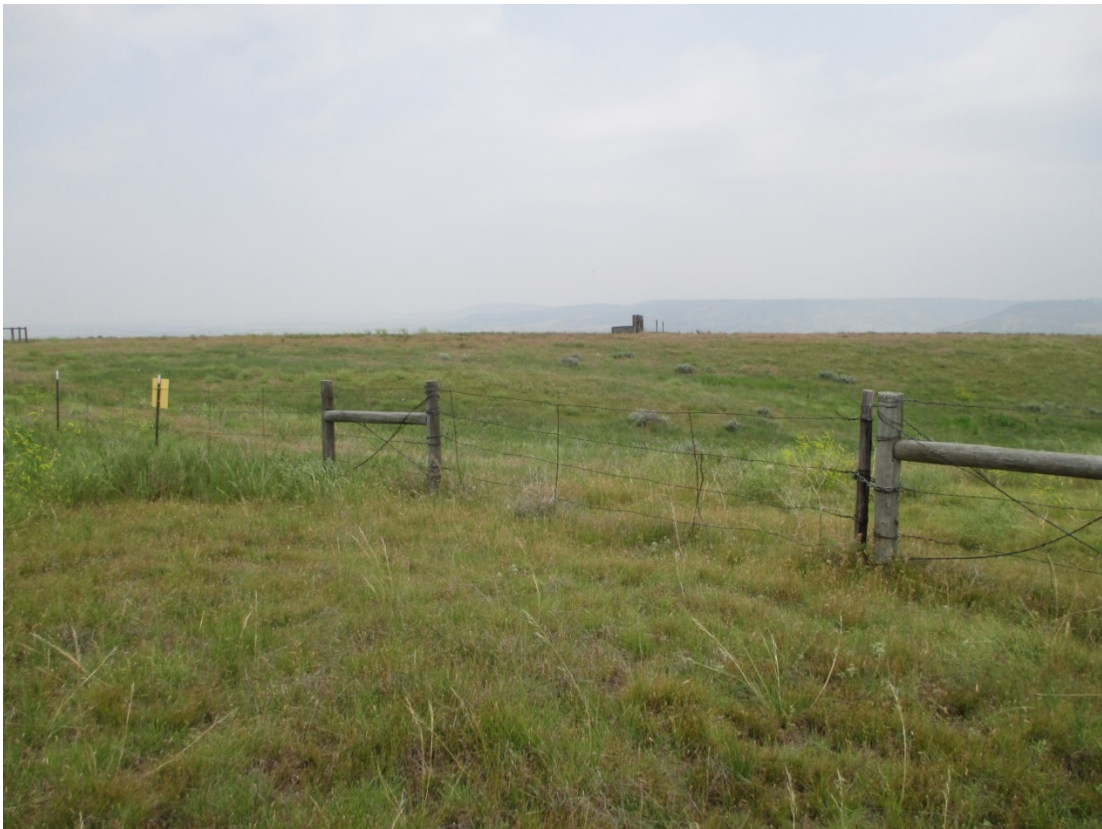
A tubular metal entrance gate is secured by a locked chain and was in excellent condition. Three wire gates are along the perimeter fence: at the northwest corner of the property; approximately 700 feet north of the southeast corner (PL-1); and at the southeast corner of the site. All gates were closed and in good condition.

EDG 7/2015. PL-1. Wire gate and perimeter sign P2 near southeast corner of site.

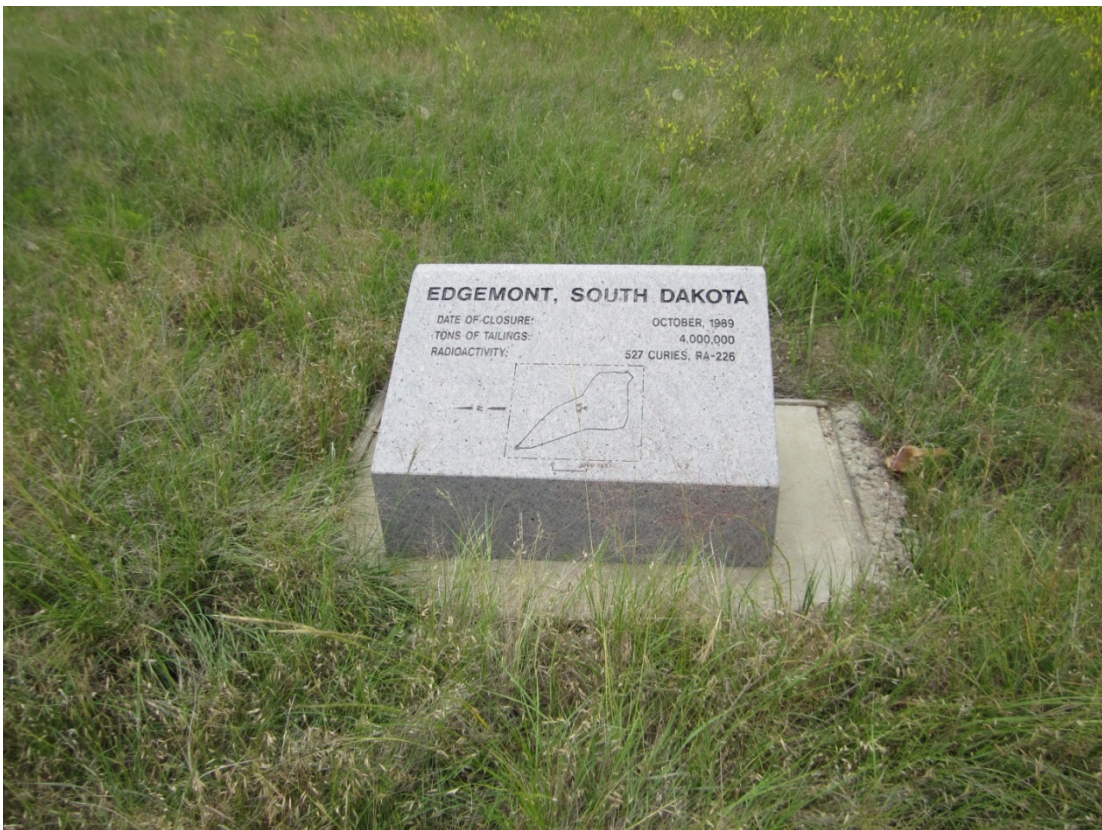
The granite site marker identifying the site is just inside the entrance gate and was in excellent condition (PL-2).

EDG 7/2015. PL-2. Granite site marker.

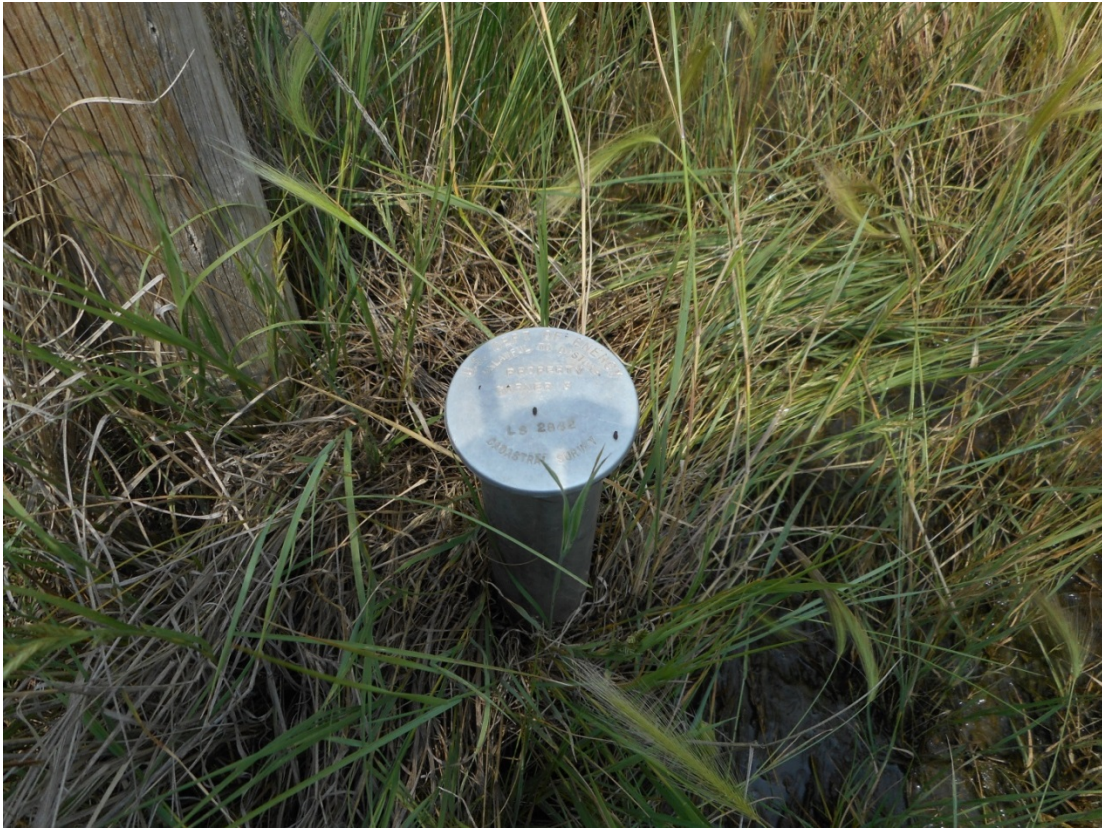
Boundary monuments are located at each of the four corners of the property. The observed monuments were in excellent condition (PL-3).

EDG 7/2015. PL-3. Boundary monument BM-3.

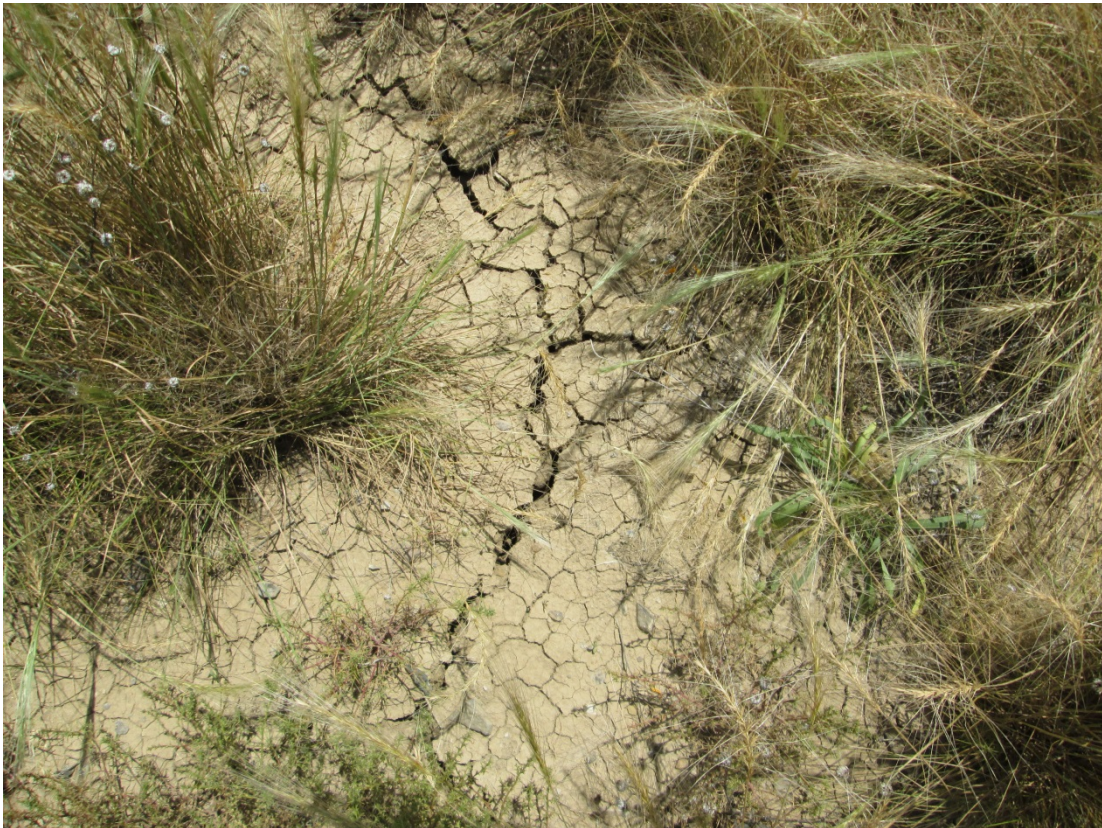
BAR 8/2015. PL-5. Desiccation cracks on the tailings impoundment top slope.

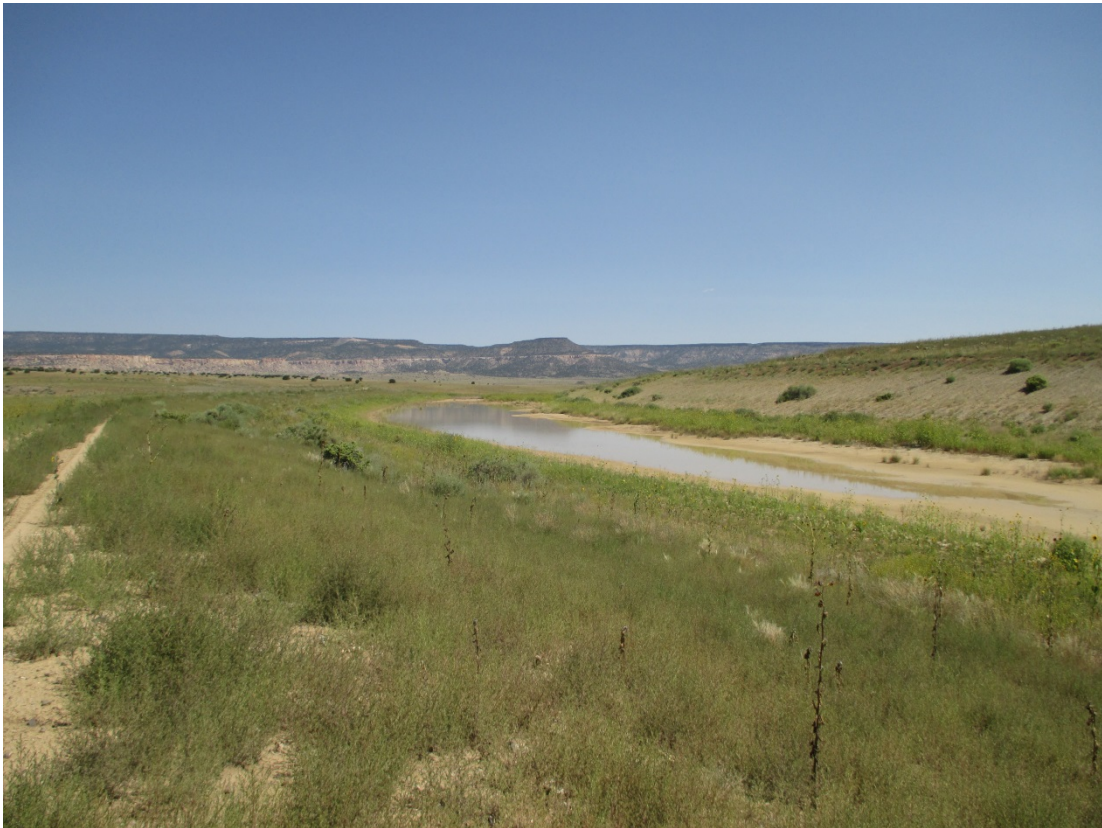
BAR 8/2015. PL-7. Ponded water in east diversion channel.

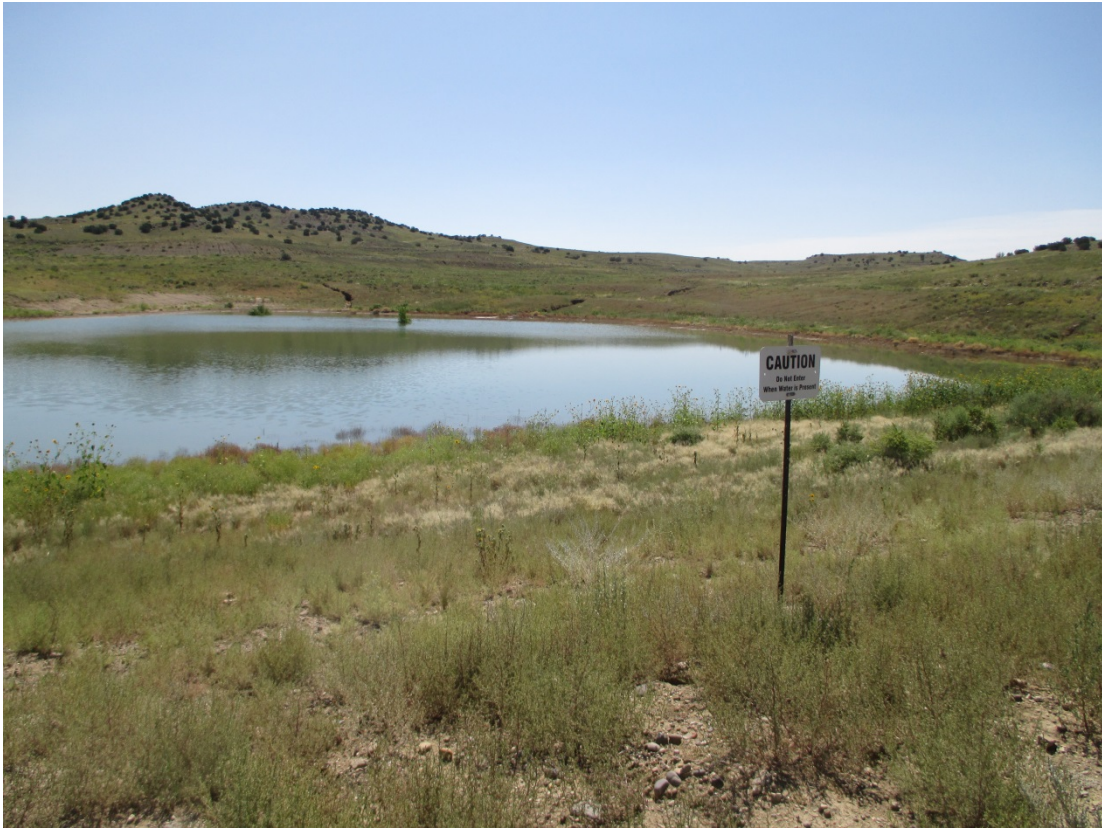
BAR 8/2015. PL-8. Ponded water in sediment trap.

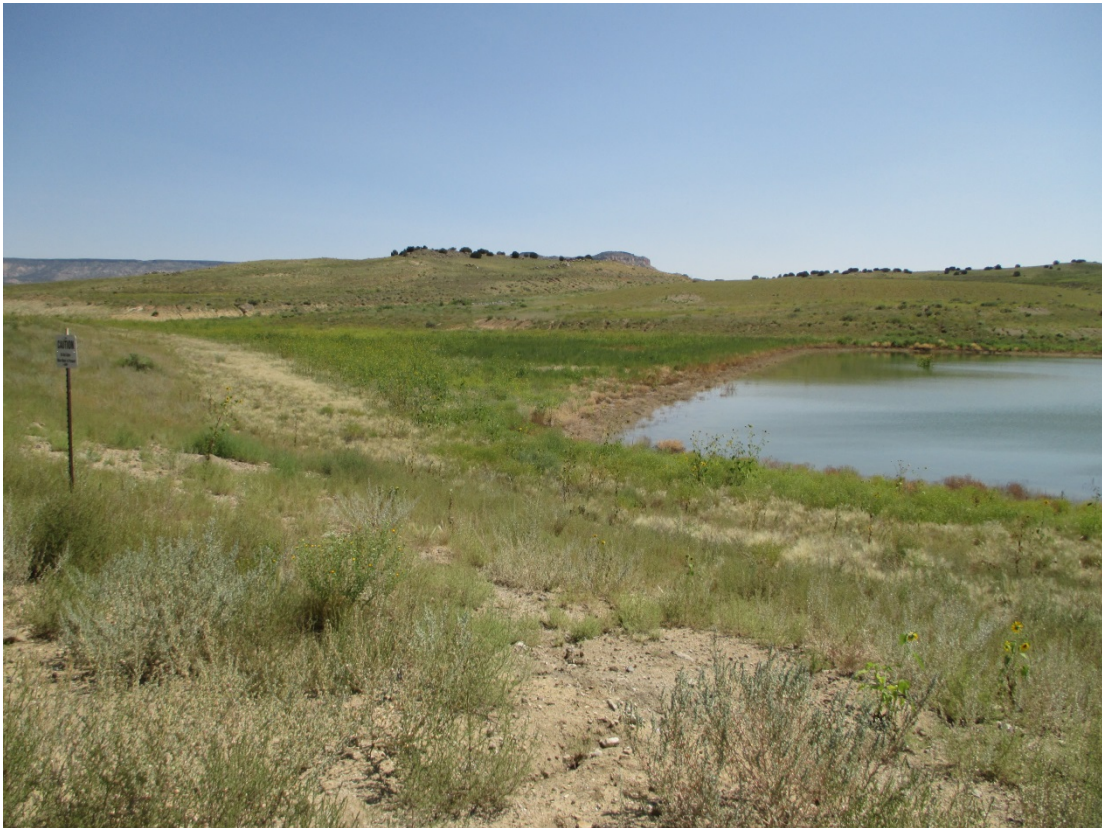
BAR 8/2015. PL-9. Area where ponded water in sediment trap spilled into east diversion channel.

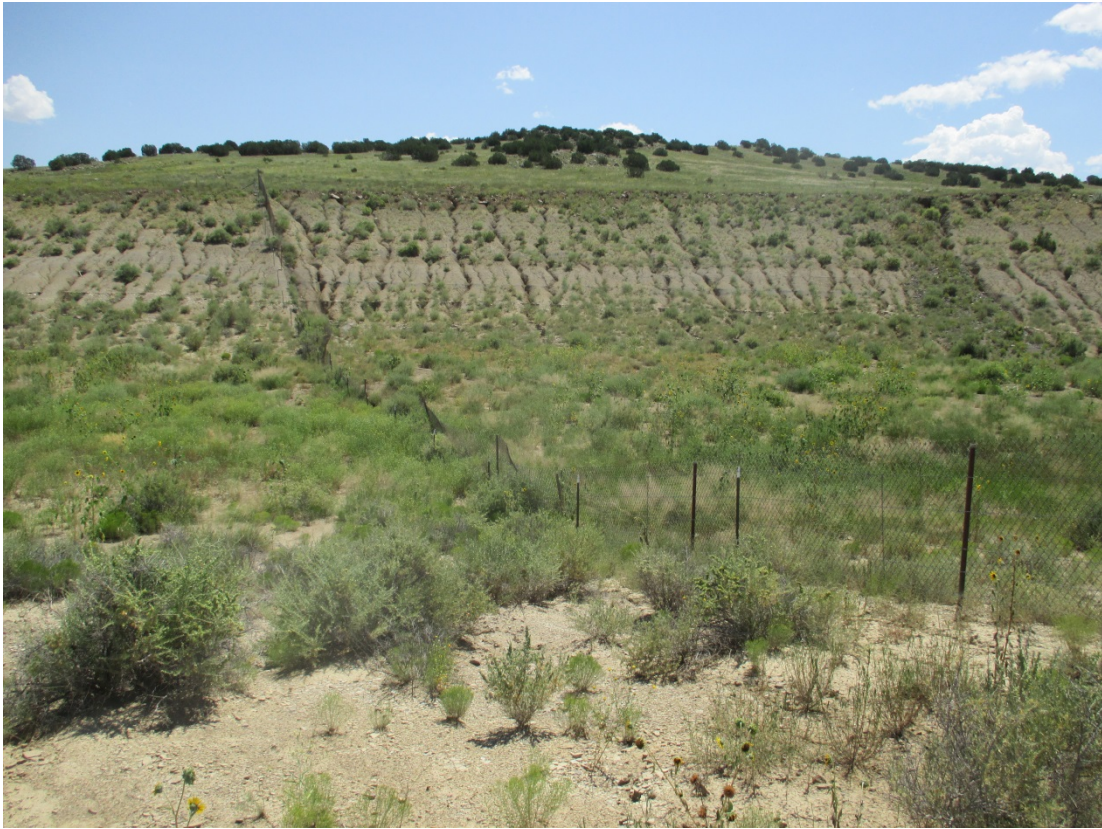
BAR 8/2015. PL-10. Slope erosion and sediment deposition in the south diversion channel.

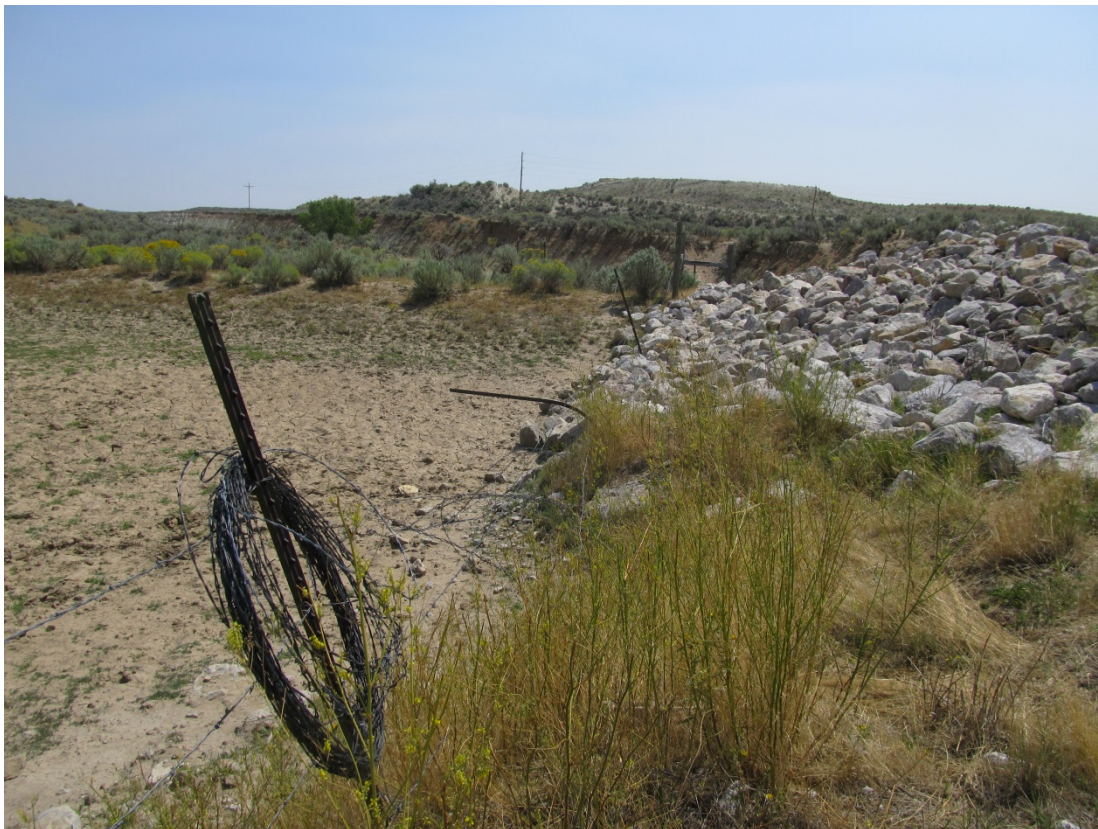
MAW 8/2015. PL-1. Fence damage near Diversion Channel No. 1 outlet channel.

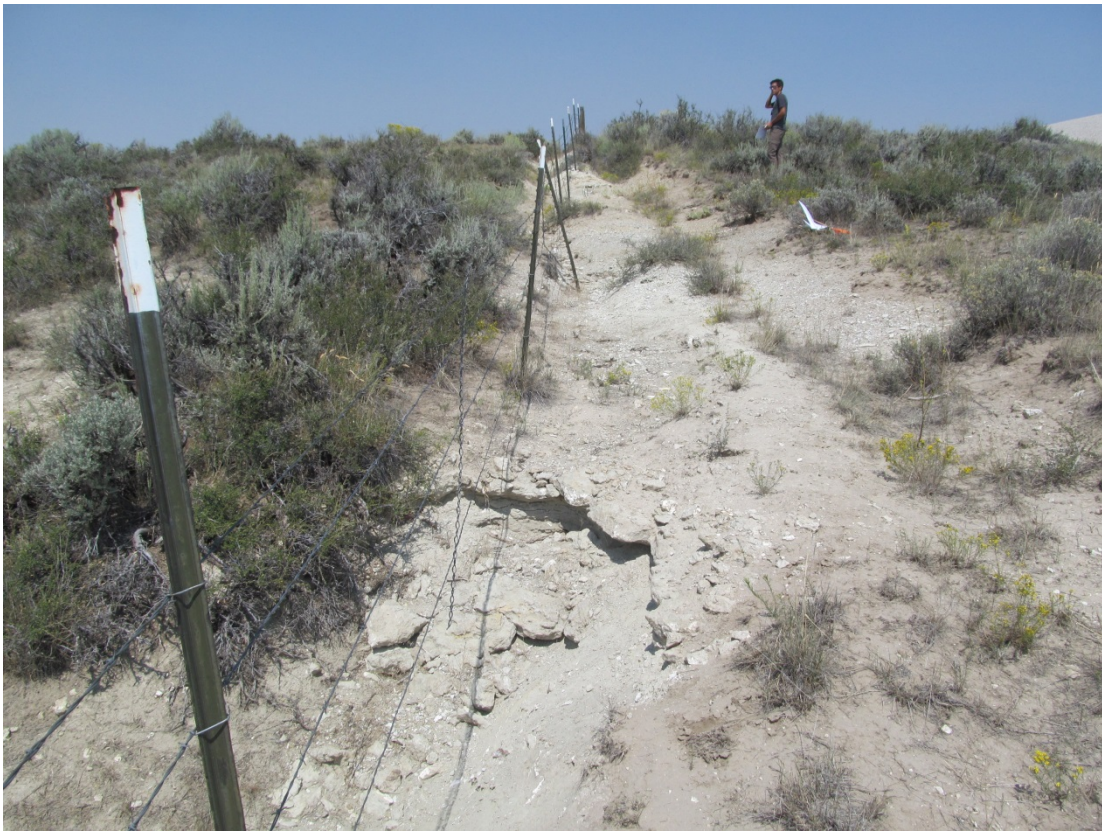
MAW 8/2015. PL-2. Erosion along perimeter fence.

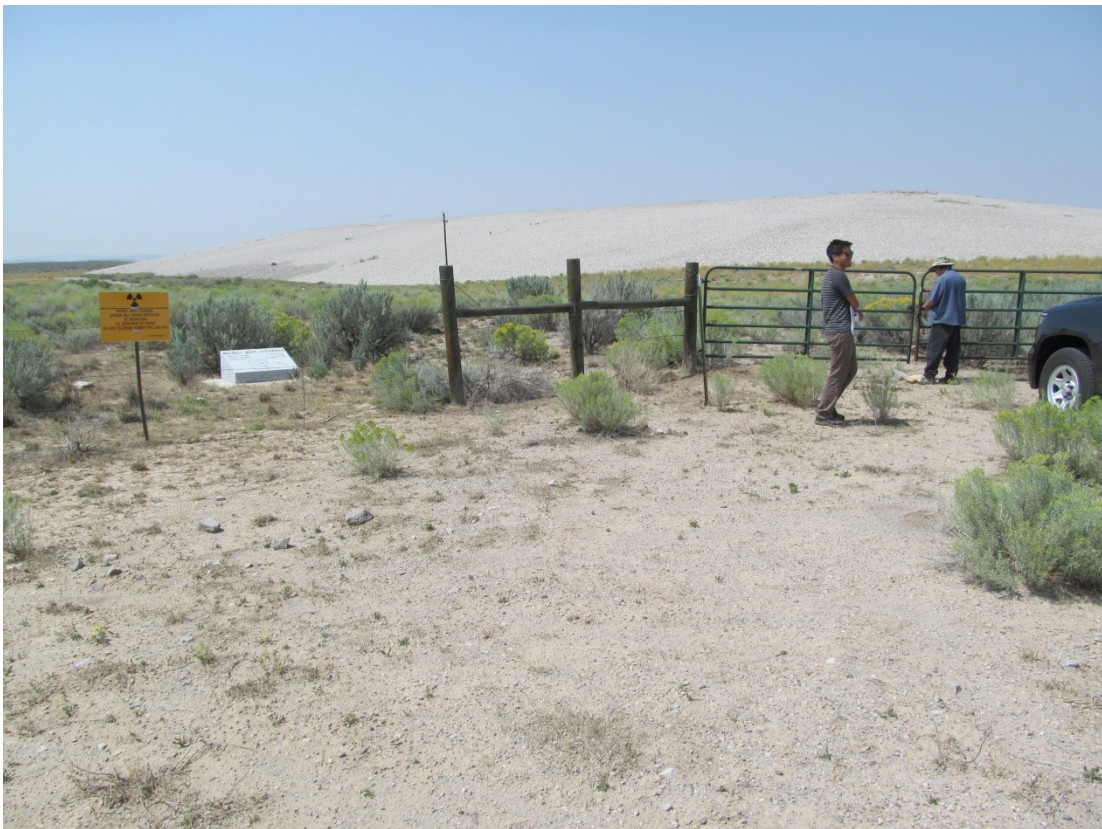
The entrance gate, a standard tubular metal stock gate, is located near the southeast corner of the site (PL-3). The gate was locked and in good condition. There are no other gates at the site.

MAW 8/2015. PL-3. Site entrance gate and sign; site marker in background.

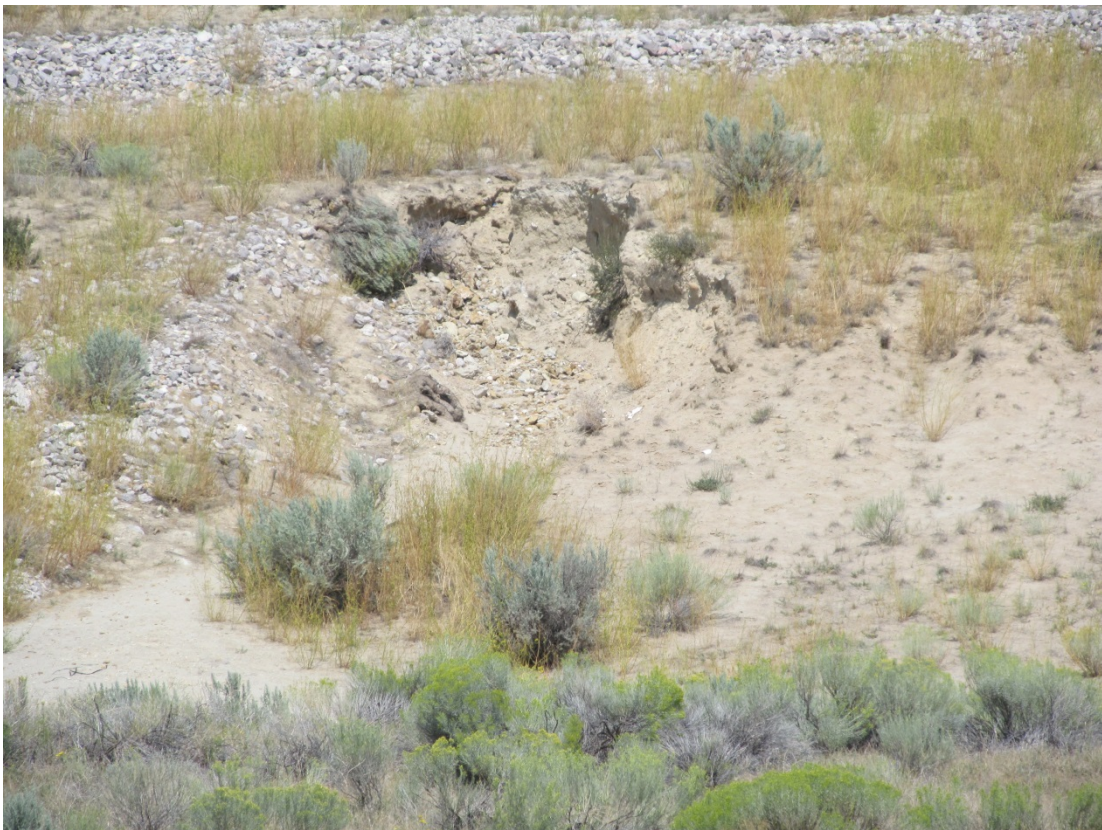
MAW 8/2015. PL-13. Gully on slope south of disposal cell.

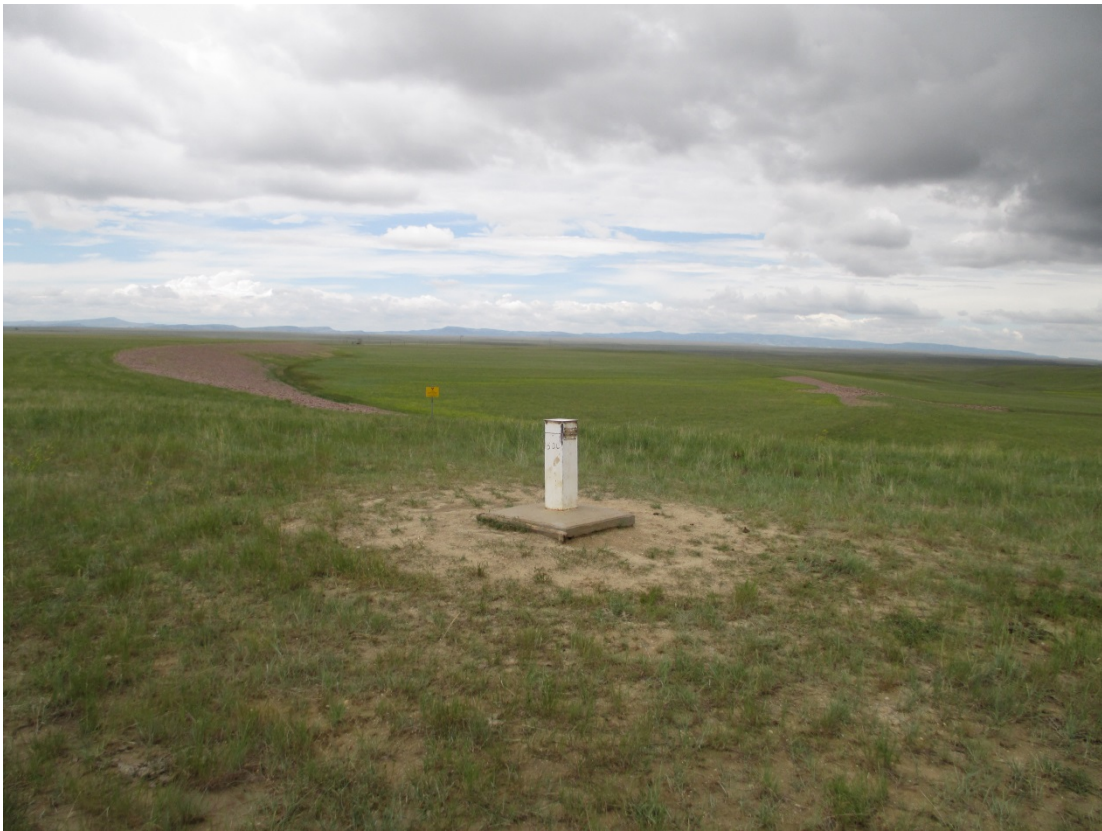
The site groundwater monitoring network consists of 14 wells; six of these wells were installed downgradient of the disposal cell during fall 2008. The wells were in excellent condition (PL-5).

SBS 7/2015. PL-5. Monitoring well 5-DC and lower surface of disposal cell.
