U.S. DEPARTMENT OF
ENERGY

2015 Annual Site Inspection and Monitoring Report for Uranium Mill Tailings Radiation Control Act Title II Disposal Sites

November 2015

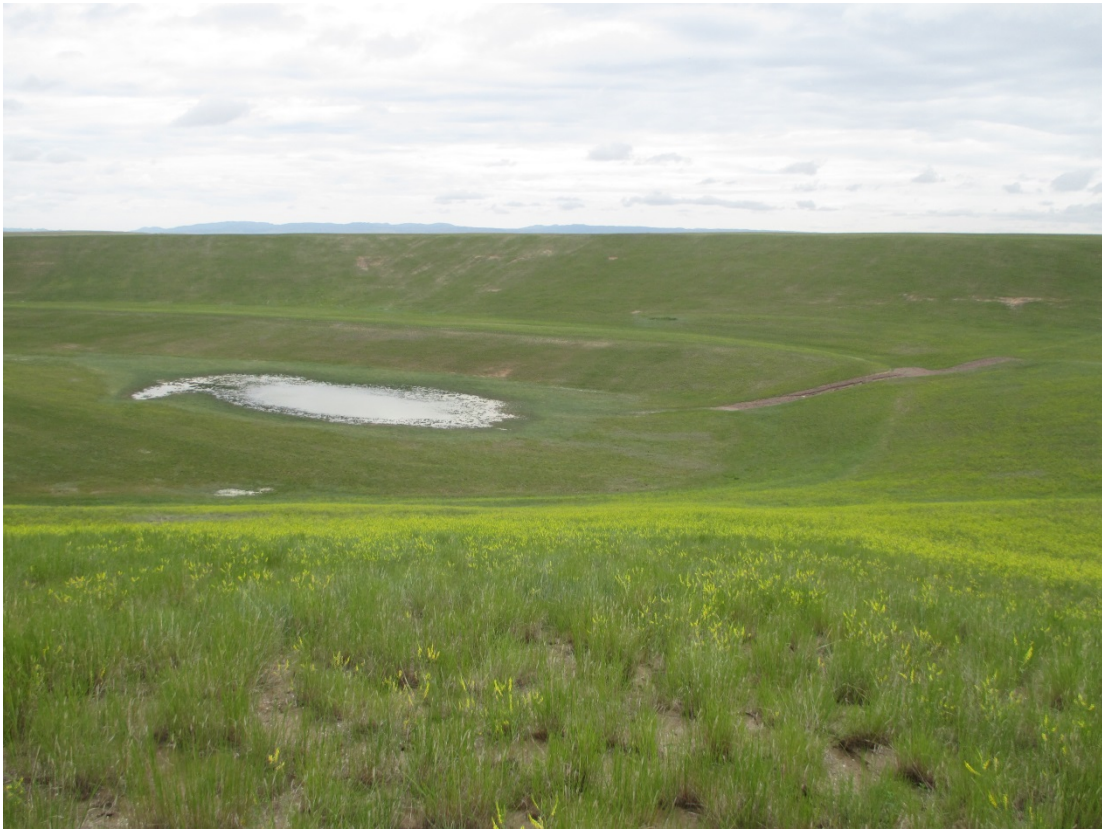
SBS 7/2015. PL-10. Pit 4 with ponded runoff water.

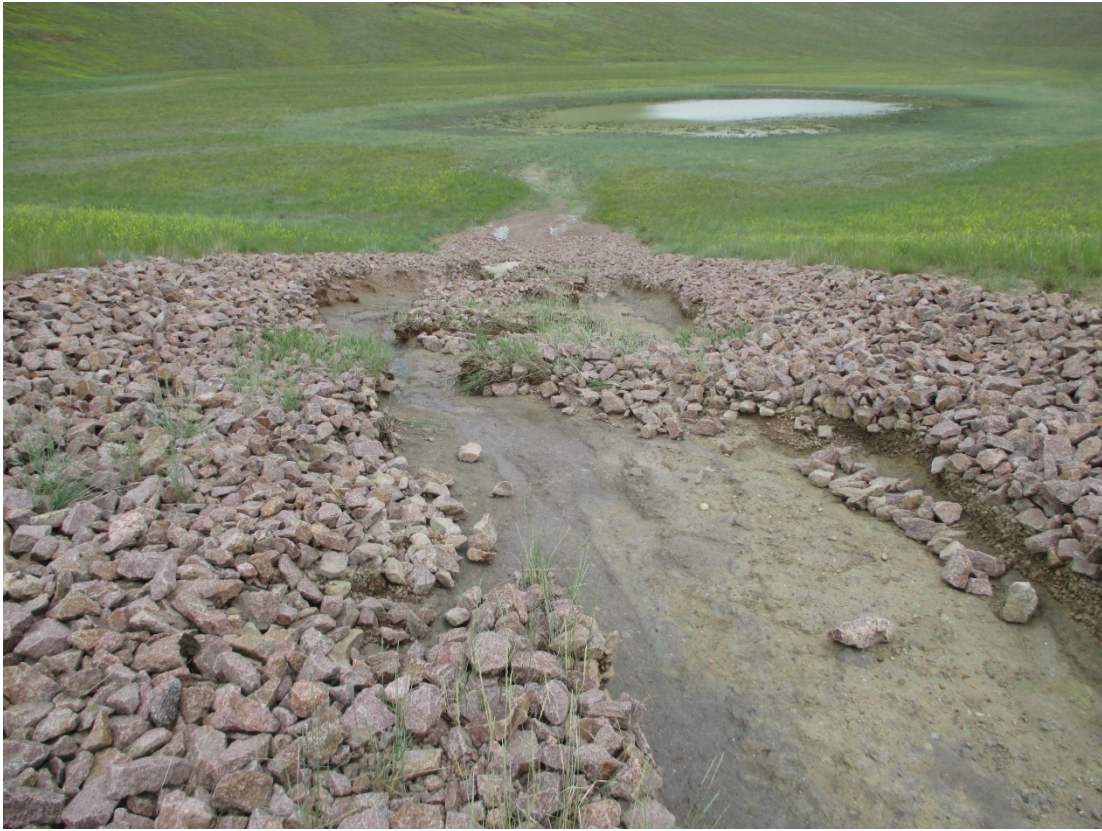
SBS 7/2015. PL-11. Eroded rock-armored channel in south end of Pit 4.
