# SITE 9920

## ACCIDENT INVESTIGATION BOARD REPORT

January 2014

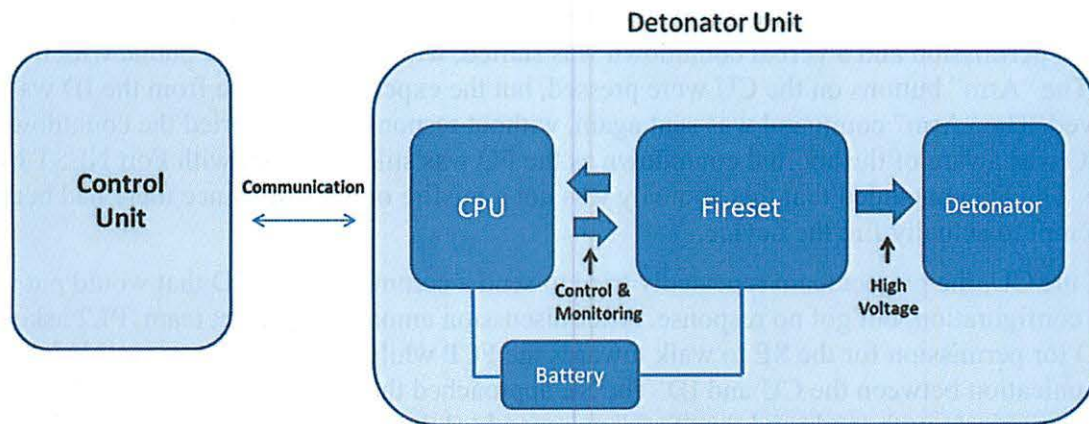
**Figure 2: Block diagram of the integrated system**

After these tests, the project team integrated the components into a single device (Fig. 2).

The TAT identified a number of hardware and software weaknesses in the design of the CU/ID system and used the scientific method to analyze the incident. Failure hypotheses considered were triggering events generated by mechanical manipulation, electromagnetic interference (EMI), and ESD.

It was demonstrated that an armed ID can be easily triggered by either mechanical or electrical mechanisms. These include mechanical insults that can momentarily disrupt battery voltage, thereby resetting the electronics due to a software initialization error, or EMI/ESD events, which can trigger the unit or upset the electronics. Both of these conditions were demonstrated in the laboratory. The system also had weaknesses in maintaining state synchronization between the CU and ID. The exchange protocols provided basic synchronization, but were not robust to losses of communication that resulted in misinforming the operators of the ID's current state.

The system's hardware safety features were not fail-safe and provided "forward only" safety. The software is in sole control of arming and firing for the system and therefore either the software must be designated as safety software by Sandia's corporate procedure IM100.3.5, *Provide Quality Software*, or the hazards must be controlled by means other than the software.
