**U.S. Department of Energy
Office of Health, Safety and Security**

Accident Investigation Report

**Accident Investigation of the June 1, 2013
Stairway Fall Resulting in a Federal Employee
Fatality at DOE Headquarters
Germantown, Maryland**

August 6, 2013

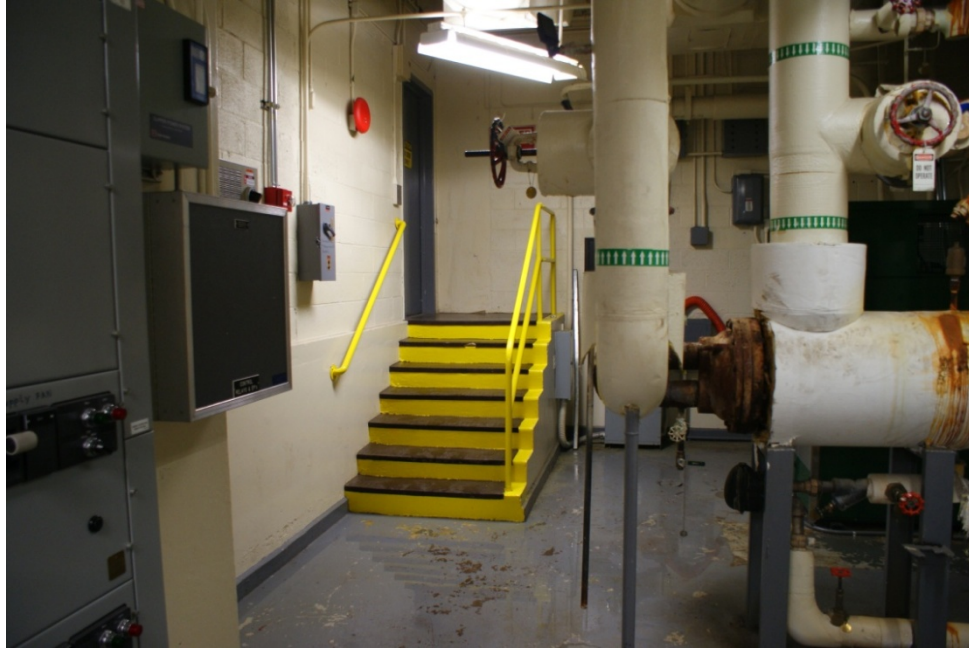
Figure 3: Mechanical Equipment Room 7 Entrance Stairs

The photographs in Figures 3 and 4 were taken two days after the accident by the initial investigator. Figure 3 shows the scene of the accident and the stairs leading into MER 7. Figure 4 shows the side view of the stairs.

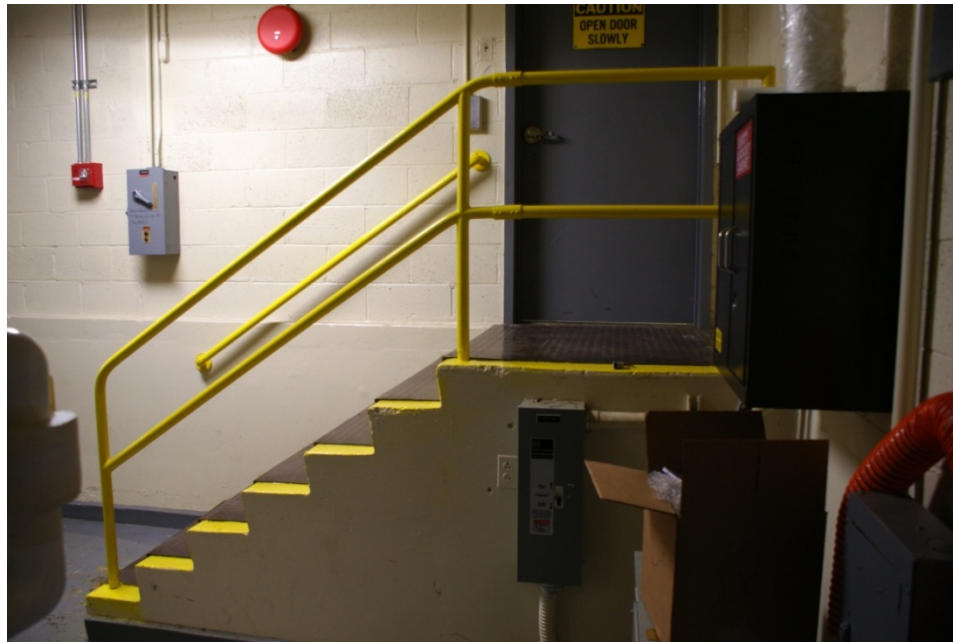
Figure 4: Mechanical Equipment Room 7 Stair Details

The stairs are poured-in-place concrete. The stairs have six steps, handrails on both sides, and a large landing area; the door opens into the hallway, not into the landing space. The steps in MER 7 are covered with rubber stair treads made by Flexco Floors.

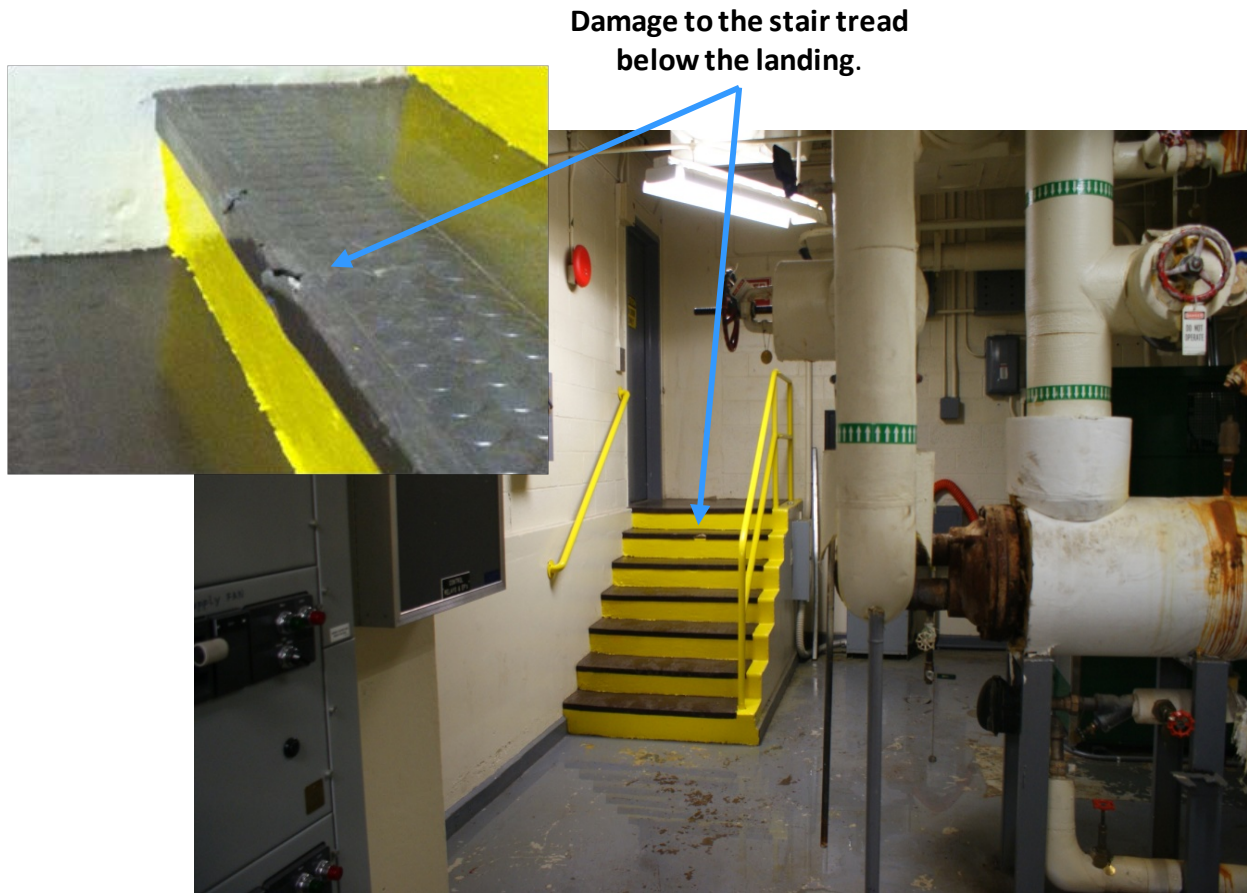
Figure 5: Damaged Edge of the Second Step on Mechanical Equipment Room 7 Stairs

In Figure 5, the inset image was taken by Pro Force (PF) personnel on the day of the accident shortly after the accident occurred. This inset shows the damaged edge of the top step present at the time of the accident. The damage was approximately two inches in length and the photo on

the right in Figure 5, taken two days later by Office of Industrial Hygiene and Safety (MA-433), shows tread damage cut away by PF.

In April 2013, the old drinking water filtering and cooling system in MER 7 was removed and replaced with a new Filtrine system. During this task, the stair railings were temporarily removed and reinstalled for equipment removal. The installation contractor stated that the stairs were scuffed. In the opinion of the Board, this was the only major work performed in MER 7 for the three to six month period prior to the accident that is likely related to damage noted on the stair treads after the accident on June 1, 2013. The Board found no one noticed and reported the tread damage before the accident.

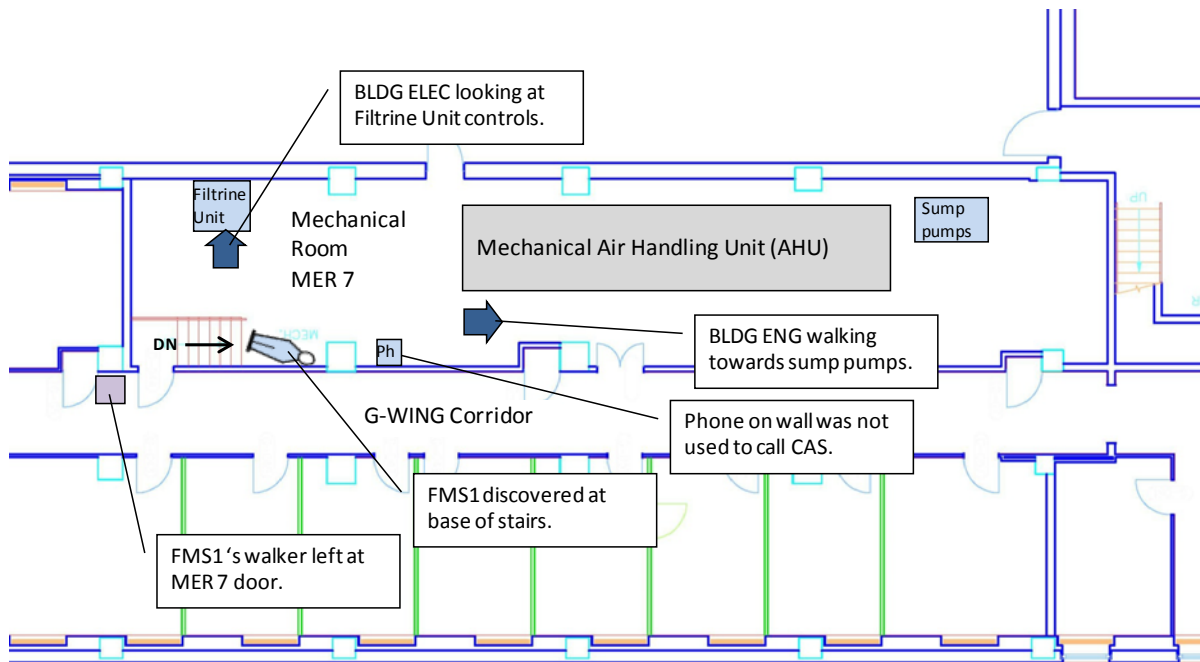
Figure 9: Mechanical Room 7 Floor Plan

The Board believes the fall was the result of FMS1 descending or transitioning from the stairs to the floor. FMS1 was last observed standing on the landing at the top of the stairs. However, the lack of other falling noises and the extended position of the body with the feet near the stairs and the head away from the stairs strongly suggest that FMS1 was at or near the bottom of the stairs when he fell. It is unclear what caused FMS1 to fall.

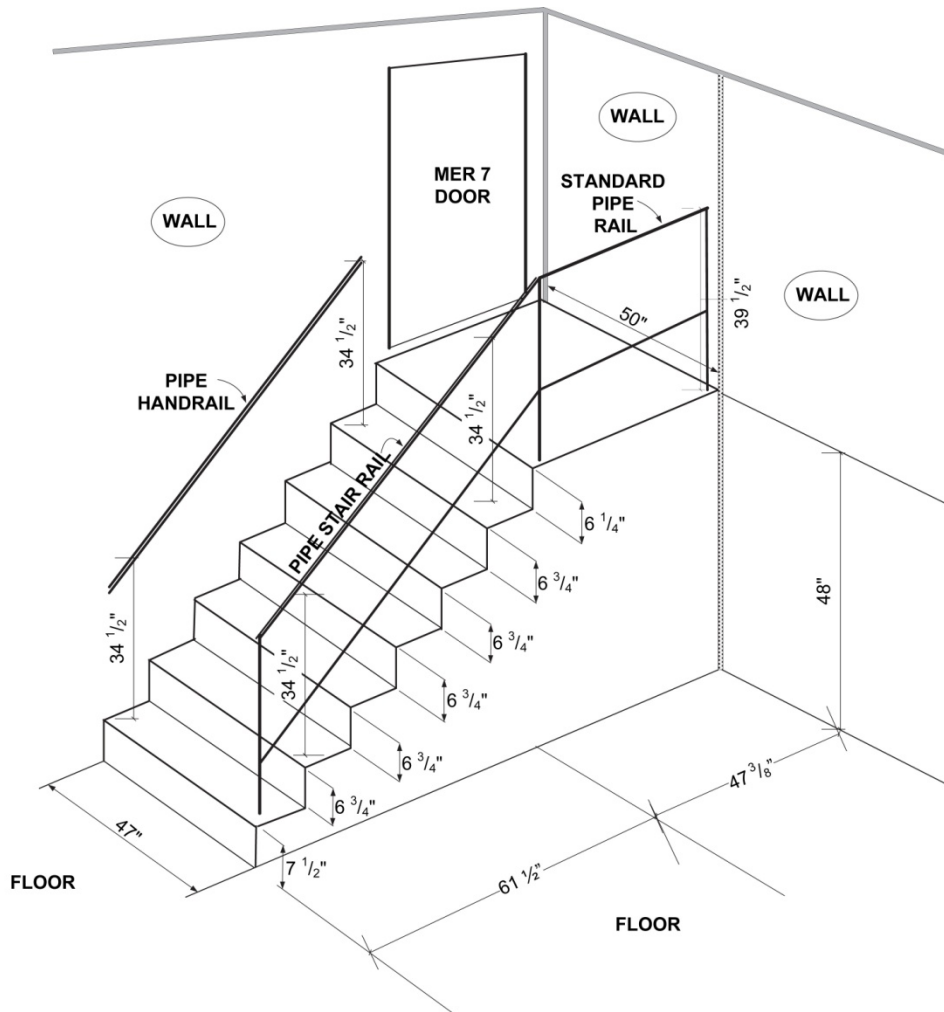
Figure 10: Isometric Drawing of Mechanical Equipment Room 7 Stairs

- FMS1 may simply have fallen due to his physical limitations;
- FMS1 may have caught his foot on the rail post at the top of the stairs because the toeboard was missing, which provides a vertical barrier at the floor level along the exposed opening at the landing;
- FMS1 may have tripped on a torn stair tread cover; or
- FMS1, leading with his cane, may have lost his balance at the bottom step because the rise of the bottom step was 0.75 inches greater than the previous steps, which would have been an unexpected condition.

CC6: The MER 7 stairs were not in compliance with codes and standards, and were not in optimum condition for traversing.
