**Independent Oversight  
Inspection of the**

# **Hanford Site Chronic Beryllium Disease Prevention Program**

**June 2010**

Office of Independent Oversight  
Office of Health, Safety and Security

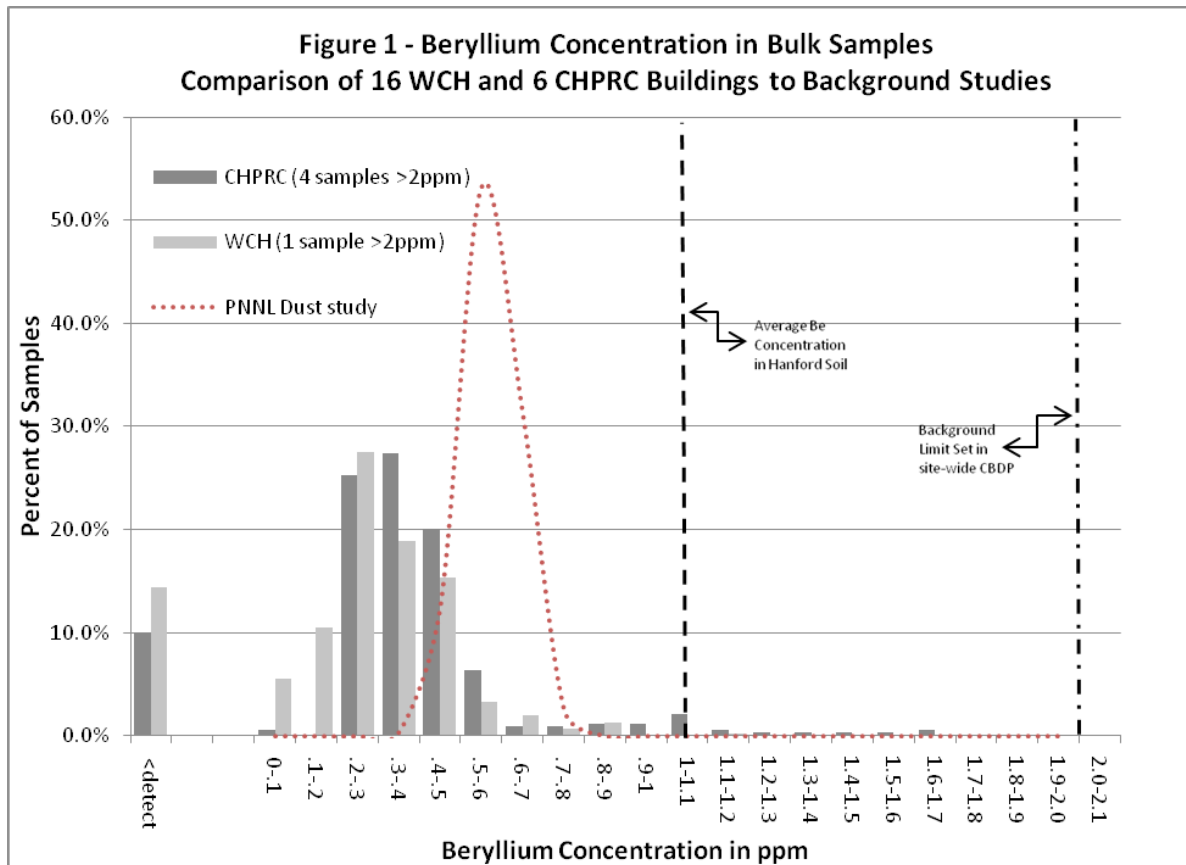
To examine the applicability of these background studies to bulk sample results at Hanford, the HSS inspection team compared the bulk sample distribution profile from 16 WCH and 6 CH2M-Hill Plateau Remediation Company buildings to the beryllium background data for local soil and airborne dust. In general, the beryllium concentration in bulk samples collected in the buildings was considerably lower than the average beryllium content in Hanford soil and somewhat lower than the background distribution profile of beryllium content in airborne dust (see Figure 1).

This comparison indicates that, in addition to some fraction of tracked dirt and settled natural dust, the building dust includes a composite of materials from a variety of other sources as well (which may include paper dust, fabric fiber, biological materials – skin cells, insect parts, etc. – and a variety of other materials) that may be essentially beryllium free. The relative fraction of each may vary widely; a bulk sample from a piece of earthmoving equipment may be nearly 100% soil, whereas an interior dust sample from an office mailroom may have a relatively high percentage of cellulose. In some cases, the

dust may also include material from beryllium-handling activities that would constitute contamination. It is not possible from this beryllium concentration data alone to determine the relative contributions of naturally occurring soil beryllium to anthropogenic (human-caused) beryllium from past operations.
