Department of Energy  
Office of Inspector General

SUBJECT: Letter Report on Environment, Safety & Health Issues at the Ashtabula Environmental Management Project, INS-L-01-05

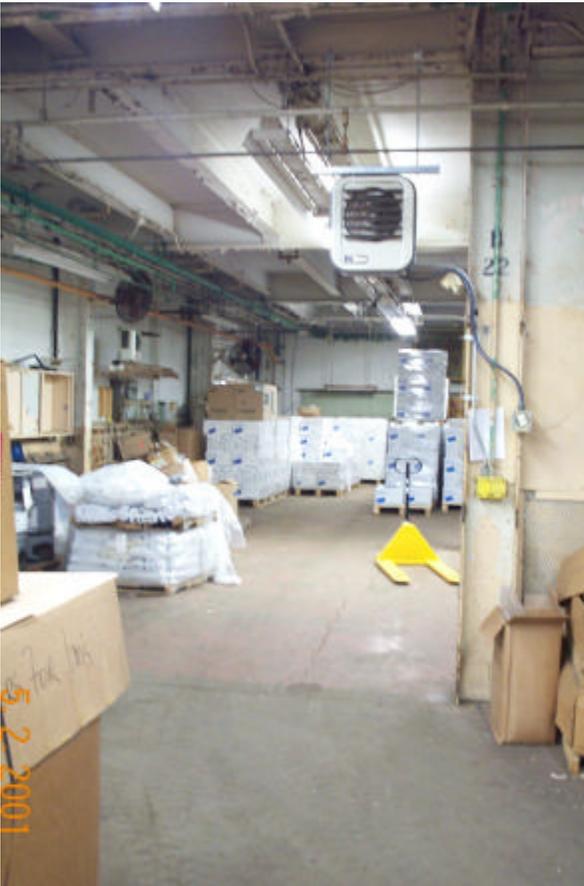
1. The photograph to the left shows a view of the DOE storeroom at Ashtabula and pallets of copy paper, approximately 21, with each pallet holding approximately 40 boxes. Note the operating heater in the top right corner of the photograph. An inspection of the copy paper found it to be covered with grime, with many boxes being “3-hole” type and many boxes being “legal size.”

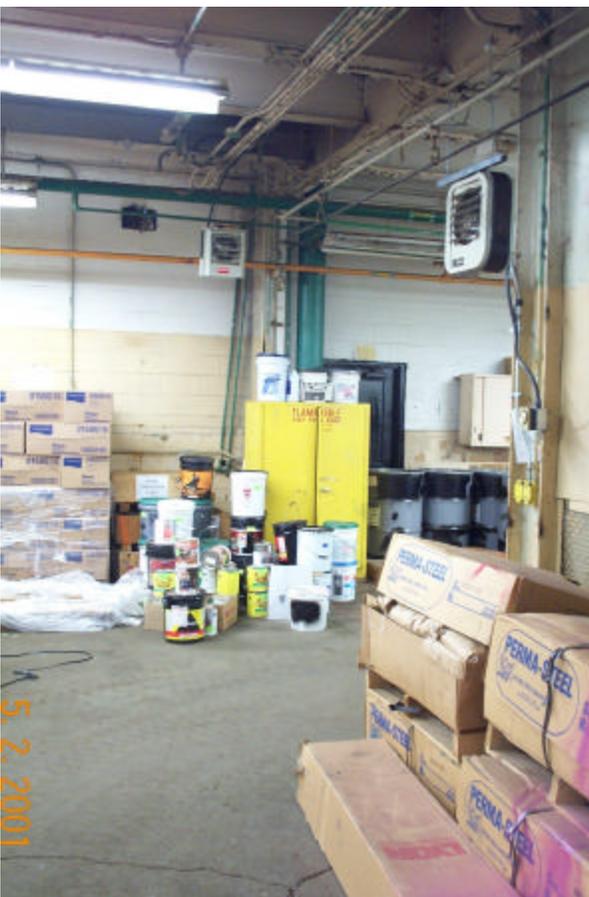
2. The photograph to the left shows a view of the DOE storeroom as seen by one entering through the main door. In the center of the photo is a fire cabinet marked “Flammable Keep Fire Away.” There is a heater above the cabinet and heater directly opposite cabinet in upper right of photo. In the floor, stored in the open and not inside a protective cabinet, are flammable/combustible containers which include black top tar, paint, deck stain, and roof sealer. There are additional items stored on top of cabinet. Finally, note that on the left side of the photo, is a stack of cardboard boxes containing paper products.

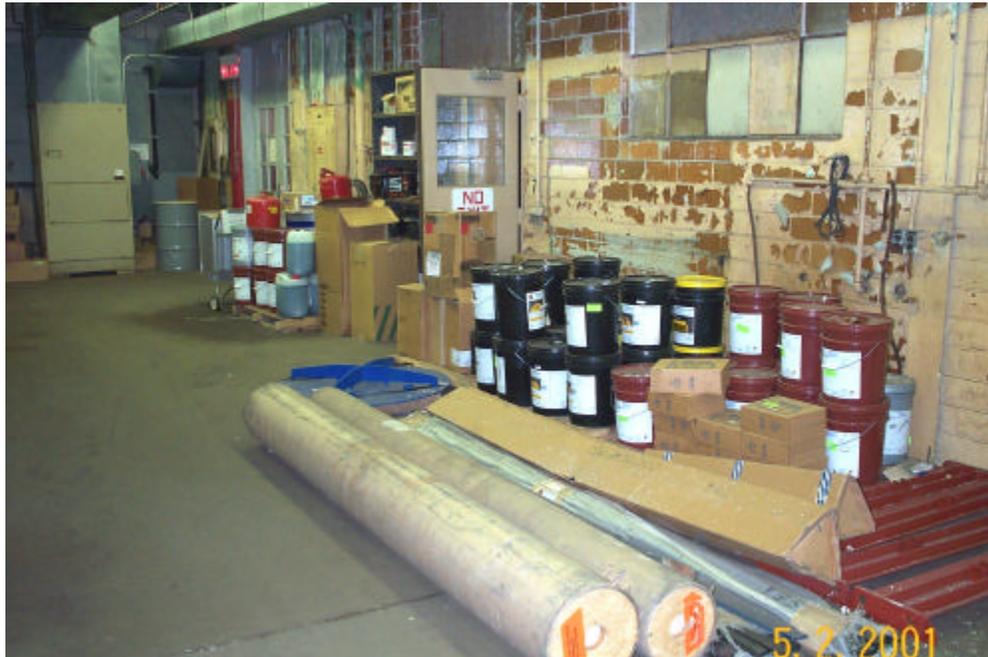
3. The photograph above shows a view the DOE storeroom. Shown are pallets holding hose lubricant, transmission and drive train oil, gasoline cans, hydraulic oil, and brake fluid. In the upper left, just in front of the gasoline can on the left, is a floor heater bearing a warning that it should not be near flammable materials.

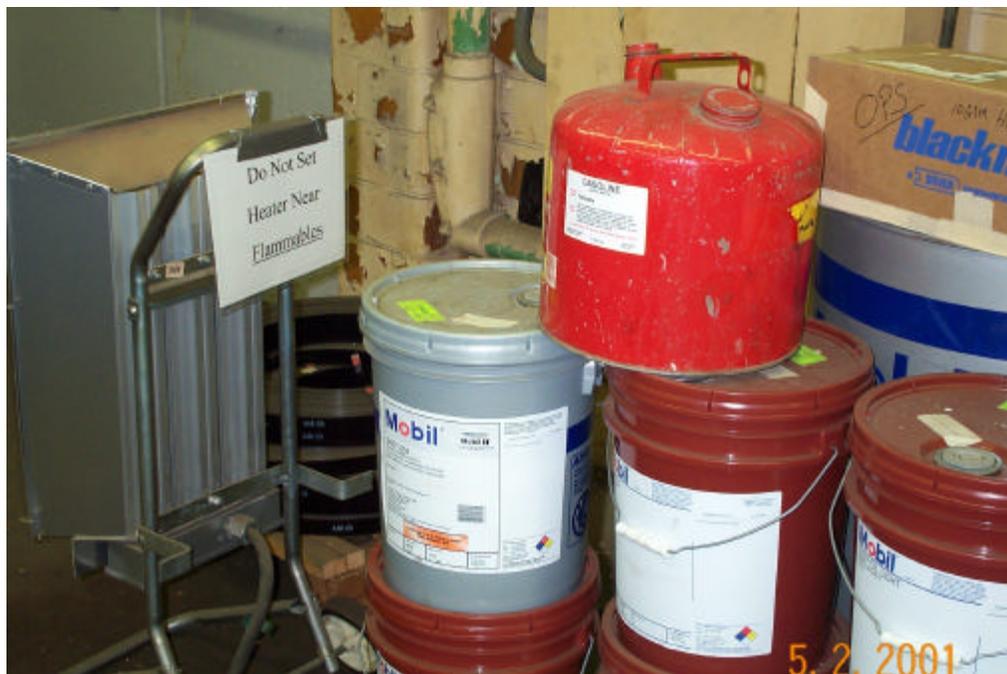
4. Photograph above shows combustible/flammable liquids stored in DOE storeroom in front of heater. Heater was "hard wired" into the wall. Note that heater bears a sign reading "Do Not Set Heater Near Flammables."

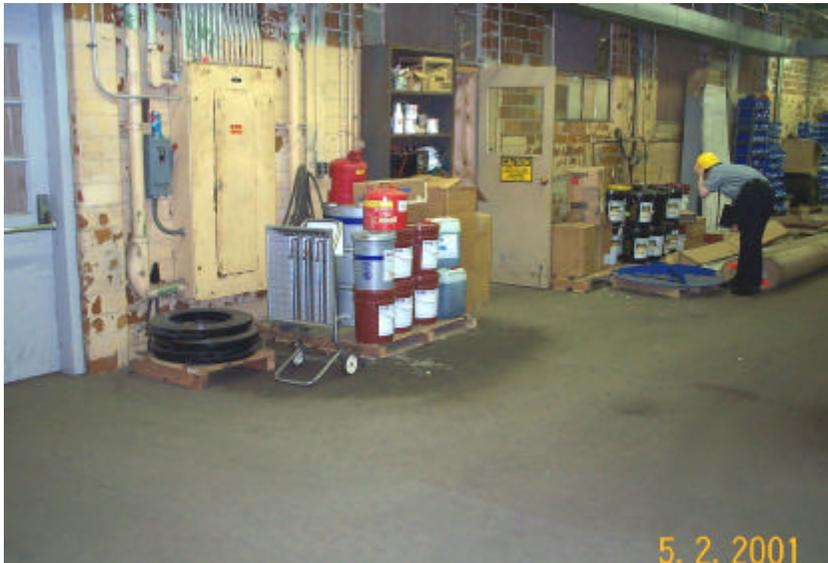
5. Photograph on left shows an expanded view of the previous photograph. Note heater, gasoline cans, and proximity to electrical cabinets behind the pallet. Behind the pallet is a door leading to another area of the storeroom where cardboard boxes of equipment is stored.

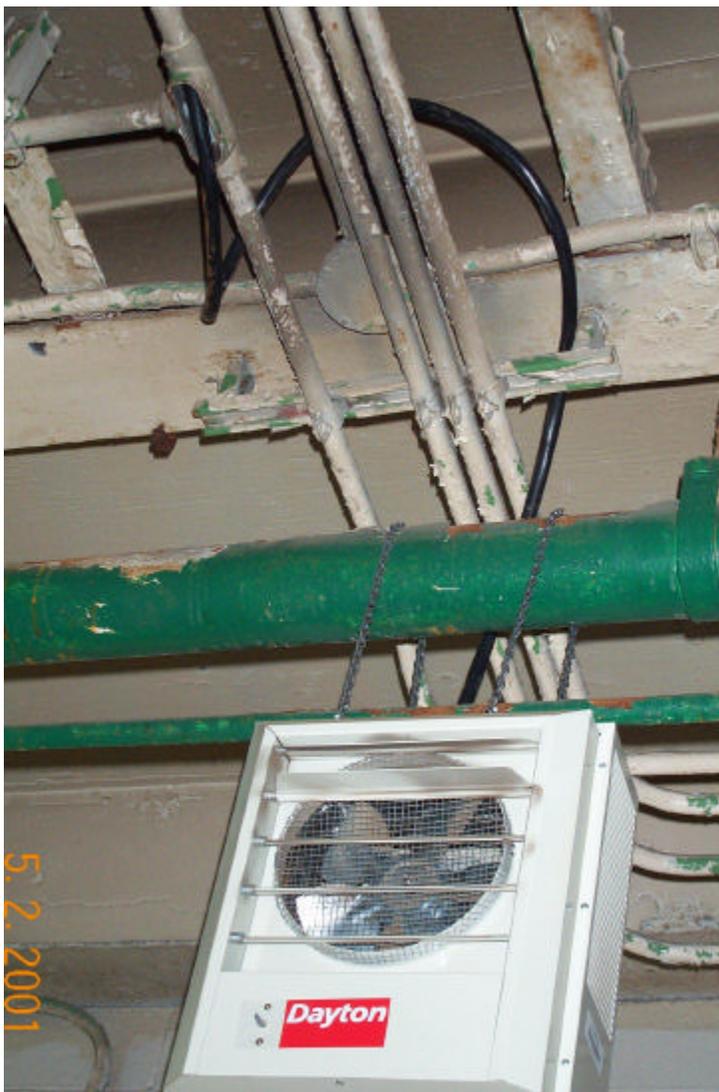
6. Photograph on left shows close-up of wiring of a ceiling heater that is positioned above the fire cabinet in the DOE storeroom. Note that the wire is not in conduit, the wire runs through the metal structure, and the wire appears to be kinked.

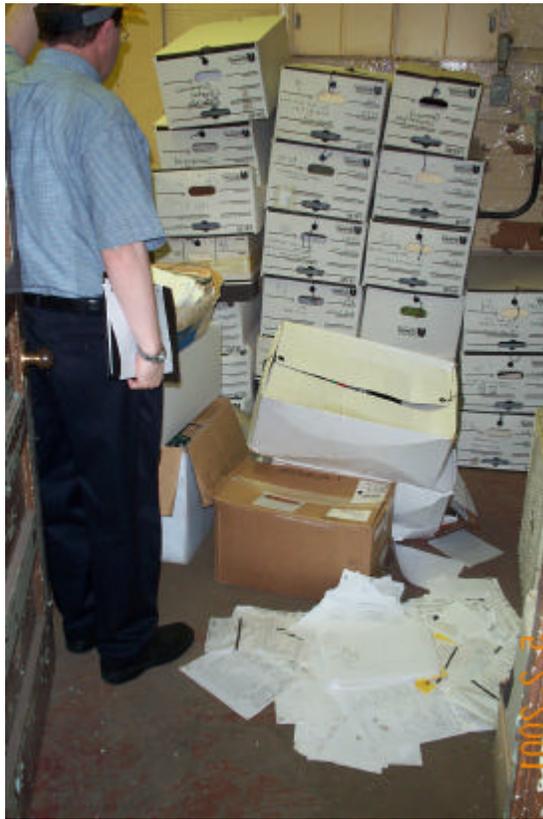
7. The photograph to the left shows conditions in a small closet type room that opens off the DOE storeroom. Multiple boxes of paper were present with papers in the floor. This material all contributes to the fire fuel load in the DOE storeroom. The Inspector was told by the Earthline property and records manager that these documents were the property of Earthline's parent company, RMI Titanium, of Niles, Ohio. The property and records manager did not believe that DOE was paying for the storage of these non-DOE records. However, when briefing the DOE site manager on the storeroom conditions he disagreed and he stated these records were being stored in space leased and paid for by DOE. A master drawing of DOE leased space in Earthline's Plant 2 appears to confirm the site manager's belief.

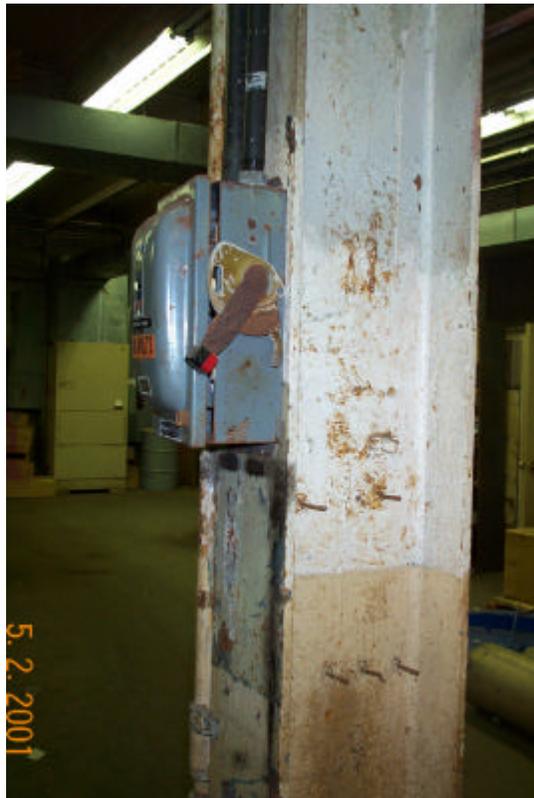
8. Photograph at left shows one example of several 480-volt electrical boxes located in the DOE storeroom. Note that the door on the box is partly open, and the box itself is corroded. There is no tag or lock present on the box to indicate whether or not it is electrically energized, or to indicate what device, if any, the box operates.

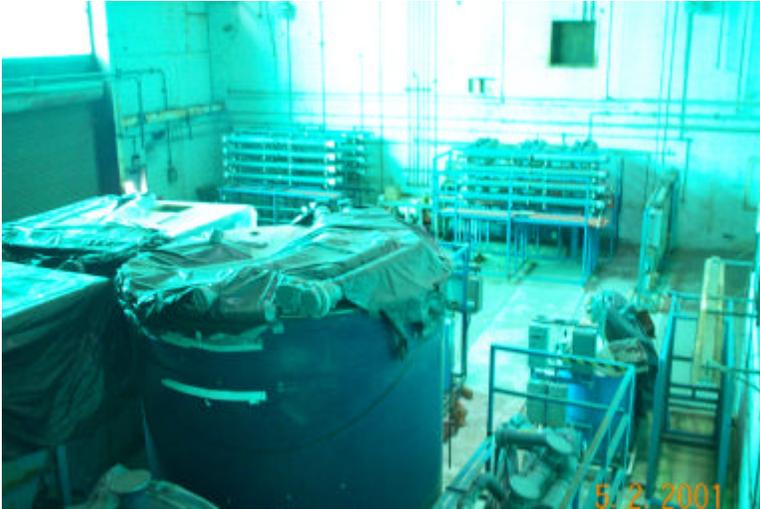
Another concern relates to a Department wastewater treatment plant stored on Earthline Plant 2 property in an area leased by the Department (see photograph 9). This plant was transferred to Ashtabula from the Department’s site in Grand Junction, Colorado, in January 1999. Our physical inspection revealed a light coating of yellow dust on the majority of the plant equipment. A September 30, 1998, report prepared by an Earthline (then RMI Decommissioning Project) contractor employee in preparation for acquiring the plant described the plant as “lightly contaminated with uranium and radium from mill tailings.” Earthline documents show that the plant was delivered in January 1999, but was not surveyed by the Earthline health physics technicians until November 1999 at which time it was found to contain significant radioactive contamination. A contamination survey report indicated that contamination control restrictions were not placed on the area where the plant was stored until after the November 1999 survey.

9. Photograph at left shows a wide view of the wastewater treatment plant obtained from Grand Junction, CO, in 1999. This wastewater plant is now stored on Earthline property in Plant 2.

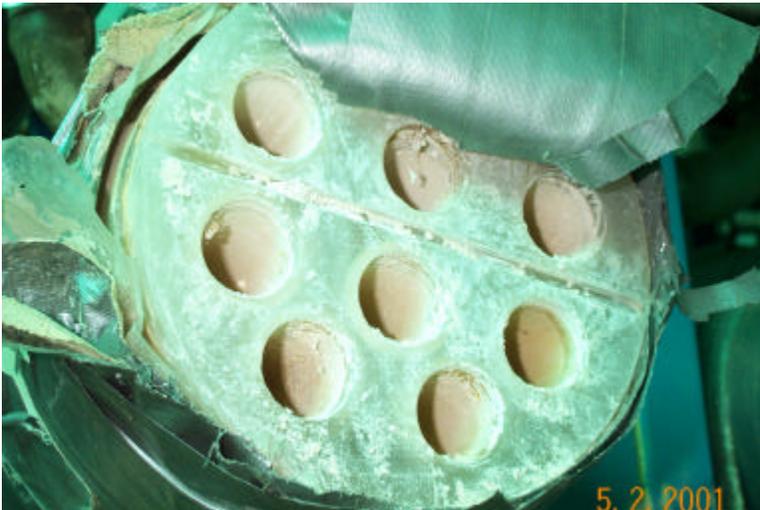
Photograph 10 shows a close up of one of many “resin” columns associated with the wastewater treatment plant. We inspected the columns and found them to contain a buildup of yellow dust. Our attempts to determine the exact nature of this dust during our visit were unsuccessful. Following our site visit, Earthline surveyed the columns and found that radioactive contamination levels were within acceptable levels. However, this survey did not sample or analyze the yellow dust in the columns to determine whether it was toxic or hazardous. We were told that the November 1999 radiation survey, which resulted in the posting of the room as a controlled area, was conducted after a safety concern was raised. However, Plant 2 is not a Department of Energy facility, and we were informed that Earthline’s Nuclear Regulatory Commission/Ohio Department of Health (NRC/ODH) license to conduct radioactive operations does not cover Department of Energy contamination at Plant 2. Therefore, we could not determine under what authority or procedures the room containing the wastewater treatment plant was designated as “controlled” or if those procedures were sufficient. In discussing this issue with the Department’s Site Manager he indicated that, if the wastewater treatment plant is contaminated with radioactivity, then he would be concerned that storage of the plant on

10. Photograph at left shows a closeup of resin column of wastewater treatment plant with yellow dust substance caked within.

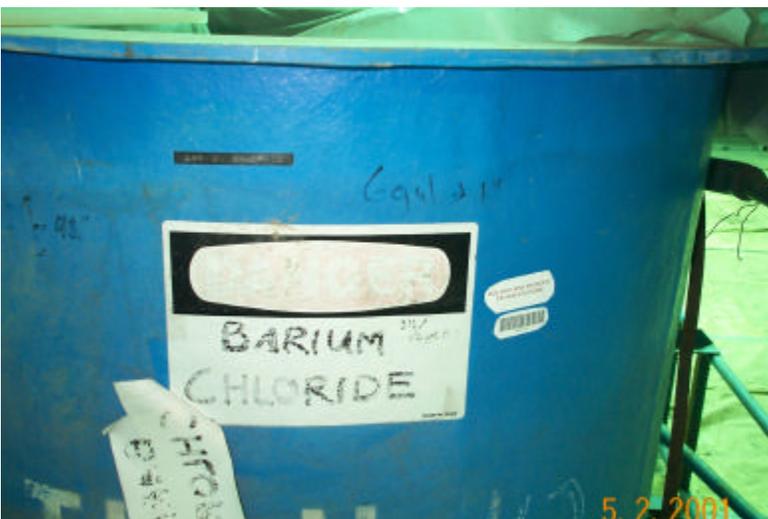
An additional concern with the wastewater plant relates to a tank which is labeled "Barium Chloride." Barium is regulated under RCRA. The tank in question appeared to contain some residues, but for safety reasons we did not closely inspect the tank (see photograph 11). We concluded that Ohio Field Office management may want to consider reviewing the storage of the wastewater treatment plant for safety, liability, and regulatory concerns and consider sampling and analyzing the material in the resin columns and Barium tank so as to properly characterize any hazards or contamination. Photographs of the wastewater treatment plant, resin columns, and Barium tank are attached to this report.

11. Photograph at left shows a closeup of wastewater treatment plant tank containing Barium residue.

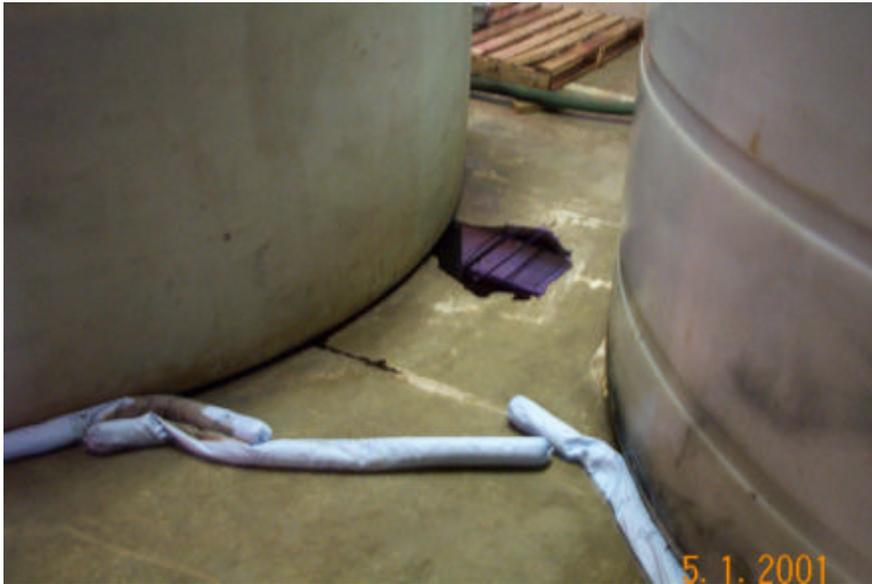
During our physical inspection of the Department's Soil Washing Plant located on Earthline property, we found thick black liquid draining from a flange in evaporator storage tank 12. A spill pan had been placed beneath the flange and had overflowed causing the liquid to run under and around tank 12. Although a technician had placed absorbent material around the tank, the leak was unattended and the black liquid had saturated the absorbent material in places and was entering a floor drain (see photographs 12 through 13).

Personnel in the Soil Washing Plant referred to the leaking liquid as "evaporator liquor." This liquid is a concentrated residue from soil washing operations, and is presumed to contain concentrated radionuclides that are washed from the site's soil during cleanup operations. We are concerned that this leak was unattended and was not being administratively controlled, such as through the use of ropes or postings. Although the area in question is inside a controlled area, soil washing plant personnel told us that they were not always present in the area. Therefore, we concluded that instituting precautionary administrative controls would be consistent with the Department's policy to limit occupational radiation exposures to a level as low as reasonably achievable. Further, in accordance with Department policies, such controls would assist with preventing the transfer of contamination from the area by employees and visitors.

12. Photograph at left shows leak of suspected radioactive liquid known as “liquor” from evaporator tank 12 in Department’s Soil Washing Plant at Ashtabula.

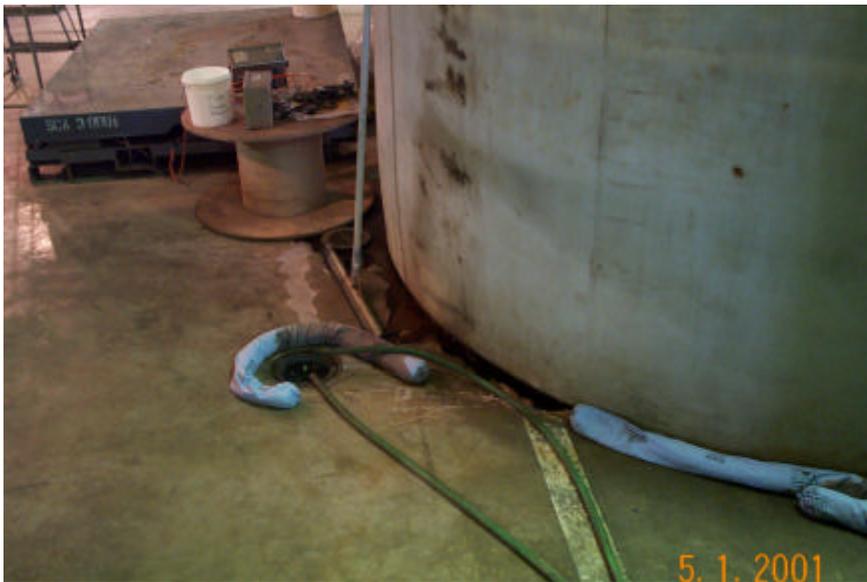
13. Photograph at left shows a different view of leak from tank 12 and illustrates proximity to floor drain.

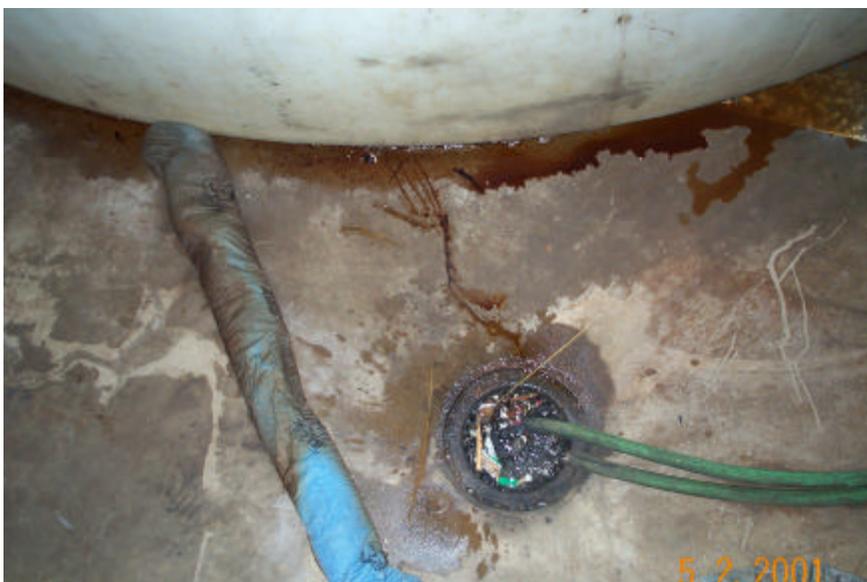
We returned to inspect the cleanup of the leak the next day, May 2, 2001, and found the tank again unattended. The original leak had been cleaned up, but seepage from under the tank was continuing to puddle and run onto the floor and into the floor drain. In interviews with personnel responsible for the cleanup, we were told that the leak had been progressing for about two days. The personnel responsible told us that they had left the leak unattended and said that they did not feel it was important to complete the clean up. These personnel stated that they were unaware of site procedures for leak and spill reporting/cleanup or for radiation control. An employee responsible for the tanks could not produce any inspection procedures or documentation for ensuring the tanks did not

14. Photograph at left shows closeup of seepage from underneath tank 12 following cleanup. Note seepage is entering floor drain.
