2025 ANNUAL SITE INSPECTION AND MONITORING REPORT FOR

# Uranium Mill Tailings Radiation Control Act Title II Disposal Sites

DECEMBER  
**2025**

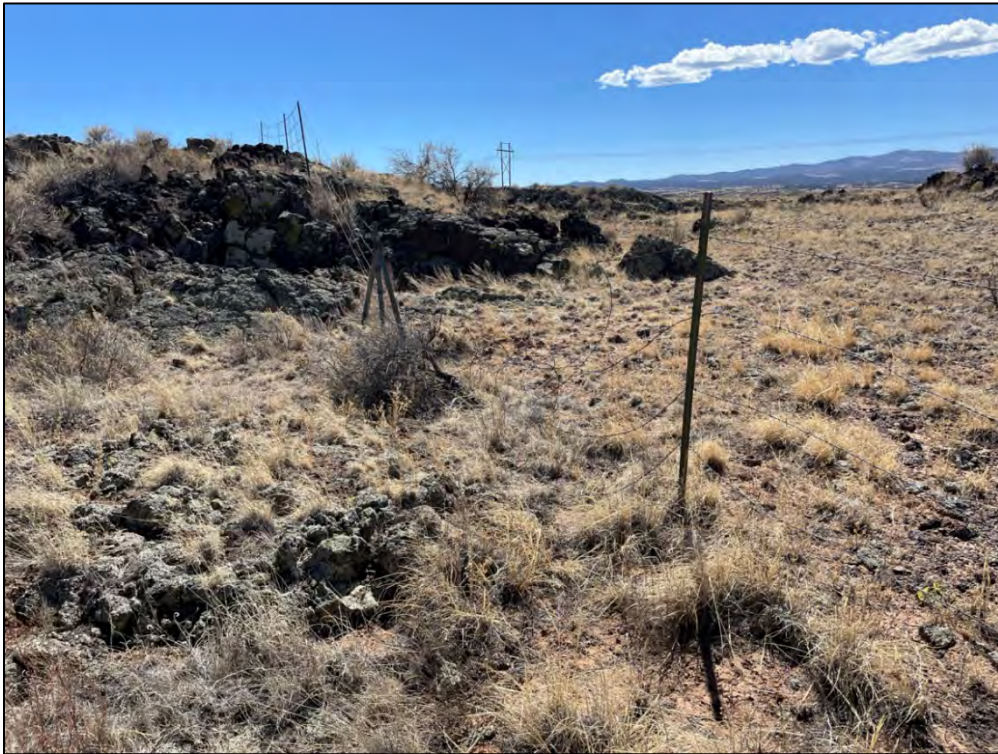
Inspectors observed the gullies, identified in the 2019 inspection, that are near the perimeter fence northwest of the main tailings disposal cell at boundary monument BM-6. The gullies are beginning to undermine the fence, and the fence was extended downward in September 2024; the fence remains protective. No significant changes were observed. LM will continue to monitor this area for damage to the perimeter fence.

*PL-3. Western Perimeter Fence Repair Section*

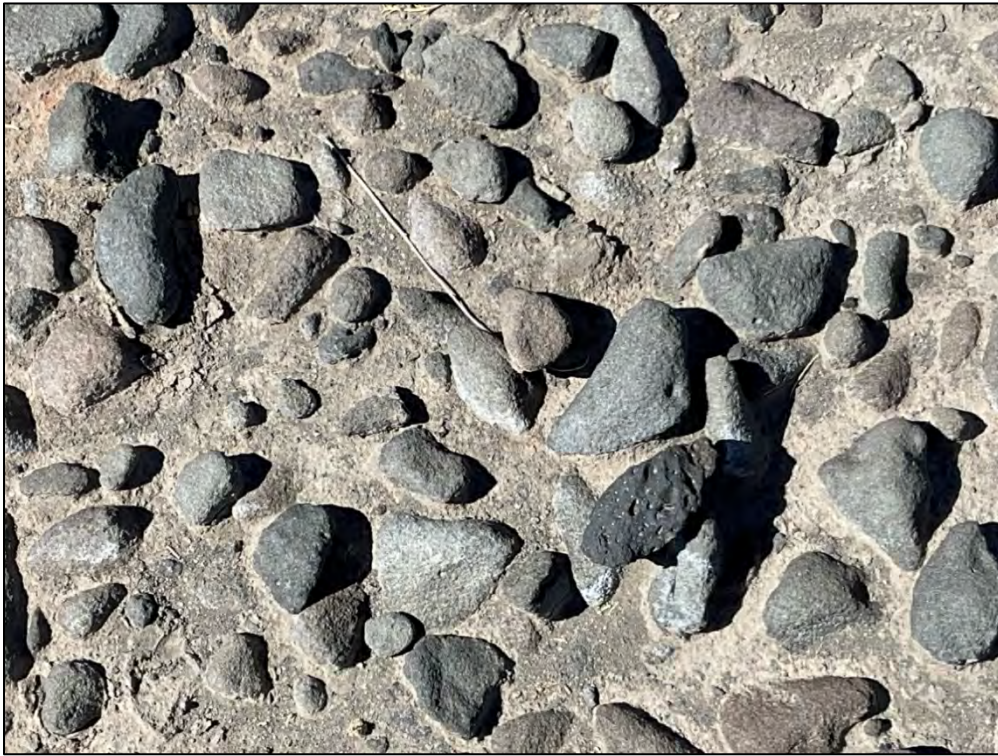
| Depression No. | General Description | Initial Observation | Monitoring Status (Y/N) | Notes | Approximate Dimensions |
|---|---|---|---|---|---|
| MT-02 | Area of ponding that occurs on the northern top slope of the cell | 1997 | Y | During annual inspections, inspectors monitor for ponded water and the presence of algae. Changes in the depression area are periodically monitored using lidar survey results. Riprap degradation was observed. | 908 ft long<br>× 440 ft wide<br>× 4 ft deep |

*PL-11. Potential Riprap Degradation Observed in Depression Area MT-02*

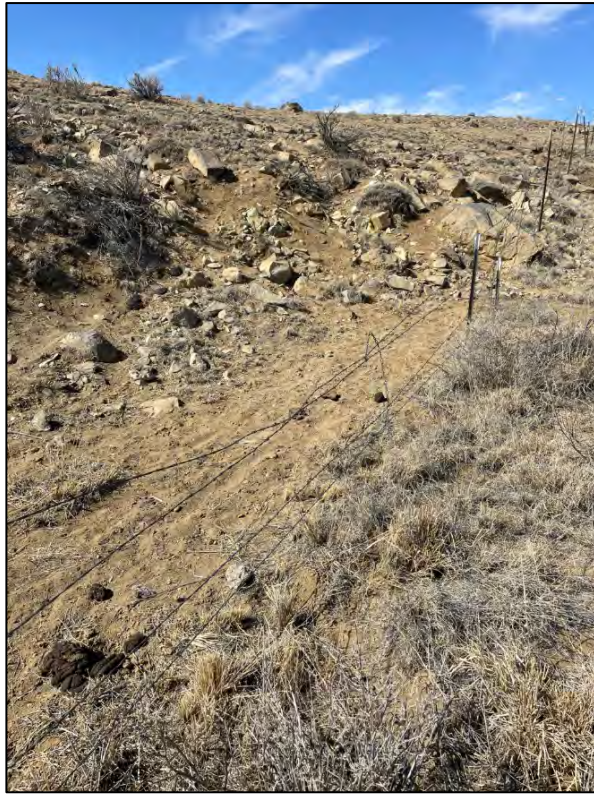
*PL-5. Broken Fence*

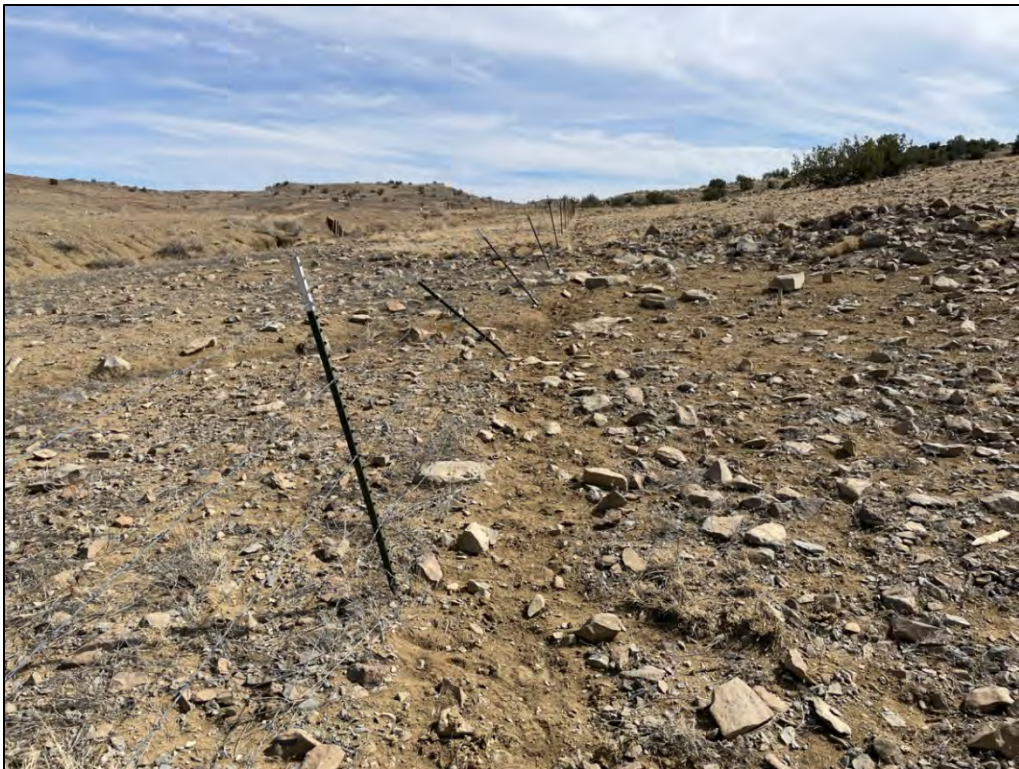
*PL-6. Loose and Leaning Fence Line*

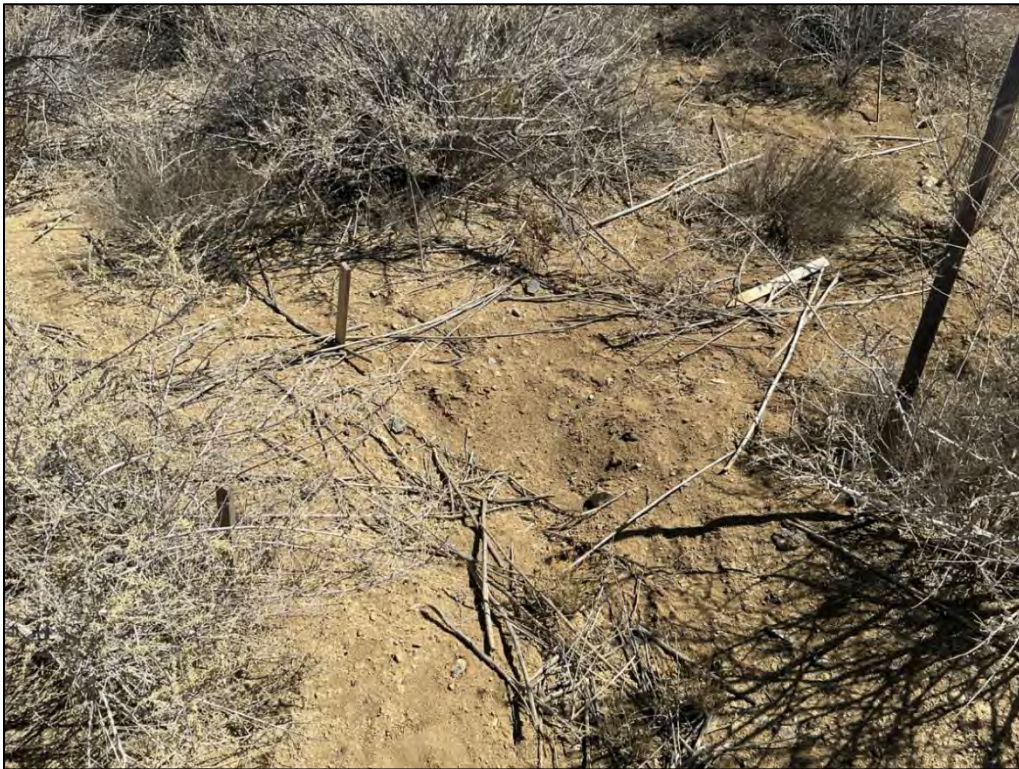
*PL-14. Collapsed Degradation Feature*

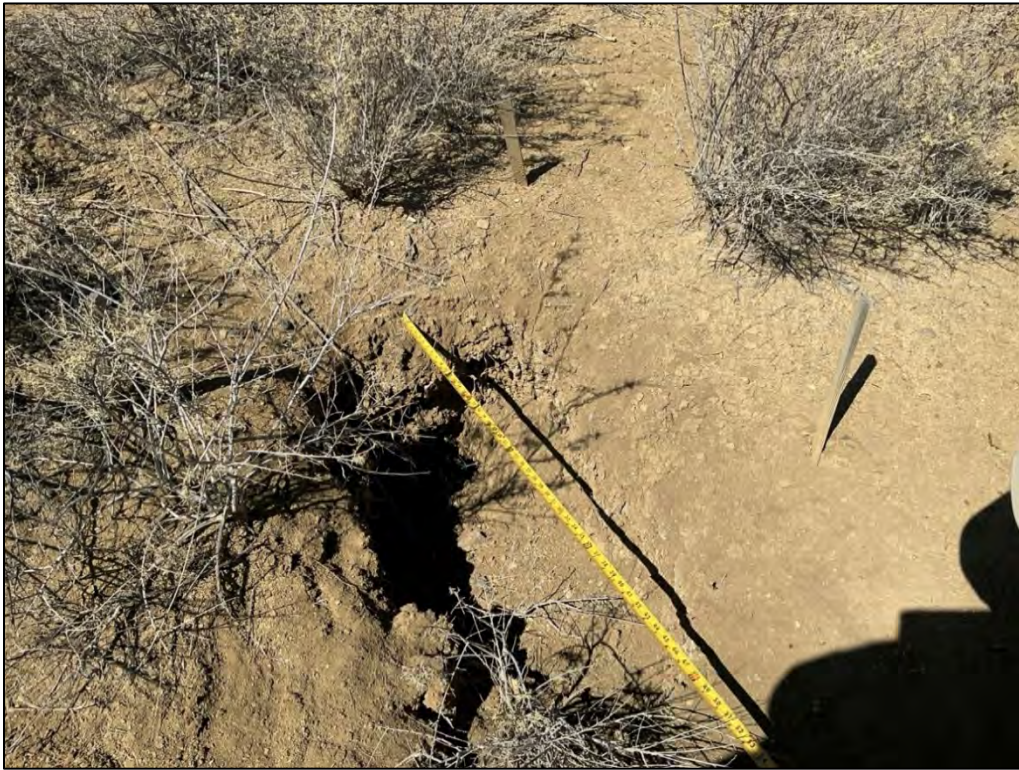
*PL-15. Degradation Feature E-004*

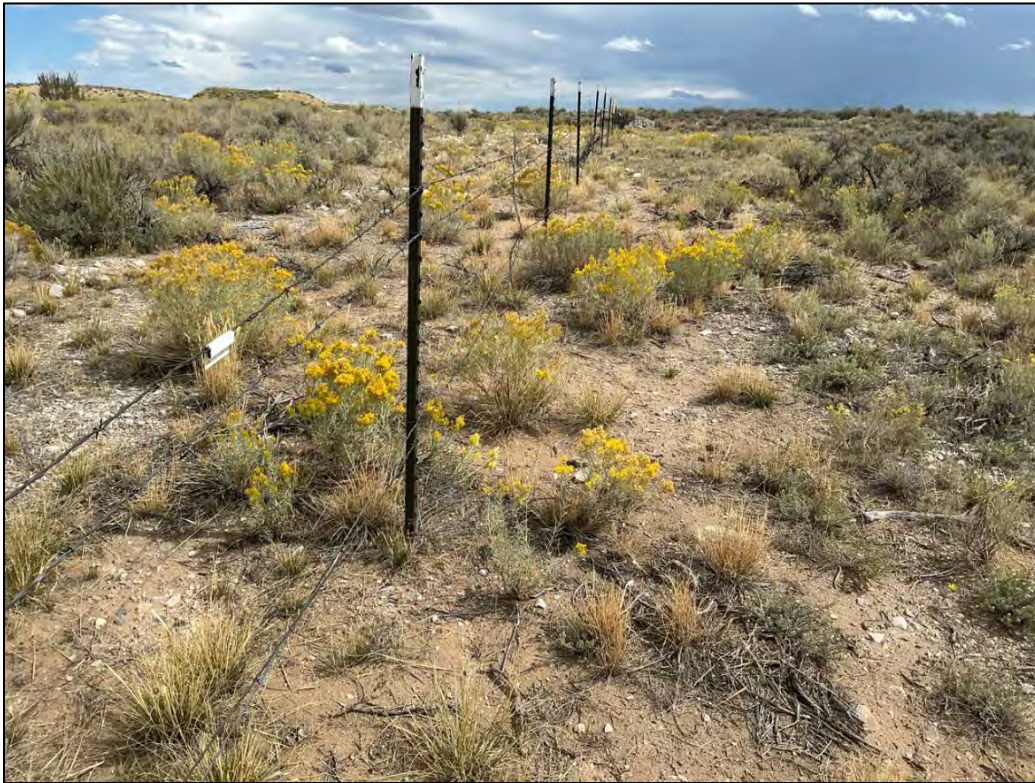
| Site | Chapter | Page(s) | Issues and Actions |
|---|---|---|---|
| Maybell West, Colorado | 4.0 | 4-2 | — A small section of fence line on the southeastern side of the site was previously damaged and was repaired during the 2025 maintenance trip. |

*PL-1. Damaged Fence Line*

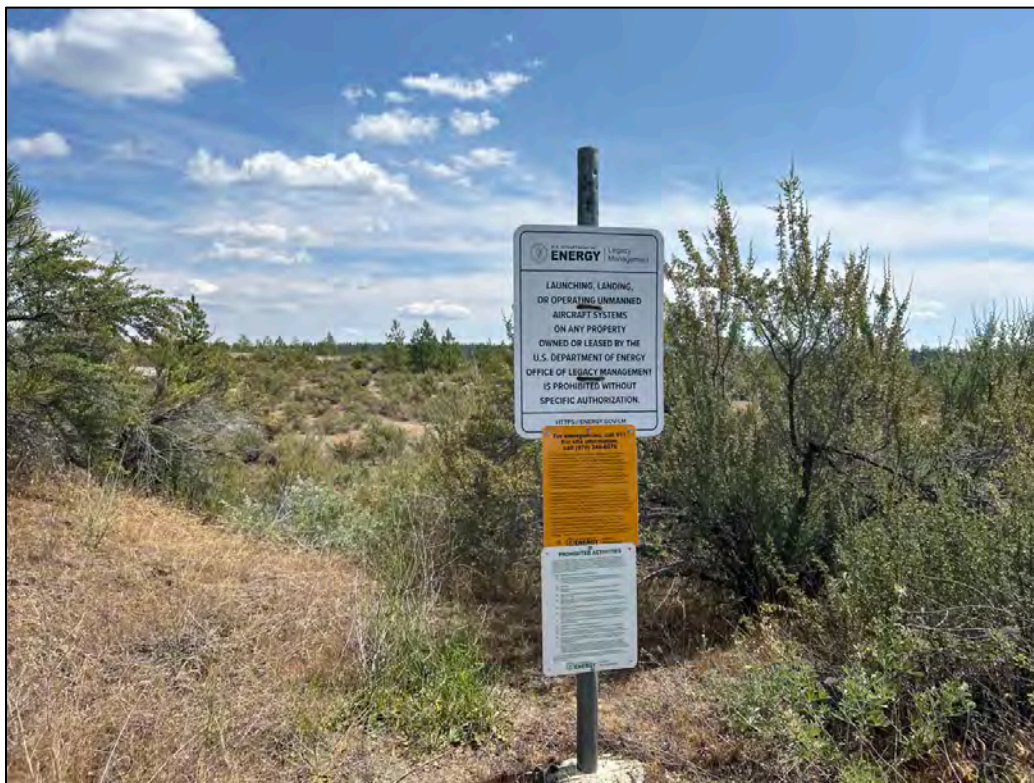
| Site | Chapter | Page(s) | Issues and Actions |
|---|---|---|---|
| Sherwood, Washington | 5.0 | 5-2 | — Perimeter sign P6 was identified as missing during the 2025 inspection and will be replaced during 2026 fieldwork. |

*PL-1. Missing Perimeter Sign P6*

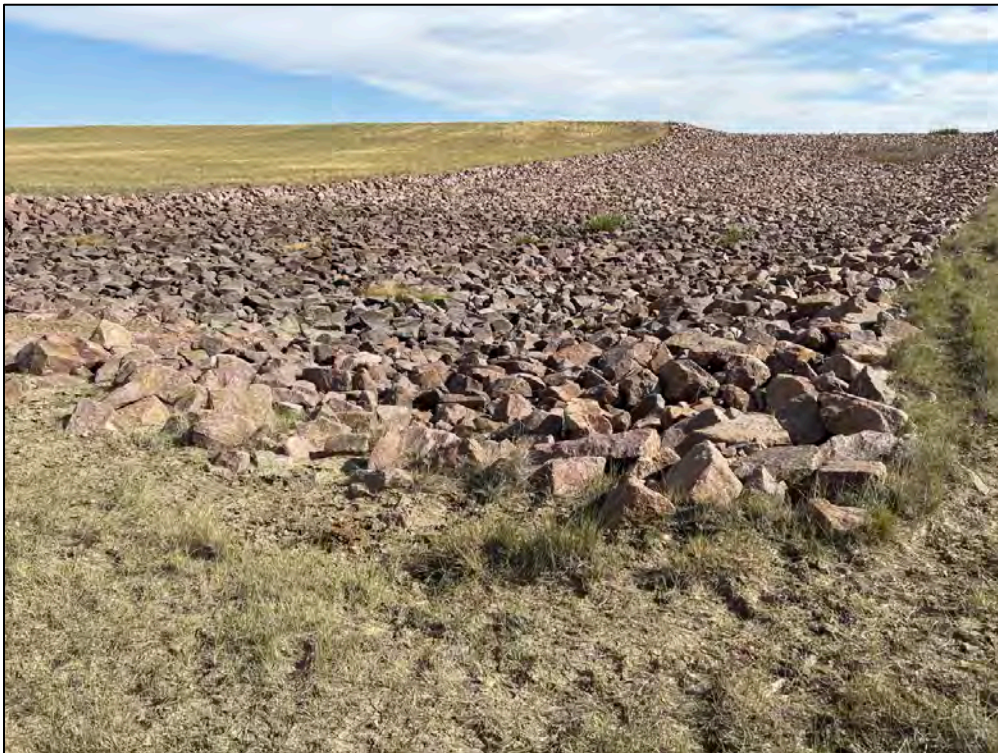
| Site | Chapter | Page(s) | Issues and Actions |
|---|---|---|---|
| | | 6-5 | — Cattle had worn paths around the north and south ends of the eastern riprap-armored slope, resulting in erosion that was repaired during the 2025 annual maintenance trip. This area will be protected from cattle by the rancher to prevent further degradation. |

*PL-6. Erosion Caused by Cattle on Edge of South Swale Discharge Point*

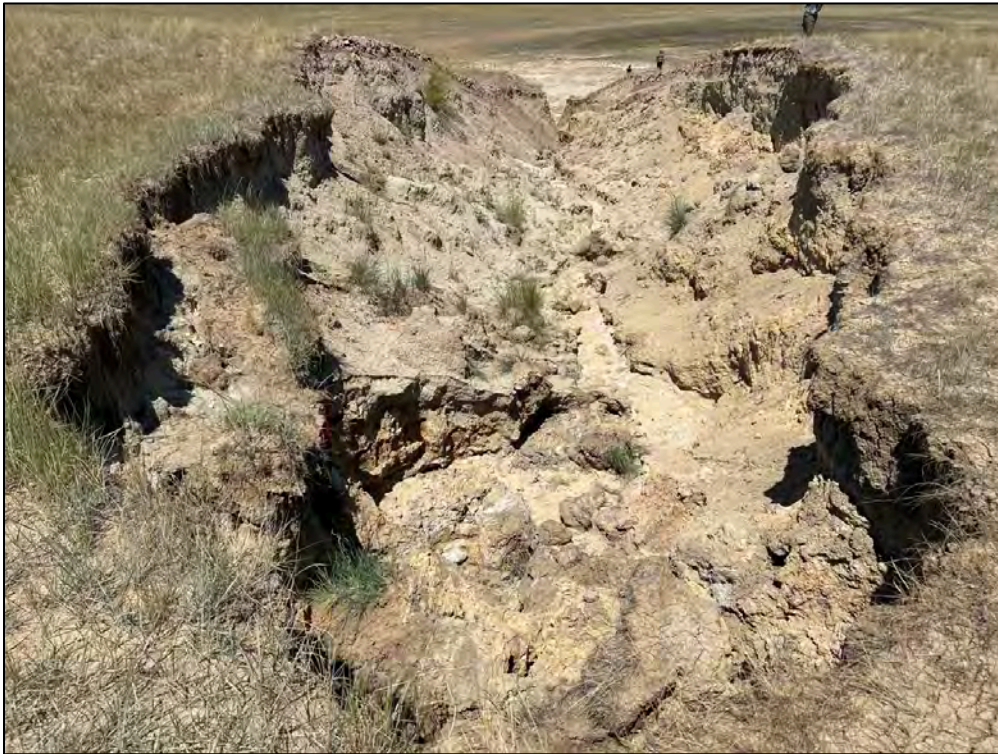
| Site | Chapter | Page(s) | Issues and Actions |
|---|---|---|---|
| | | 6-6 | — The riprap-armored drainage in Pit 4 was first noted to have erosion in 2016 and has continued to erode; repair of the riprap armor is not necessary at this time as erosion is not expected to impact slope stability. |

*PL-7. Pit 4 Lower Riprap-Armored Drainage Channel Erosion*

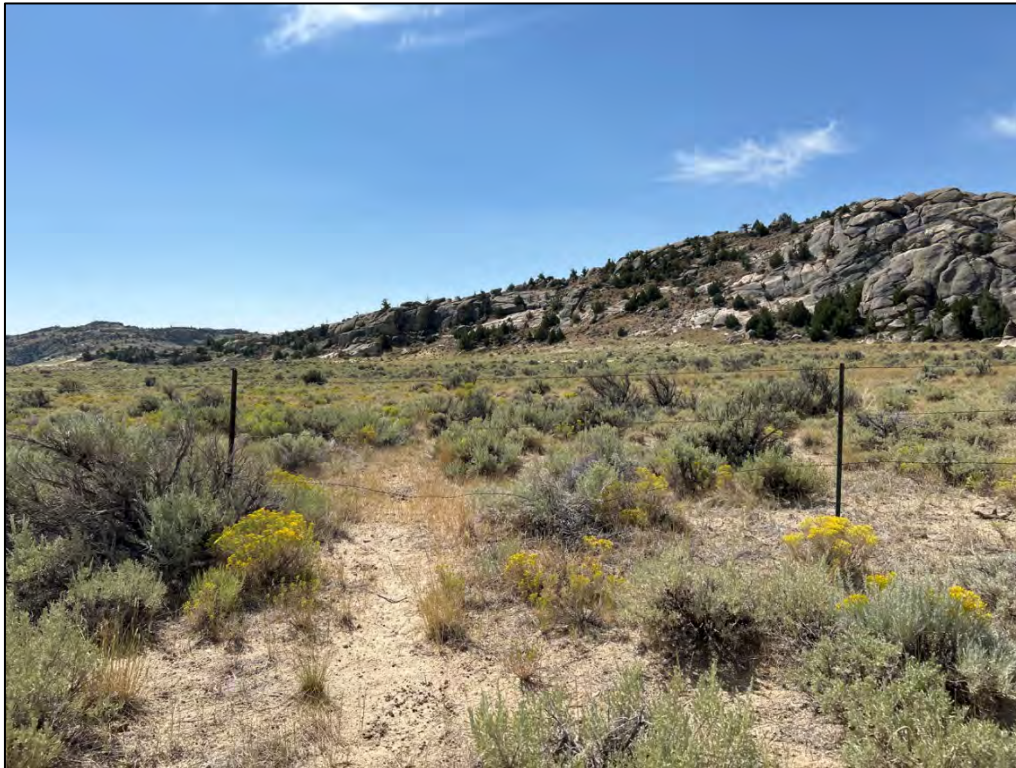
| Site | Chapter | Page(s) | Issues and Actions |
|---|---|---|---|
| | | 7-4, 7-8 | — The fence line along Ore Road was damaged, and repairs were completed during the 2025 annual maintenance trip. |

*PL-3. Damaged Fence Along Ore Road*

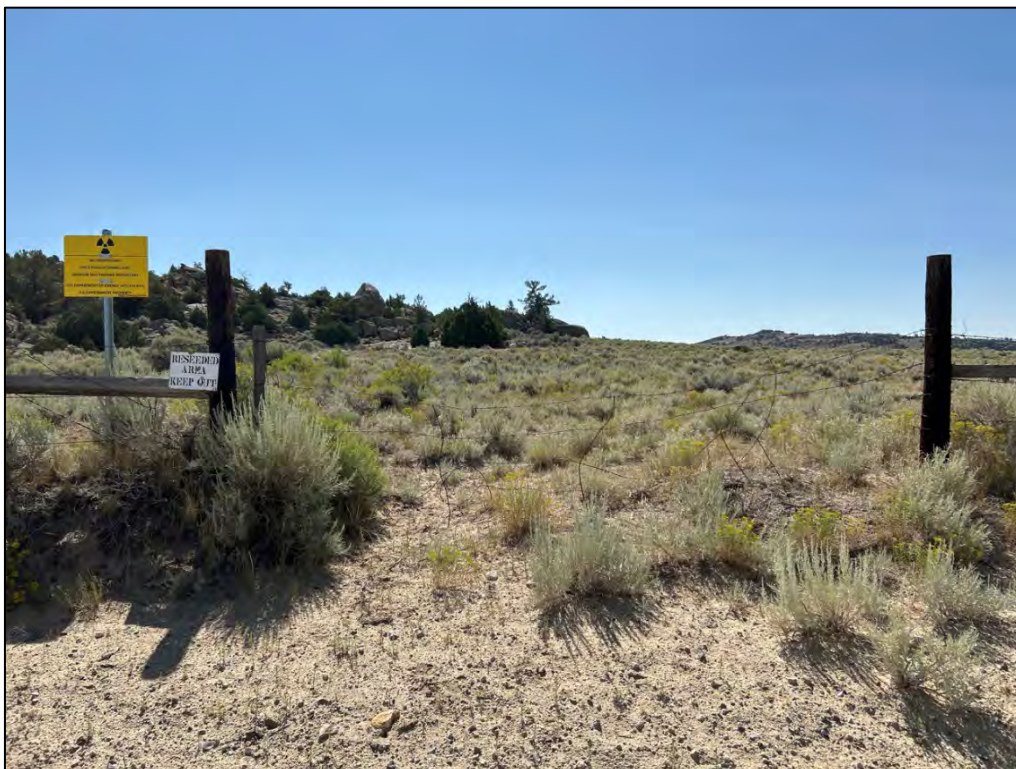
*PL-22. Damaged Fence Along Ore Road*
