OFFICE OF  
ENVIRONMENTAL  
MANAGEMENT

# Individual Permit Corrective Actions Update

March 5, 2025

**N3B** Los  
Alamos

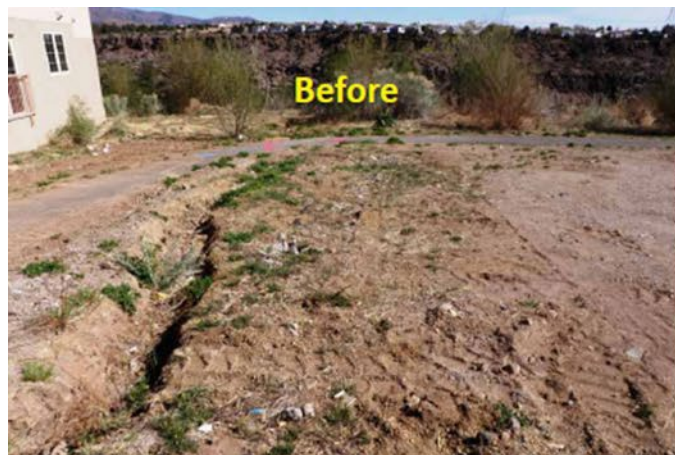
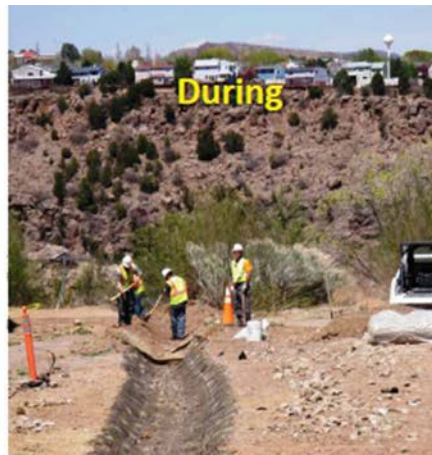
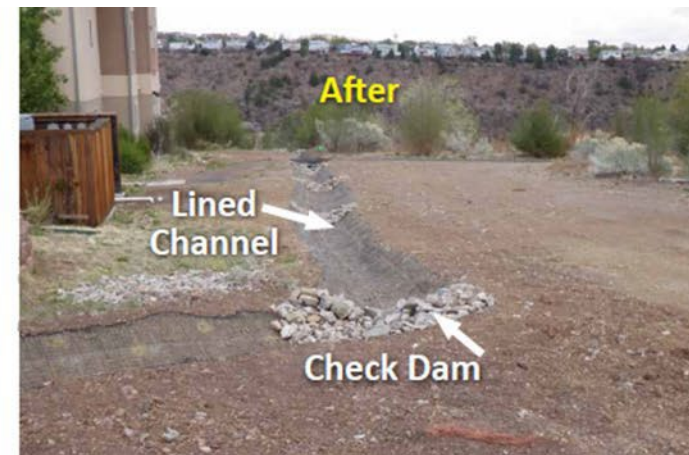
Installation of storm water controls as a corrective action at P-SMA-2.2 in 2011

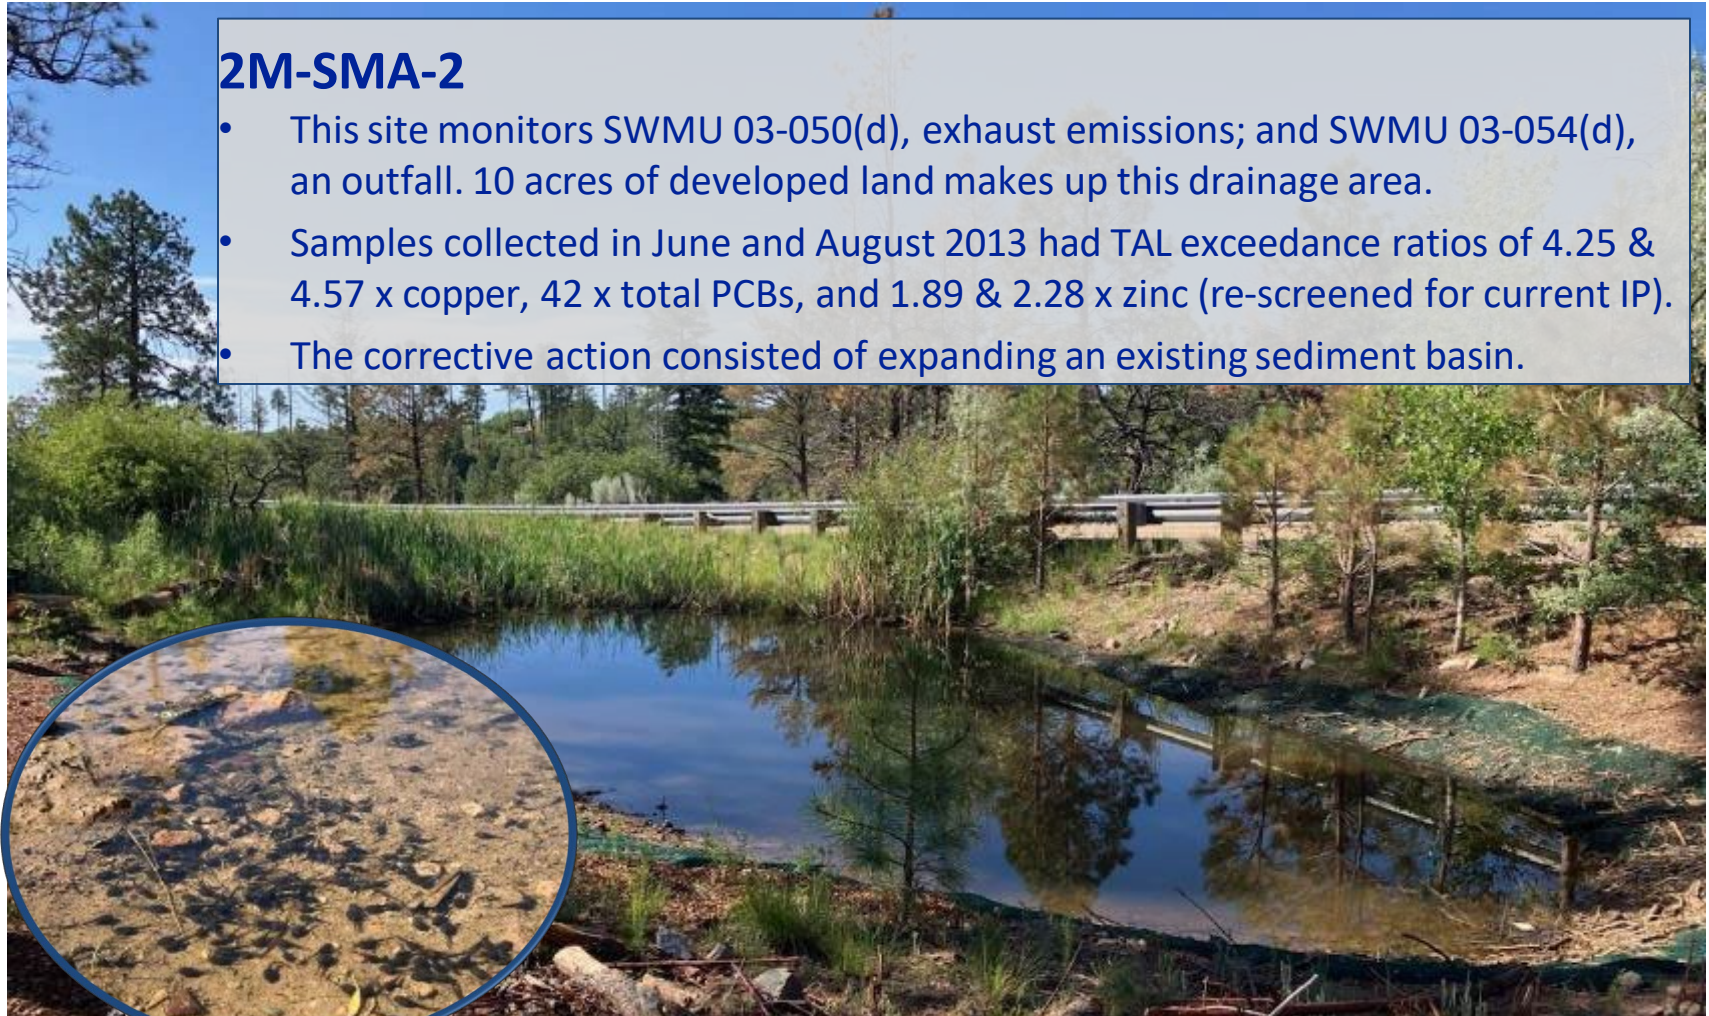
## 2M-SMA-2

- This site monitors SWMU 03-050(d), exhaust emissions; and SWMU 03-054(d), an outfall. 10 acres of developed land makes up this drainage area.
- Samples collected in June and August 2013 had TAL exceedance ratios of 4.25 & 4.57 x copper, 42 x total PCBs, and 1.89 & 2.28 x zinc (re-screened for current IP).
- The corrective action consisted of expanding an existing sediment basin.

Sediment basin E01205020016 at 2M-SMA-2. Tadpoles in basin observed summer 2024 (inset) .

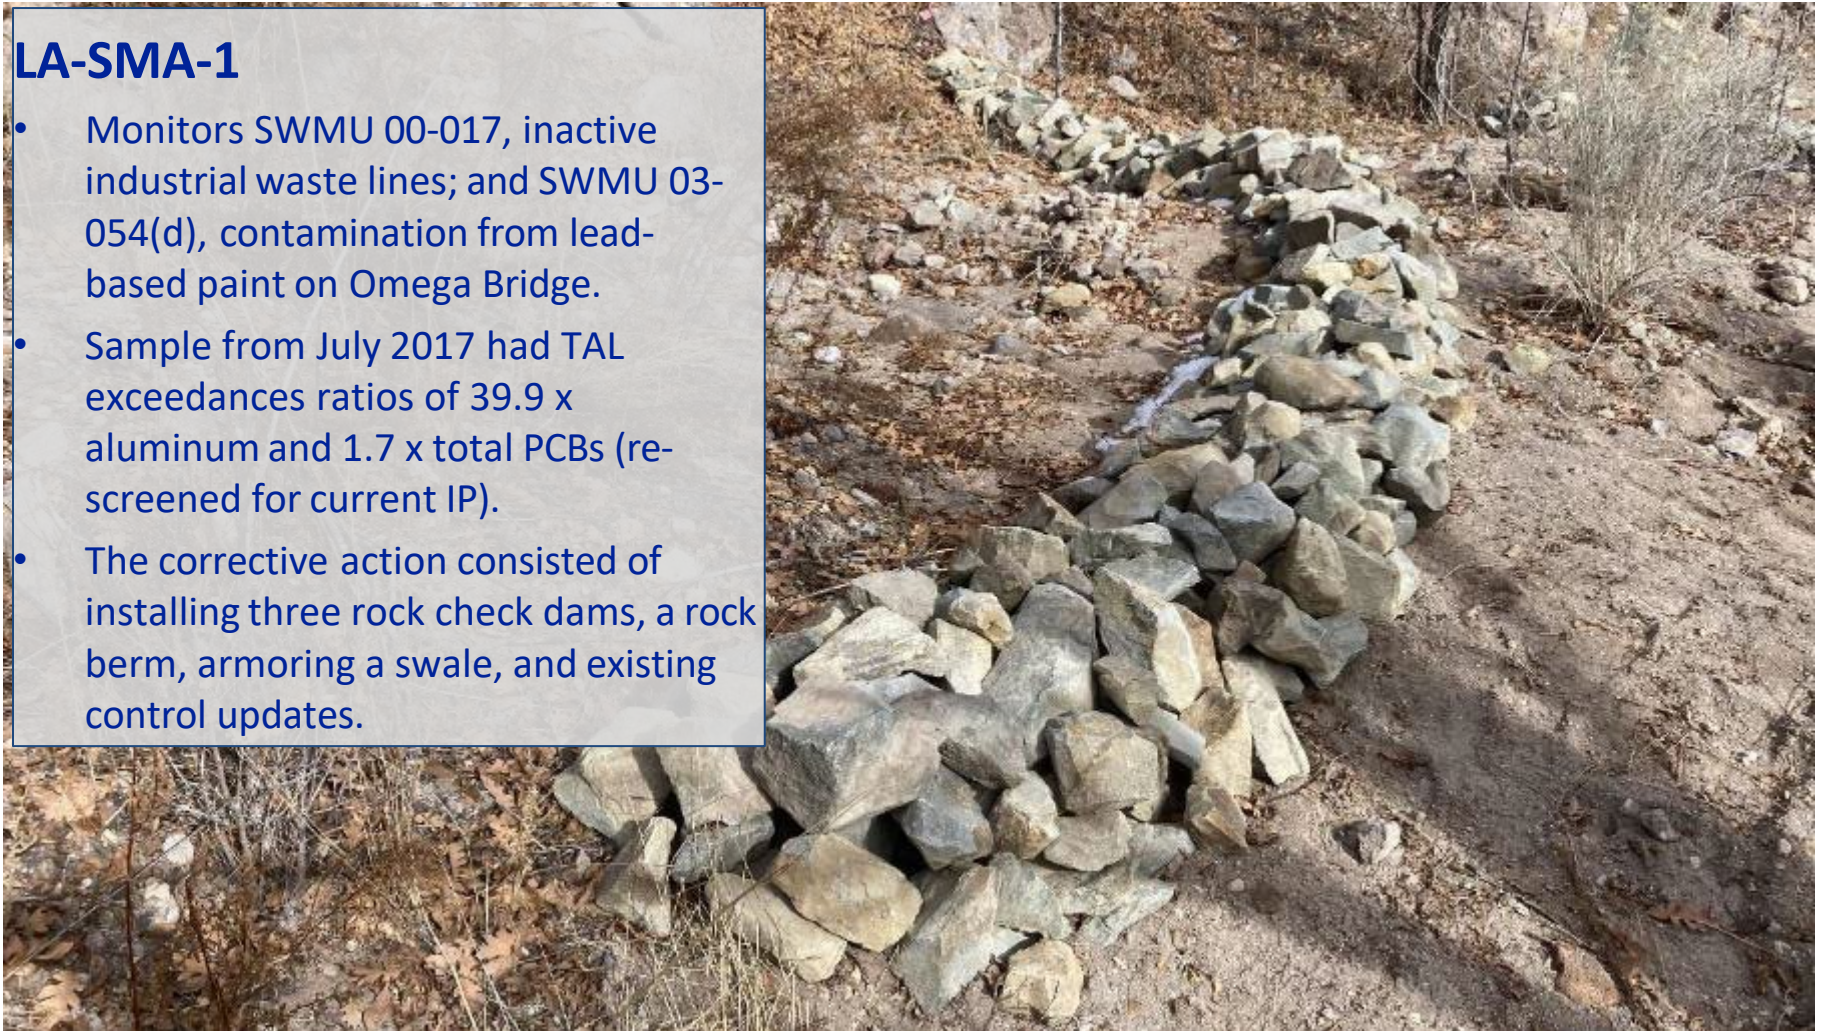
## LA-SMA-1

- Monitors SWMU 00-017, inactive industrial waste lines; and SWMU 03-054(d), contamination from lead-based paint on Omega Bridge.
- Sample from July 2017 had TAL exceedances ratios of 39.9 x aluminum and 1.7 x total PCBs (re-screened for current IP).
- The corrective action consisted of installing three rock check dams, a rock berm, armoring a swale, and existing control updates.

Rock berm L00303120032 at LA-SMA-1.

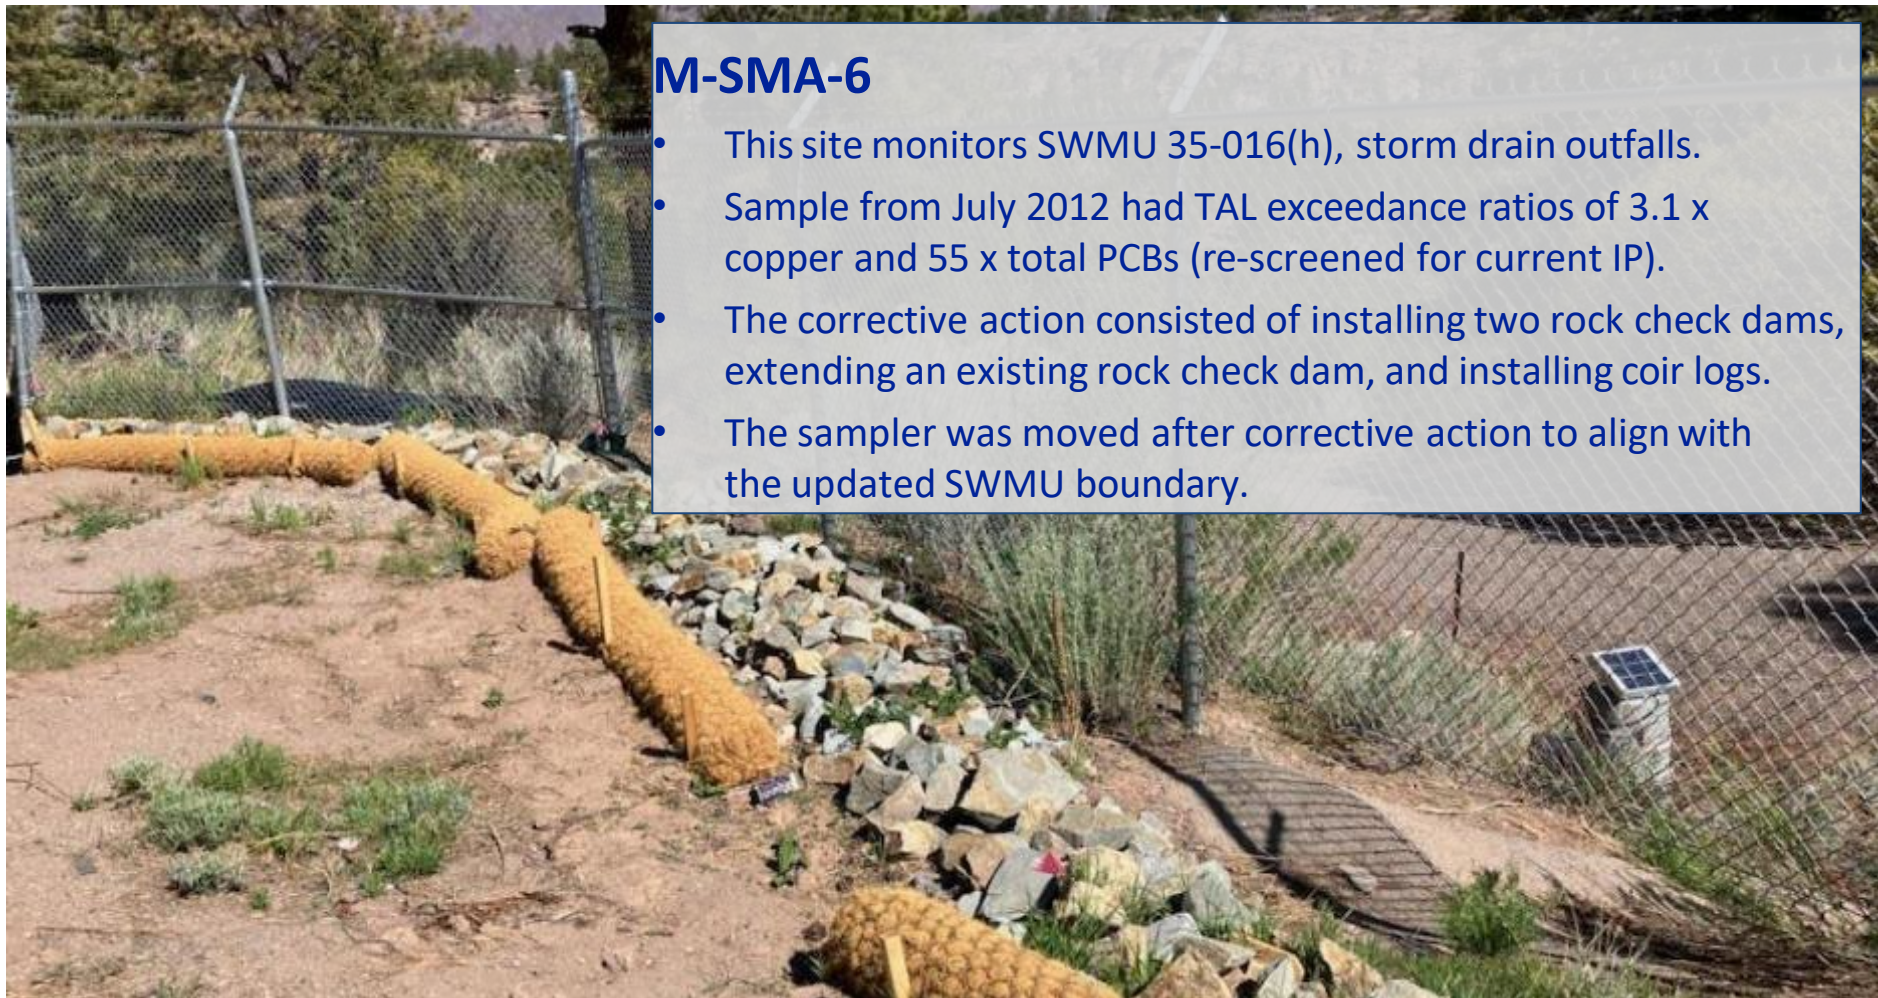
Coir logs M00803140051 and M00803140052, rock berm M00803140031, and sampler at M-SMA-6.

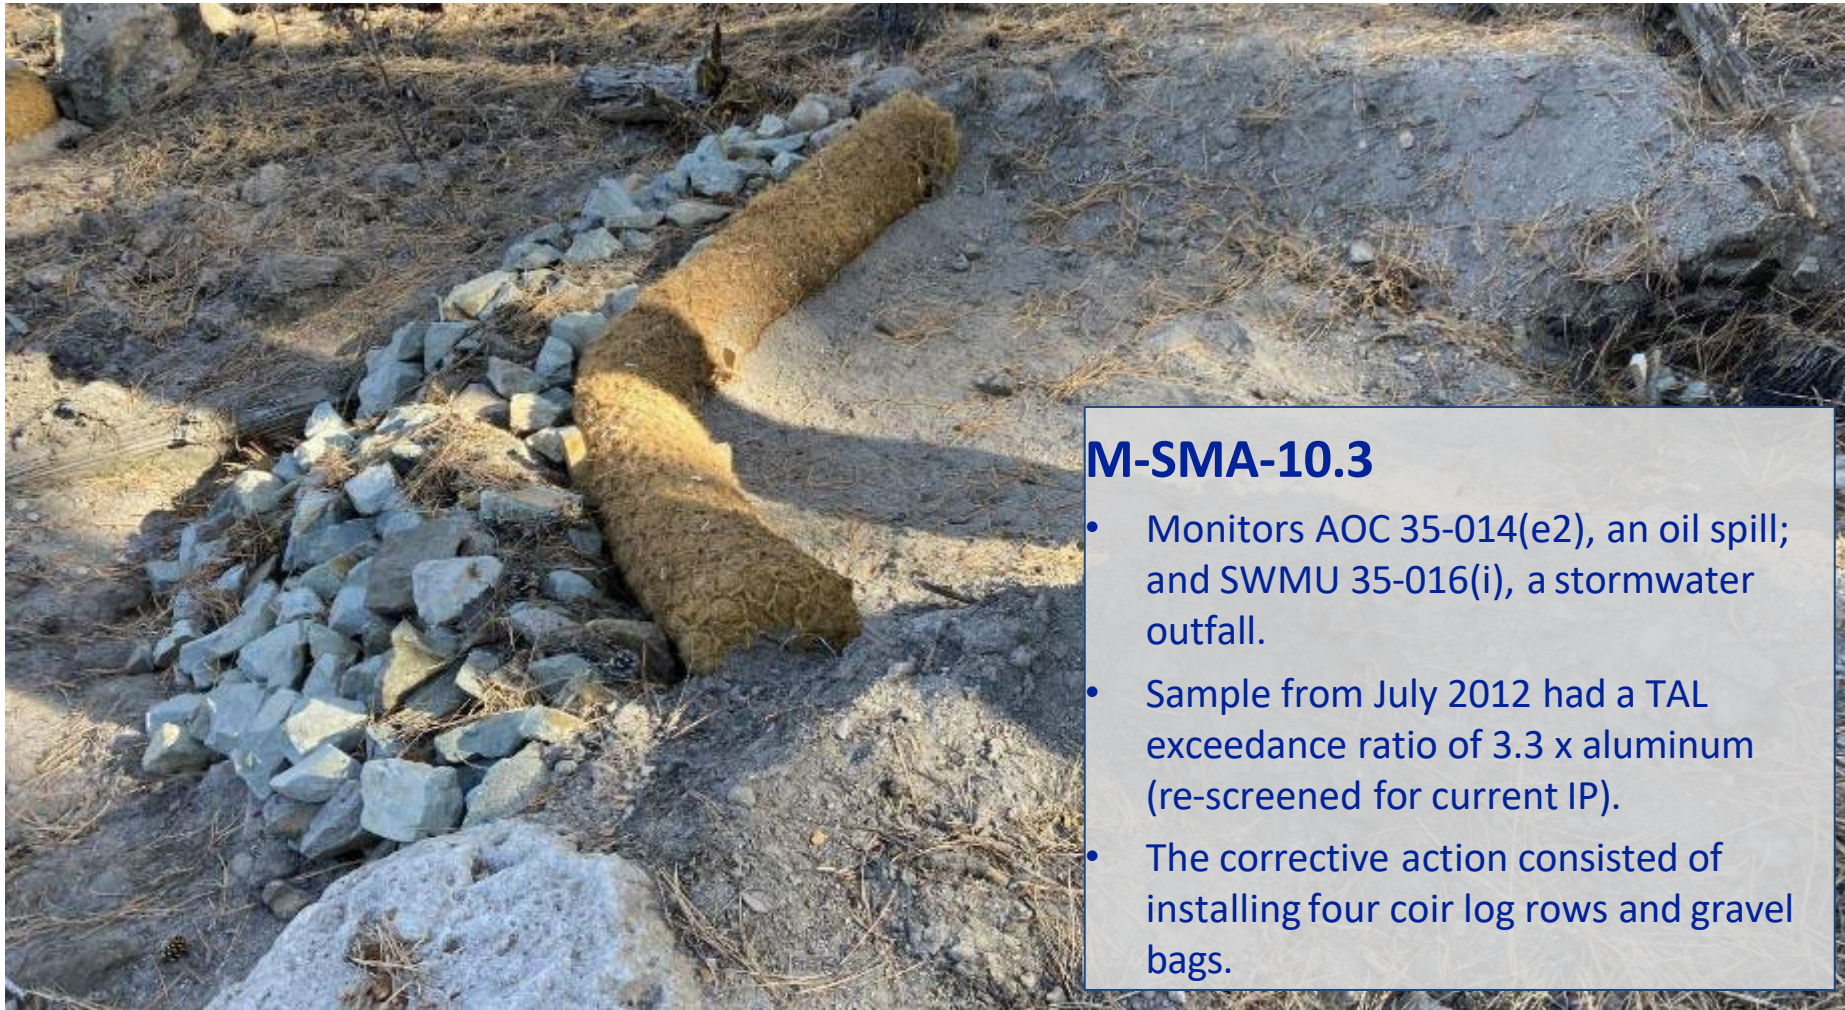
## M-SMA-10.3

- Monitors AOC 35-014(e2), an oil spill; and SWMU 35-016(i), a stormwater outfall.
- Sample from July 2012 had a TAL exceedance ratio of 3.3 x aluminum (re-screened for current IP).
- The corrective action consisted of installing four coir log rows and gravel bags.

Rock check dam M01306010017 and coir log M01306010023 at M-SMA-10.3.

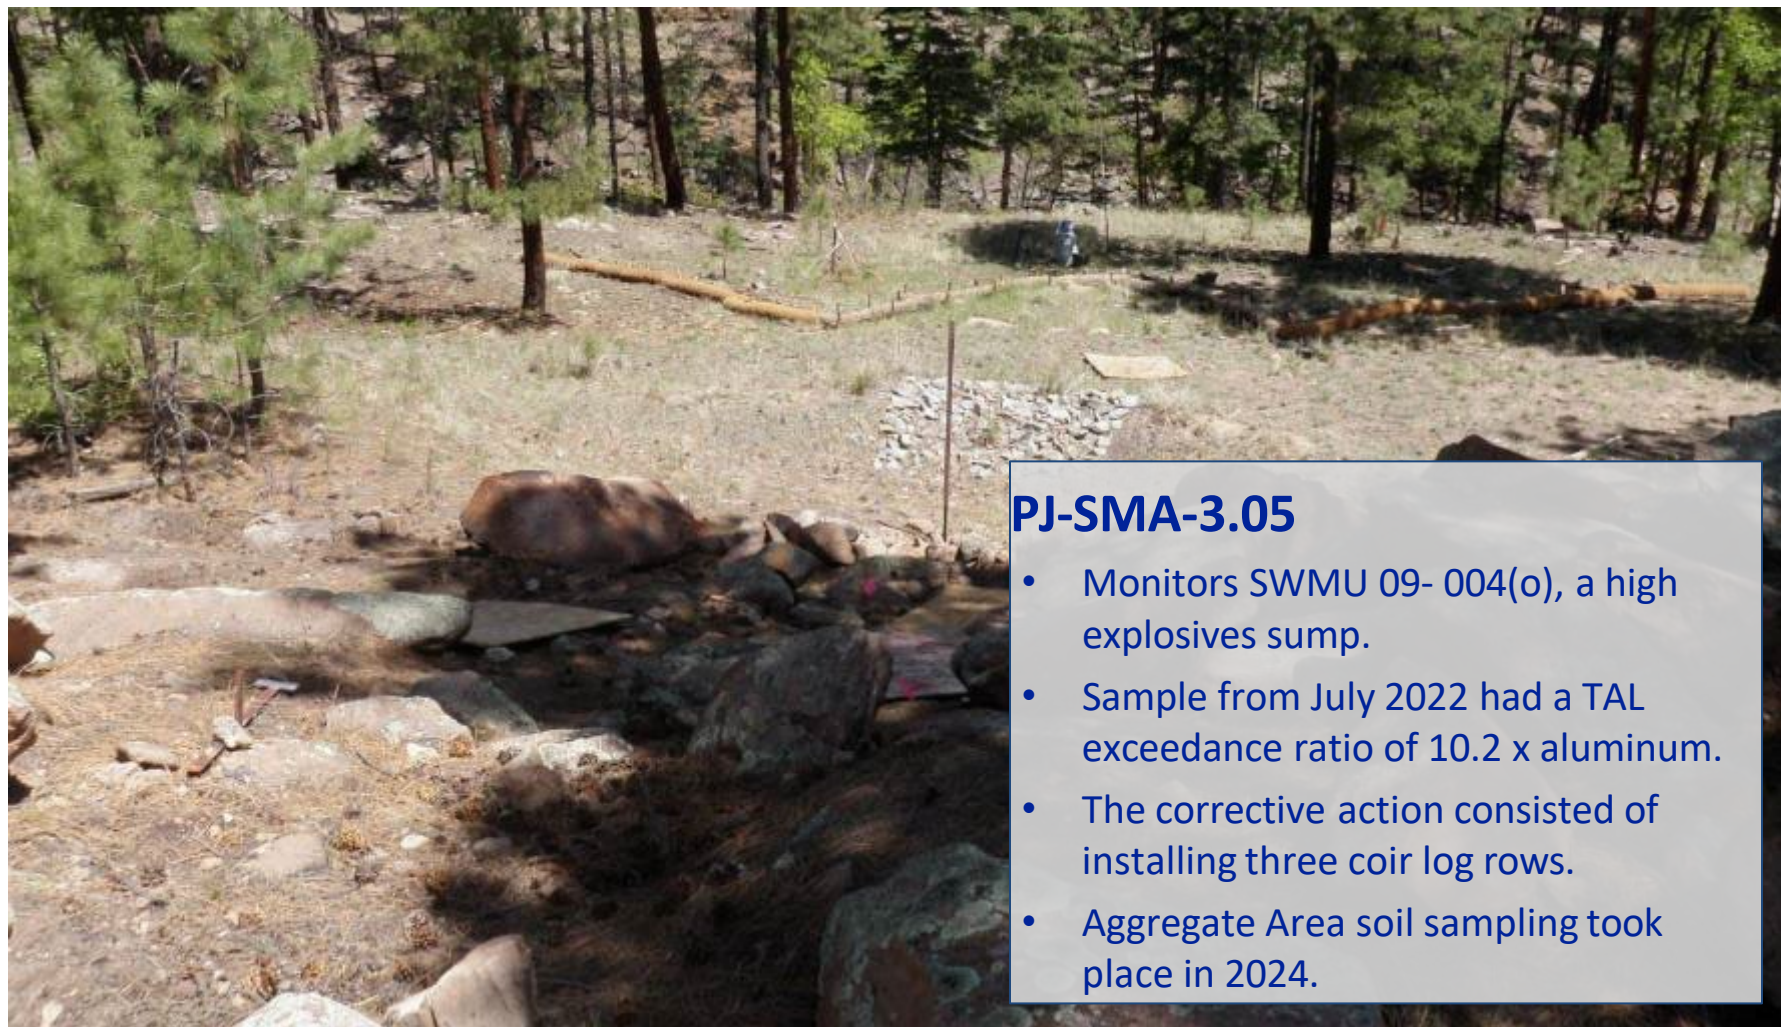
## PJ-SMA-3.05

- Monitors SWMU 09- 004(o), a high explosives sump.
- Sample from July 2022 had a TAL exceedance ratio of 10.2 x aluminum.
- The corrective action consisted of installing three coir log rows.
- Aggregate Area soil sampling took place in 2024.

Earthen berm with riprap spillway J00303140011, and multiple coir and compost logs in background at PJ-SMA-3.05.

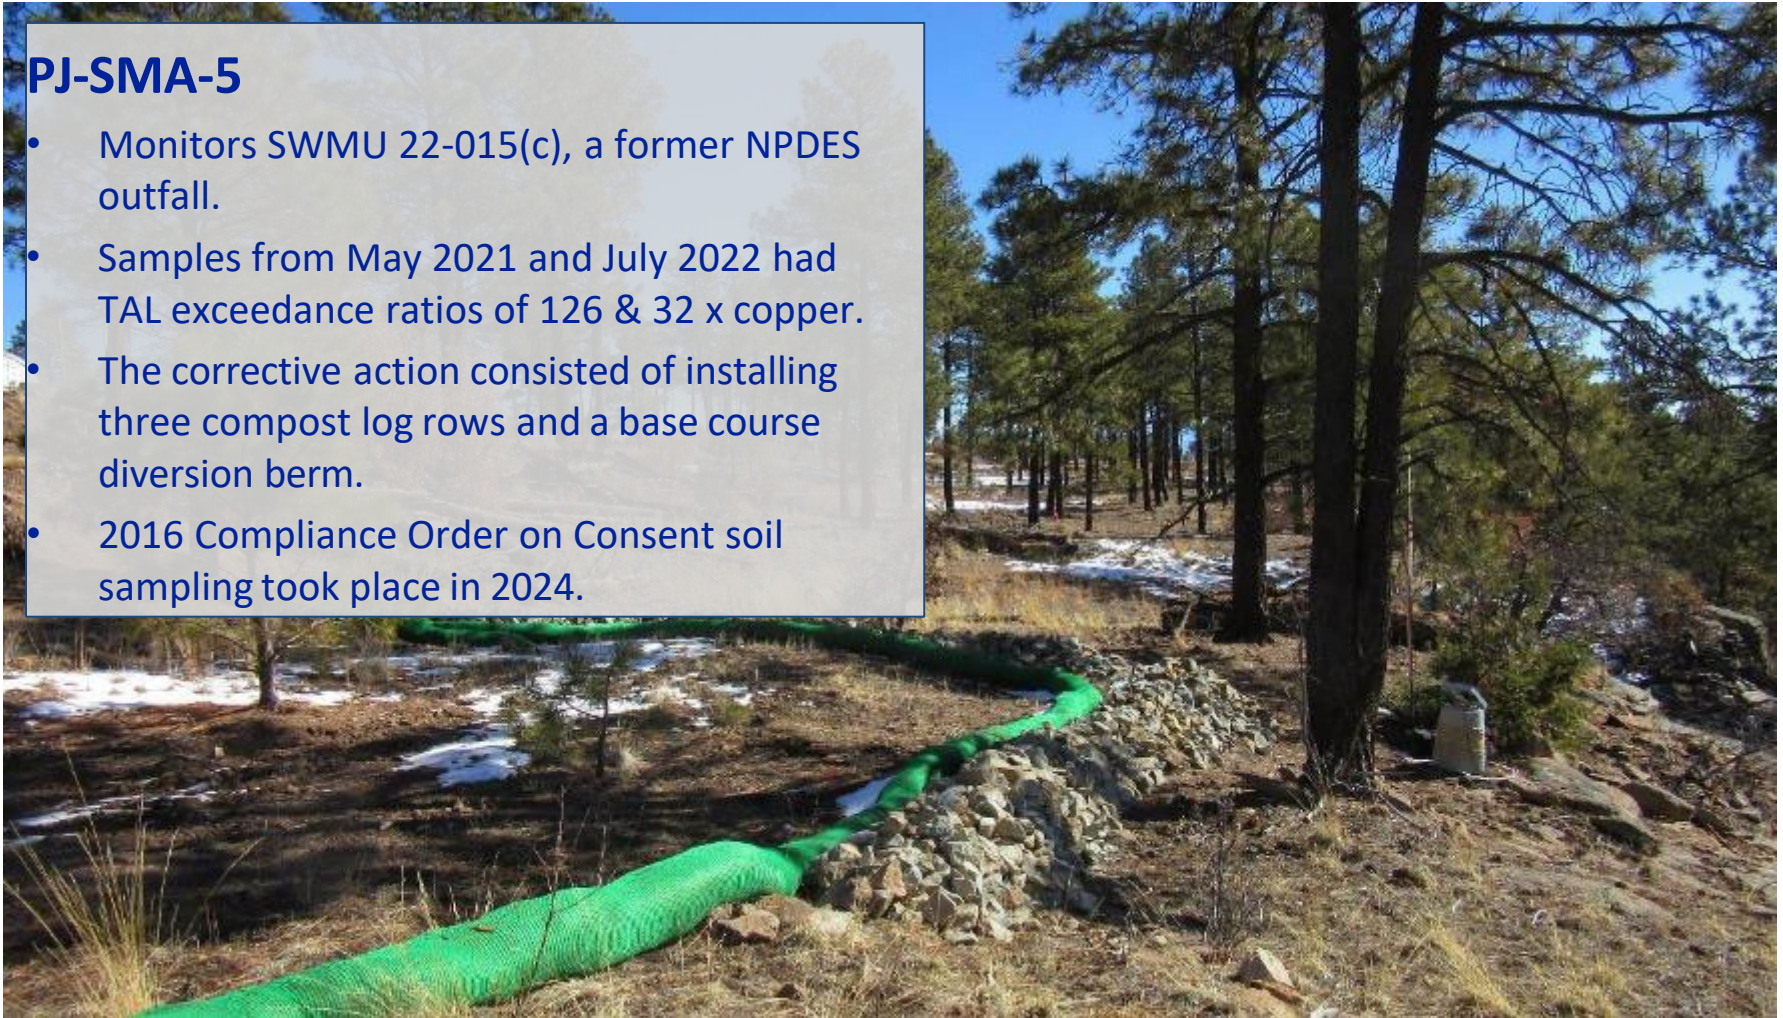
## PJ-SMA-5

- Monitors SWMU 22-015(c), a former NPDES outfall.
- Samples from May 2021 and July 2022 had TAL exceedance ratios of 126 & 32 x copper.
- The corrective action consisted of installing three compost log rows and a base course diversion berm.
- 2016 Compliance Order on Consent soil sampling took place in 2024.

Rock check dam J00506010024, compost log J00506010028, and sampler at PJ-SMA-5.

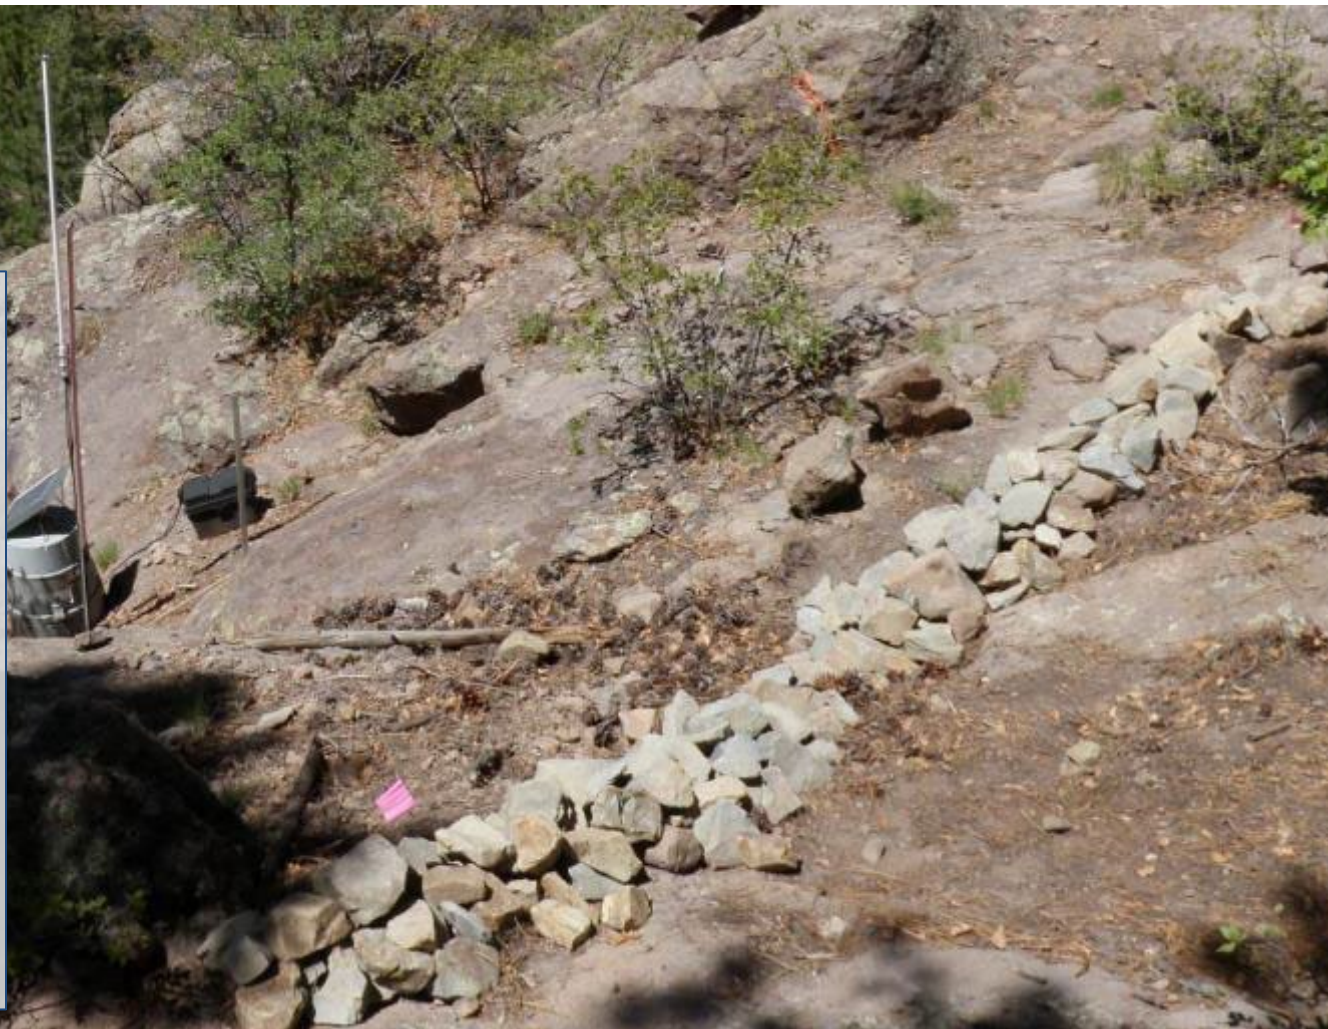
## PJ-SMA-9

- Monitors SWMU 40-009, a surface disposal area.
- Samples from July 2021 and July 2022 had TAL exceedance ratios of 8.5 & 11.0 x copper.
- The corrective action consisted of installing one row of coir logs, two rows of compost logs, and two rock check dams.

Rock check dam J01006010027 and sampler at PJ-SMA-9.02.

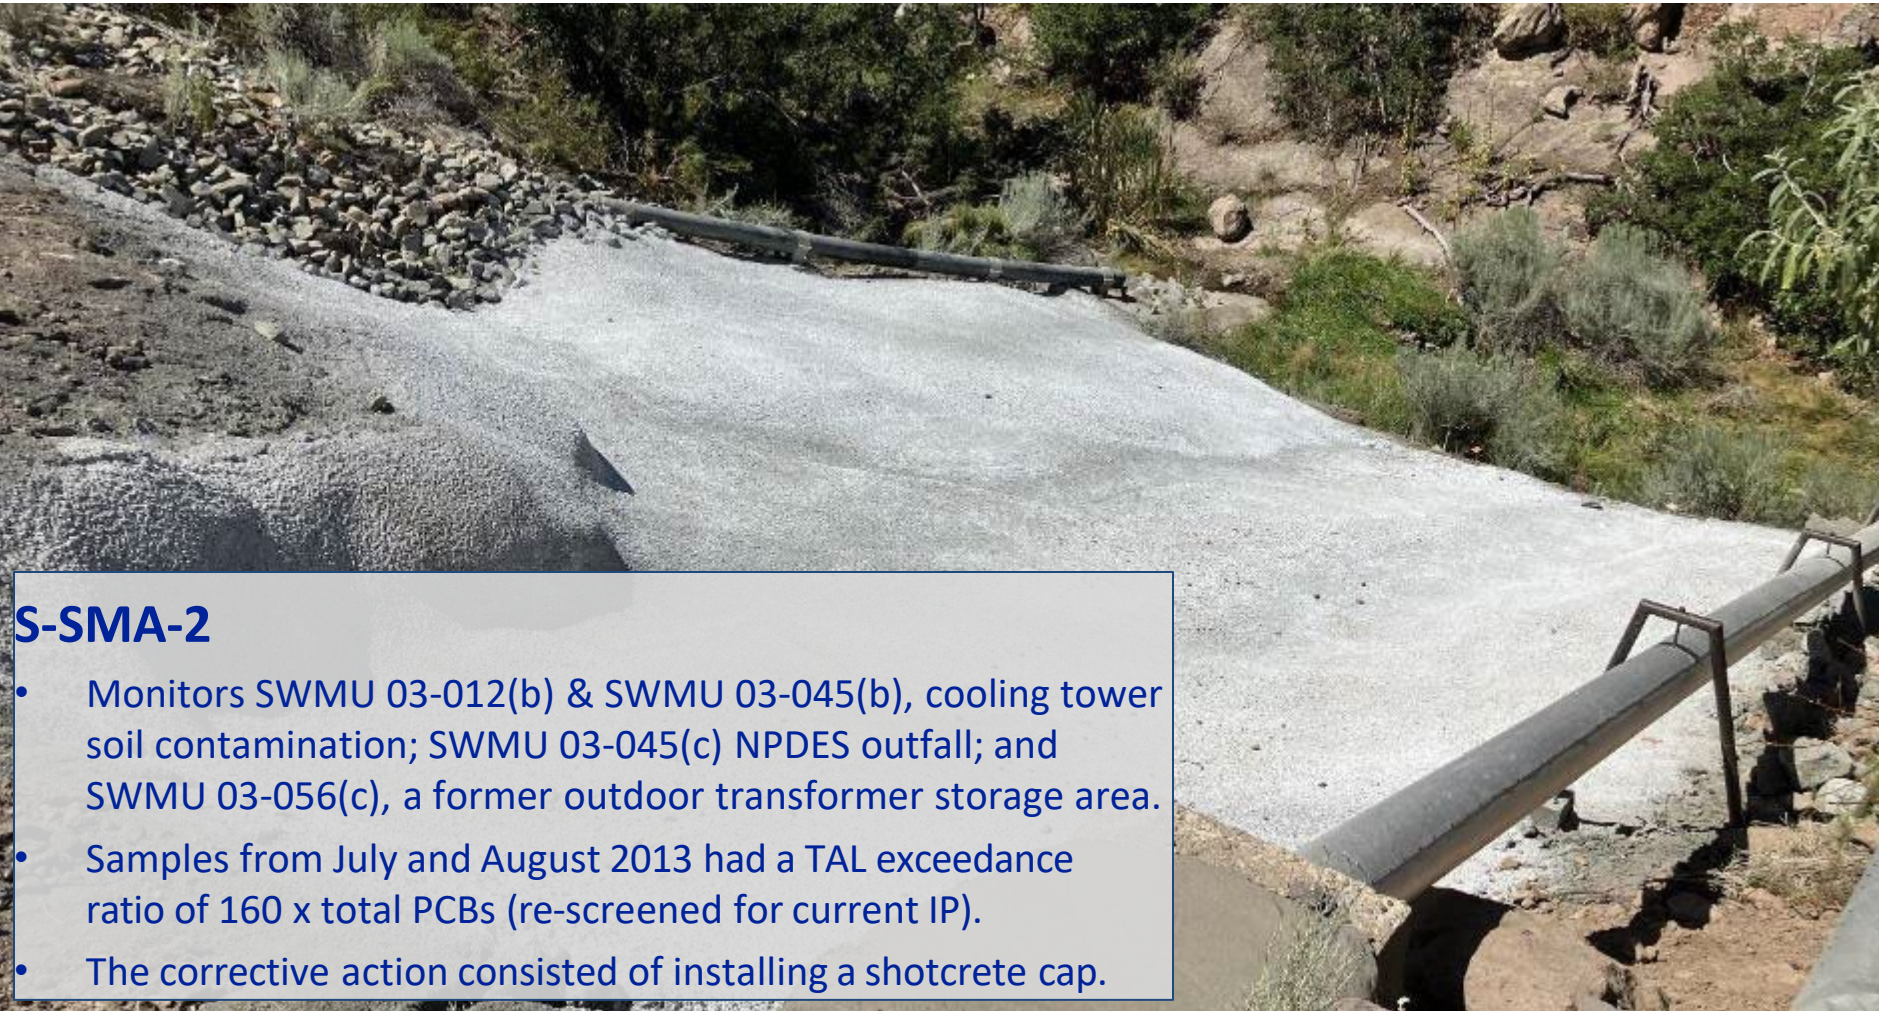
## S-SMA-2

- Monitors SWMU 03-012(b) & SWMU 03-045(b), cooling tower soil contamination; SWMU 03-045(c) NPDES outfall; and SWMU 03-056(c), a former outdoor transformer storage area.
- Samples from July and August 2013 had a TAL exceedance ratio of 160 x total PCBs (re-screened for current IP).
- The corrective action consisted of installing a shotcrete cap.

Shotcrete cap S00308060028 at S-SMA-2.

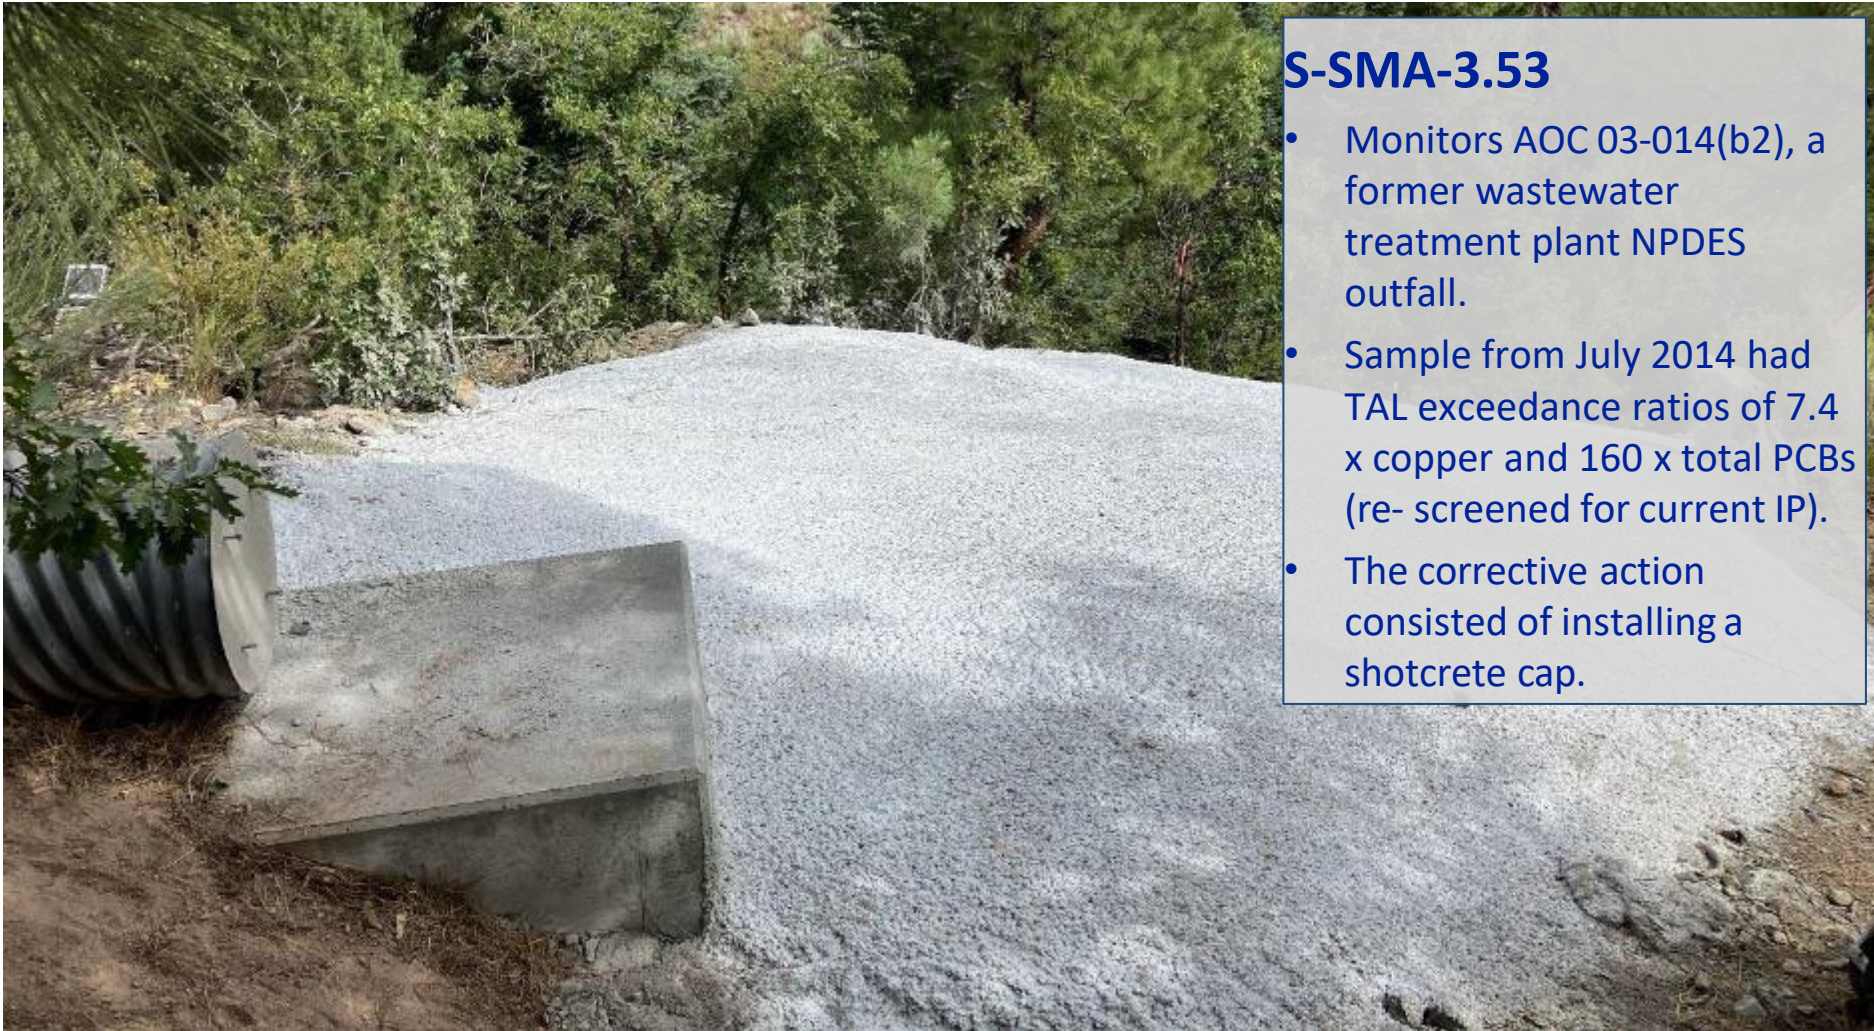
## S-SMA-3.53

- Monitors AOC 03-014(b2), a former wastewater treatment plant NPDES outfall.
- Sample from July 2014 had TAL exceedance ratios of 7.4 x copper and 160 x total PCBs (re- screened for current IP).
- The corrective action consisted of installing a shotcrete cap.

Shotcrete cap S005B08030008 at S-SMA-3.53.

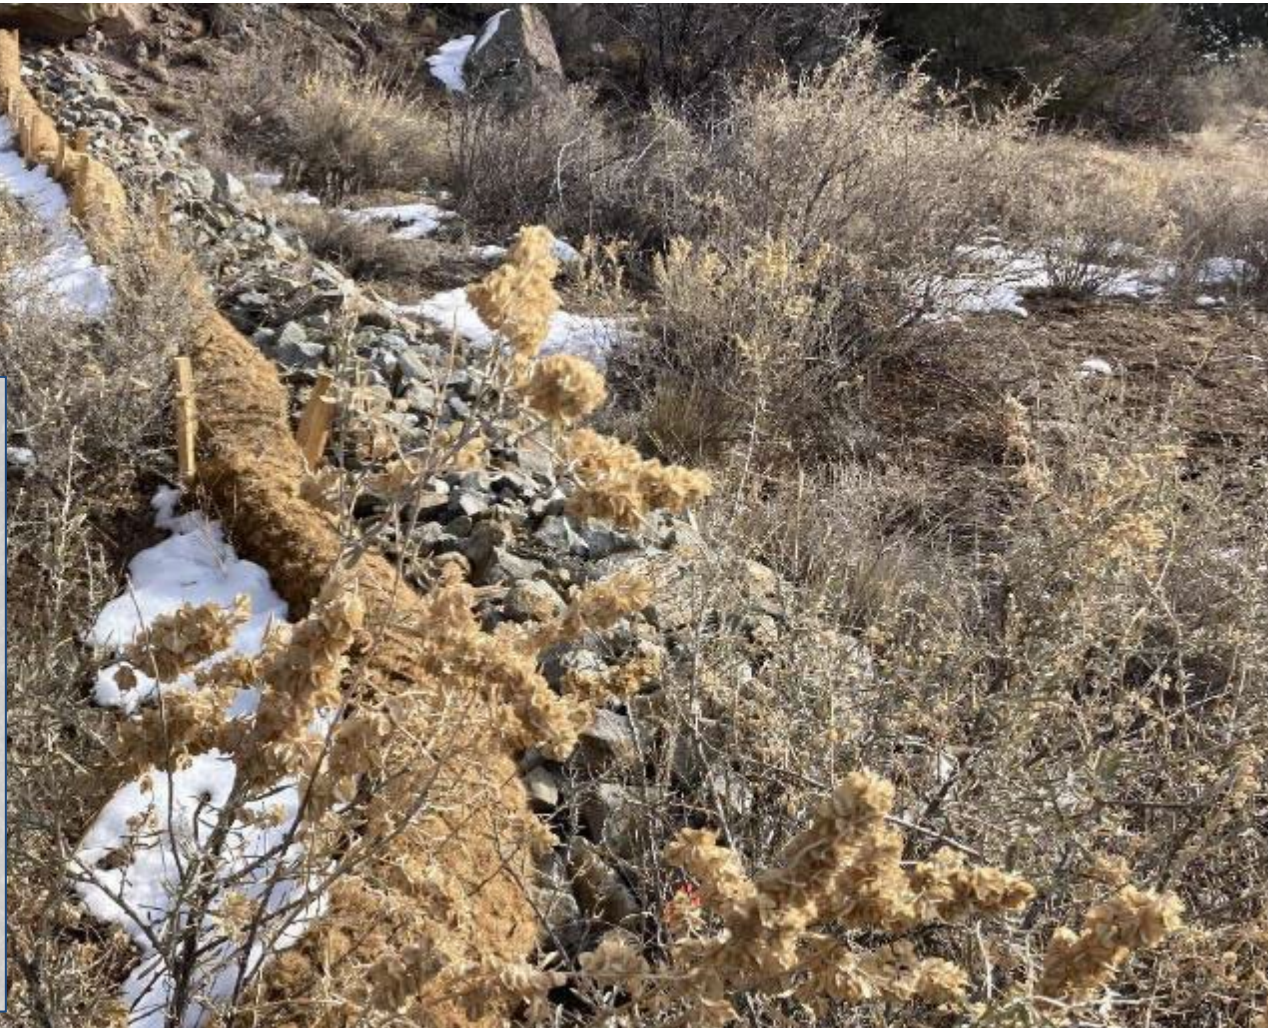
## S-SMA-5.2

- Monitors AOC 20- 003(c), a former gun mount.
- Sample from July 2019 had a TAL exceedance ratio of 190 x hexachlorobenzene (re-screened for current IP).
- The corrective action consisted of installing three rows of coir logs and two rock check dams.

Coir log S01403140024 and rock berm S01403140017 at S-SMA-5.02.

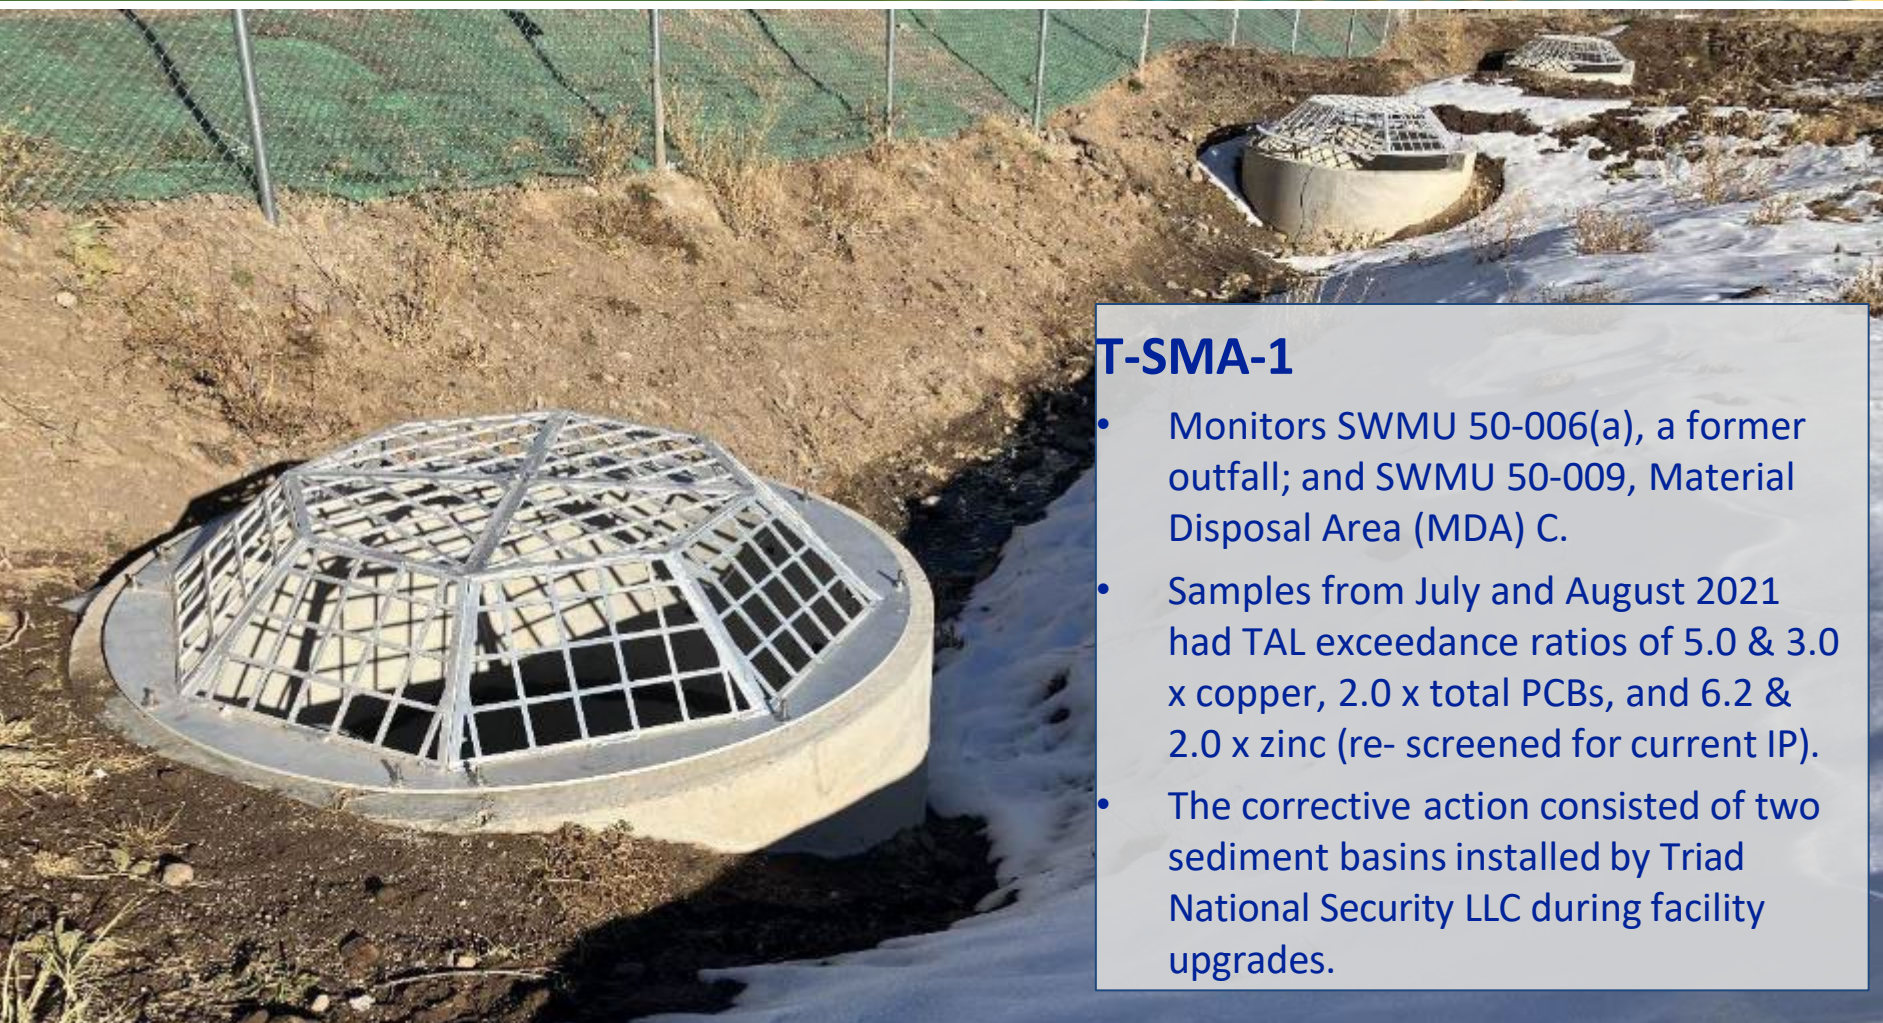
## T-SMA-1

- Monitors SWMU 50-006(a), a former outfall; and SWMU 50-009, Material Disposal Area (MDA) C.
- Samples from July and August 2021 had TAL exceedance ratios of 5.0 & 3.0 x copper, 2.0 x total PCBs, and 6.2 & 2.0 x zinc (re- screened for current IP).
- The corrective action consisted of two sediment basins installed by Triad National Security LLC during facility upgrades.

Sediment basins T00205020029 and T00205020030 at T-SMA-1.
