OFFICE OF  
ENVIRONMENTAL  
MANAGEMENT

# Individual Permit Corrective Actions Update

March 5, 2025

**N3B** Los  
Alamos

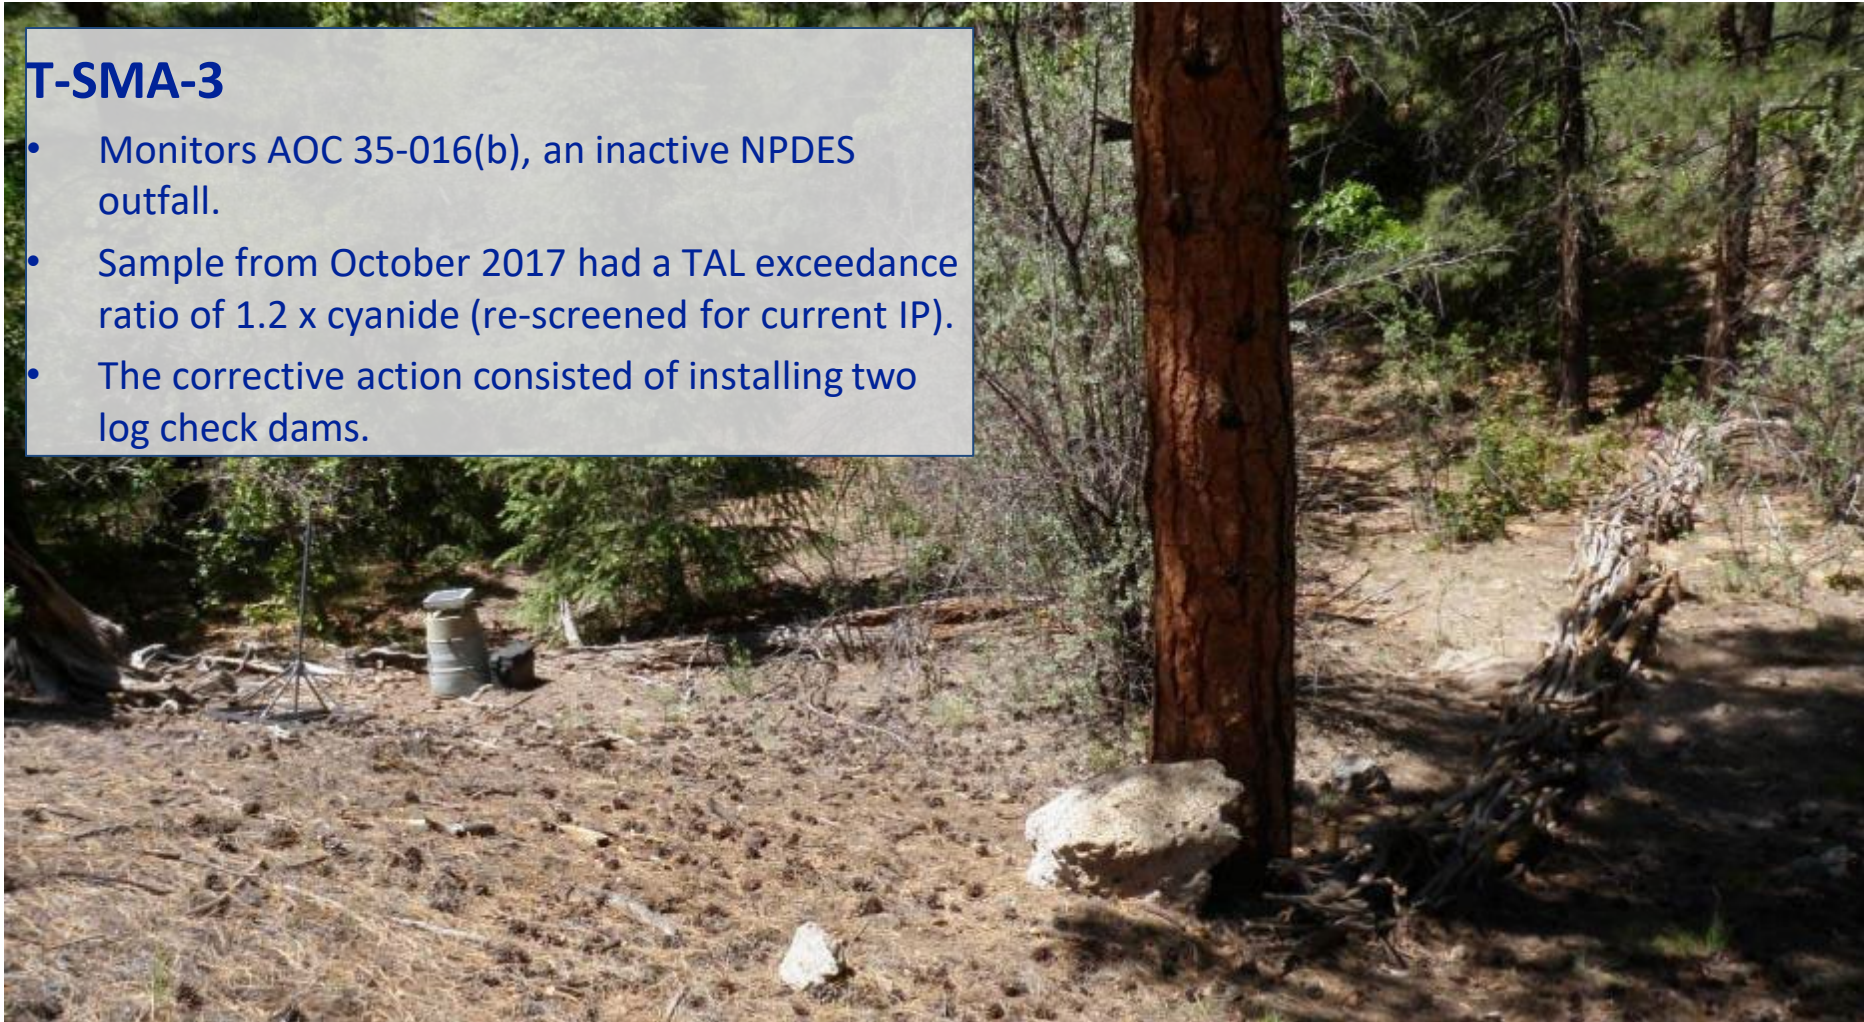
## T-SMA-3

- Monitors AOC 35-016(b), an inactive NPDES outfall.
- Sample from October 2017 had a TAL exceedance ratio of 1.2 x cyanide (re-screened for current IP).
- The corrective action consisted of installing two log check dams.

Sampler and log check dam T00506020015 at T-SMA-3.

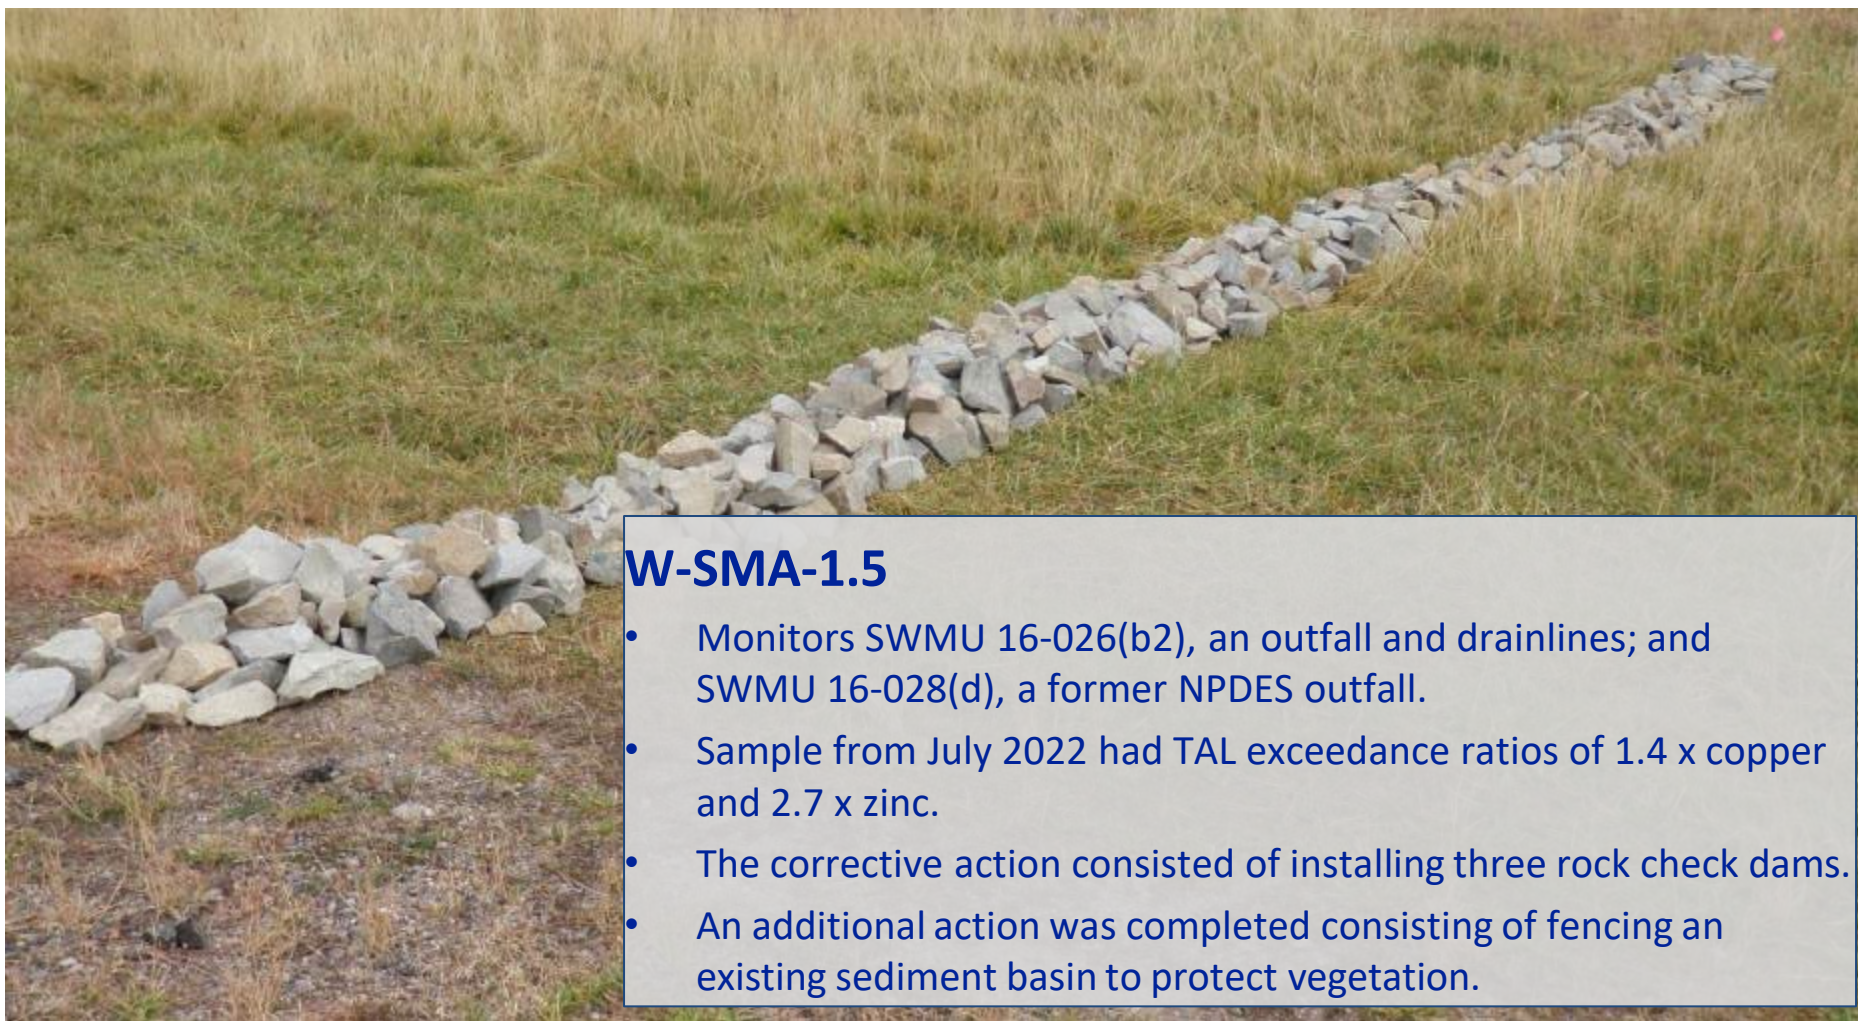
## W-SMA-1.5

- Monitors SWMU 16-026(b2), an outfall and drainlines; and SWMU 16-028(d), a former NPDES outfall.
- Sample from July 2022 had TAL exceedance ratios of 1.4 x copper and 2.7 x zinc.
- The corrective action consisted of installing three rock check dams.
- An additional action was completed consisting of fencing an existing sediment basin to protect vegetation.

Rock check dam W00206010026 at W-SMA-1.5.
