# Operating Experience Summary

OES 2025-05

## A Preventable Tragedy – Tree Trimming Requires Rigorous Planning and Hazard Mitigation

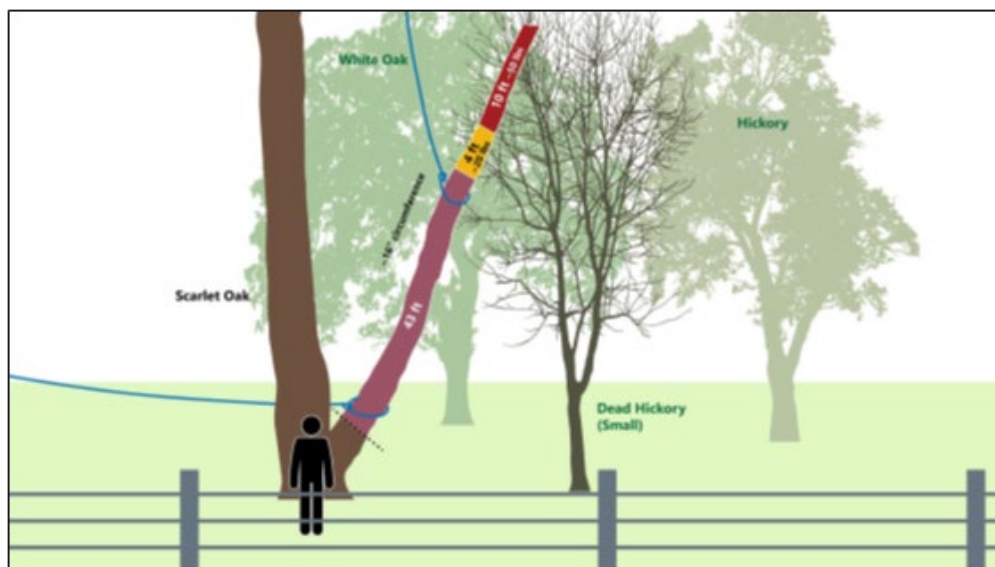
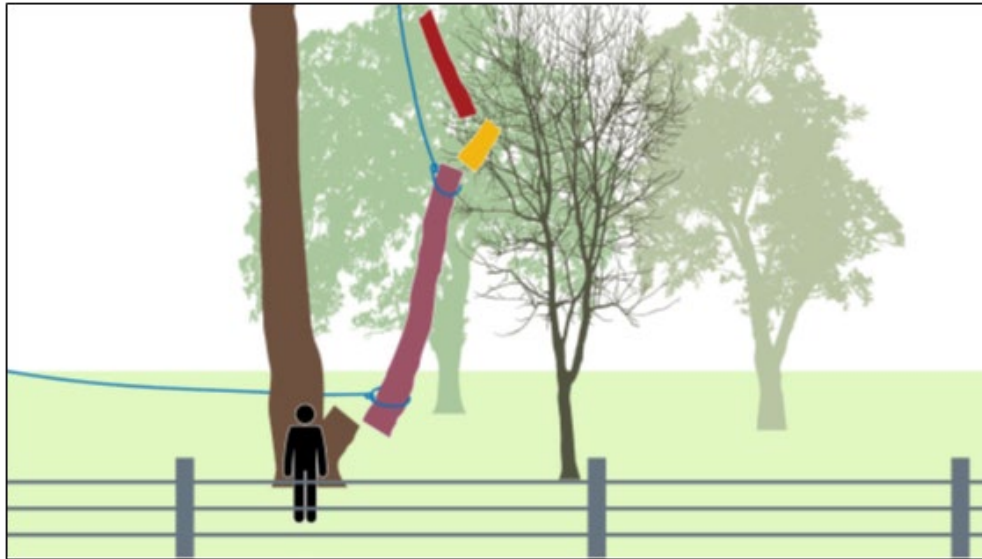
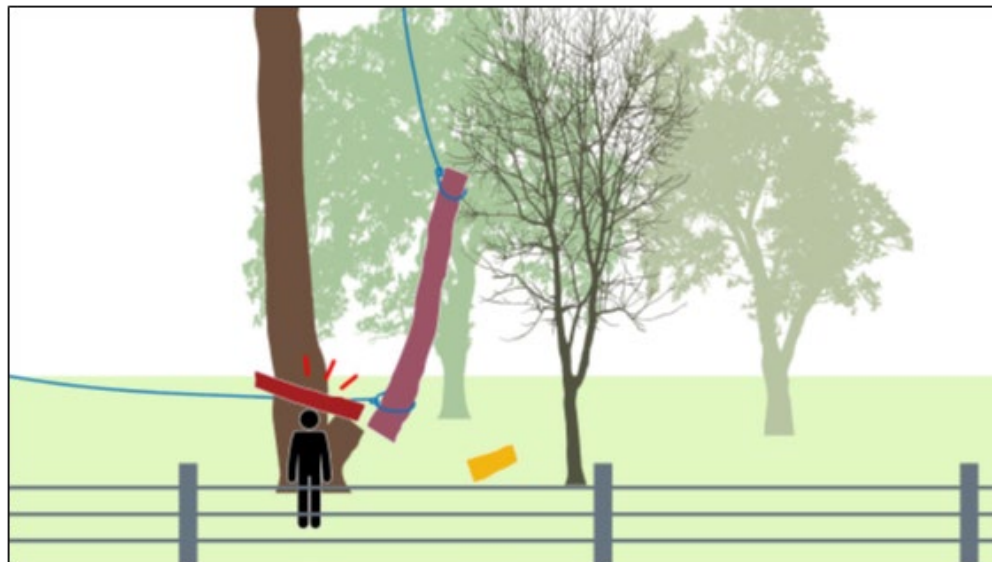
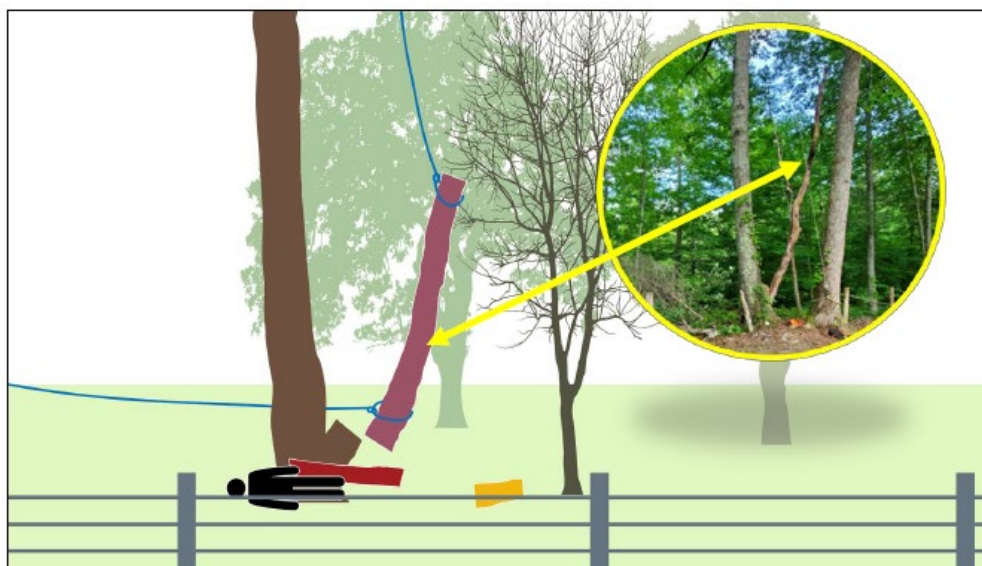
**Figures 1 through 4 provide a visual representation of the accident sequence (not to scale)**

Prior to taking down (dropping) the dead limb, the tree specialists placed both a lower tag line at the base and an upper rigging line approximately 45 feet up from the base of the dead limb.

Once rigged, one of the tree specialists (CoTW-2) held the lower tag line while the other tree specialist (CoTW-1) began using a chainsaw to make multiple cuts in which to drop the dead limb. When the final cut was made, the base of the dead limb struck the ground, while the upper portion contacted the adjacent trees, causing the top 14 feet of the dead limb to break into two pieces. One piece measured approximately 4 feet long and the other, approximately 10 feet long.

The 10-foot section of dead limb struck CoTW-1 directly on the head, and even though they were wearing a safety helmet, the 50-pound dead limb piece had an estimated force transmission far exceeding the helmet's rated capacity. The two prime contractor workers at the site responded to the scene, moved the 10-foot section of dead limb, and called 911 while CPR was immediately initiated by CoTW-2. Emergency Management Services (EMS) arrived from both the town of Oak Ridge and Y-12, and once stabilized, CoTW-1 was transported to Oak Ridge Methodist Medical Center and subsequently airlifted to the University of Tennessee Medical Center where they succumbed to their injuries.
