**KASGRO REPORT 1  
METALLURGICAL REPORT**

**Metallurgical Evaluation of a Welded Steel Plate**

**REPORT No. 202201788**

## Customer Claim - Triad Metals Investigation

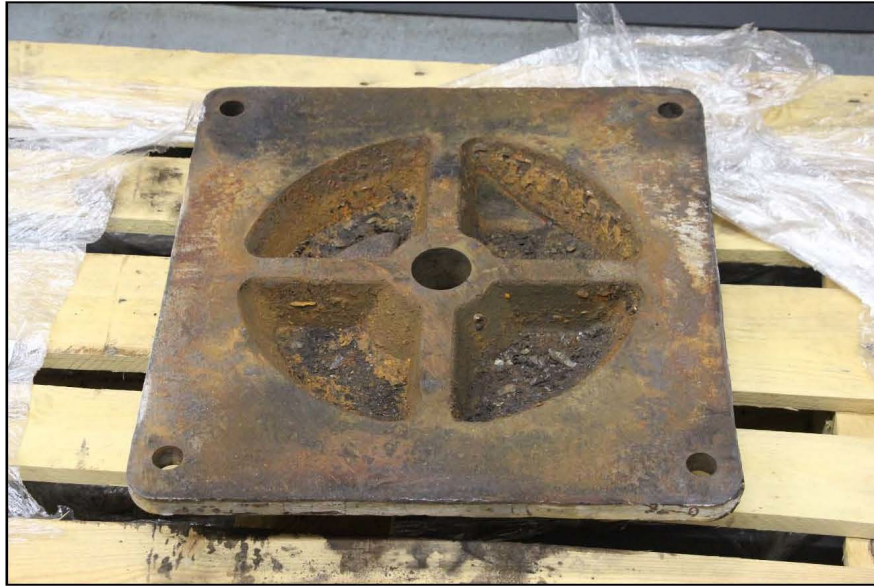
The submitted plate is shown in the as-received condition in Figure 1. The rectangular plate was relatively flat and did not exhibit any gross mechanical damage. One edge of the plate was cut and ground and this is oriented toward the bottom in Figure 1. This edge exhibited the presence of cracks that were the concern of this investigation. A number of visible crack -like features were apparent along

Figure 1. Photograph showing the submitted center plate. The ground weld edge that exhibited cracks is toward the bottom in this image.

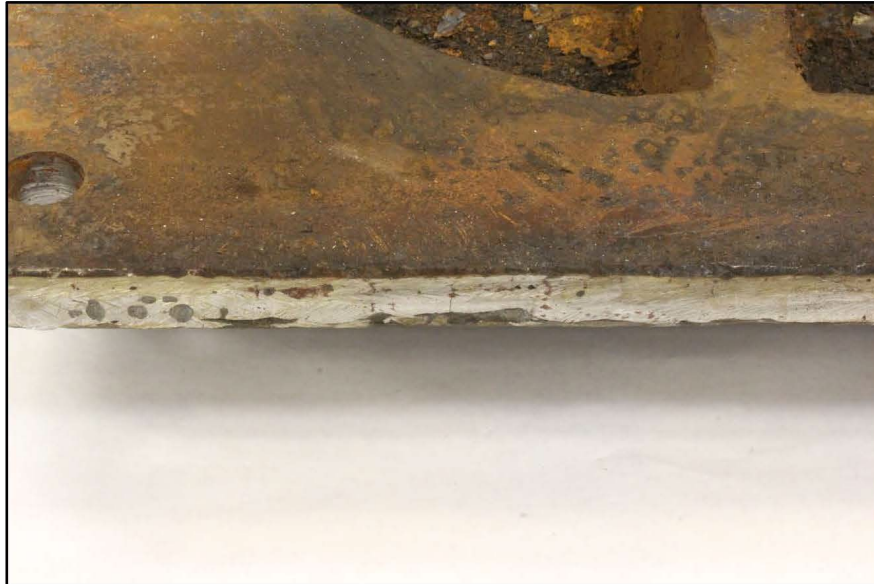
this cut edge and two prominent areas were selected for laboratory analysis. These regions were arbitrarily identified as Regions A and B, as shown in Figures 2 and 3, respectively. These regions contained small clusters of cracks that were primarily through the thickness of the cast plate. The top and bottom surfaces of the plate were relatively rough and rusted, so it was not possible to determine how far the cracking continued into the plate. Similarly, it was not possible to determine how deep the weld continued into the base metal due to prior grinding that had been performed. Inspection of the other three edges of the plate did not exhibit analogous cracking, however, those edges were not prepared to the same finish as the edge identified for analysis.

Figure 2. Image showing a cluster of cracks identified as Region A. A number of individual vertical cracks were evident on the cut and ground surface.

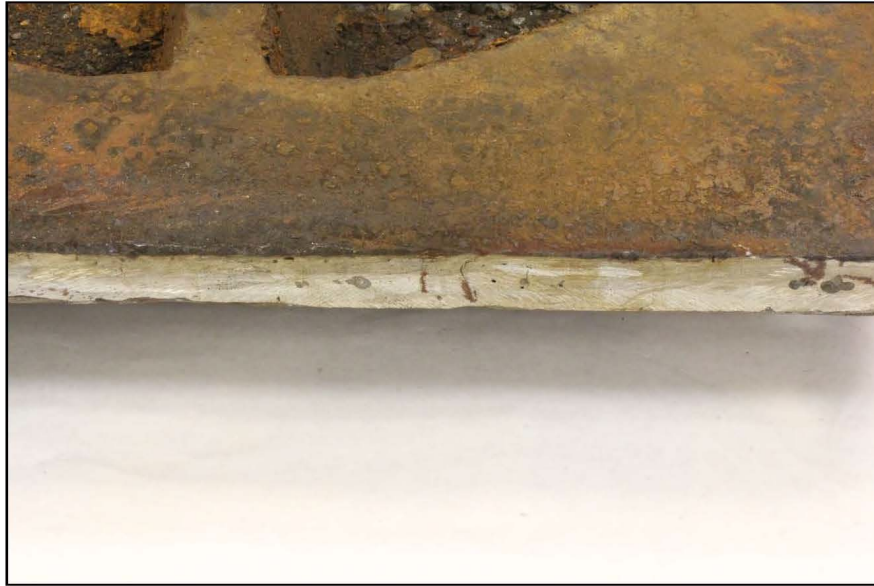
Figure 3. Image showing a cluster of cracks identified as Region B. A number of individual vertical cracks were evident on the cut and ground surface.

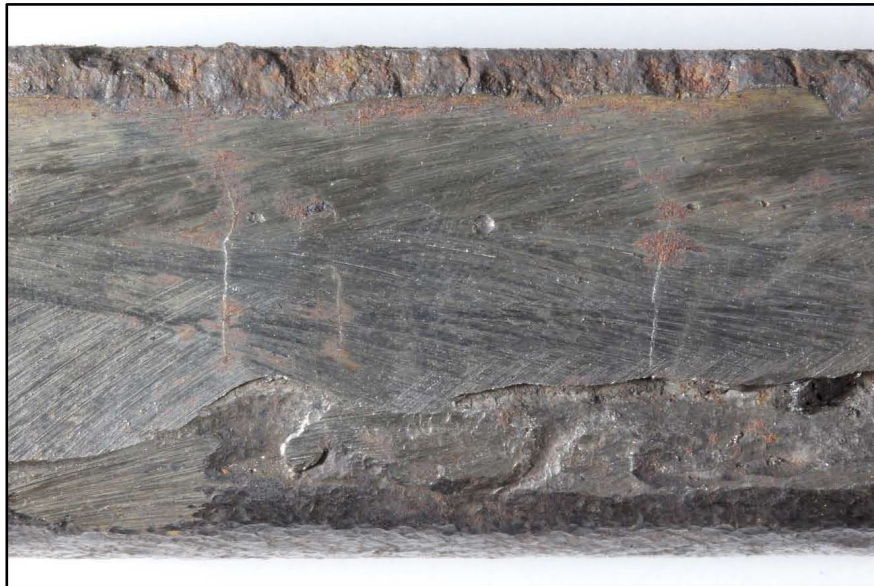
Photographs of representative cracking are shown as Figures 4 and 5. Cracking was irregular and contained some reddish rust. Some features such as porosity in the material surrounding the cracks confirmed that the cracking at the surface was within weld metal. The areas of interest were then examined using optical stereomicroscopy at magnifications up to 100X. Representative images of cracks are included as Figures 6 and 7. The nature of the cracks could not be determined visually, but they were relatively jagged rather than curved, which can be suggestive of incomplete fusion during the welding process.

Figure 4. Close-up image of several of the Region A cracks. The top and bottom edges of the cast plate were ground. A cross-section specimen was prepared through the center of these cracks.

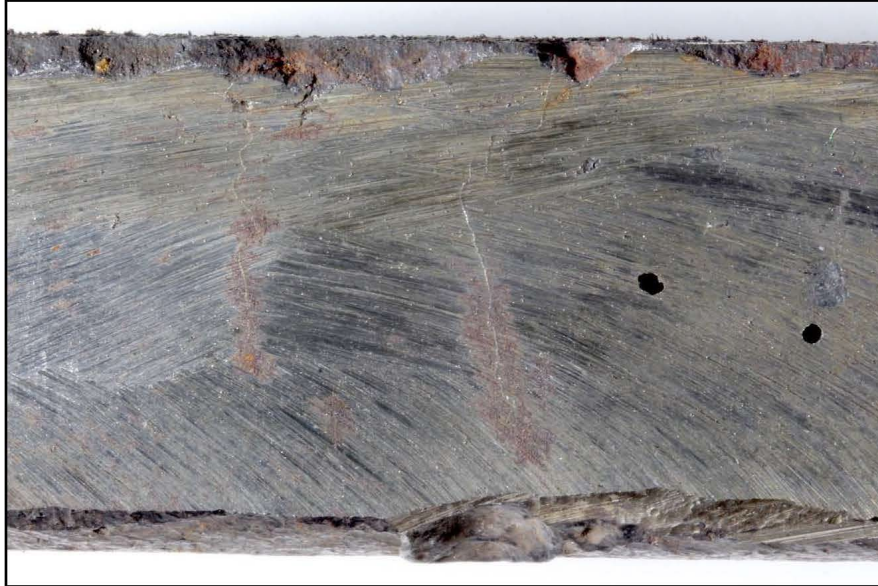
Figure 5. Close-up image of several of the cracks at Region B. A cross-section specimen was prepared through the center of these irregular cracks. Several gas pores are also apparent in this image.

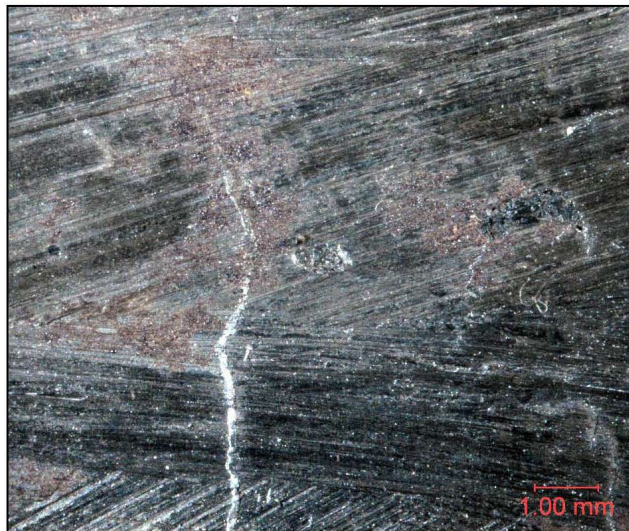
Figure 6. Stereomicroscope image showing some of the fine crack features at Region A. (4.9X)

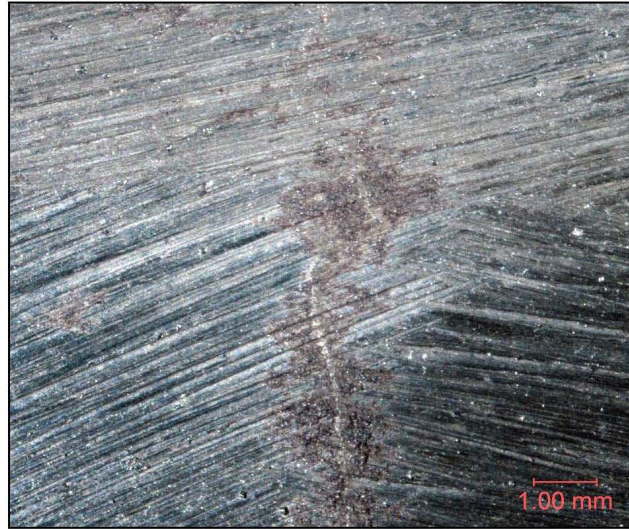
Figure 7. Stereomicroscope image showing some of the fine crack features at Region B. (4.9X)

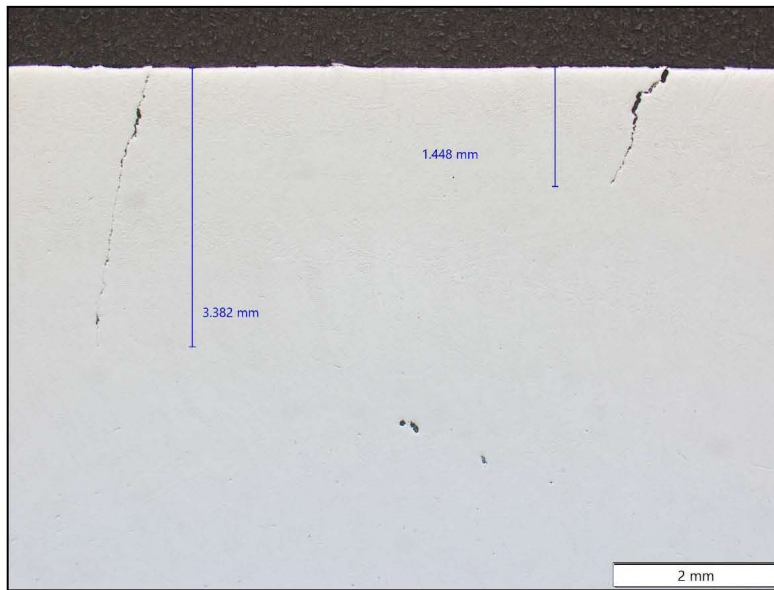
Figure 8. Metallographic cross-section specimen through one part of Region A. Irregular, angled cracks were evident to a maximum depth of 3.4 mm (0.134"). (As-polished, 14.9X)

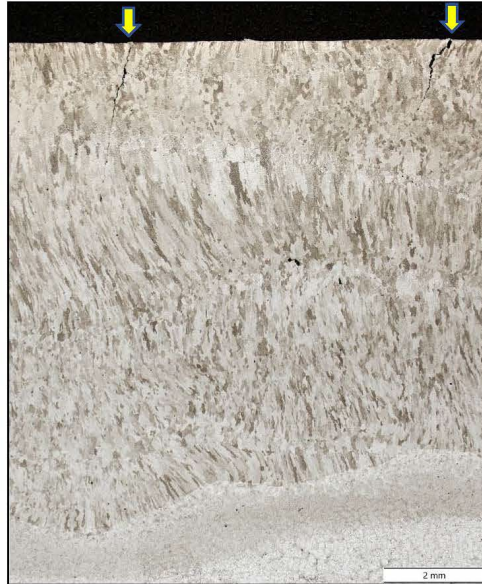
Figure 9. Photomontage of the crack region in Figure 8 after metallographic etching. The cracks were entirely within the weld (arrows). (2% Nital etch, 8.8X)

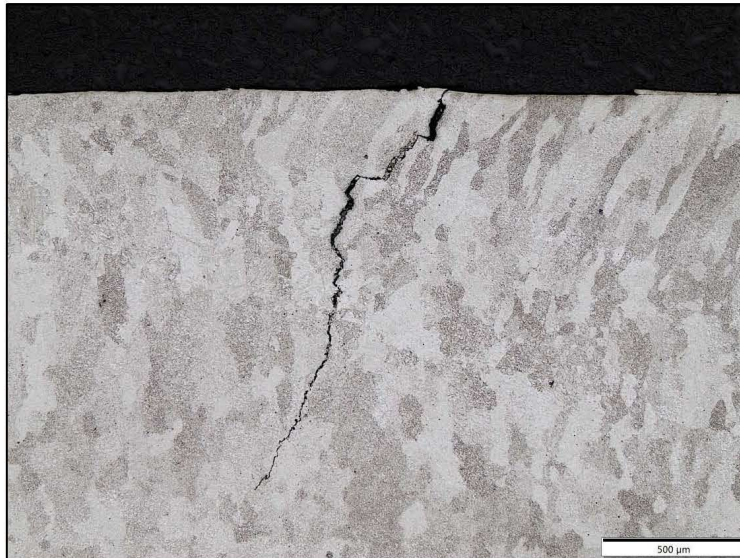
Visual and cross-section microscopic evaluation of the transverse cracks on the welded edge of the plate revealed that they were welding hot cracks. The cracks were jagged and generally followed the columnar solidification grains evident within the weld. Most of the cracks were within the weld, however, one unusually long crack continued through the weld, the heat affected zone (HAZ), and terminated in the base metal. This crack was approximately 7.9 mm (0.311") deep. No gross fusion flaws were identified in the regions that were studied.

Figure 10. Low magnification image showing the jagged crack toward the right in Figure 9. The cracking followed the columnar solidified grains within the weld. (2% Nital etch, 50X)

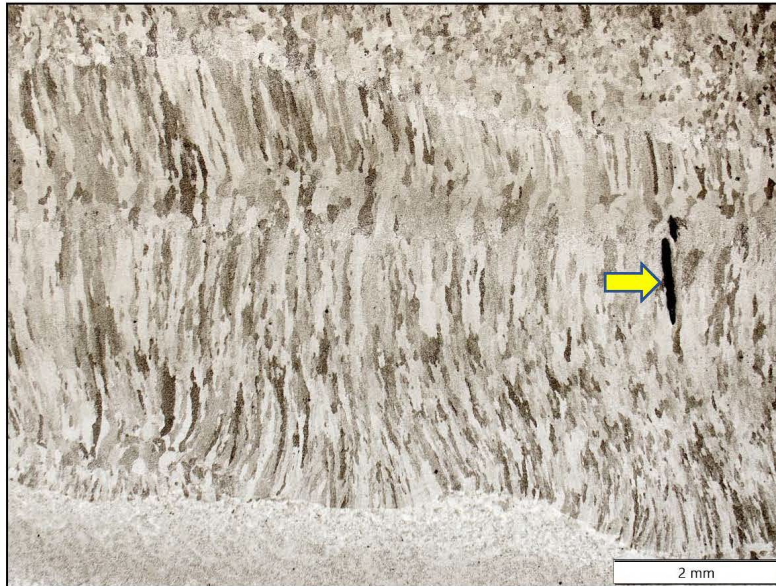
Figure 11. Metallographic cross-section specimen through an additional location of Region A where a subsurface fissure (arrow) was evident. (As-polished, 14.4X)

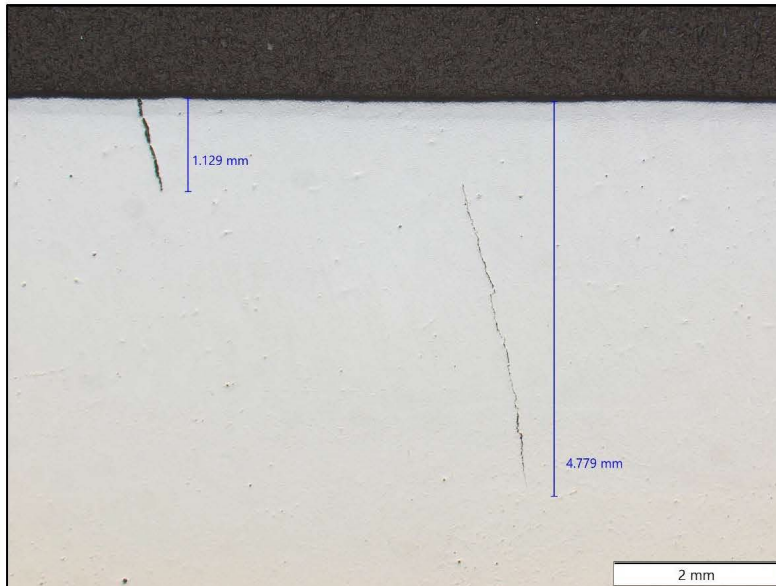
Figure 12. Metallographic cross-section specimen through one part of Region B. Irregular, angled cracks were evident to a maximum depth of 4.8 mm (0.188"). (As-polished, 14.4X)

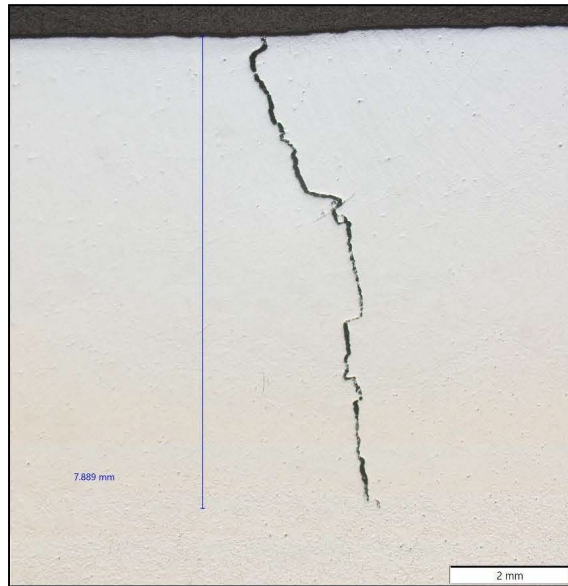
Figure 13. Photomontage of the deepest crack on the specimen from Region B. This jagged crack was approximately 7.9 mm (0.311"). (As-polished, 10.4X)

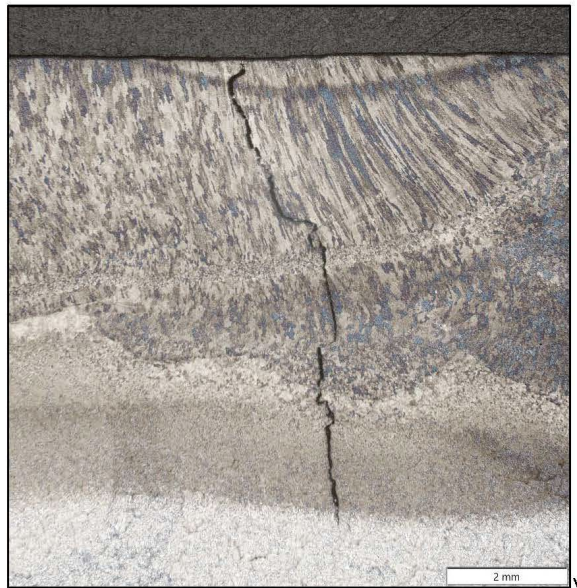
Figure 14. Etched view of the crack in Figure 13 showing that the tip of the crack stopped within the base metal, below the weld heat affected zone. (2% Nital etch, 10.5X)

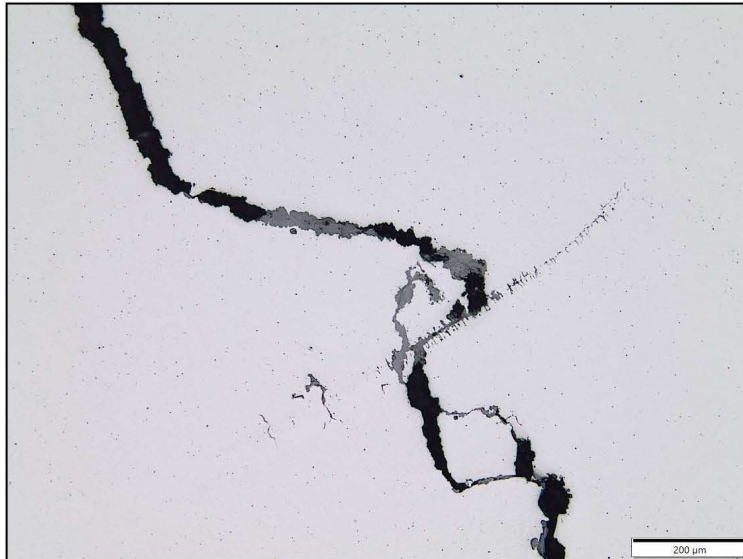
Figure 15. A region within the center of the largest crack is shown. Oxidized incomplete fusion and intergranular cracking were apparent. (As-polished, 100X)

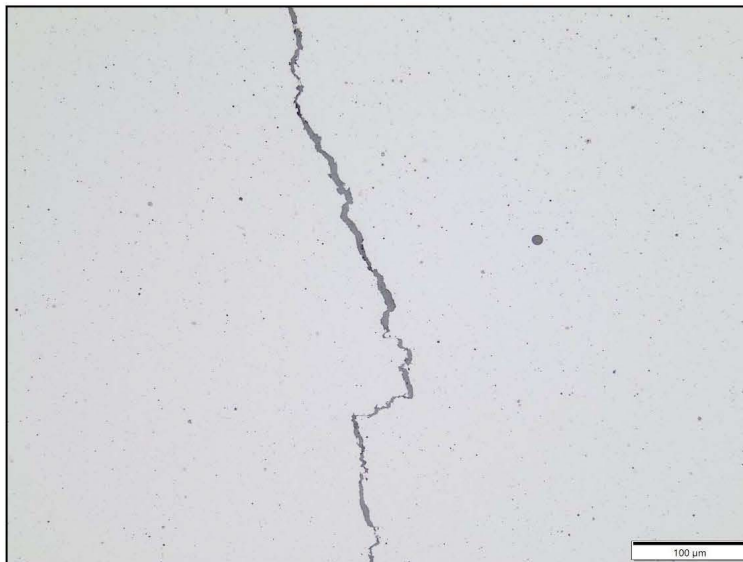
Figure 16. Image of a portion of the crack toward the right in Figure 12 showing that the tight crack was filled with oxide. (As-polished, 200X)

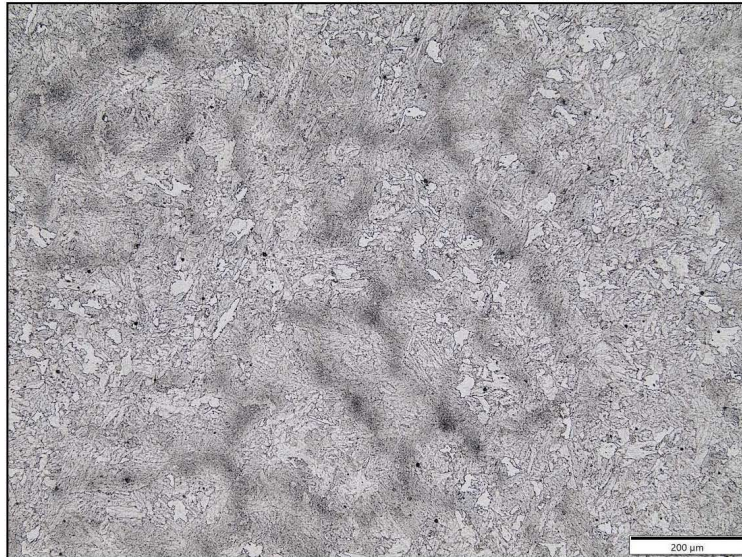
Figure 17. Metallographic image showing the typical core microstructure of the cast steel plate. Dendritic solidification segregation evidence was observed. (2% Nital etch, 100X)

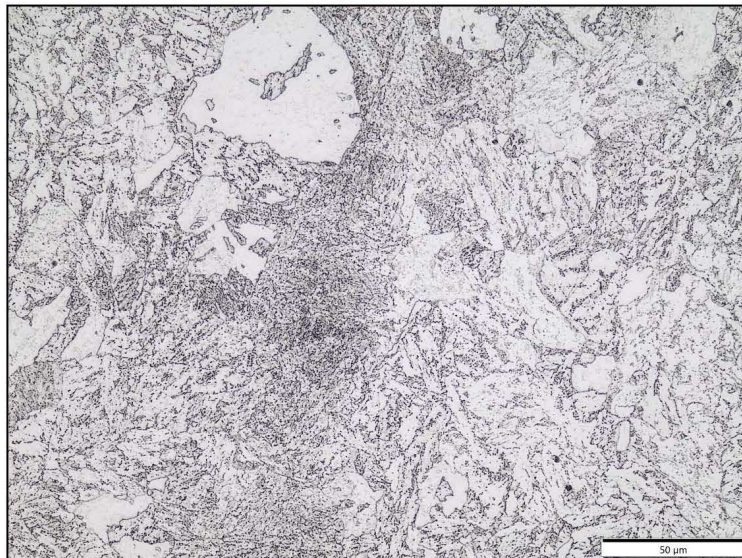
Figure 18. High magnification image of the typical core microstructure of the plate which consisted of a highly tempered lath structure. (2% Nital etch, 500X)

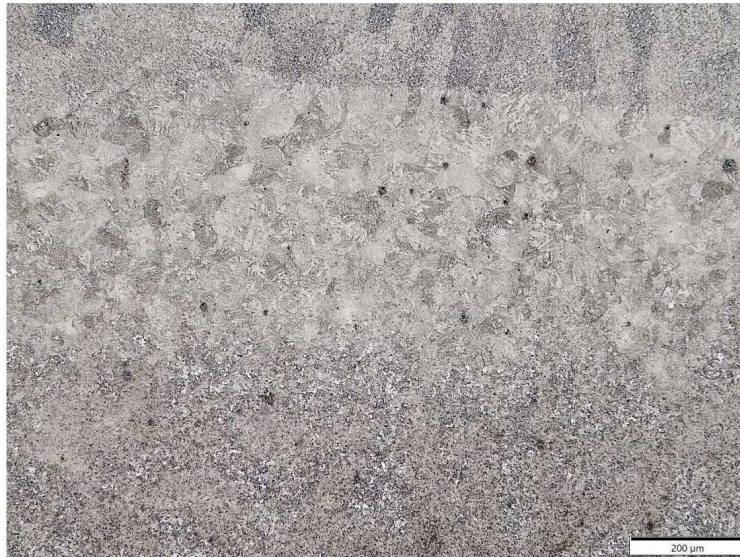
The typical microstructure of the cast plate consisted of ferrite, coarse lath martensite and temper carbides. The observed structure was consistent with the specified normalized and tempered condition. The heat affected zone contained substantial martensite transformation, confirming prior hardness testing results. The weld microstructure also contained ferrite and coarse martensite.

Figure 19. Metallographic image showing the typical heat affected zone microstructure of the cast steel plate adjacent to the weld. (2% Nital etch, 100X)

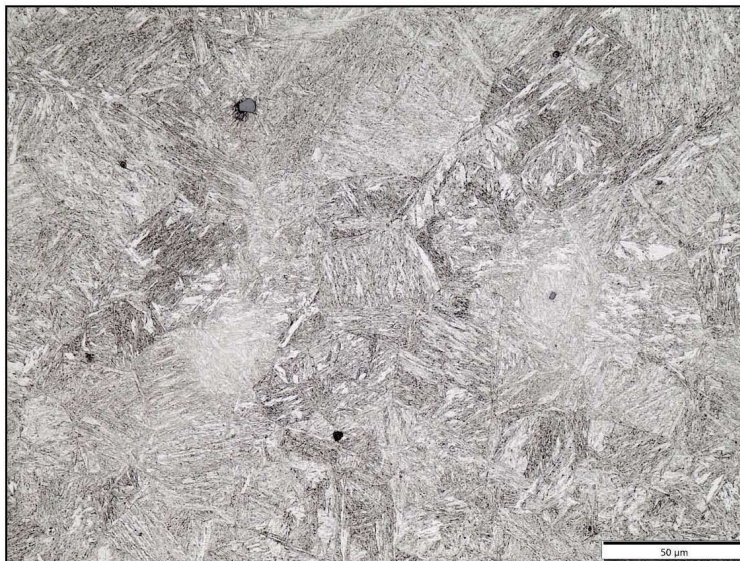
Figure 20. High magnification image showing the fine martensite evident in the heat affected zone of the weld. (2% Nital etch, 500X)

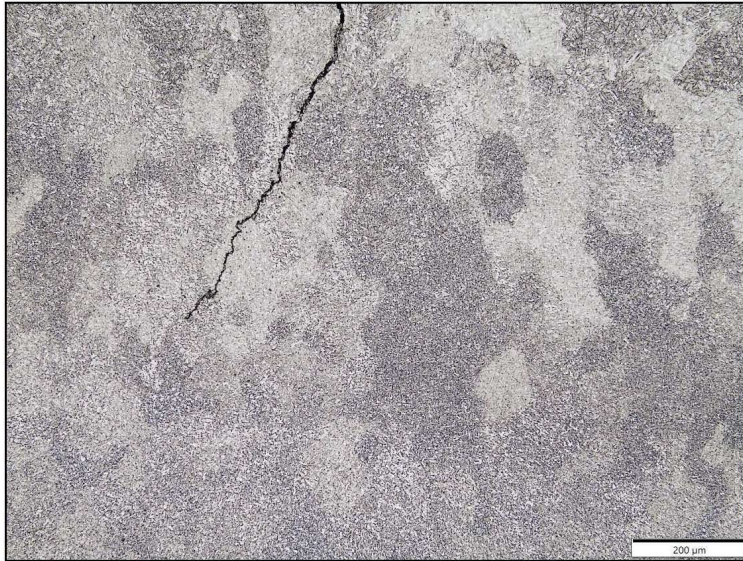
Figure 21. Metallographic image showing the typical weld zone microstructure. (2% Nital etch, 100X)

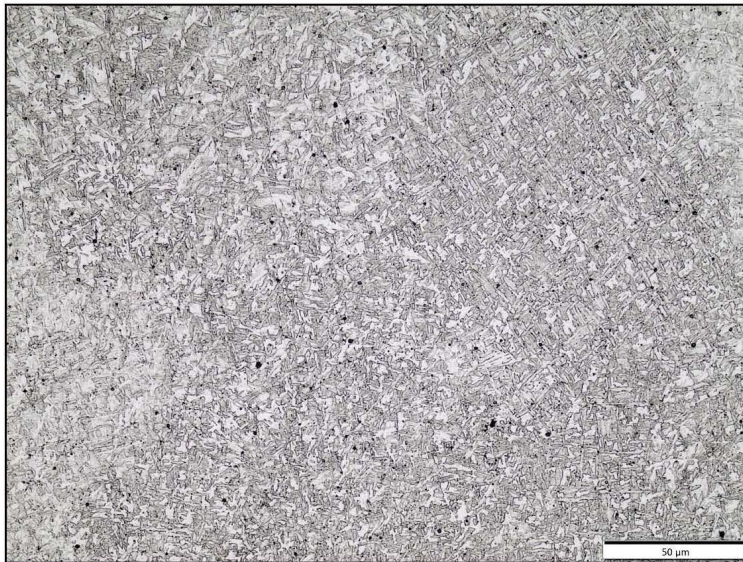
Figure 22. High magnification image of the typical weld microstructure which contained some lower transformation products. (2% Nital etch, 500X)

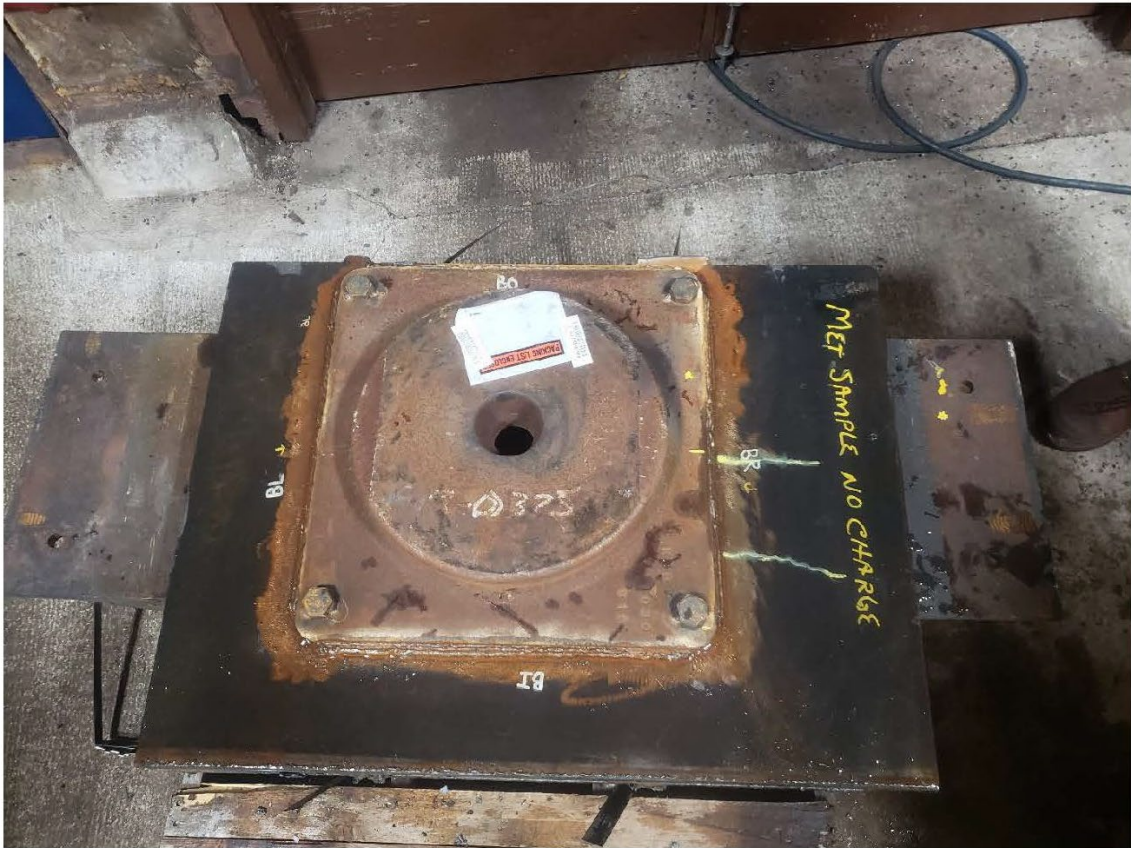
During the inspection of the sample two ( 2 ) cracks indications were found on the BR side of the sample. The two crack indications in question extend 5" and 6" in length. These indications do not appear to encroach to the exterior edges of the test sample.

Figure 1: Image of Trispan Test Piece showing two ( 2 ) crack indications on the BR side of the sample

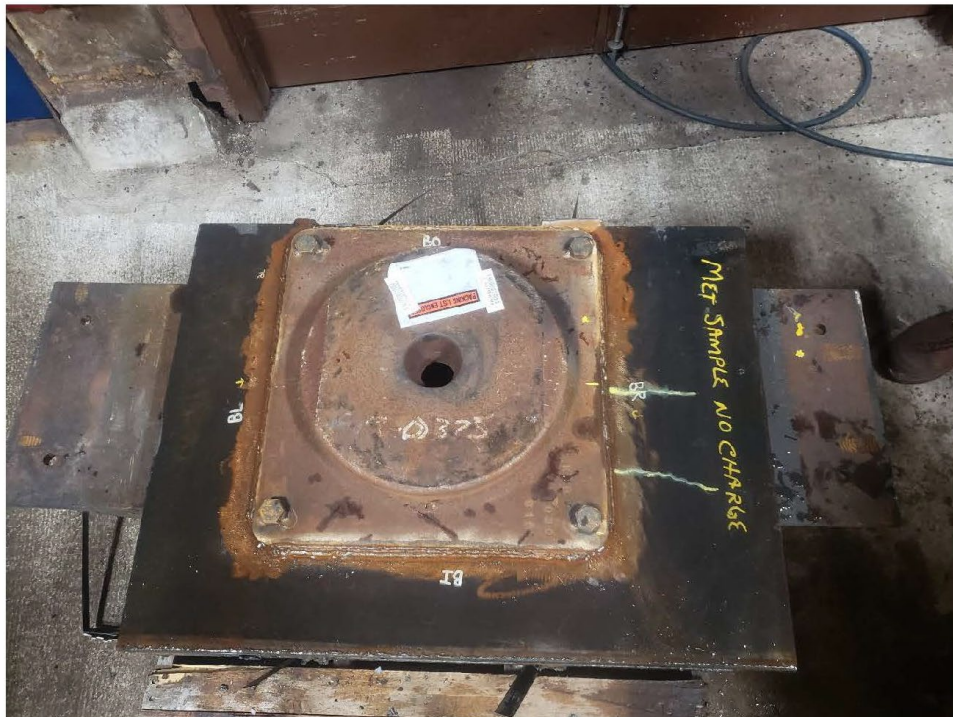
During the inspection of the sample two ( 2 ) cracks indications were found on the BR side of the sample. The two crack indications in question extend 5" and 6" in length. These indications do not appear to encroach to the exterior edges of the test sample.

Figure 1: Image of Trispan Test Piece showing two ( 2 ) crack indications on the BR side of the sample

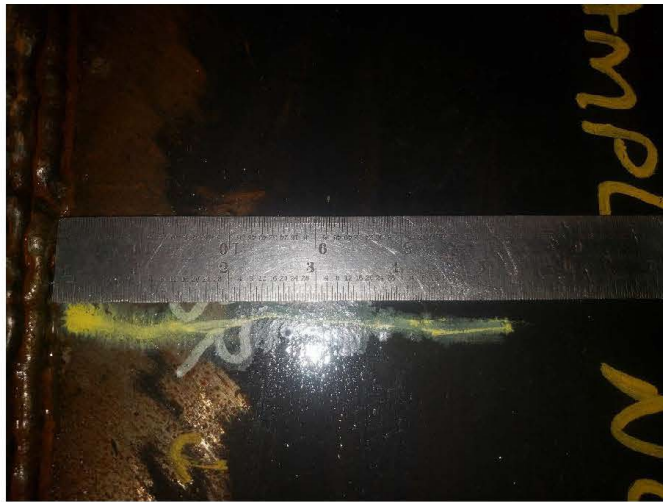
Figure 2: Image showing the crack indication that is 5" in length

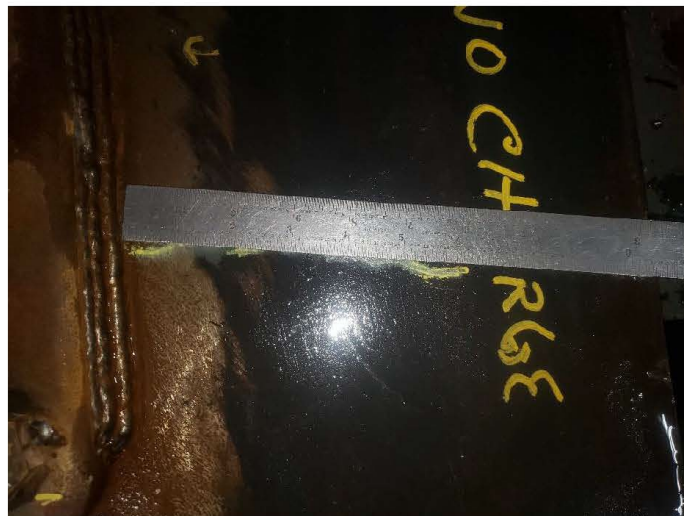
Figure 3: Image showing the crack indication that is 6" in length

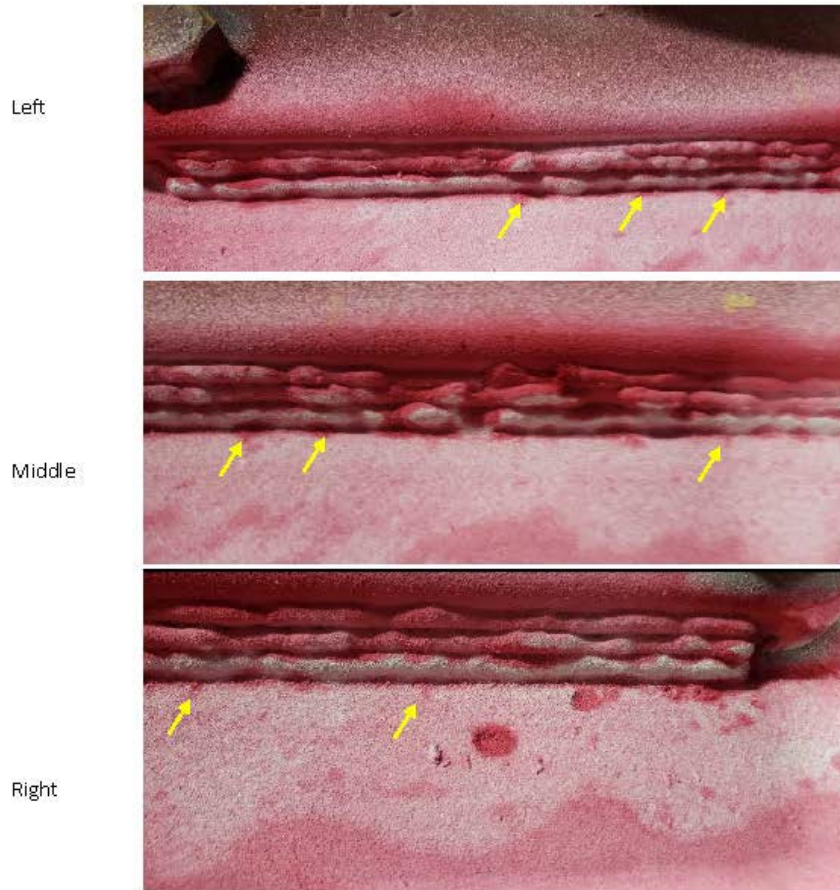
Dye penetrant testing was performed on the BR side of the sample. Multiple small crack indications were found along the weld in the Heat Affected Zone (HAZ). Refer to the arrows in Figure 2 and Figure 3.

**Figure 2.** Multiple small cracks in the HAZ detected by Dye Penetrant inspection in the BR side of the sample received for investigation.

Based on the results from the sample received from the investigation there is no evidence that point out issues related to the material. The multiple cracks that were observed are most probably related to the welding practice used during the fabrication of the part.

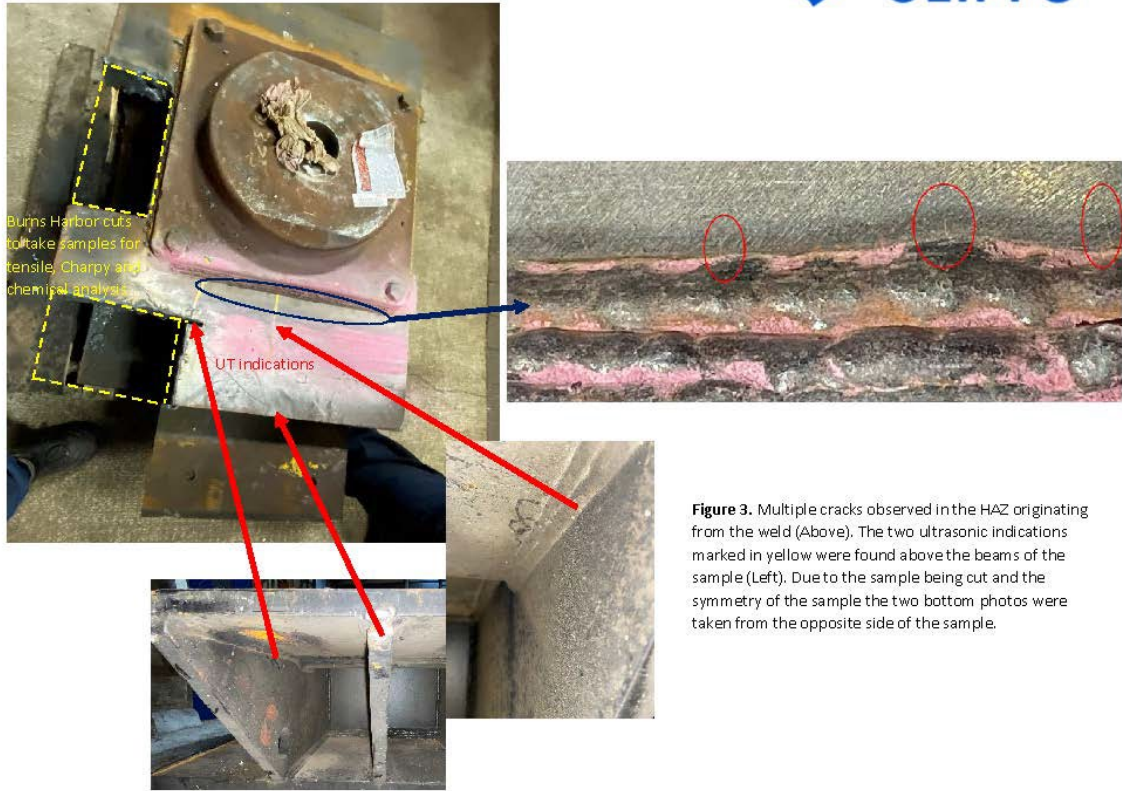
An Ultrasonic evaluation was conducted on the sample, two ultrasonic indications were found on the BR side of the sample. These indications were found roughly one inch into the sample and did not propagate to the surface or edge of the material. These indications lined up with the location of the support beams on the bottom of the part, as shown in Figure 3.

**Figure 3.** Multiple cracks observed in the HAZ originating from the weld (Above). The two ultrasonic indications marked in yellow were found above the beams of the sample (Left). Due to the sample being cut and the symmetry of the sample the two bottom photos were taken from the opposite side of the sample.
