Appendix E

Photos from September 20, 2018 Site Visit

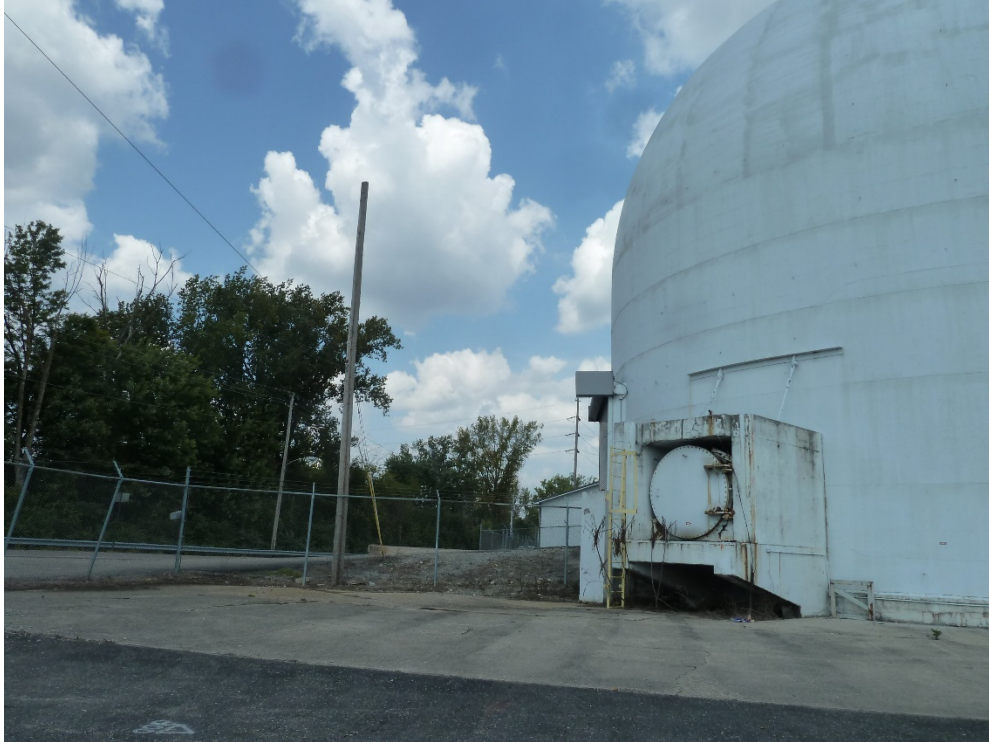
Photo 1. Exterior of aboveground steel containment dome showing barbed wire fence providing security for the site. On other side of containment dome is a secure, motorized, sliding access gate.

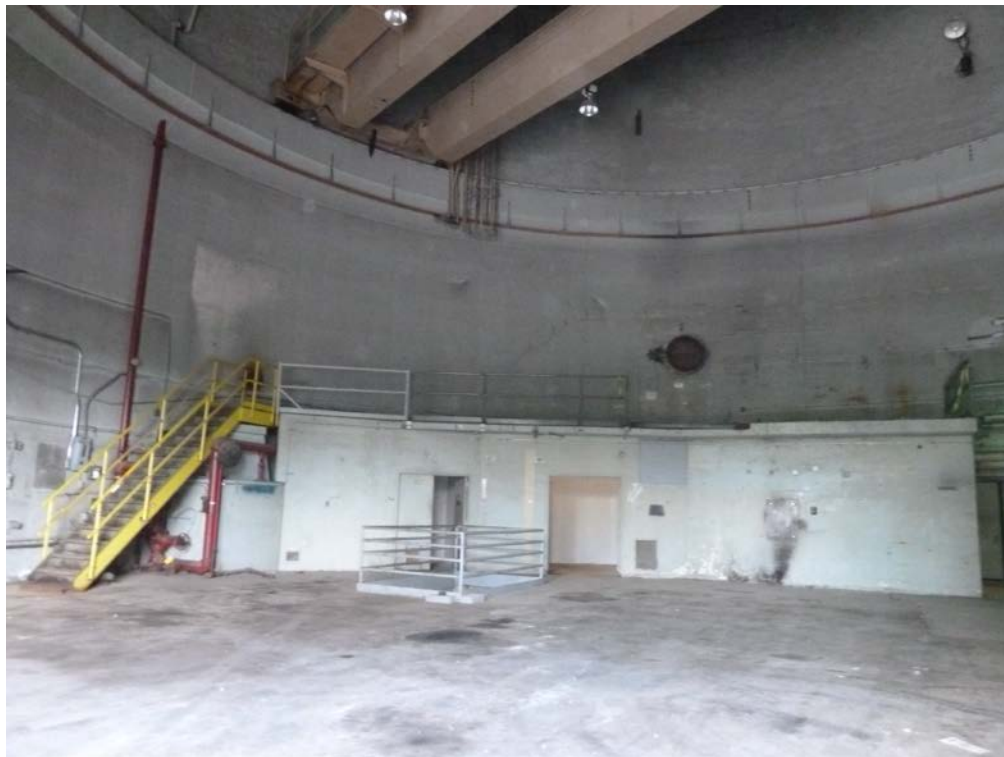
Photo 4. Platform within interior of aboveground containment dome. Chemicals were previously stored under platform.

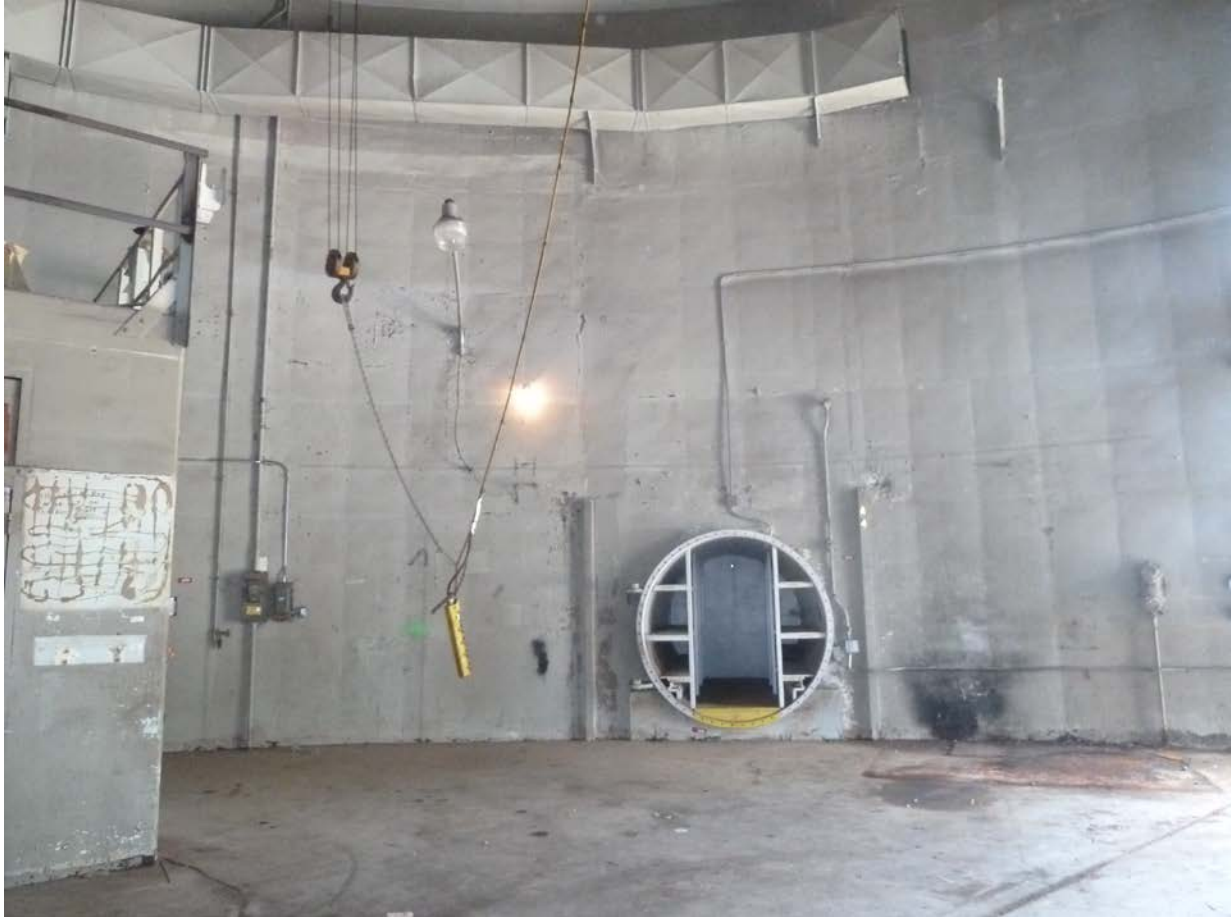
Photo 5. Round air-lock from interior of aboveground containment dome to outdoor locker that leads to administration building.

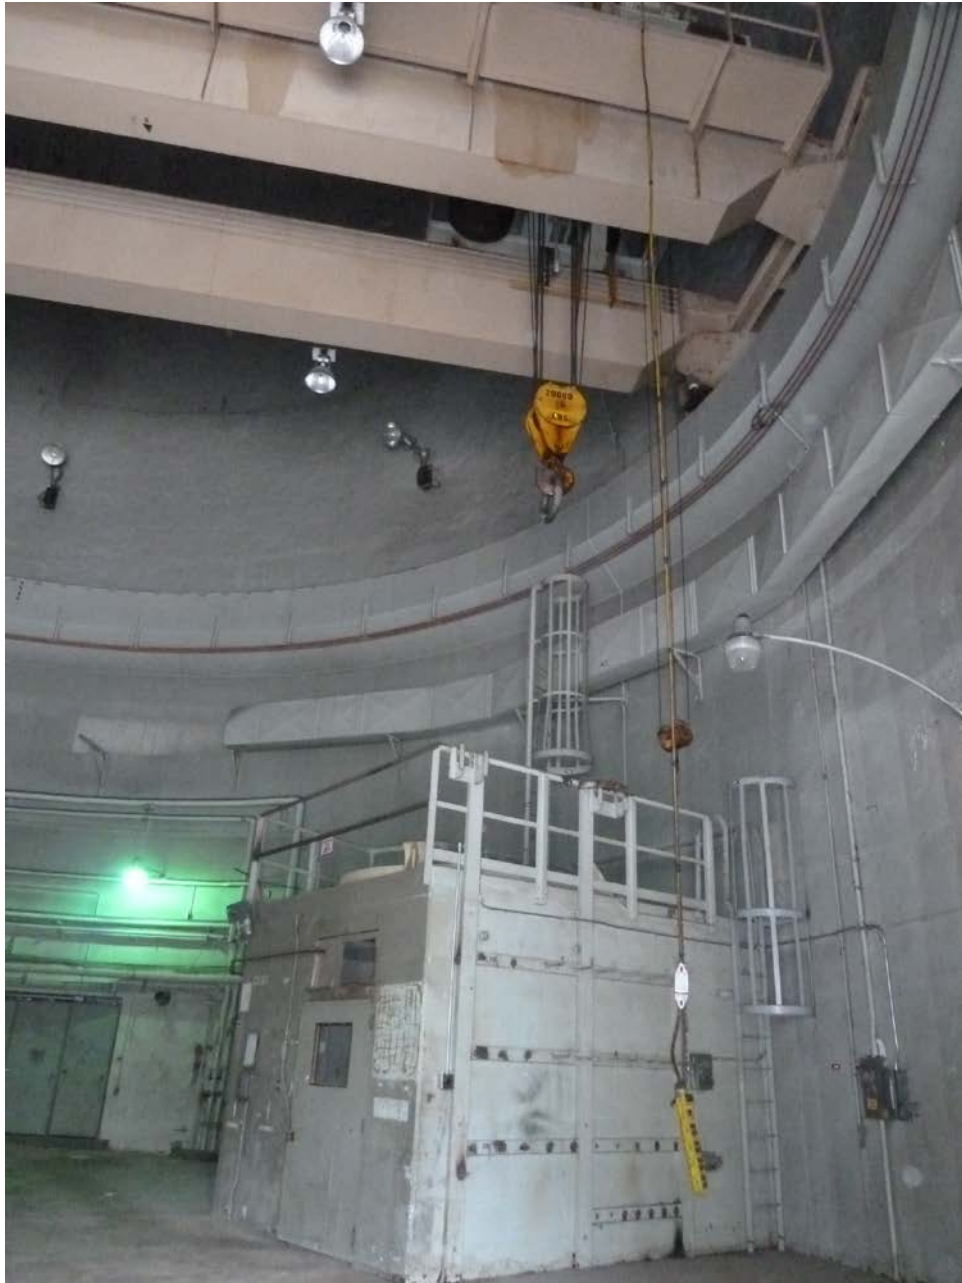
Photo 6. Portion of interior of aboveground containment dome. Brown paint shown in photo contains lead and PCBs. Handrails and interior surfaces of steel containment dome also contain layer(s) of LBP with PCB constituents.

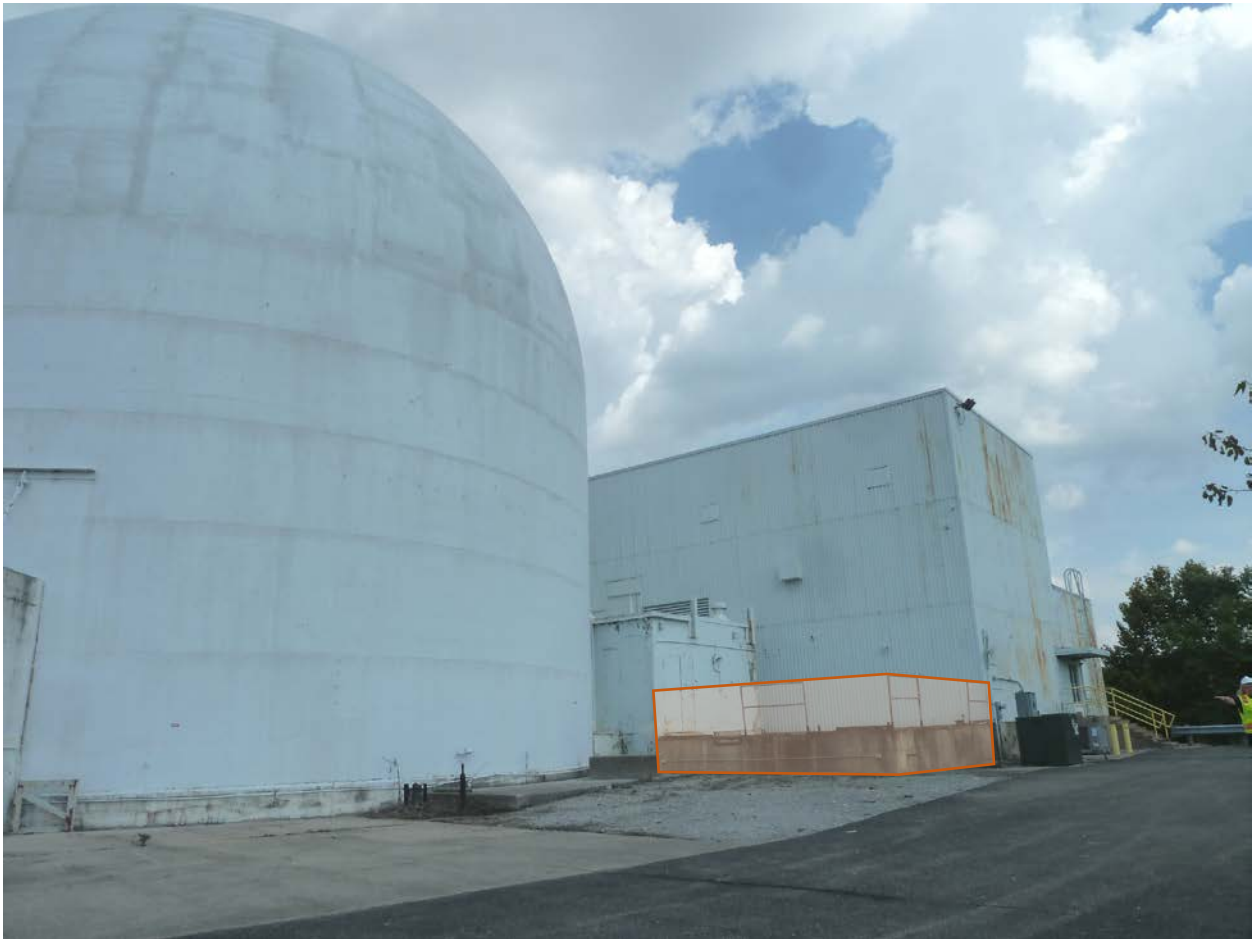
Photo 7. Steel containment dome above the belowground entombment in left of frame. Administration building shown in right of frame. Building between the containment dome and the administration building is an outdoor locker previously used for chemical storage. The concrete pad adjacent to the outdoor locker (indicated with orange outline and tint) may contain PCBs due to previous storage of equipment and fuels.

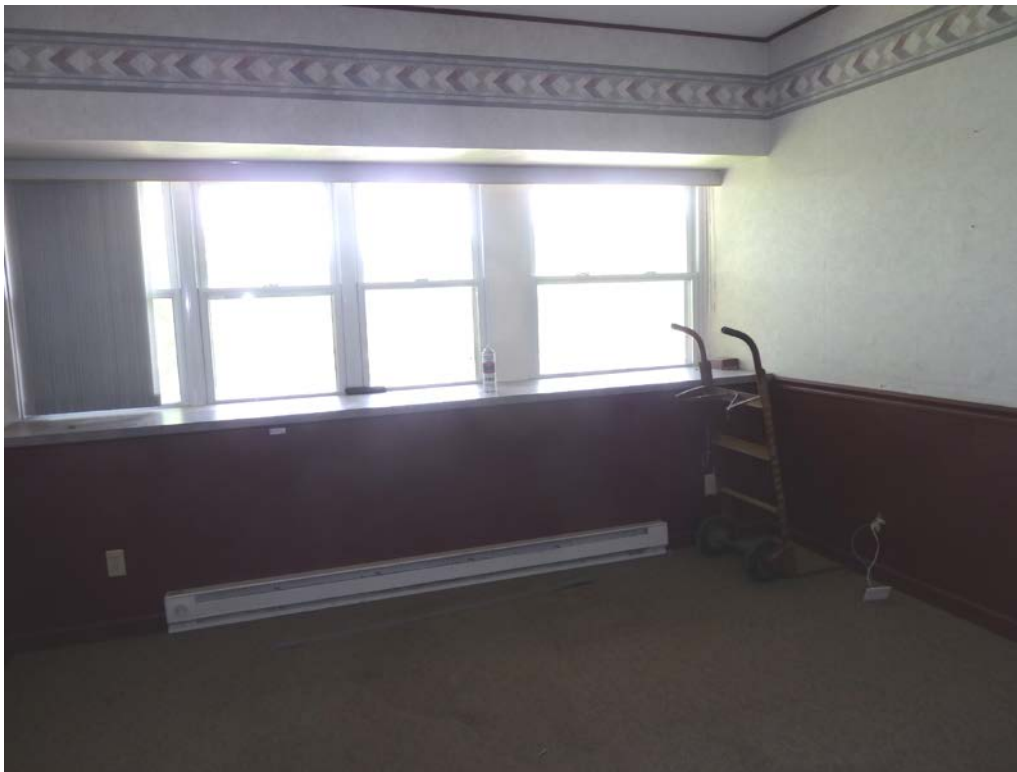
Photo 15. One of three offices in the administration building.
