Well MIDDLE-2051 Investigation and Results

Presentation to Citizens Advisory Board

Idaho Cleanup Project

October 26, 2017

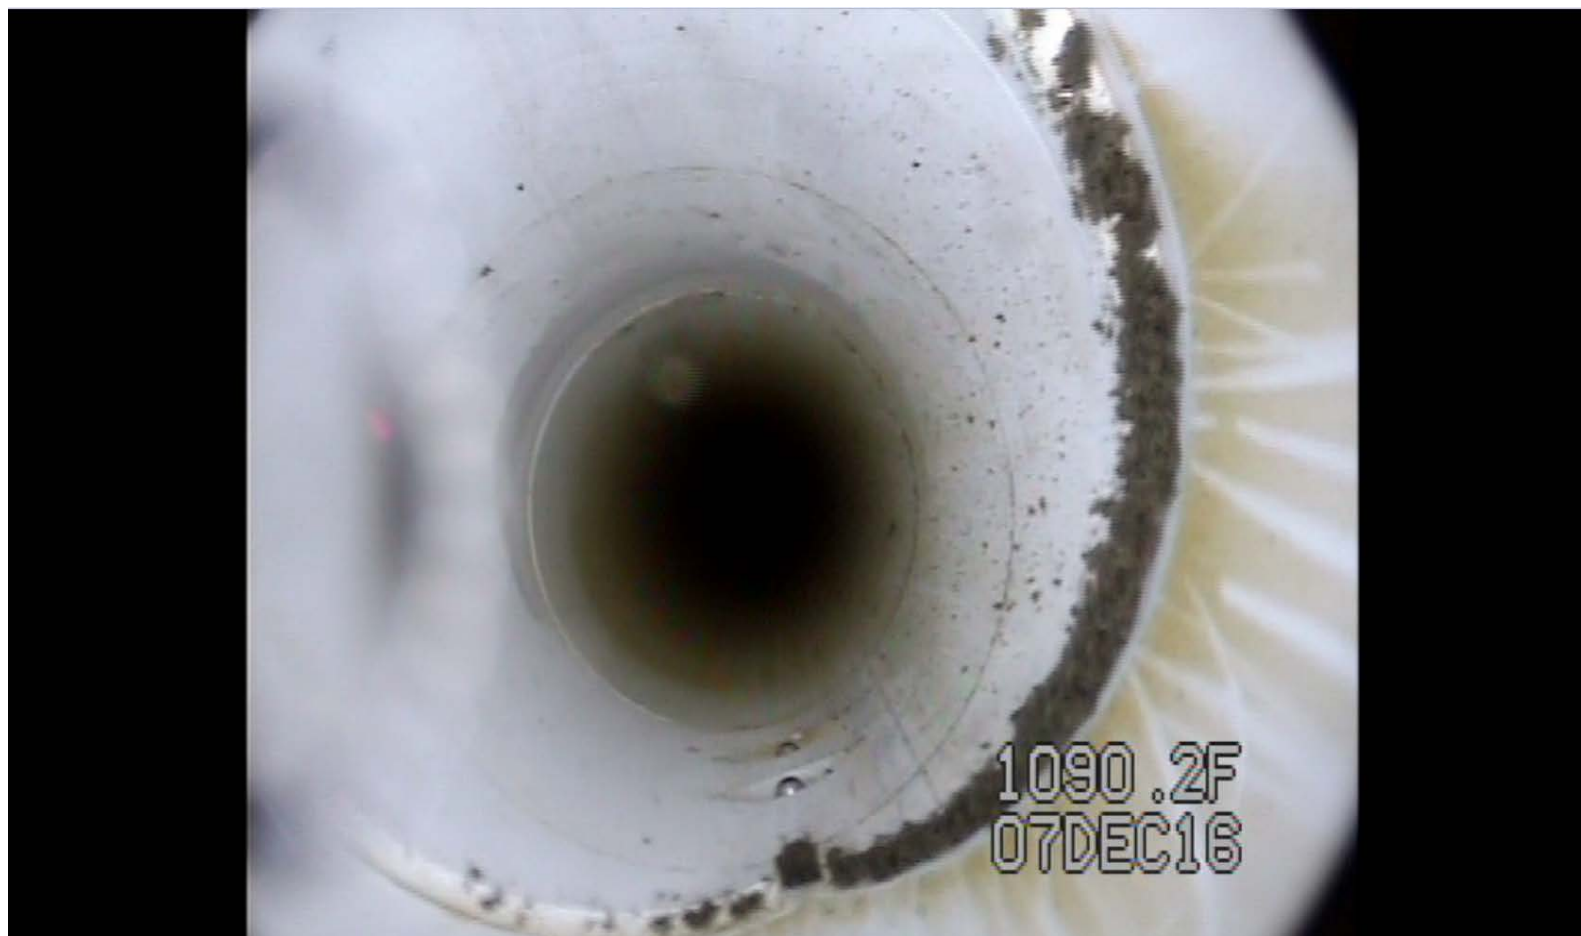
Downhole Camera Image

Well MIDDLE-2051 sampling port (looking down)

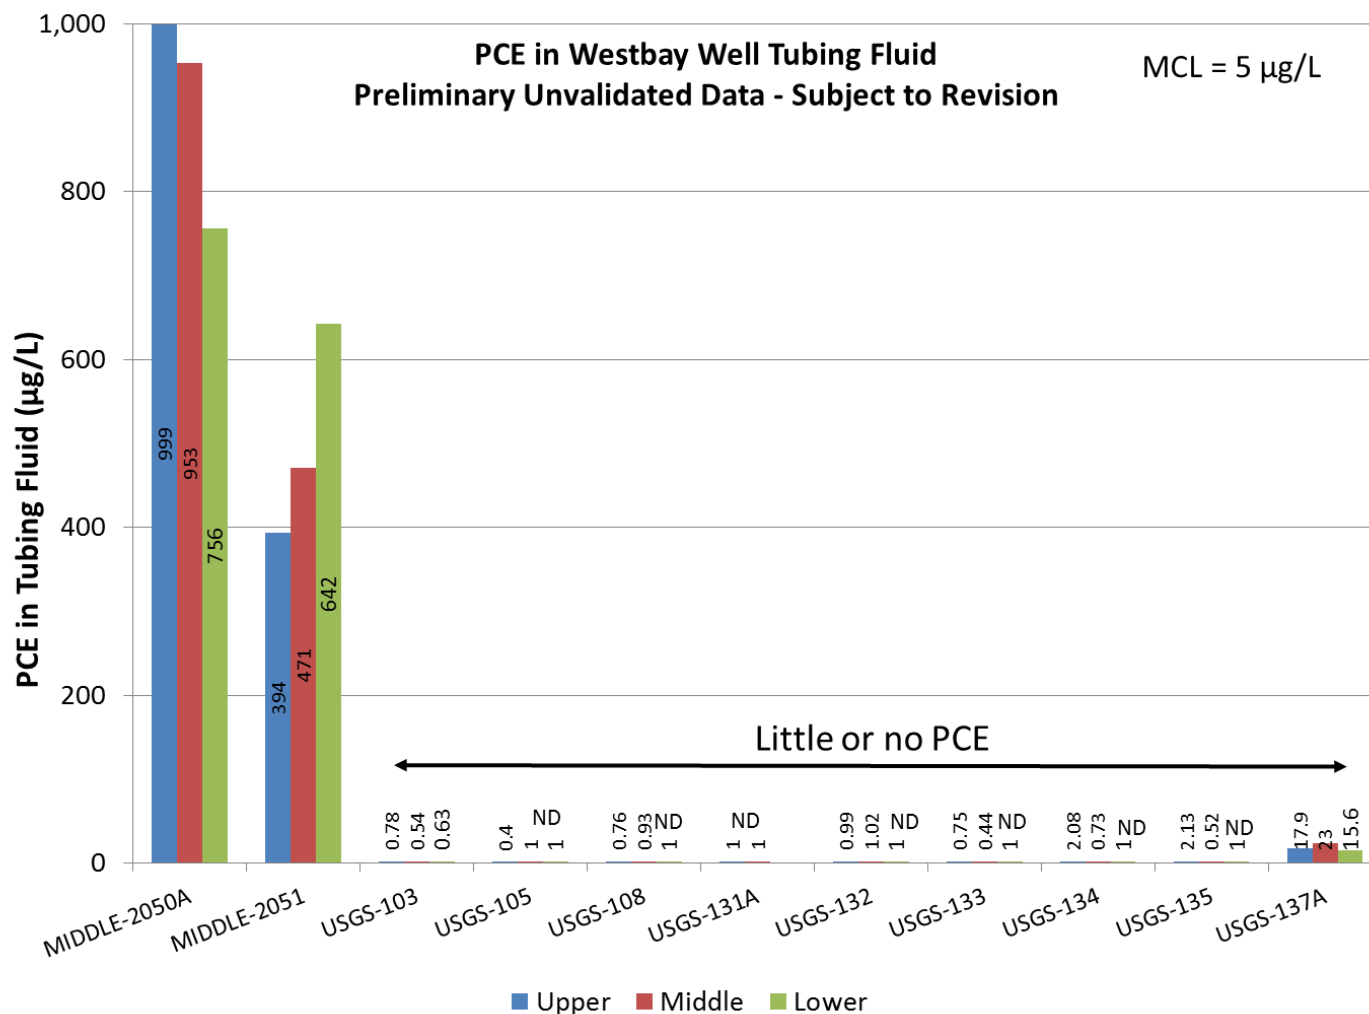
Results - Westbay Tubing Fluid

Note: tubing fluid is isolated within the Westbay well and does not contact the groundwater.
