New Waste Calcining Facility Ventilation Upset

Citizens Advisory Board

April 8, 2015

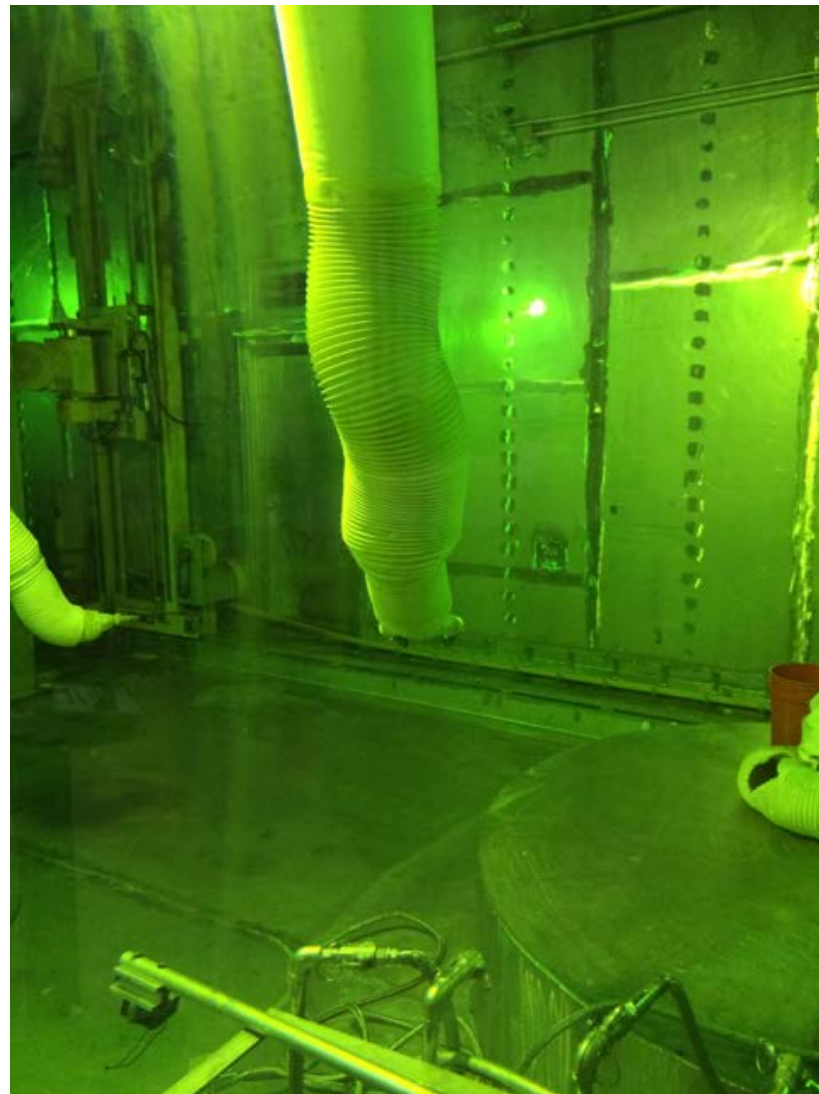
On October 23, 2014, Waste Management Operators were removing a cell port cover from Decontamination Cell 308 to load material out of the cell following RH-TRU repackaging activities

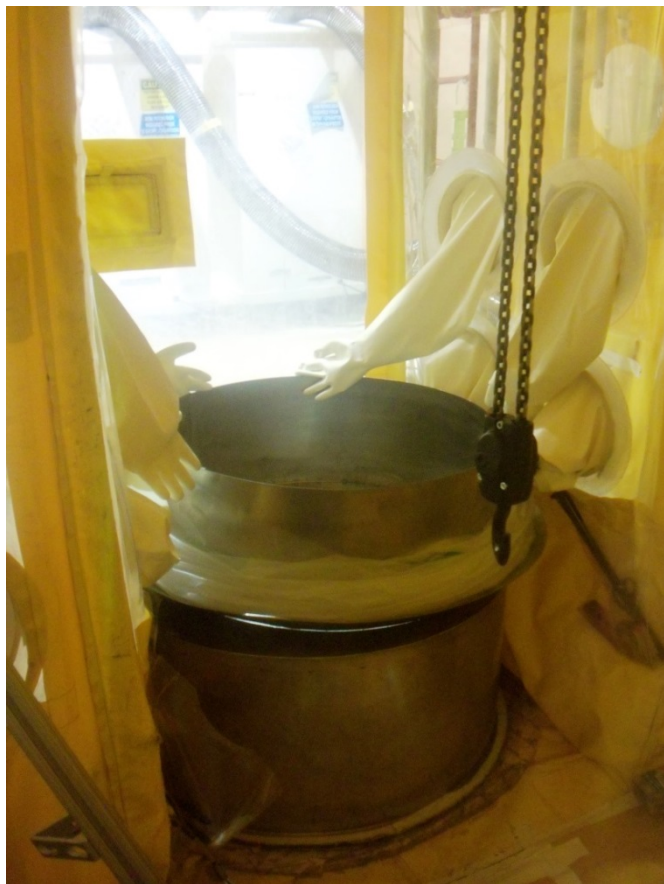
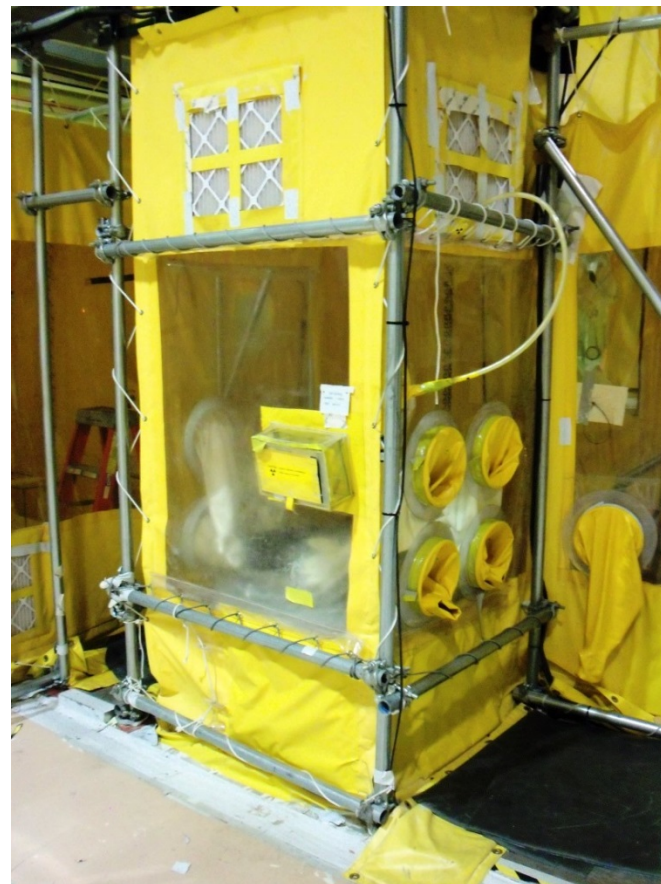
Removing the cell port cover (above the cell) significantly increased ventilation flow through Decontamination Cell 308 and reduced the vacuum in the cell, which maintains contamination confinement

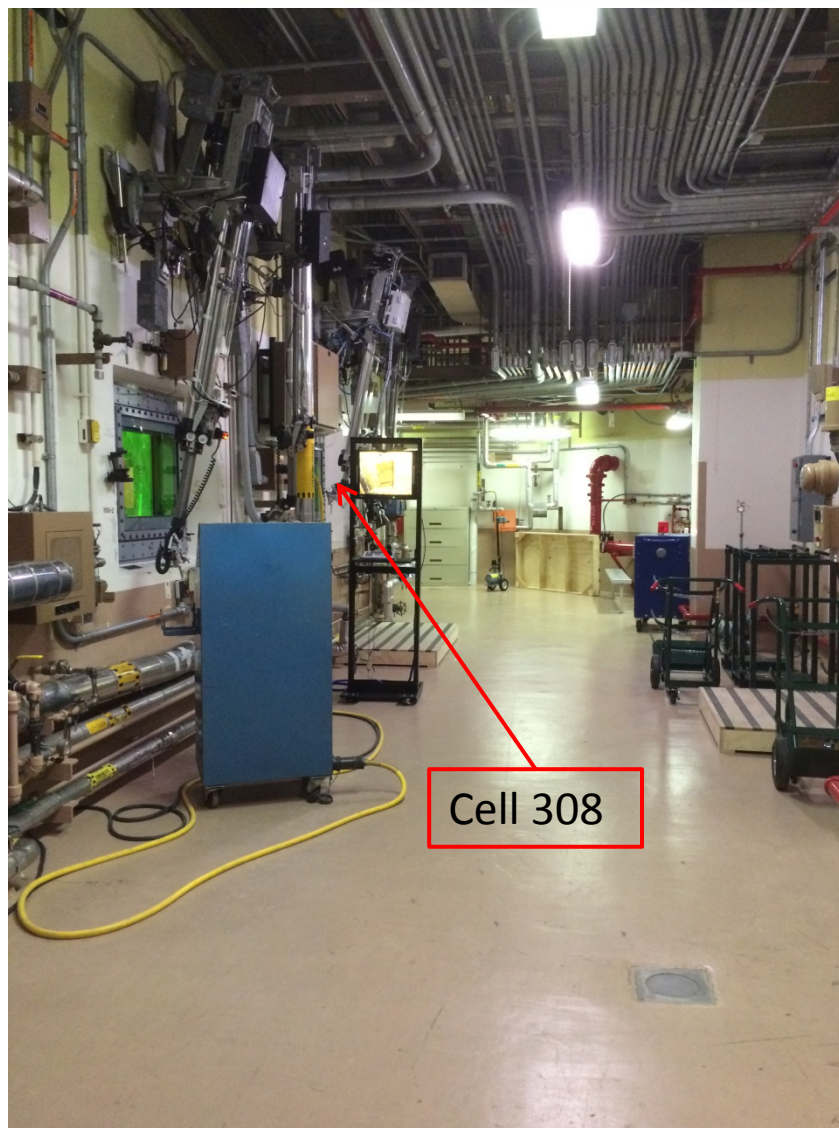
As a result, contamination migrated outside of Cell 308 within the NWCF building Corridors, but was limited to the corridors immediately adjacent to and below Cell 308
