# Mexican Hat, Utah, Disposal Site Disposal Cell Evaluation Information Sheet

This information sheet provides information about observed disposal cell conditions and anomalies of the **Uranium Mill Tailings Radiation Control Act of 1978 Title I processing site at Mexican Hat, Utah**. This site is managed by the **U.S. Department of Energy Office of Legacy Management**.

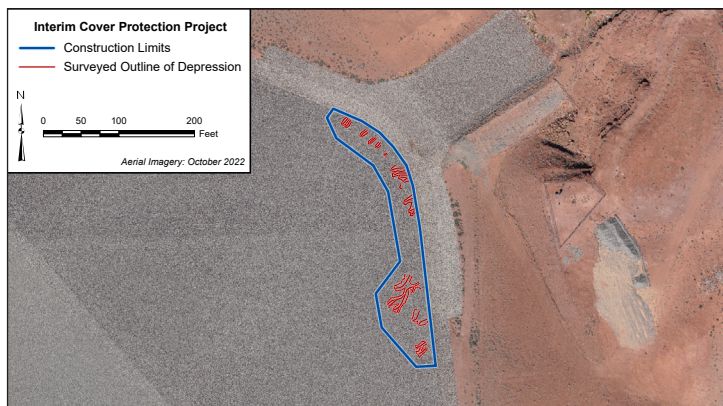
*Depression features on northeast side slope and approximate area of interim cover protection area.*

- Replacement of a 20,000-square-foot area of the northeast side slope, where depressions were detected by lidar with an interim cover protection (ICP), which consisted of placing IRBP in degraded radon barrier areas, replacing the existing bedding layer with a bedding layer that met original design specifications, and then re-covering with the original riprap material.

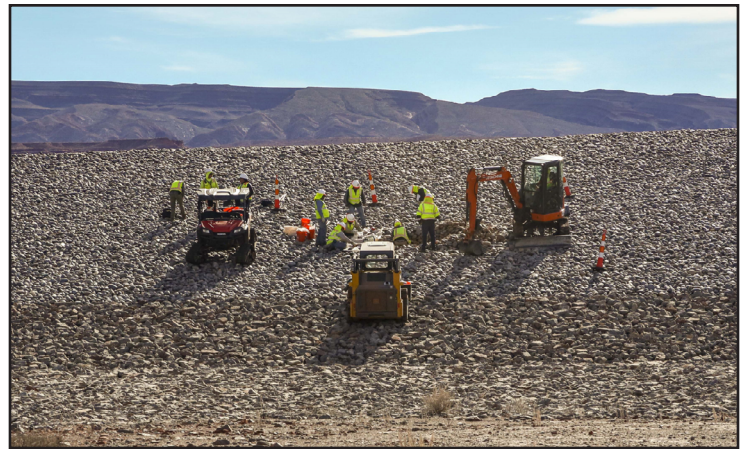
*Mexican Hat test pit.*

additional voids and depressions were detected, as well as apparent erosion of the radon barrier at three test pit locations. No elevated radiological readings relative to background were observed. Additional radiological surveys were conducted in April 2018 and no elevated readings were detected relative to background. Other April 2018 activities included the annual site inspection, baseline aerial and terrestrial topographic surveys, and a settlement plate survey. No additional depressions were detected during the annual inspection and data from the aerial and terrestrial survey provided a baseline for possible future changes in surface observations. Settling was not apparent based on the settlement plate survey. An August 2018 rain event triggered a terrestrial survey; no changes in depressions were observed.

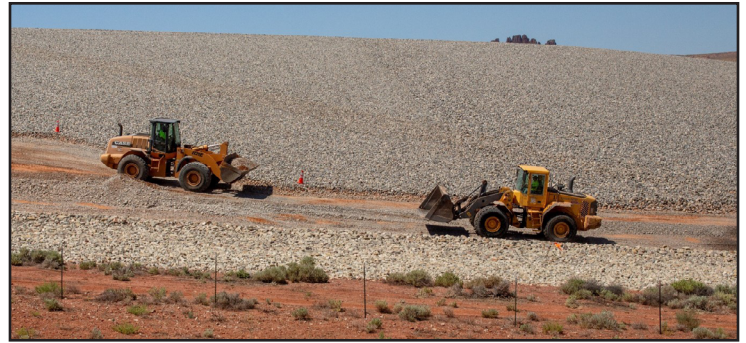
*Mexican Hat disposal cell during the interim cover protection project.*
