# Hooper Bay Housing Analysis and Energy Feasibility Report

Prepared for:  
Sea Lion Corporation  
Main Airport Road  
Hooper Bay, AK  
99604

December 30th, 2012

Prepared by:  
Cold Climate Housing Research  
Center  
1000 Fairbanks, AK 99708  
907.457.3454  
[www.cchrc.org](http://www.cchrc.org)

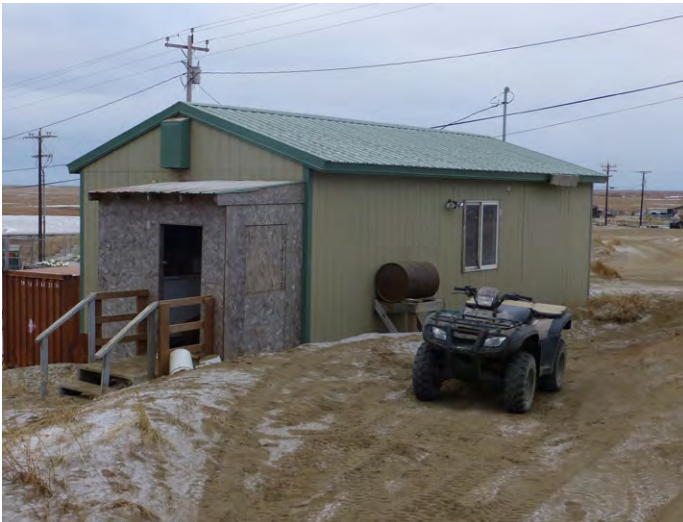
The Blaze Tinker House. Arctic Entry constructed by resident.

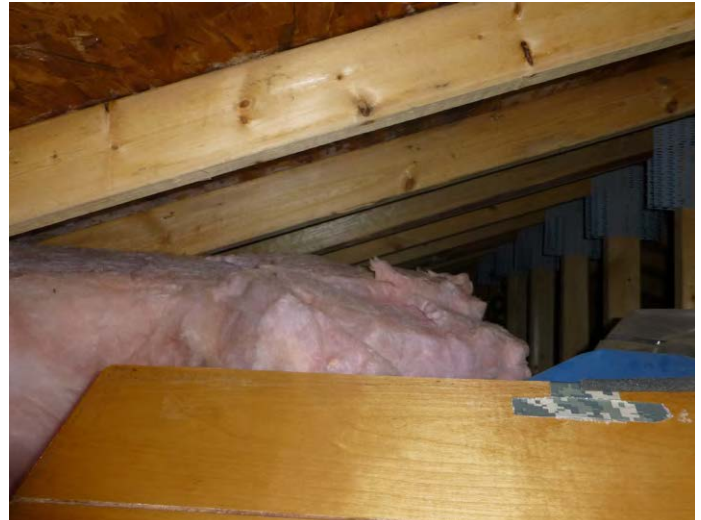
The cold roof with 8" of bat insulation and hatch into main living area

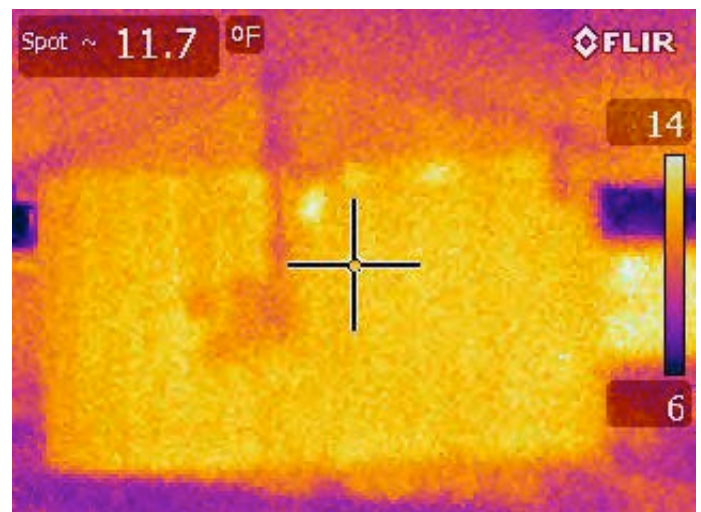
Thermal image of the Blaze Tinker House. Brighter yellow tones show locations of greatest heat flow. Batting insulation seems to slump at the top of wall cavity.

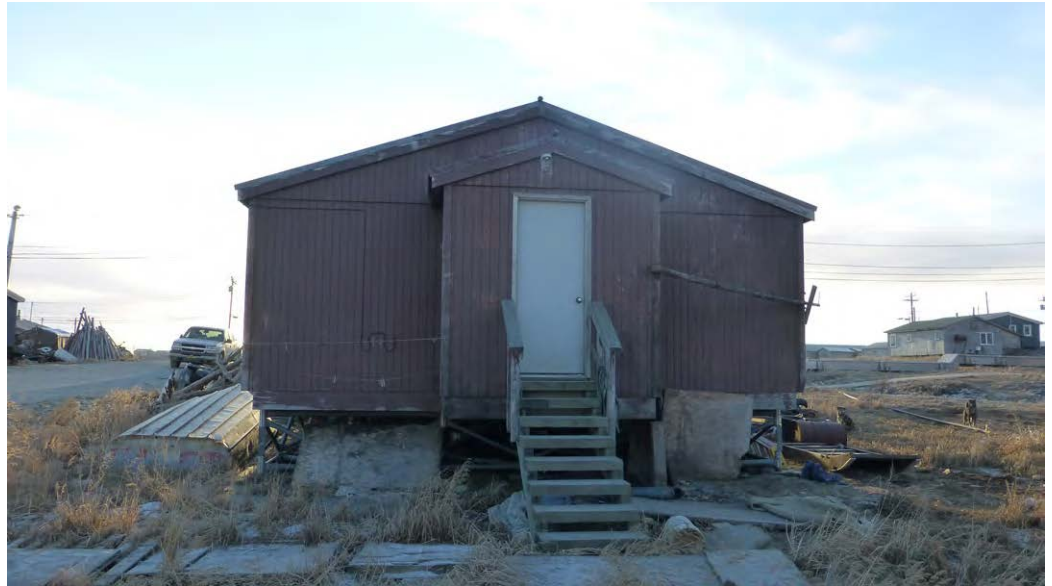
Bosco Olson House. The home was retrofitted with a triodetic foundation after experiencing differential settlement issues.

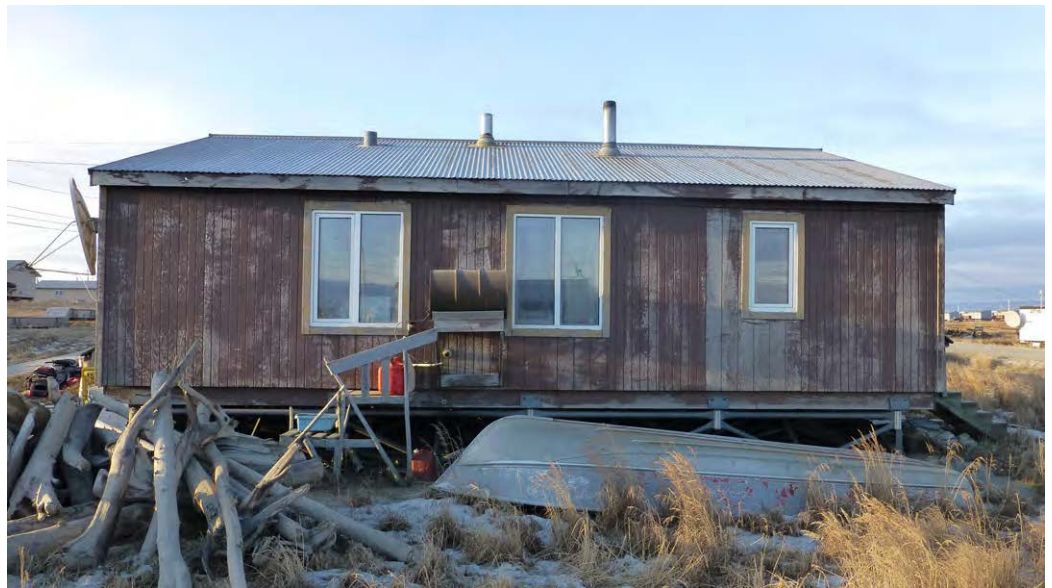
Bosco Olson House. The building has an interior arctic entry for cold storage. It is oriented so that no windows are on the south side to take advantage of solar gain.

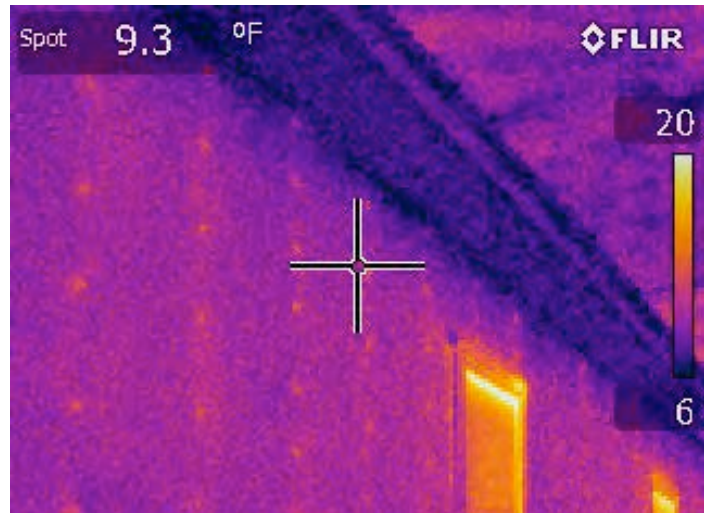
Thermal imaging reveals that the prior retrofit of the attic was effective, but that the windows still leak heat.

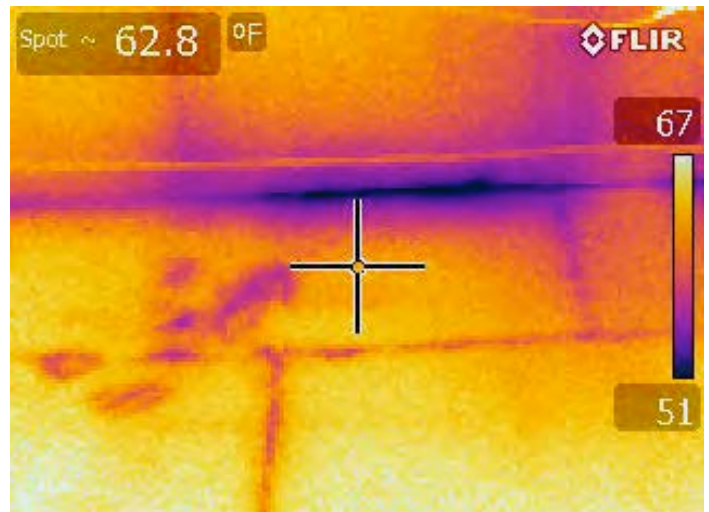
Thermal imaging reveals poor sealing or a cold spot where the wall meets the floor, possibly at the rim joist.

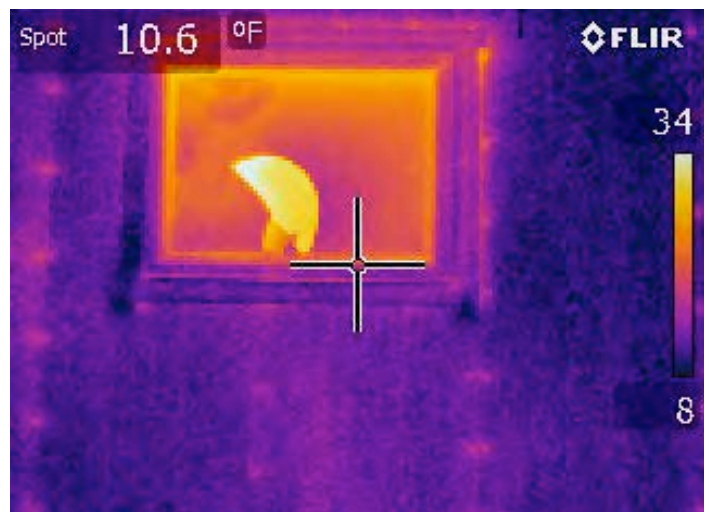
Although the breakage is obvious, also of note is the poor sealing along the frame of the window.

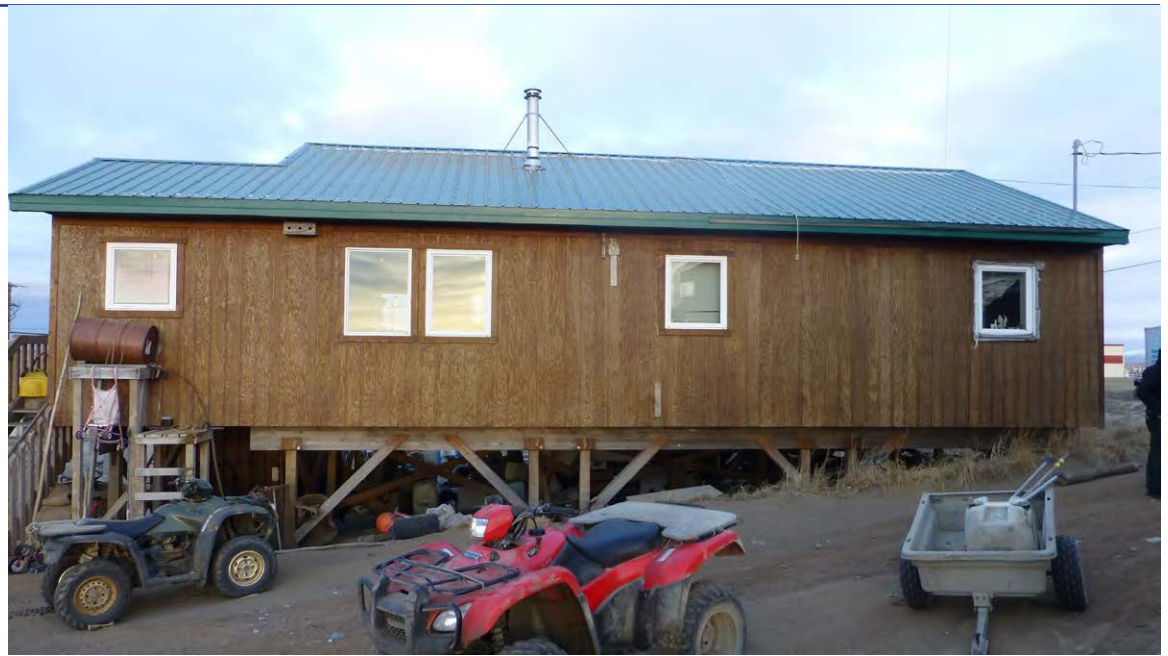
The house has experienced some settlement, but the foundation is not adjustable by occupant.

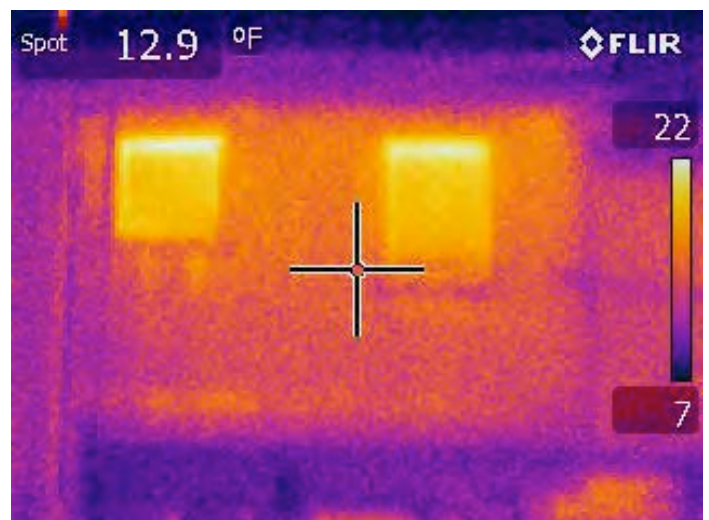
Thermal imaging of the home. Note the effective cold roof and the area of leakage at the base of the wall.

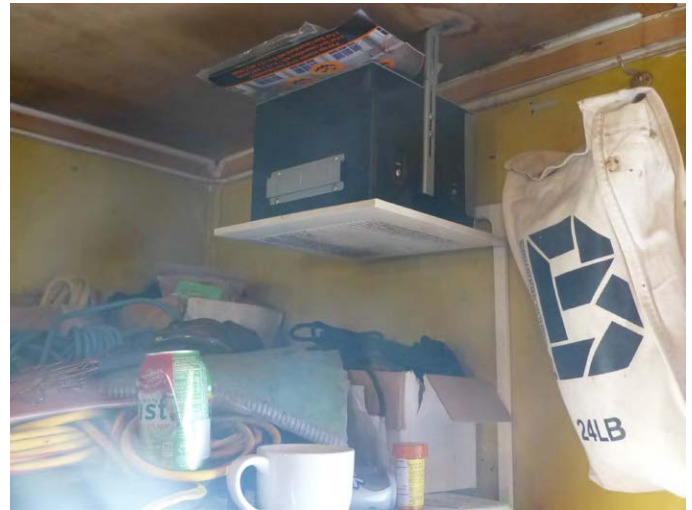
Ventilation system from a prior weatherization attempt has been disabled.

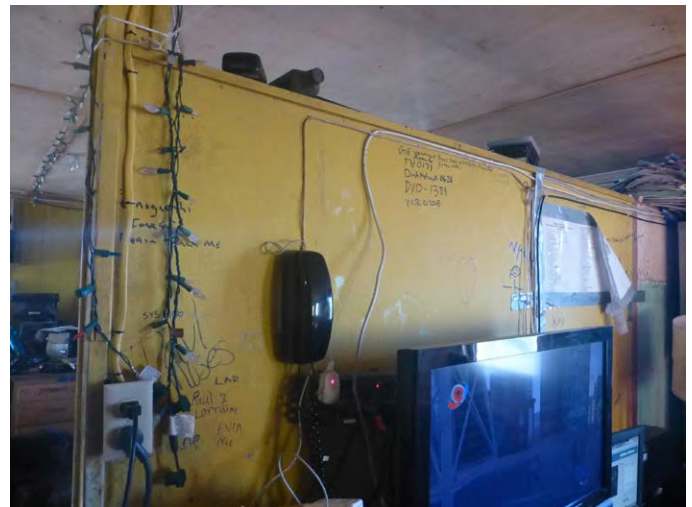
Interior walls are cut short of floor and ceilings to allow heat to move from room to room.

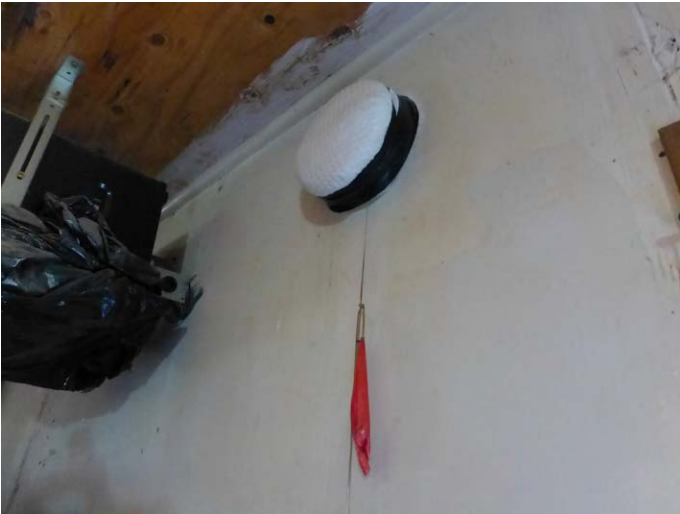
Ventilation system from a prior weatherization attempt has been disabled.

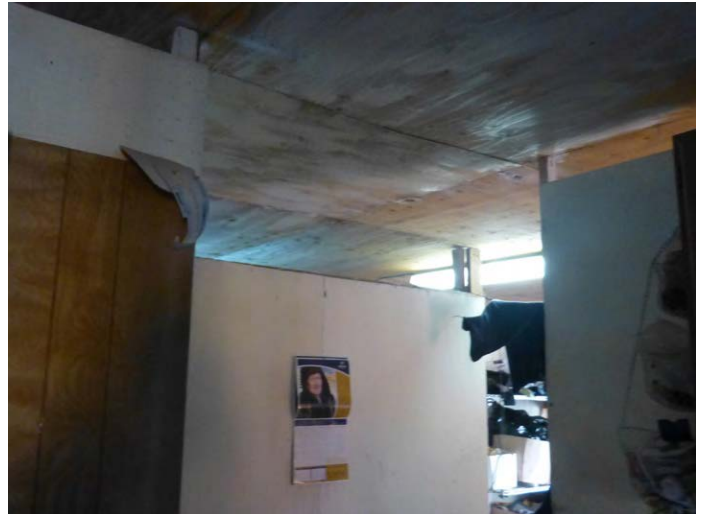
Interior walls are cut short of floor and ceilings to allow heat to move from room to room.

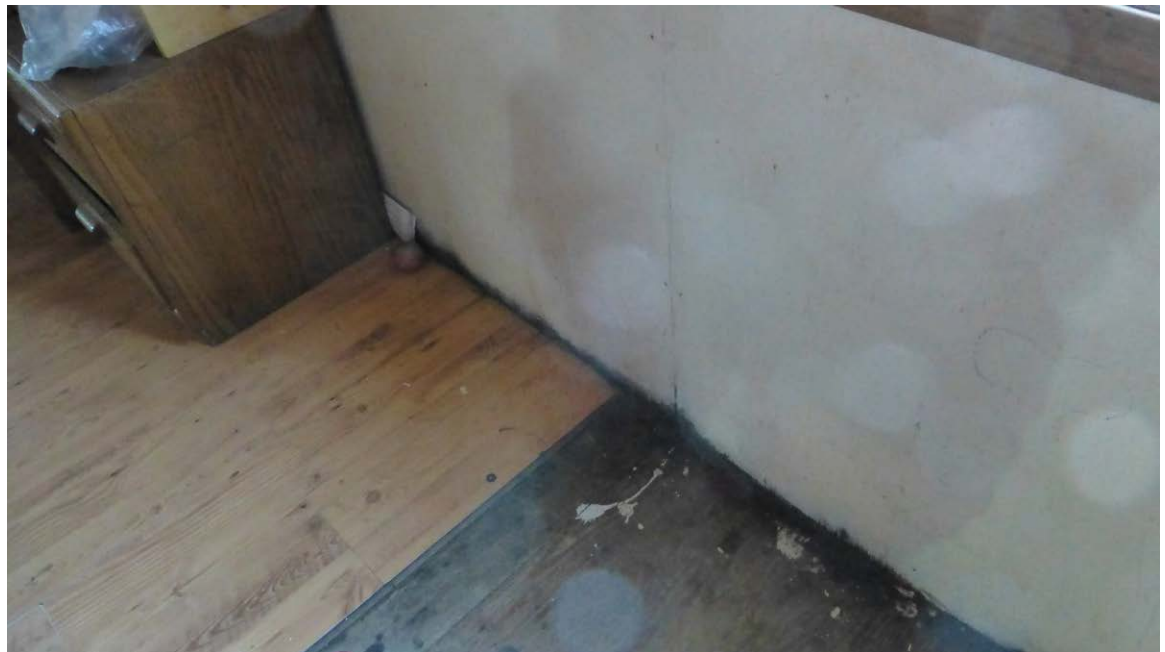
Exterior walls exhibit mold and rot at floor connection.

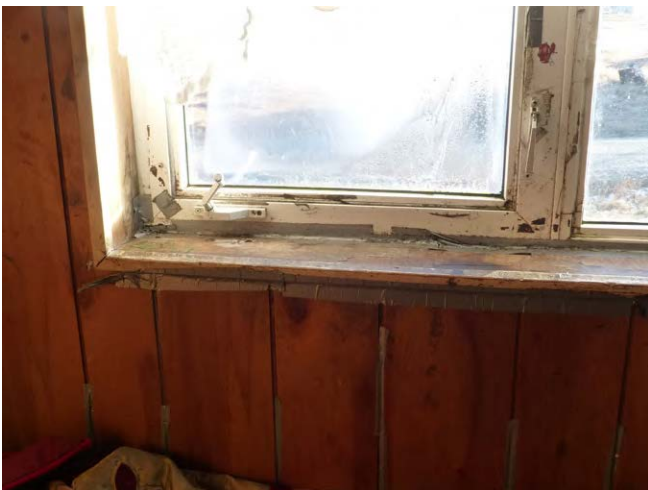
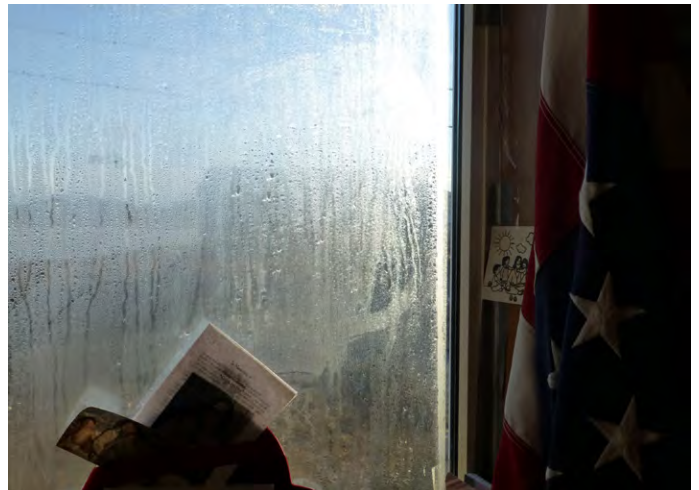
Moses Night House. Windows exhibit air leakage and condensation.

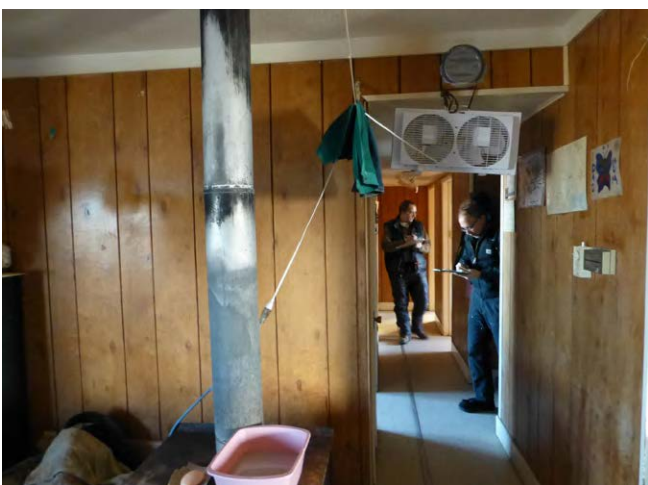
Moses Night House. Occupant has disabled ventilation system but moves warm air through house with fans.

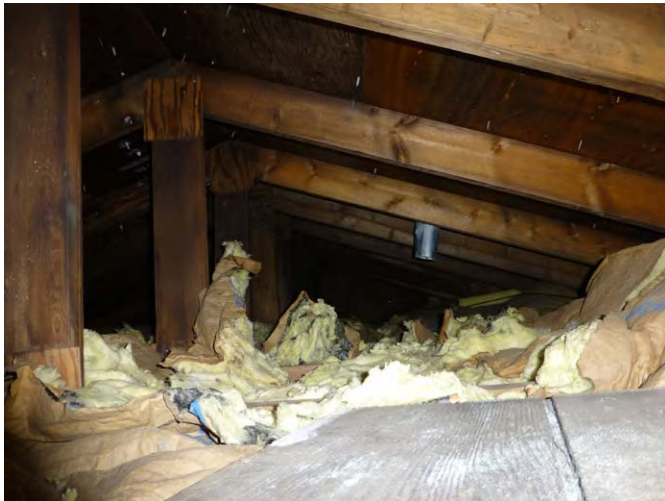
The attic hatch has no seal and is not insulated above the hatch.

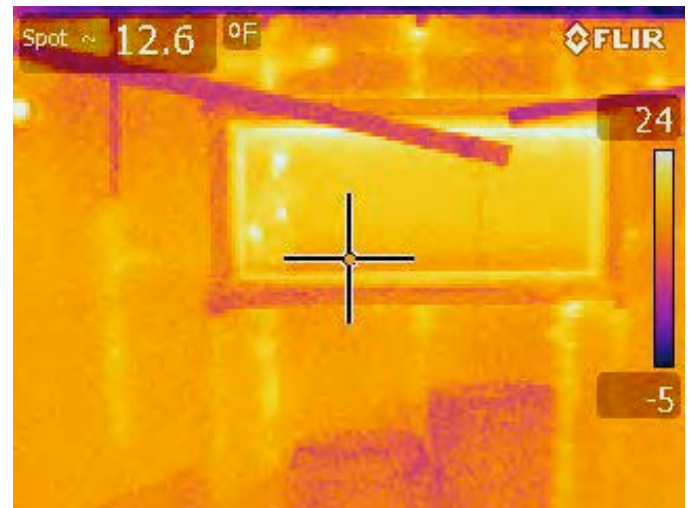
Glen Joe Sr. Home. Exterior view. Thermal imaging shows heat leakage both at windows and along studs.

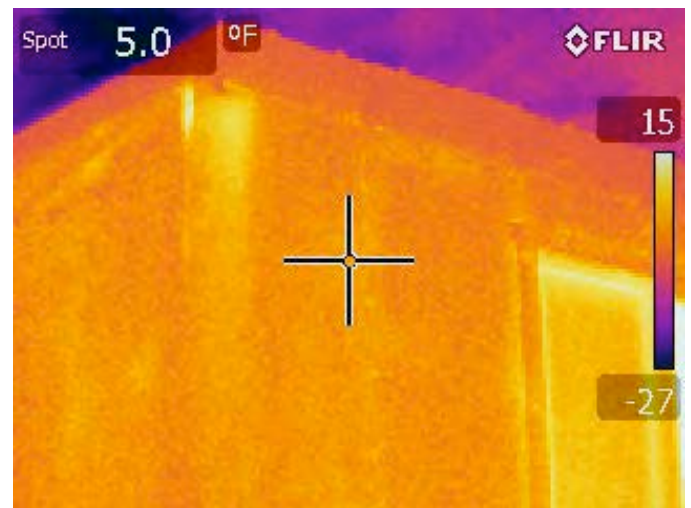
Glen Joe Sr. Home. Exterior view. Corner cold spot due to poor air sealing and/or slumping insulation.

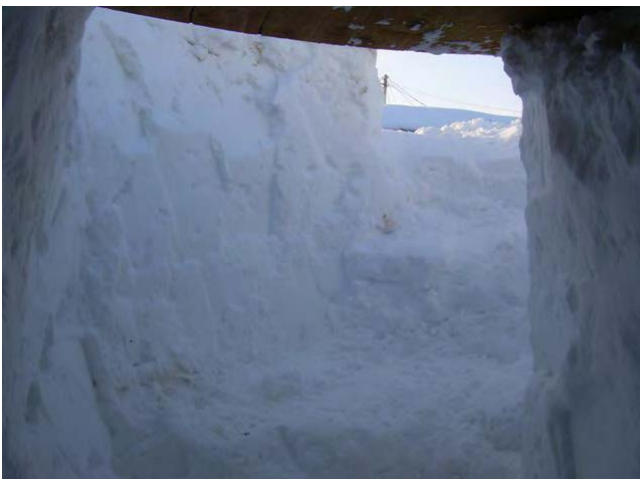
Indoor air quality concerns are compounded by snowdrifting, which can bury homes entirely and seal up natural ventilation paths and trap exhaust from heating appliances. The picture at left is the view from the front door of a home in Hooper Bay. The entrance has been dug out of a snow drift and the roof of the neighboring house is visible from the entry.
