Type B Accident Investigation Board Report Employee Burn Injury at the D Area Powerhouse

September 23, 2009

October 2009
U.S. Department of Energy
Savannah River Site

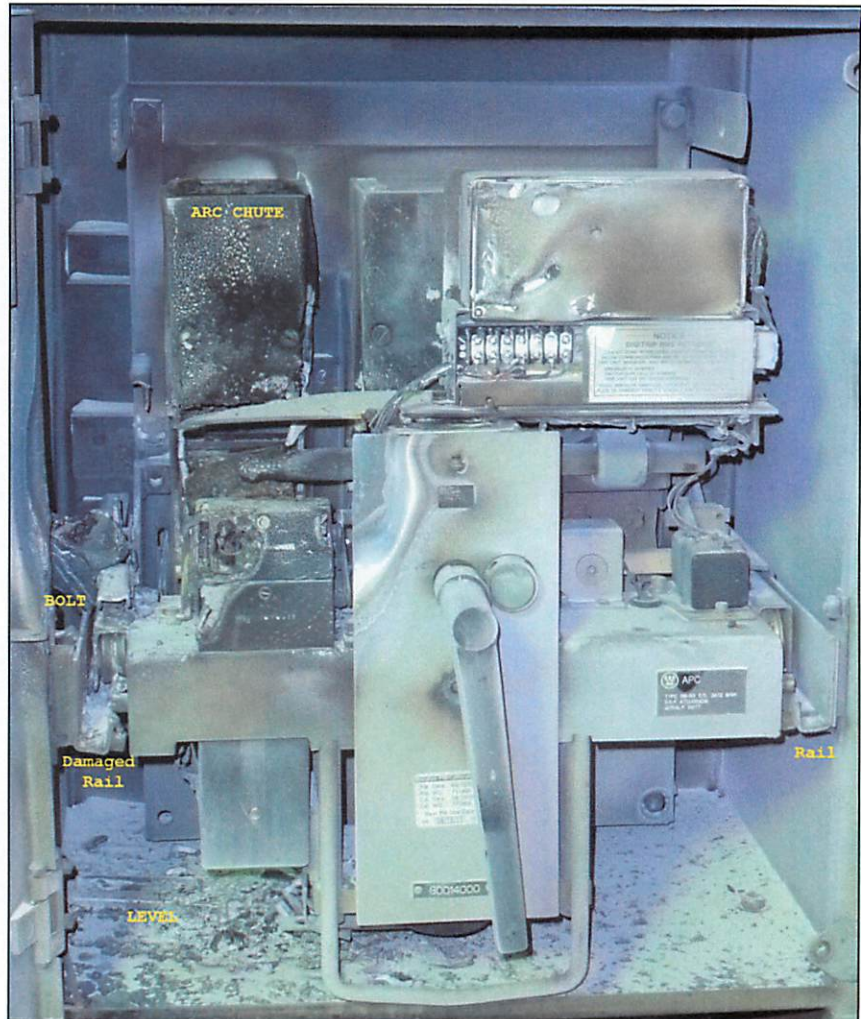
Figure 2-2: AT2AL Breaker

- Unknown: E&I Mechanics #1 and #2 begin troubleshooting breaker
- 1245 hours: E&I Mechanic #2 places metal torpedo level on breaker and walks away
- 1246 hours: Metal torpedo level falls in breaker while E&I Mechanic #1 is attempting to stabilize it

When the damaged breaker was removed from the cubicle during recovery actions on October 3, 2009, wooden shims were found on the right track. The Board determined that attempts to level the breaker via wooden shims were made during the unauthorized work on the morning of the event.

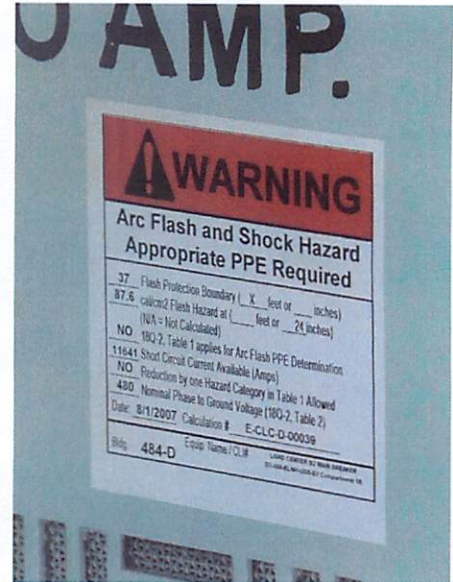
Figure 3-1: AT2AL Arc Flash Label

Arc flash calculations had been completed on the breaker and labels had been clearly affixed to the front of the cabinet door in accordance with NFPA 70E requirements. Based on the calculated arc flash hazard of 87.6 calories/cm² and the requirements set forth in the SRNS implementing procedure for NFPA 70E (Procedure 18Q-2), this breaker cubicle was not allowed to be worked in an energized state without special reviews and authorizations – which were not obtained. The Board reviewed the drawings and the arc flash study applicable to the electrical system under investigation and concluded that the methods used to estimate incident energy for the purpose of selecting appropriate arc flash PPE are conservative and consistent with generally accepted industry standards. However, the following opportunities for improvement in the accuracy of the estimates and the margin of safety were noted:

- The E&I First Line Manager (FLM) stated that he assumed the arc flash hazard was less than 40 calories/cm² in accordance with labels on the other breaker cubicles of bus B2.

The AT2AL breaker has the required NFPE 70E arc flash label affixed to the breaker door. The information on the label indicates a flash protection boundary of 37 feet and an 87.6 calories/cm² flash hazard at 24 inches. There was some discussion regarding the arc flash hazard between the FLM and E&I Mechanic #2 but work proceeded based on the assumption that the arc flash hazard was less than 40 calories/cm². A time-out was not implemented at this point to verify the information on the label. E&I Mechanic #1 donned the arc flash suit rated for 40 calories/cm² or less based solely on information from the E&I FLM. E&I Mechanic #1 only wore the suit during racking in or out of the breaker. The FLM and E&I Mechanic #2 did not don arc flash protective equipment during any of the work activities performed the day of the incident.
