U.S. Department of Energy Office of Environmental Management

Fire Forensic Analysis of the Radiological Release Event at the Waste Isolation Pilot Plant on February 14, 2014

April 6, 2015

**Prepared in Support of the U.S. DOE Accident Investigation
Board for the Radiological Release Event at the Waste
Isolation Pilot Plant on February 14, 2014**

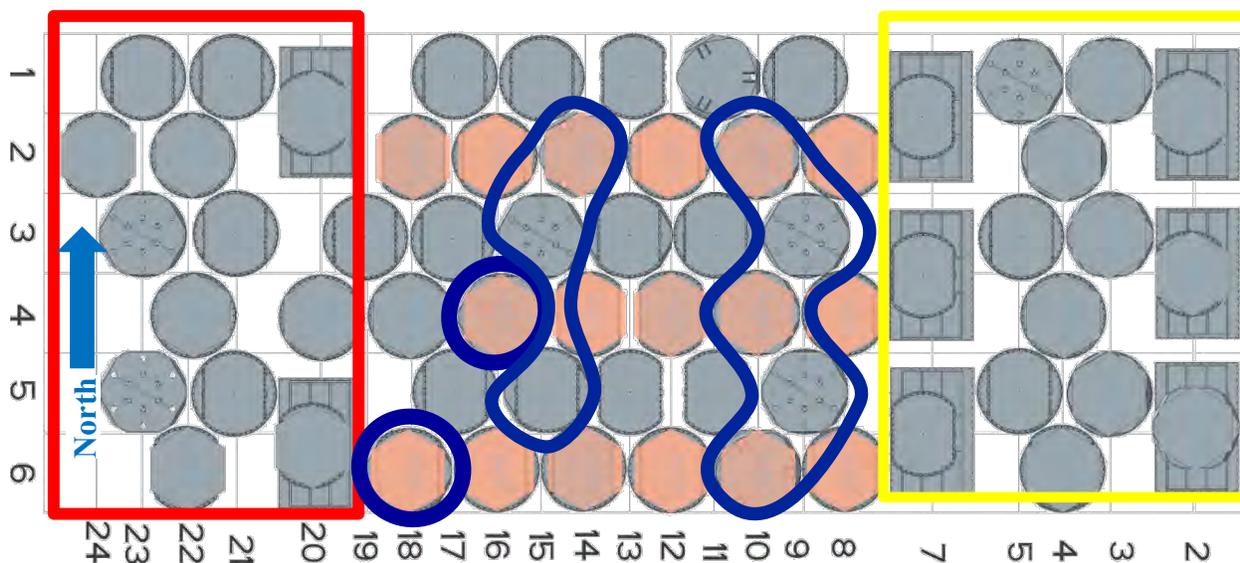
Figure 4-1: Array Damage Summary

The array inspections and visual evaluation demonstrated that the primary fire damage was intermittently dispersed in the array between Rows 8 through 18. Figure 4-1 provides an overview of the array damage, which is more fully described in Sections 4.4 through 4.25. No physical damage was evident for waste containers in Rows 2 through 7 (yellow box in Figure 4-1), or Rows 19 through 24 (red box in Figure 4-1). The most significant damage occurred in the regions marked in blue on Figure 4-1.

temperature). The lack of uniformity in temperatures and the nonuniform damage supports the conclusion that flashover* did not occur in Panel 7 Room 7.

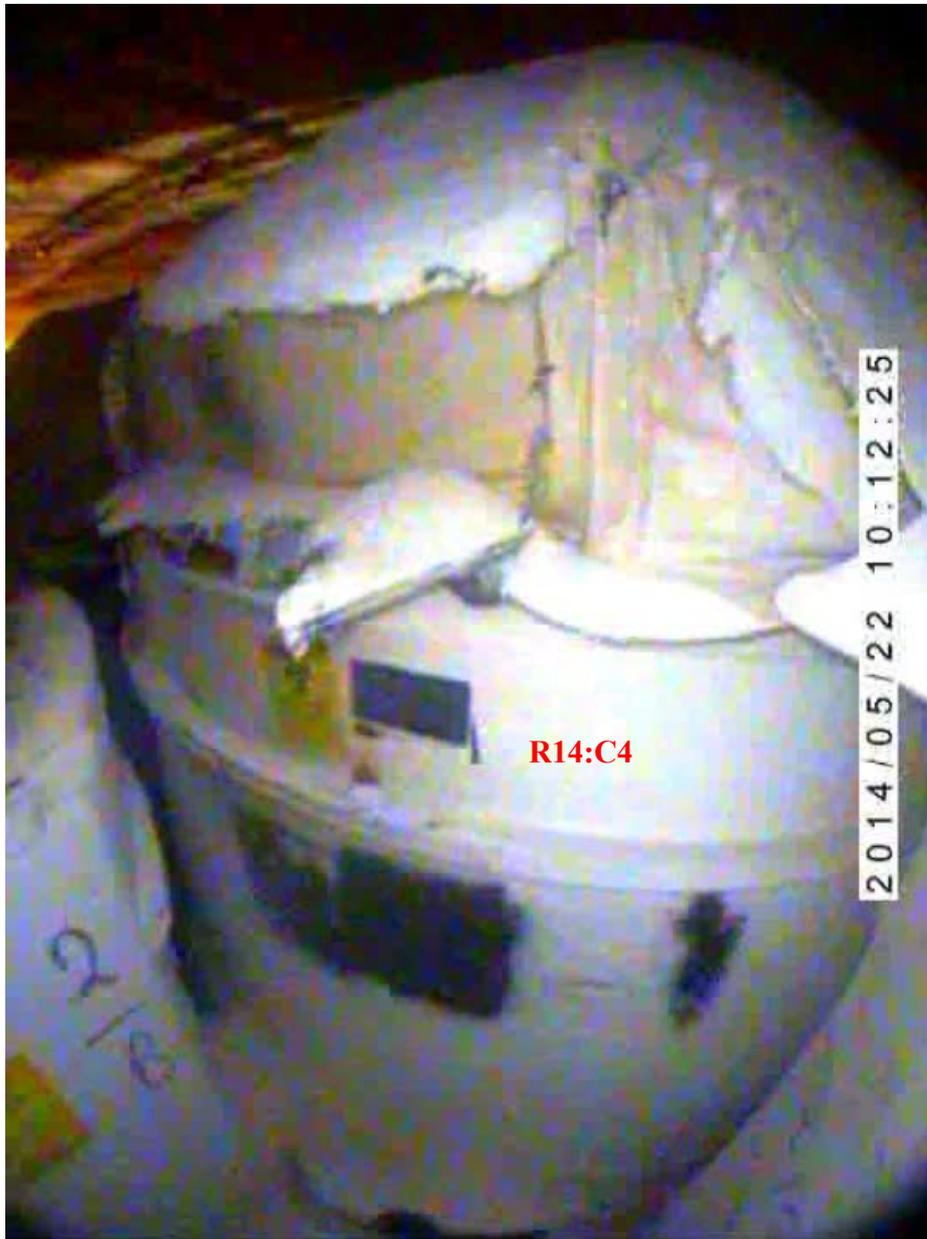
AIB-FST-02028: R14:C4 – Partially damaged Mg super sack

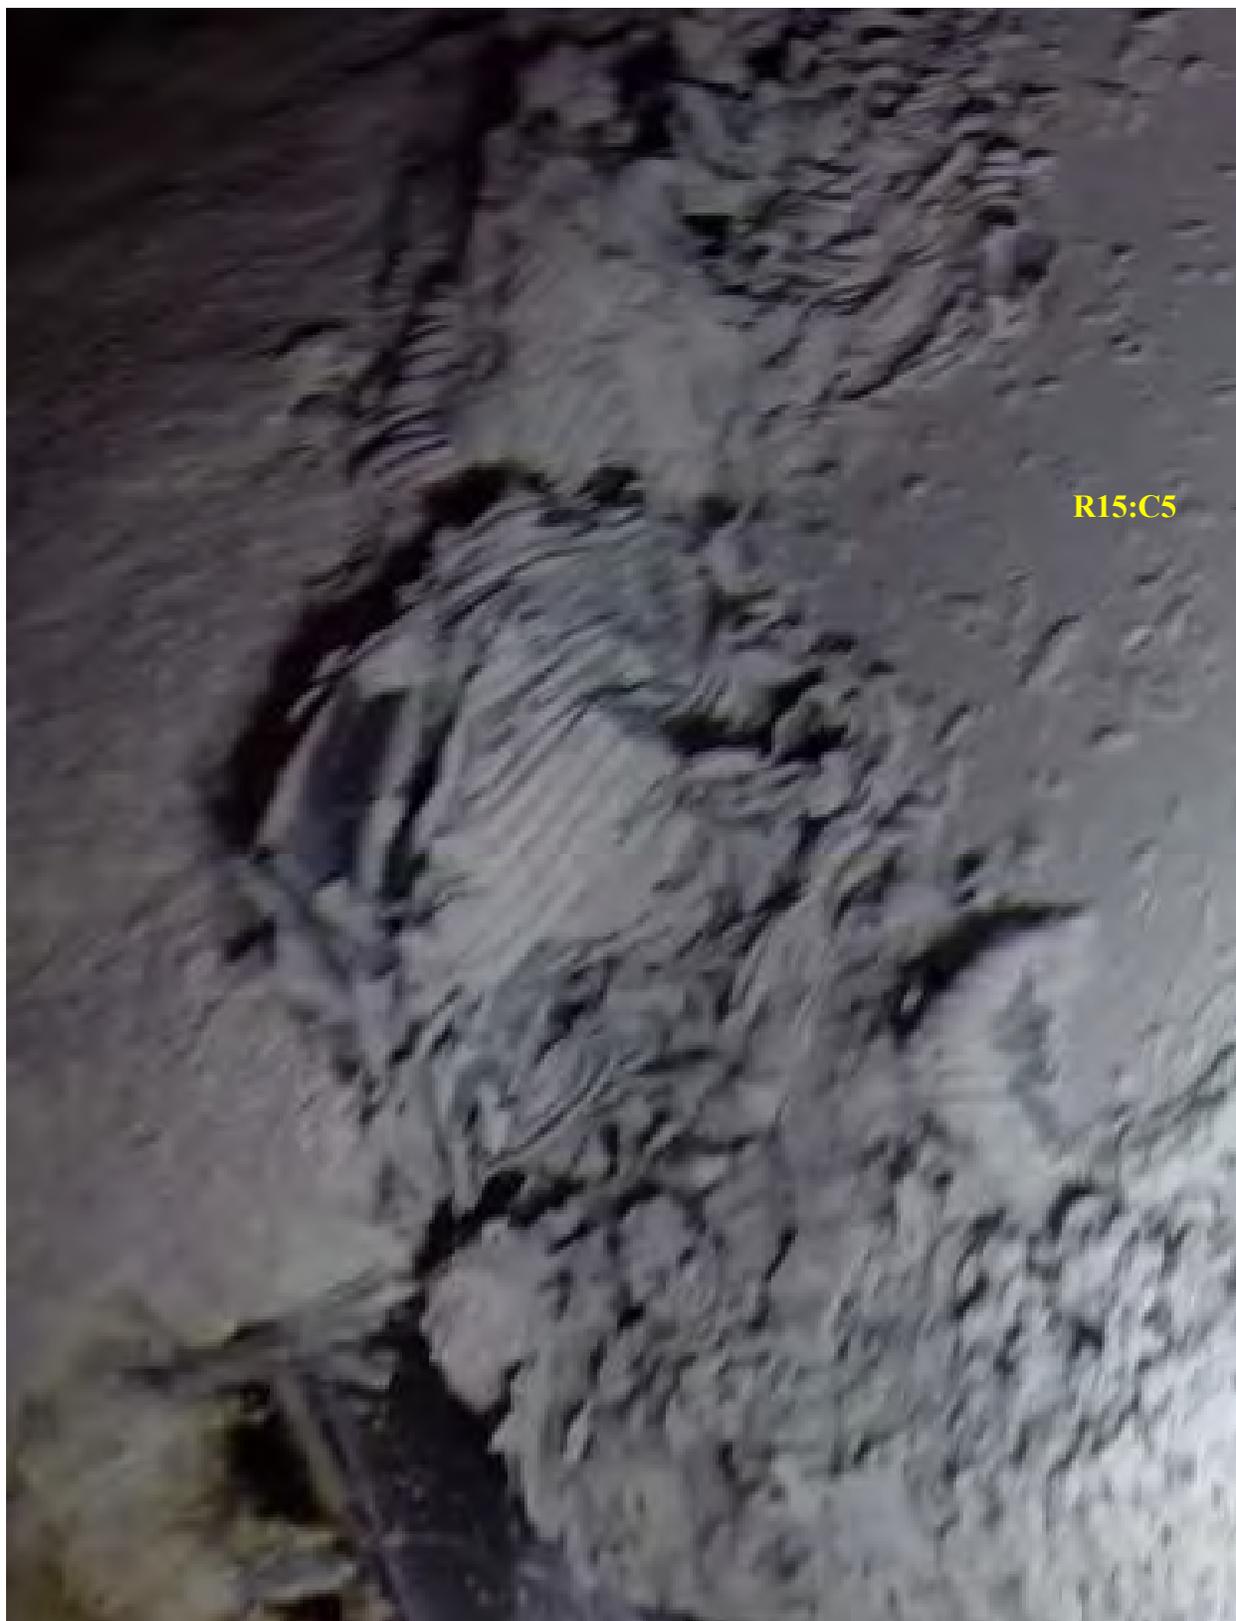
AIB-FST-02048: R15:C5 – SWB lid debris – Zoom-in view from AIB-FST-02047

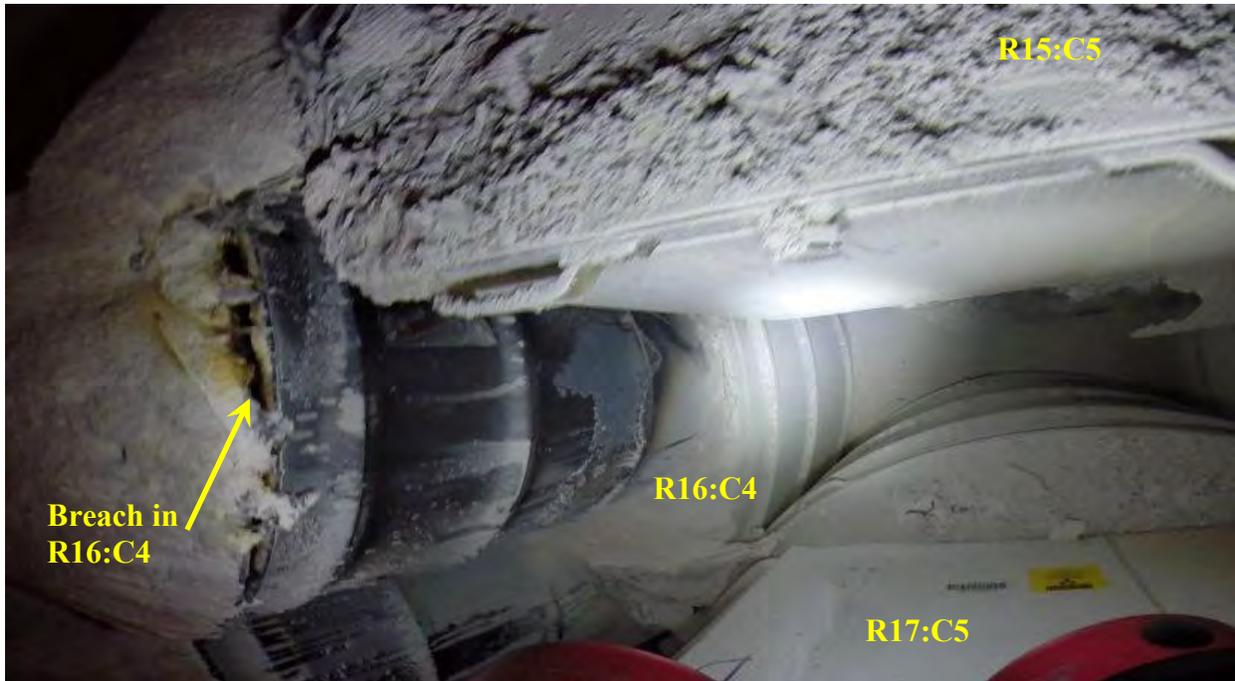
AIB-FST-02051: Breached drum at R16:C4

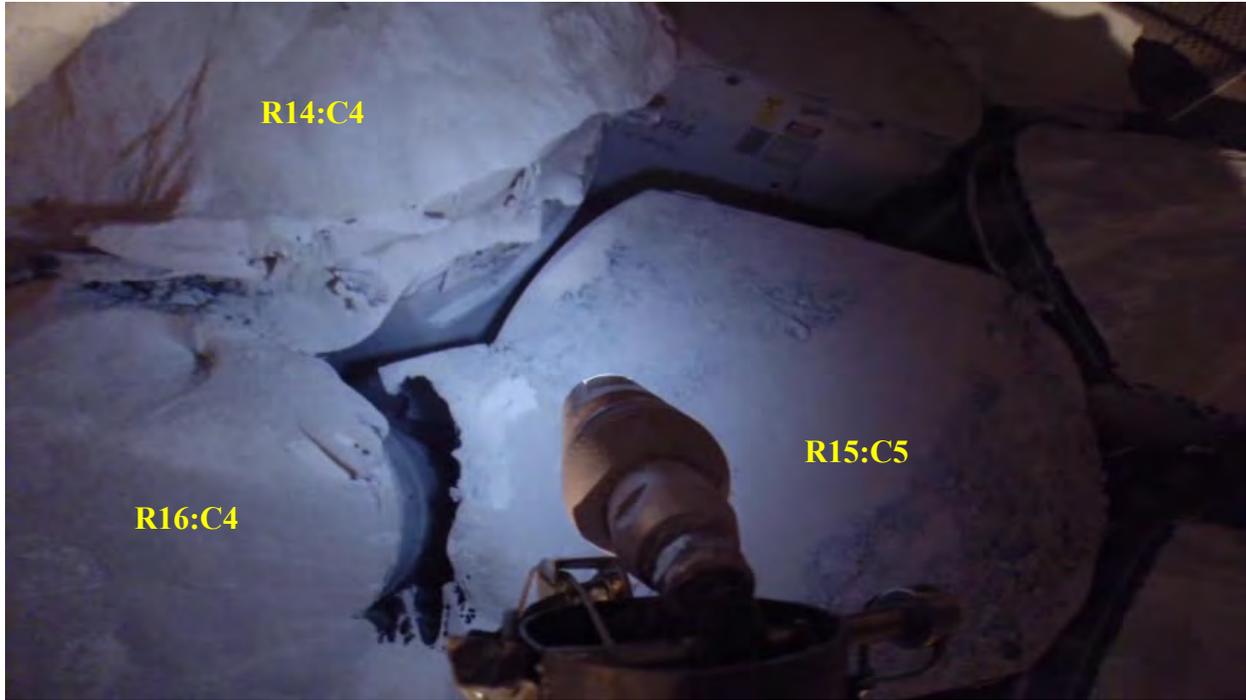
AIB-FST-02075: R16:C4 evidence of Flaming Combustion

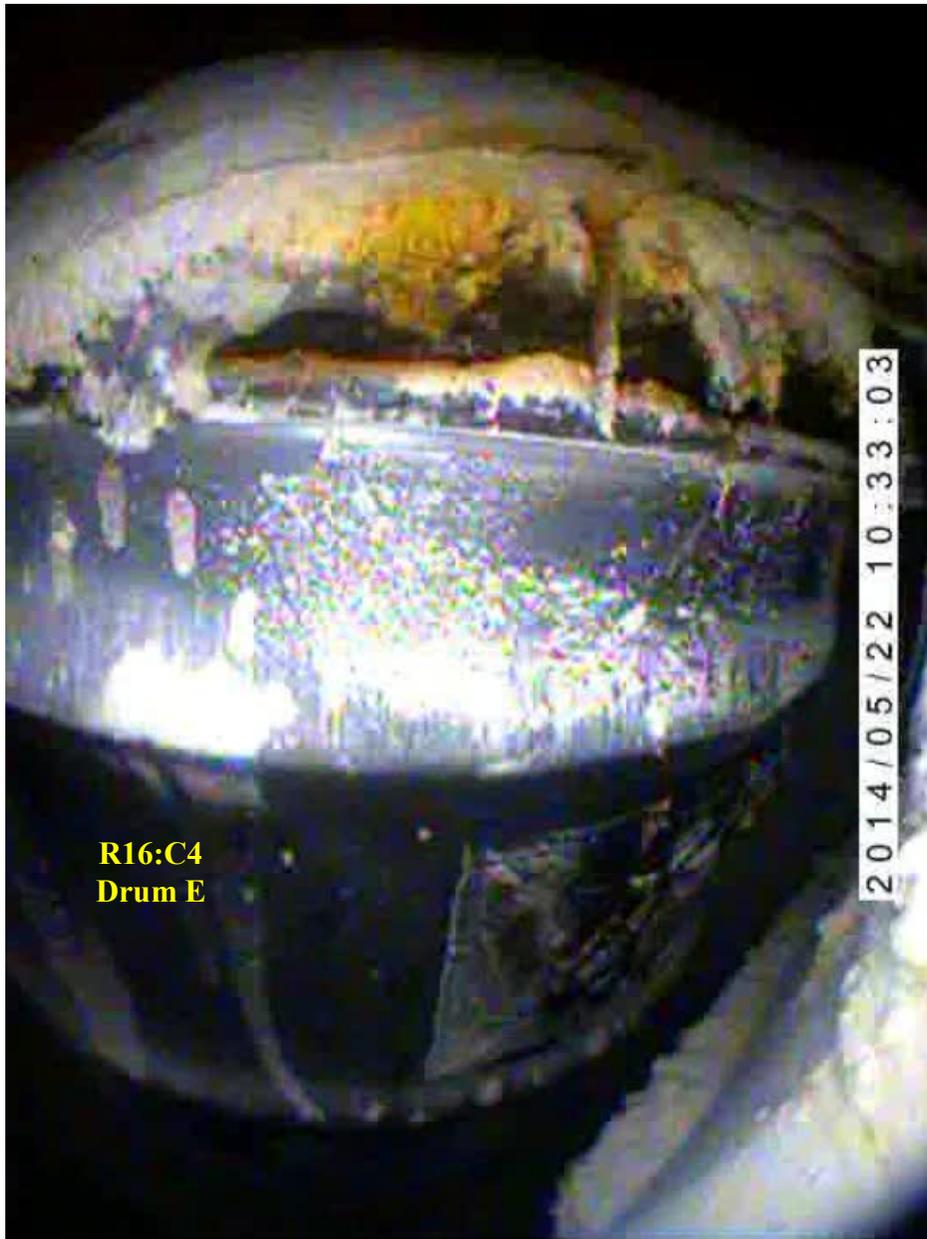
AIB-FST-02085: R16:C4 – Breached lid of waste drum 68660

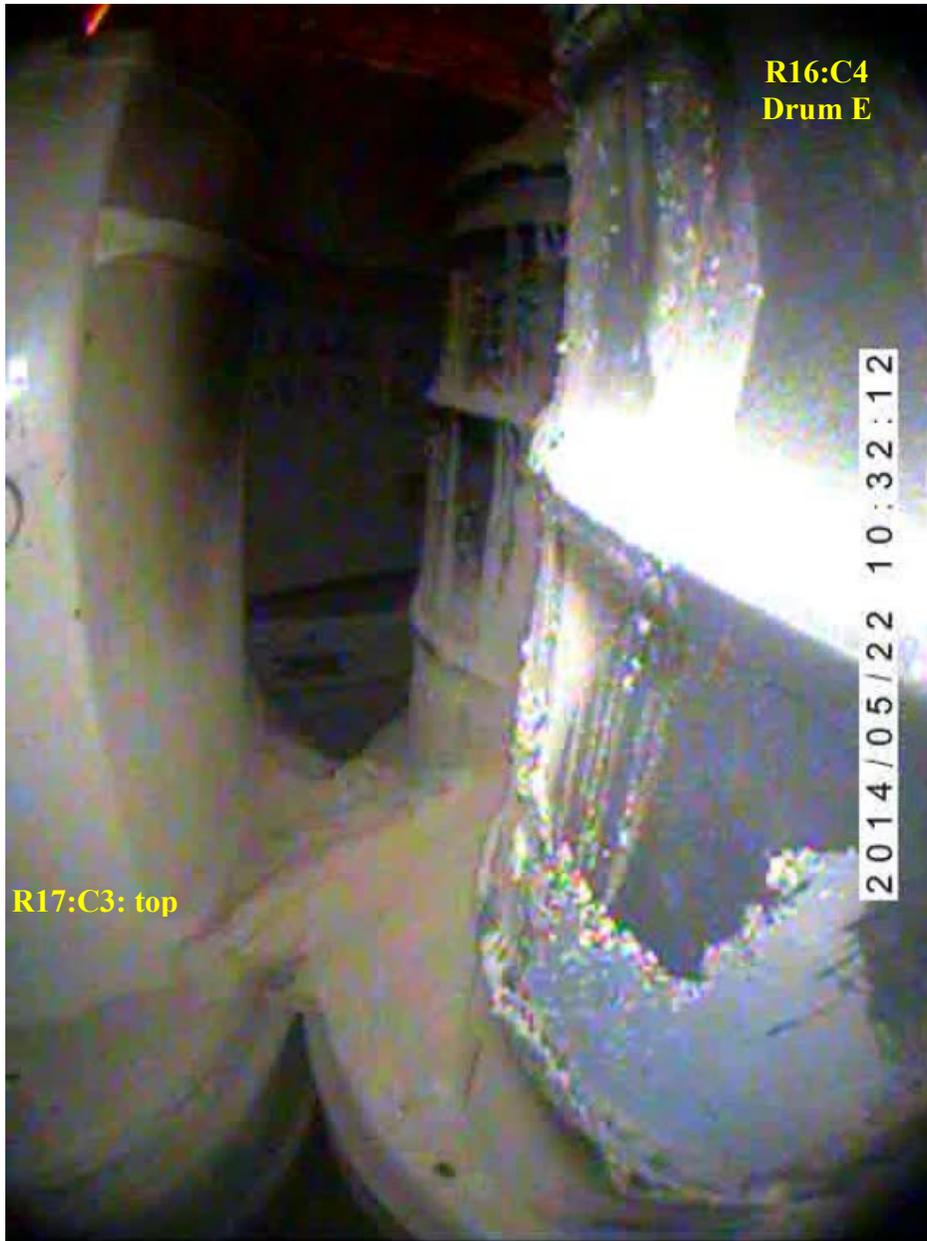
AIB-FST-02086: R16:C4 – Clean burn pattern on waste drum 68660

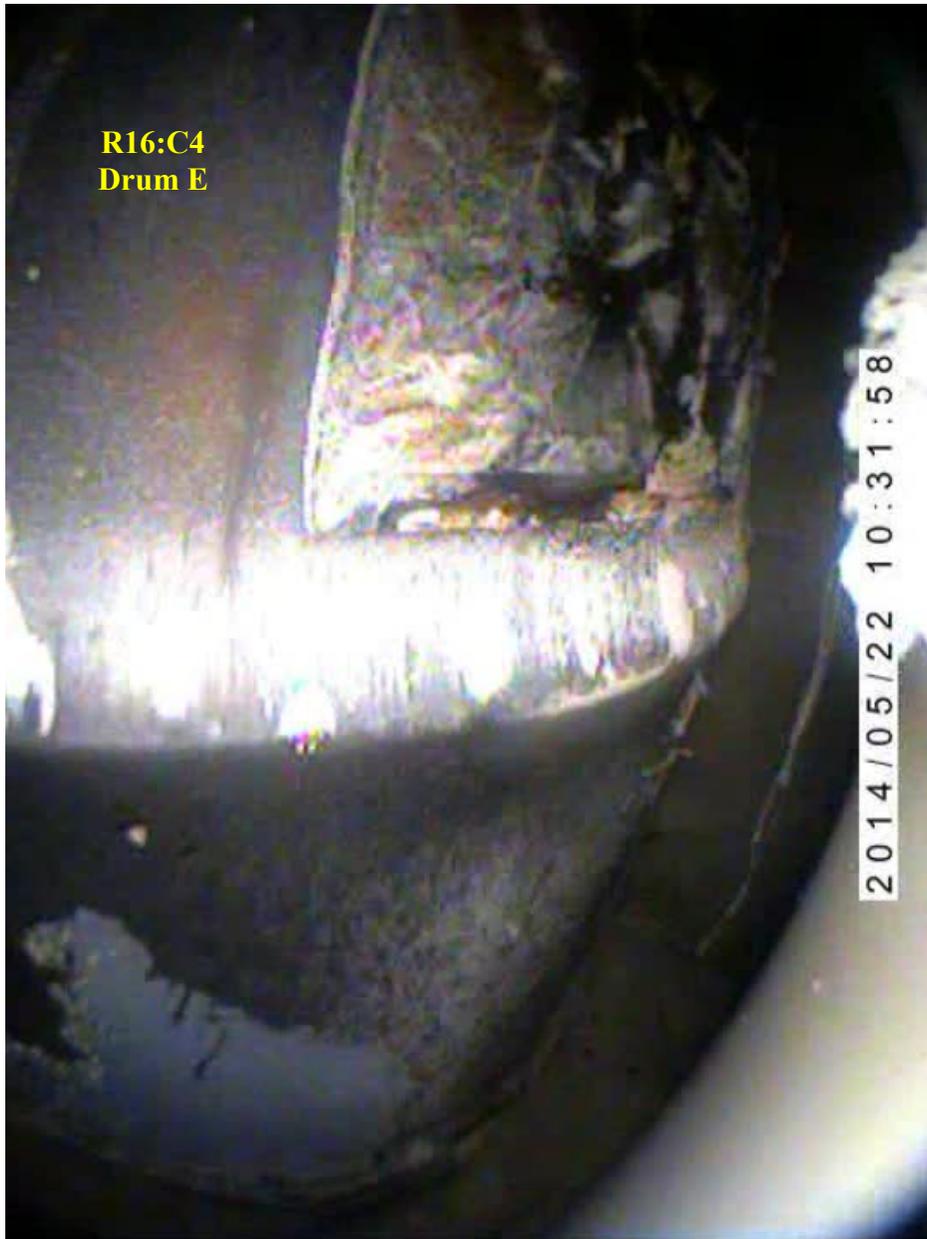
AIB-FST-02087: R16:C4 – Label damage on waste drum 68660

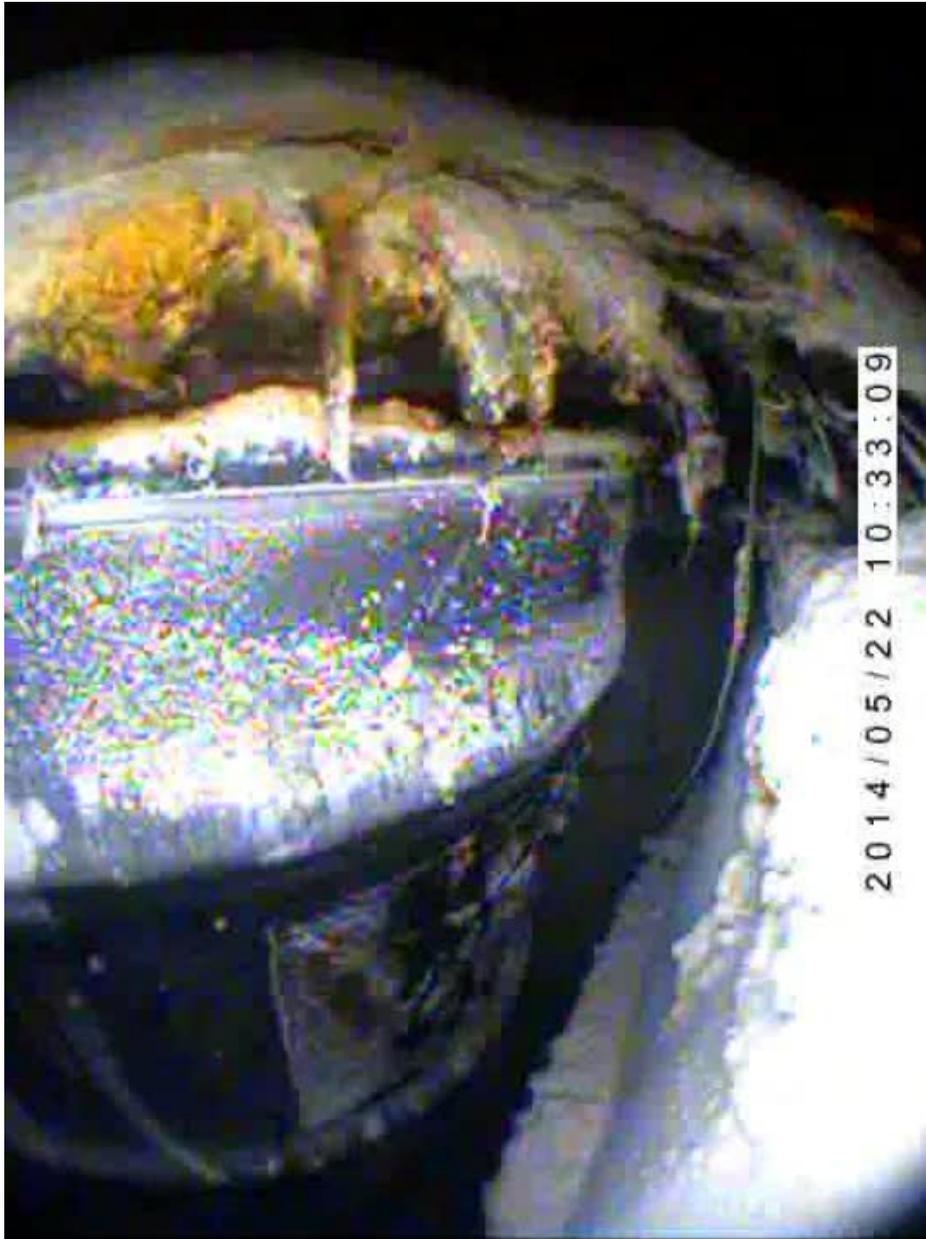
AIB-FST-02107: R16:C4 – Breached lid of waste drum 68660

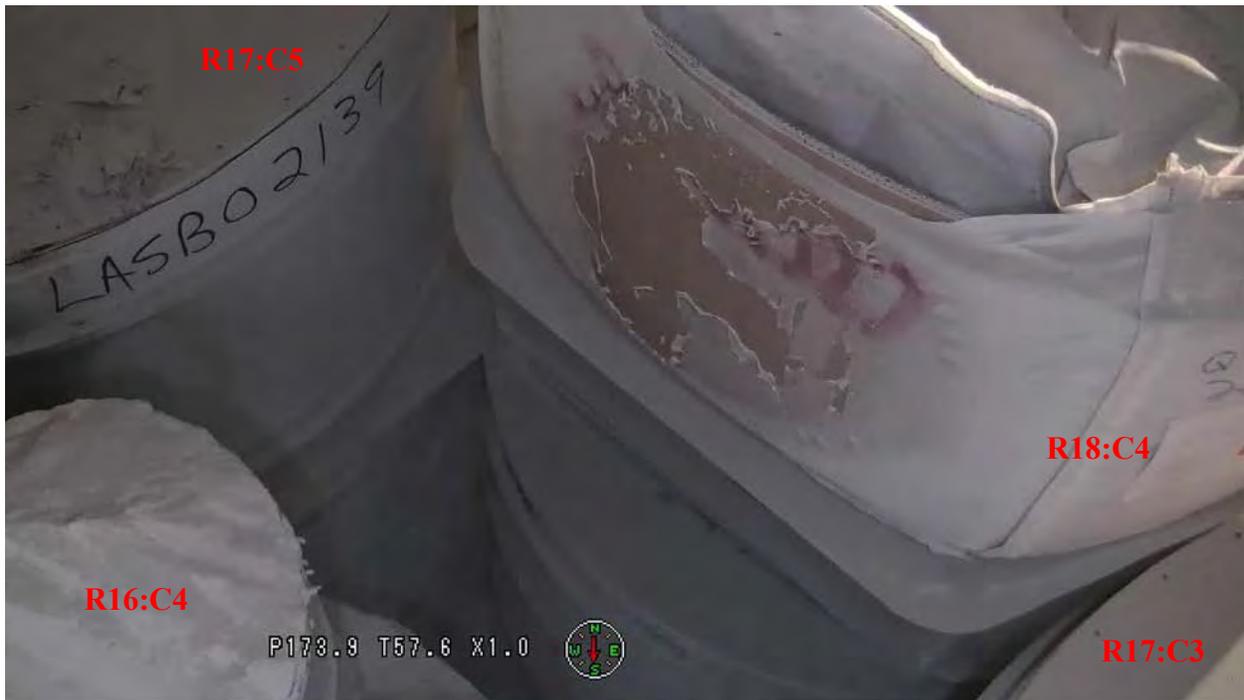
AIB-FST-10080: R18:C4 – Heat flux damage to Mg super sack fabric

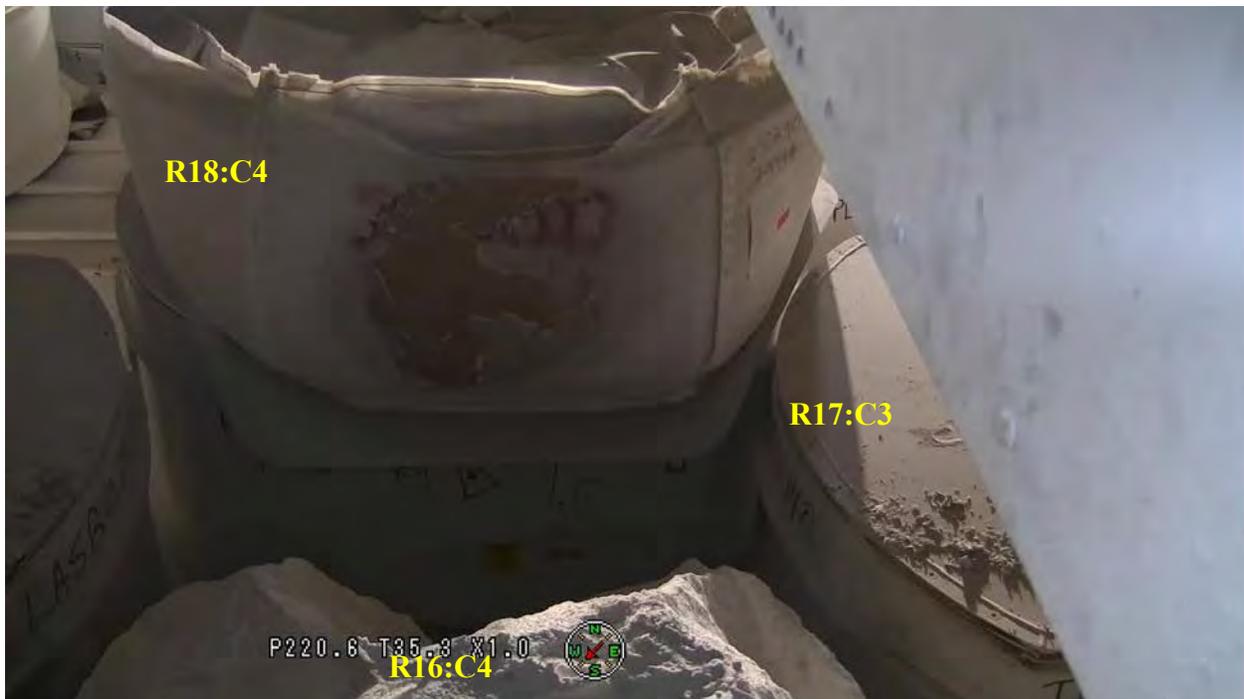
AIB-FST-10087: R18:C4 – Heat flux damage to Mg super sack fabric

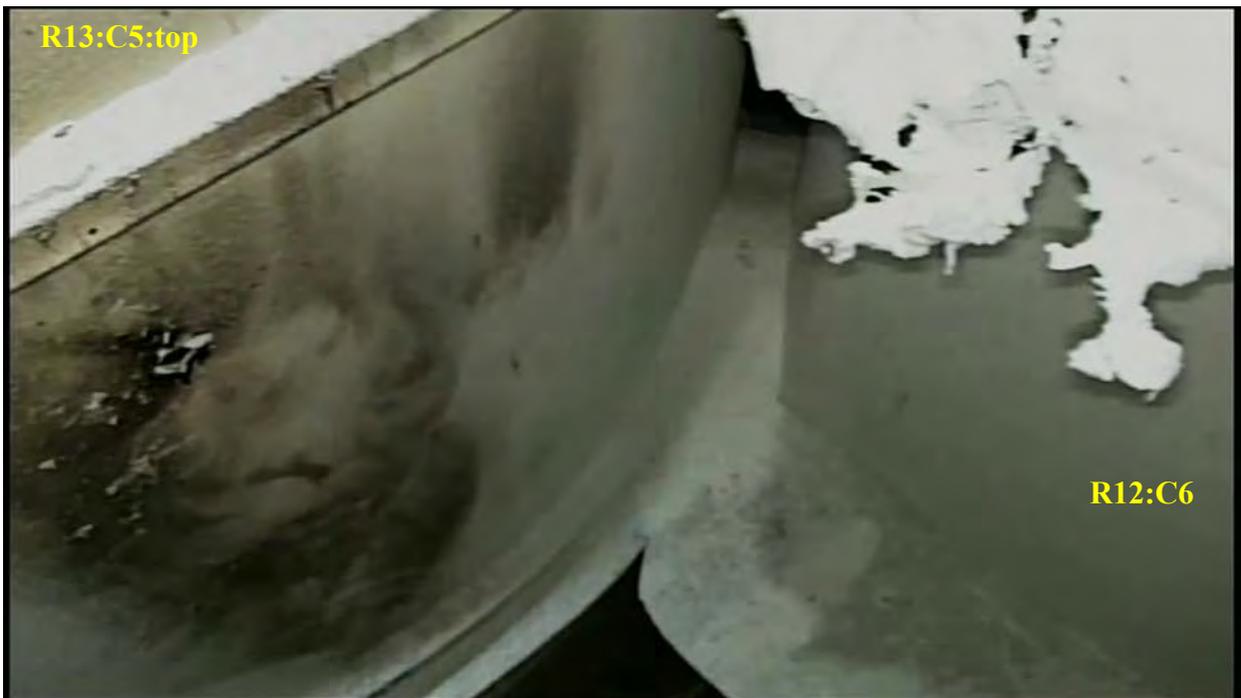
AIB-FST-10121: R12:C6 and R13:C5 – Damage to SWB from super sack fabric burn

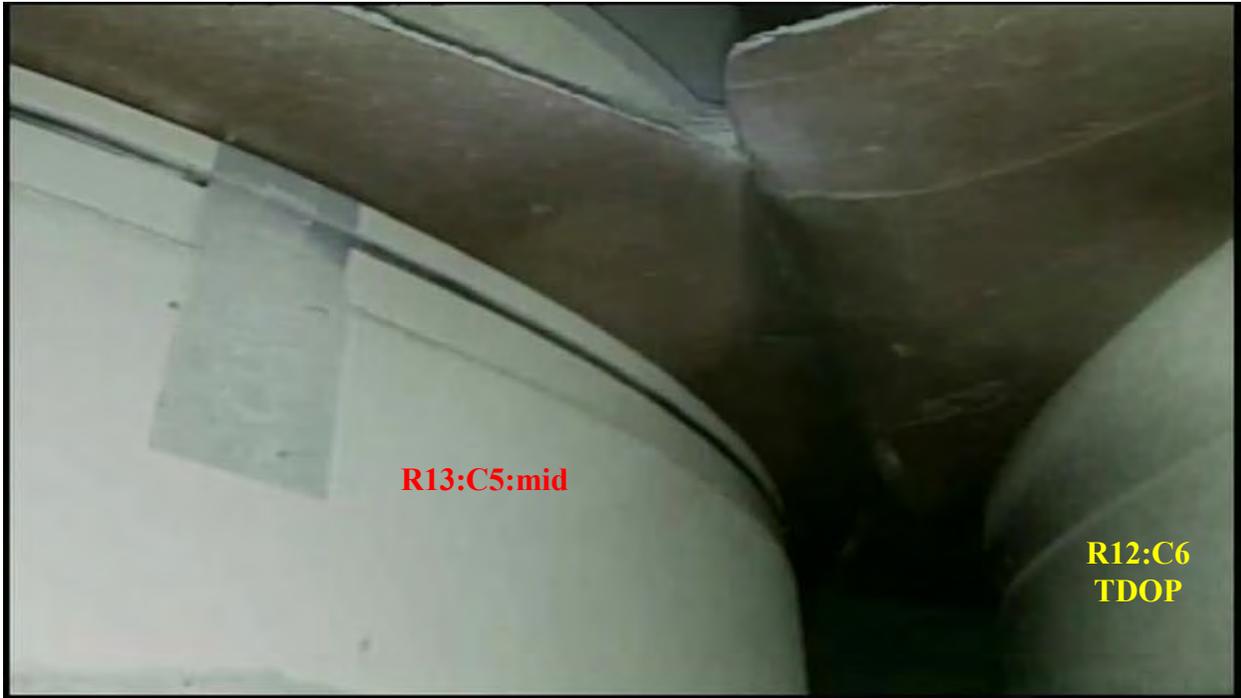
AIB-FST-10122: R12:C6 and R13:C5 – Underside of slip sheets

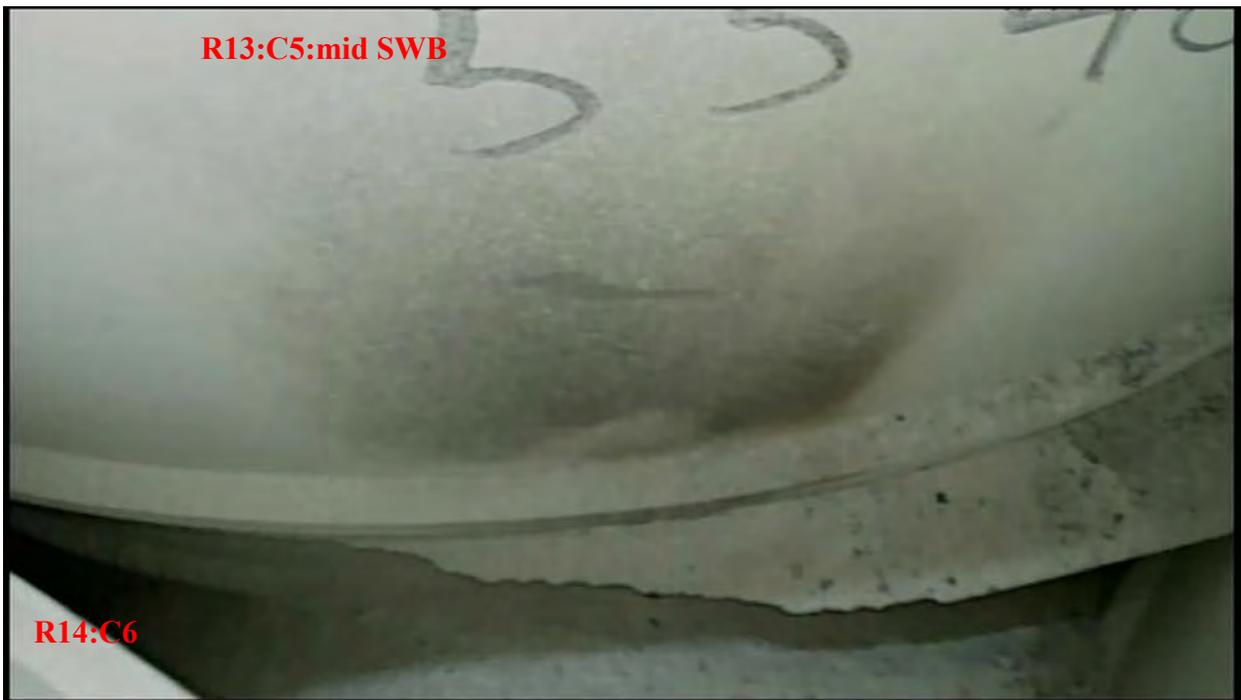
AIB-FST-10123: R13:C5 and R14:C6 – Damage to slip sheet

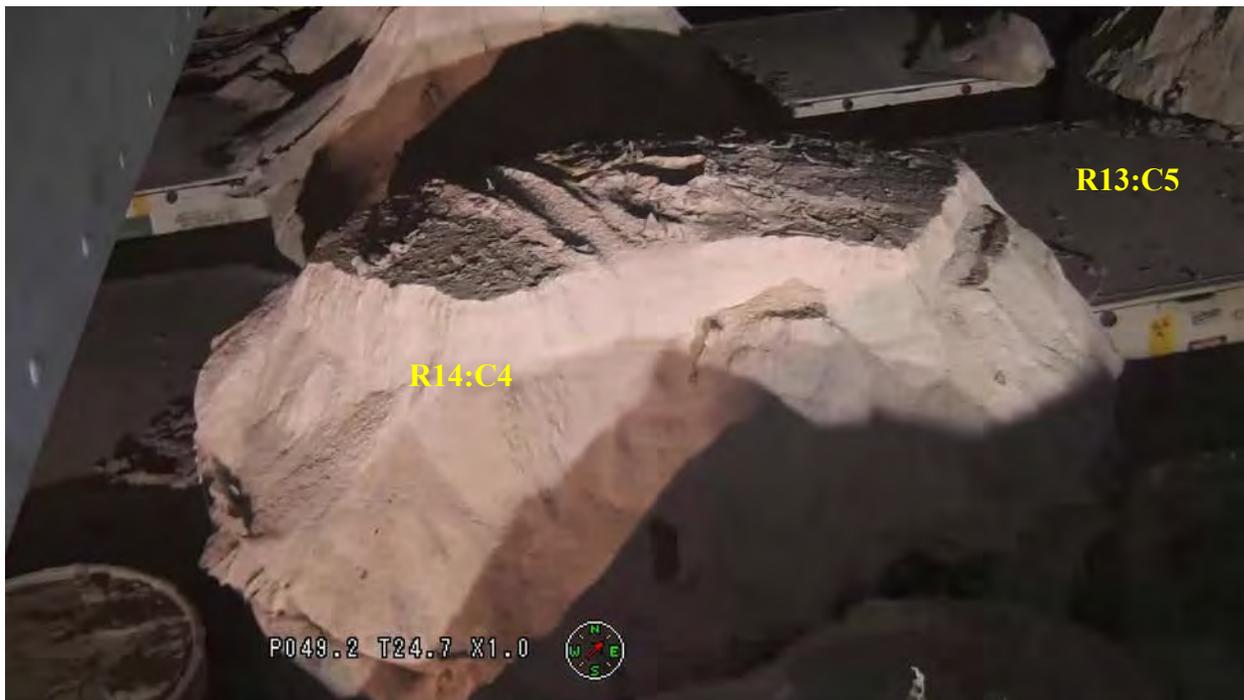
AIB-FST-10271: R14:C4 - Severe damage to MgO super sack

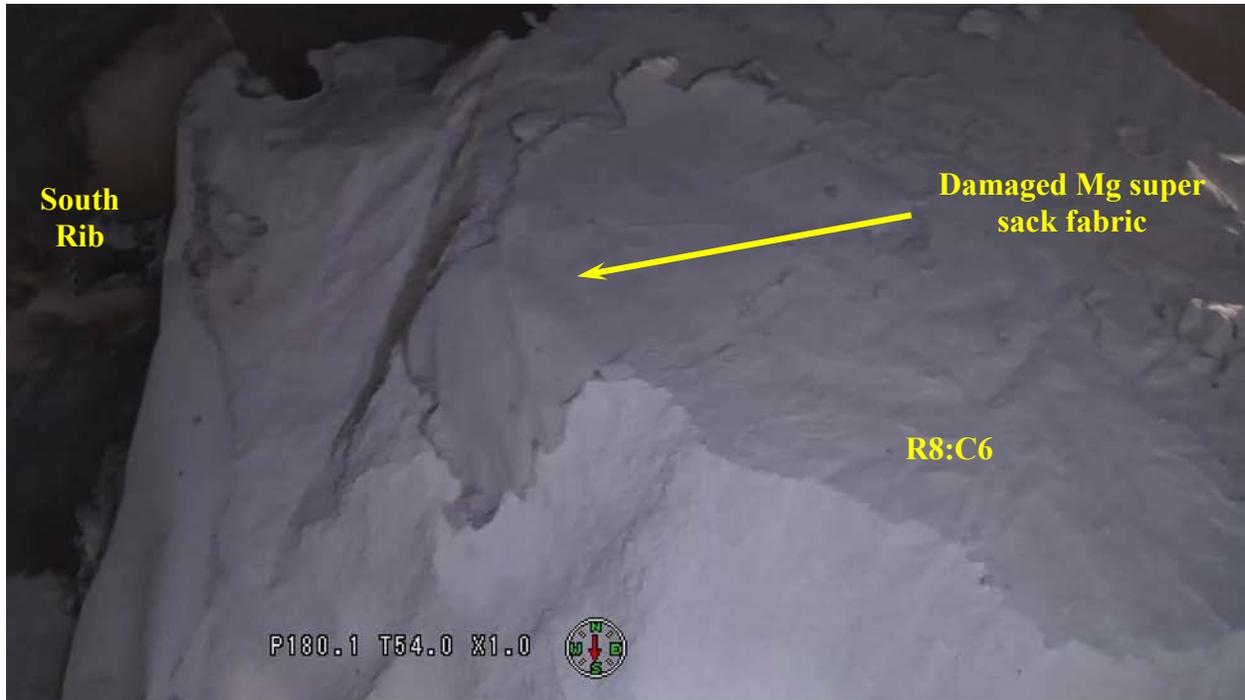
AIB-FST-10479: R8:C6 – Bulkhead (east) view – Damaged Mg super sack fabric

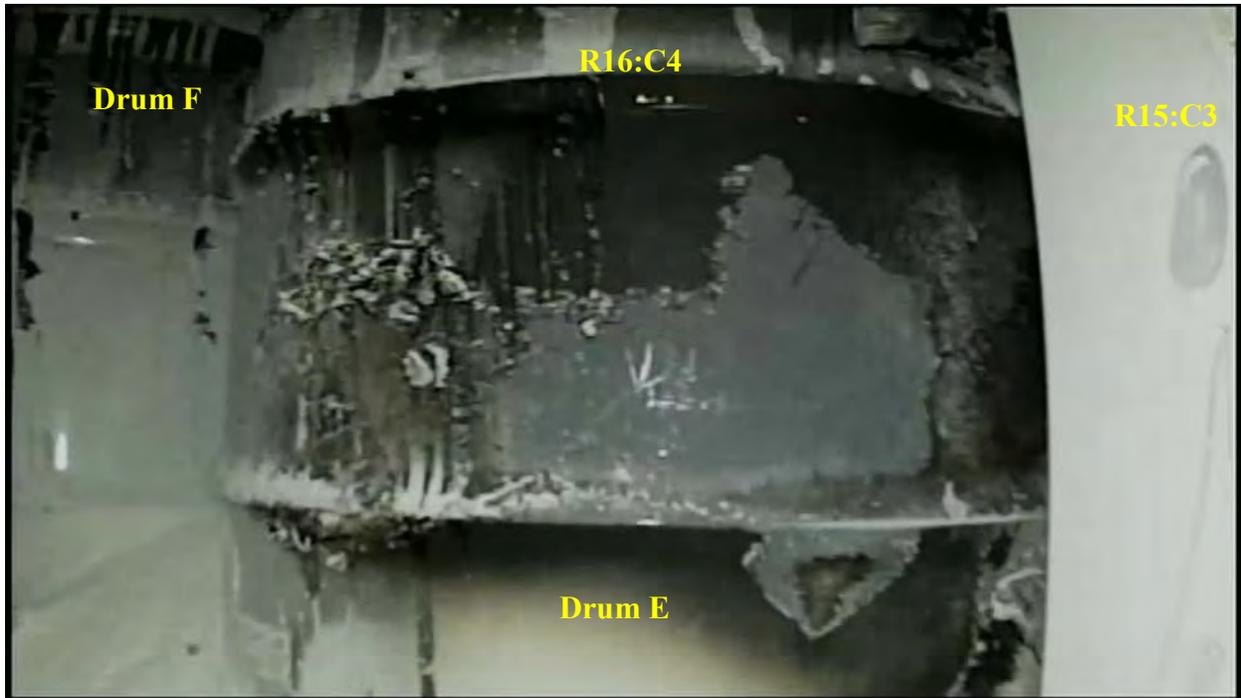
AIB-FST-10529: R16:C4 – Waste drum 68660 – Clean burn area

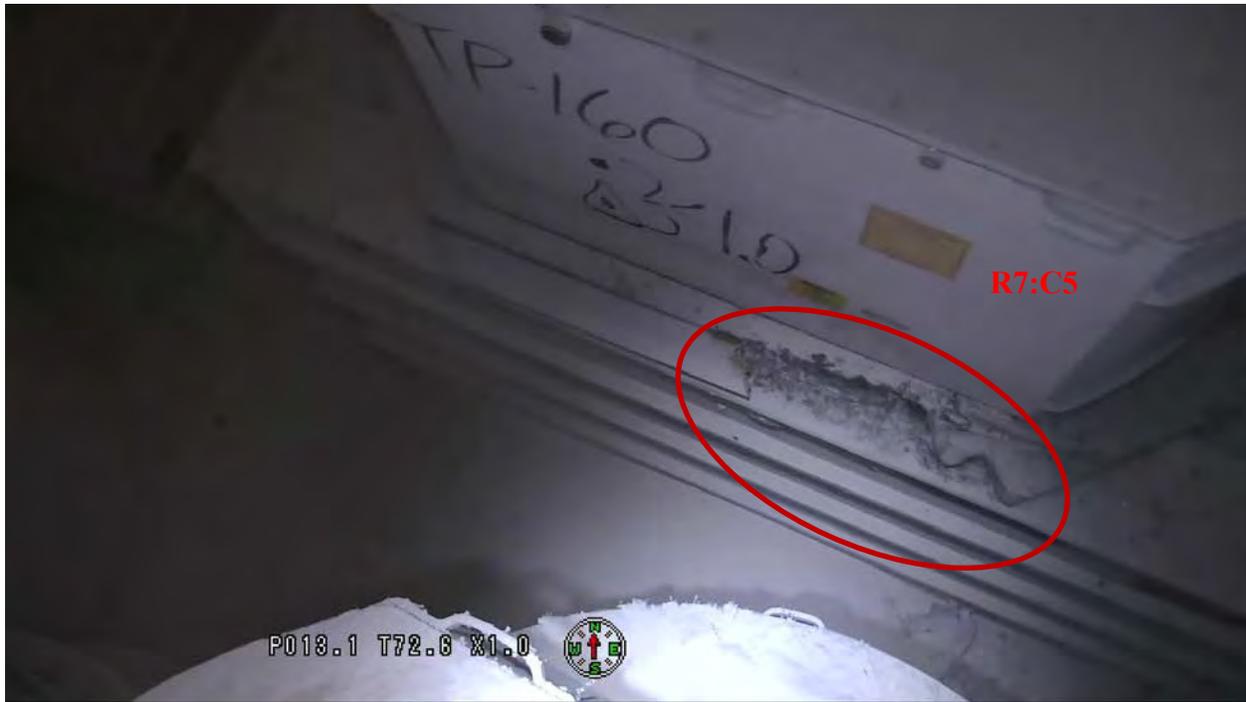
Rows 2 through 7 contained a mix of TDOPs, SWBs, 55GD assemblies, 100GD assemblies, and SLB2s. These rows were closest to the bulkhead. There was one fiberboard slip sheet that had localized char damage; it was at R7:C5. This was the only fire-related damage in Rows 2 through 7. The inspections identified no fire-related damage to the polyethylene stretch wrap or the polypropylene super sacks in these rows. The lack of damage to the stretch wrap in these rows establishes that the bulk air temperature passing over the array was low, nominally below 135°C, which is the upper value of the melting temperature range of the polyethylene stretch wrap† (AIB-FST-10093, AIB-FST-10164, and AIB-FST-11145).

AIB-FST-10541: R7:C5 – Array face (west) view – Slip sheet damage

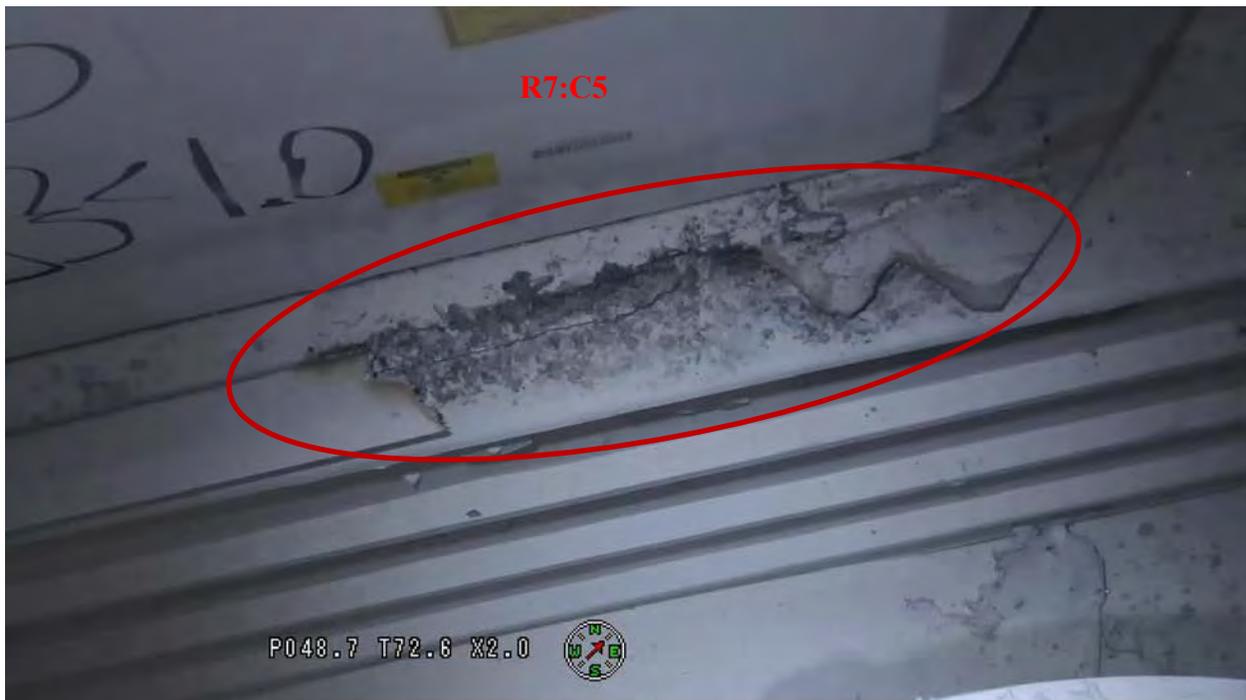
AIB-FST-10542: R7:C5 – Array face (west) view – Slip sheet damage

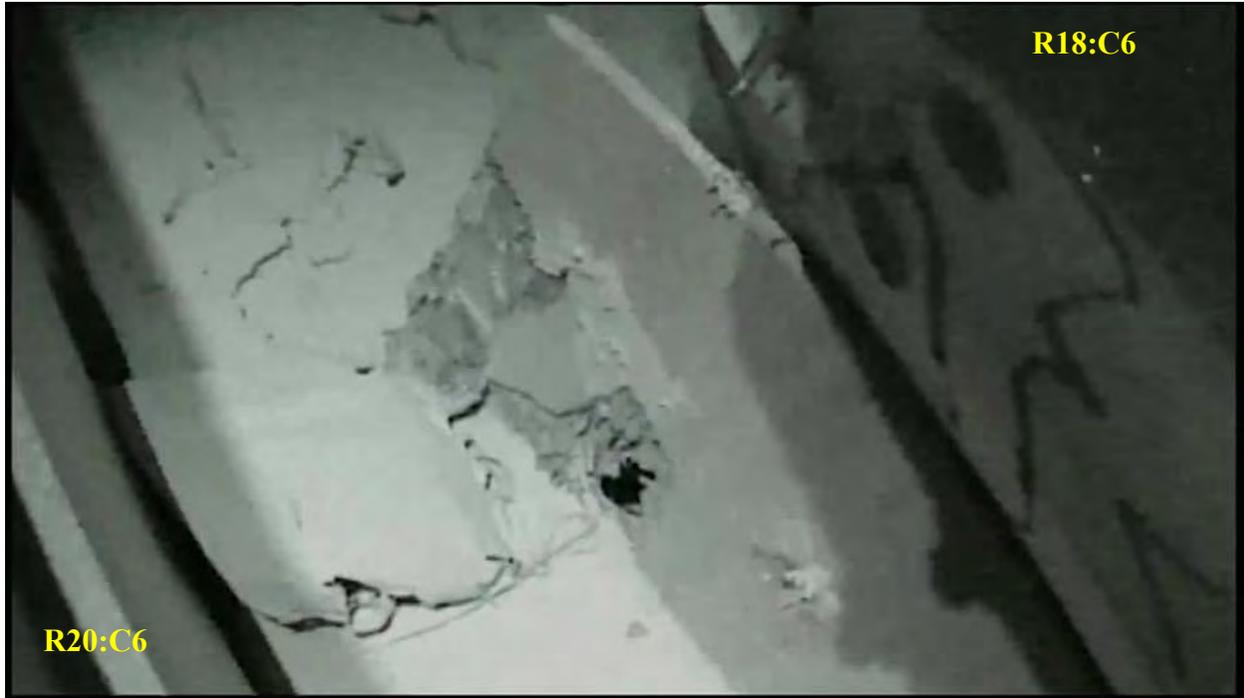
Rows 19 through 24 contained a mix of TDOPs, SWBs, 55GD assemblies, and Standard Large Box Type 2s. These rows were closest to the array face. With the exception of some char material from a cardboard stiffener that had fallen onto R:19:C3 from R18:C2, the inspections identified no fire-related damage in these rows.

AIB-FST-10623: R18:C6 and R20:C6 – Damaged cardboard stiffener

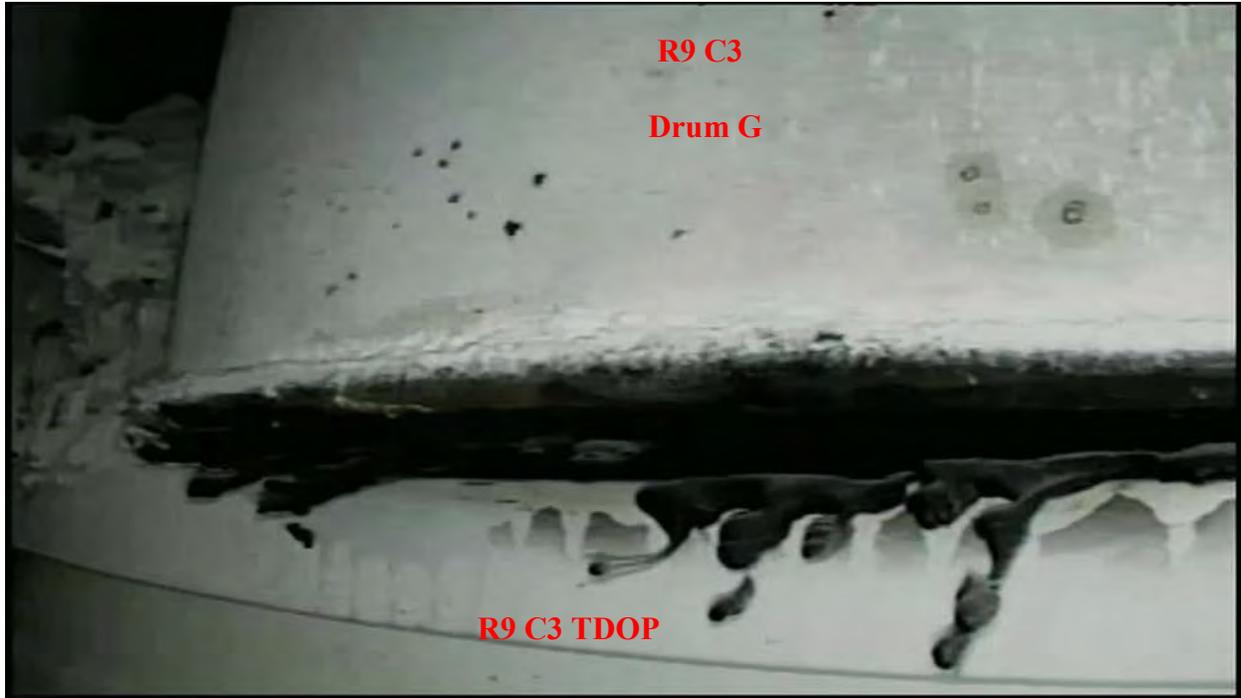
AIB-FST-10677: R9:C3 – Damaged slip sheet below drum G
