Connector Issues in Reliability*

Juris Kalejs, Jeff Gadomski and Zach Nobel
American Capital Energy, Lowell, MA 01854

Examples of wiring failures after 2-4 years field exposure

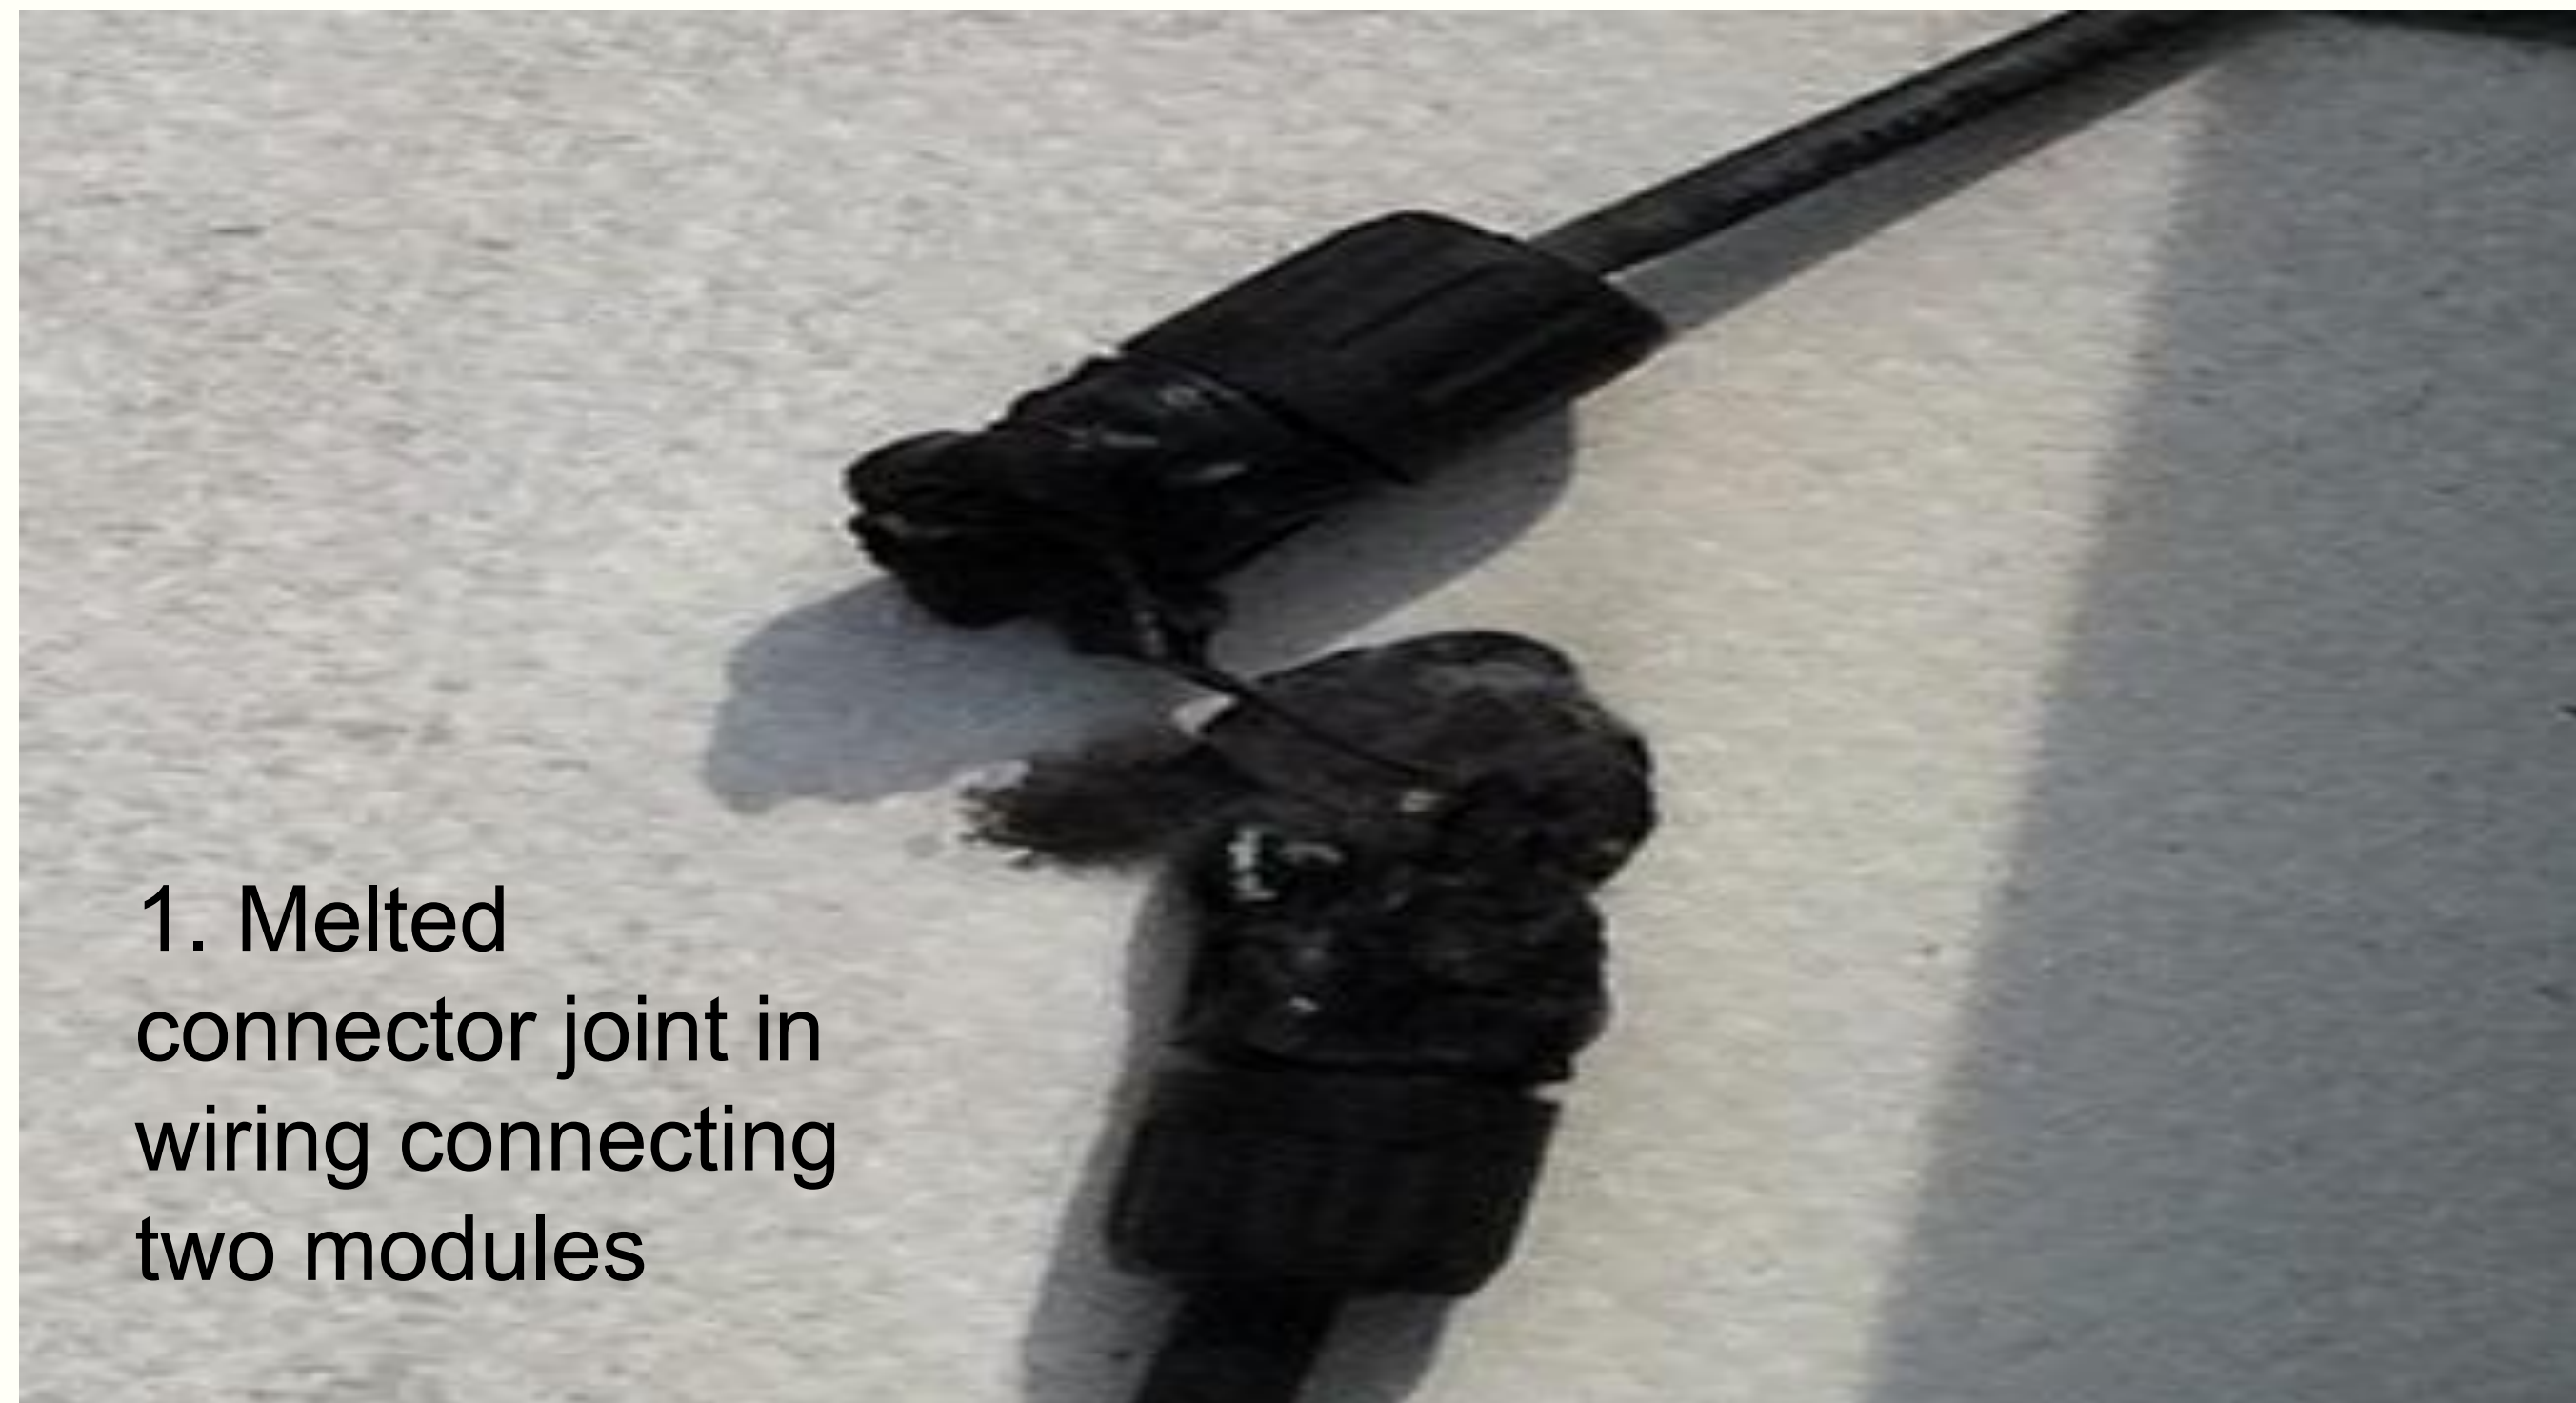
1. Melted connector joint in wiring connecting two modules

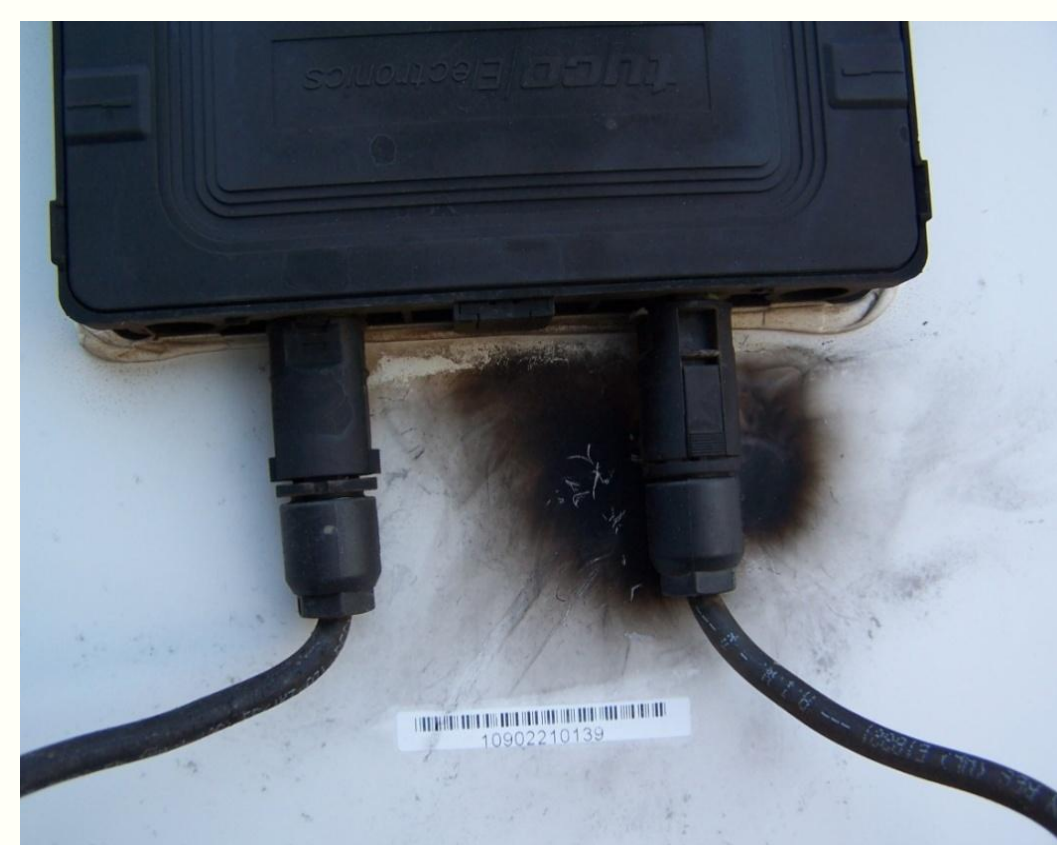
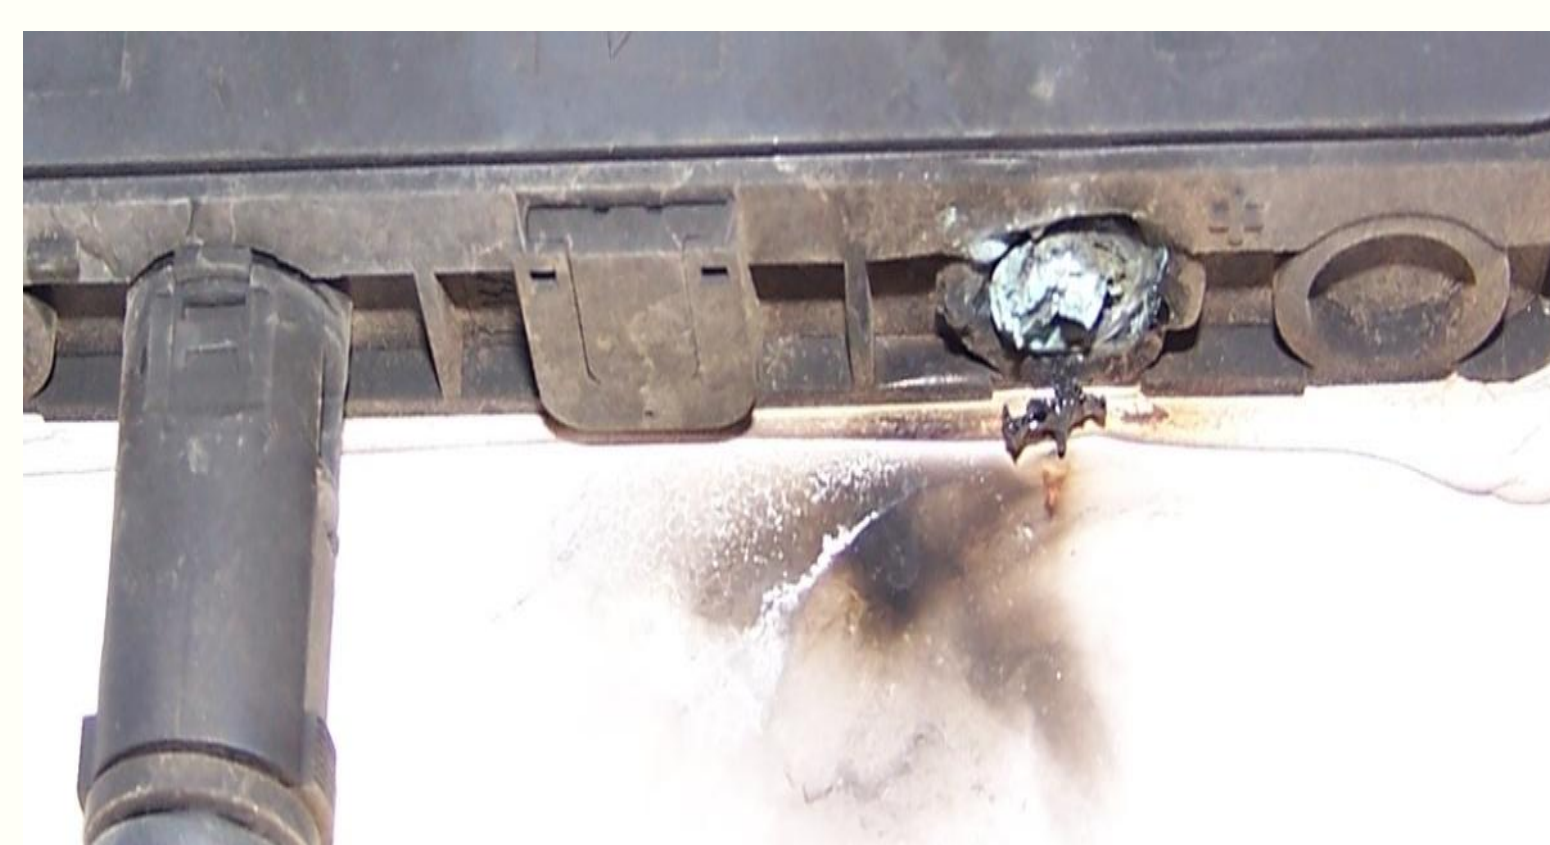
2. Connector failures at junction box

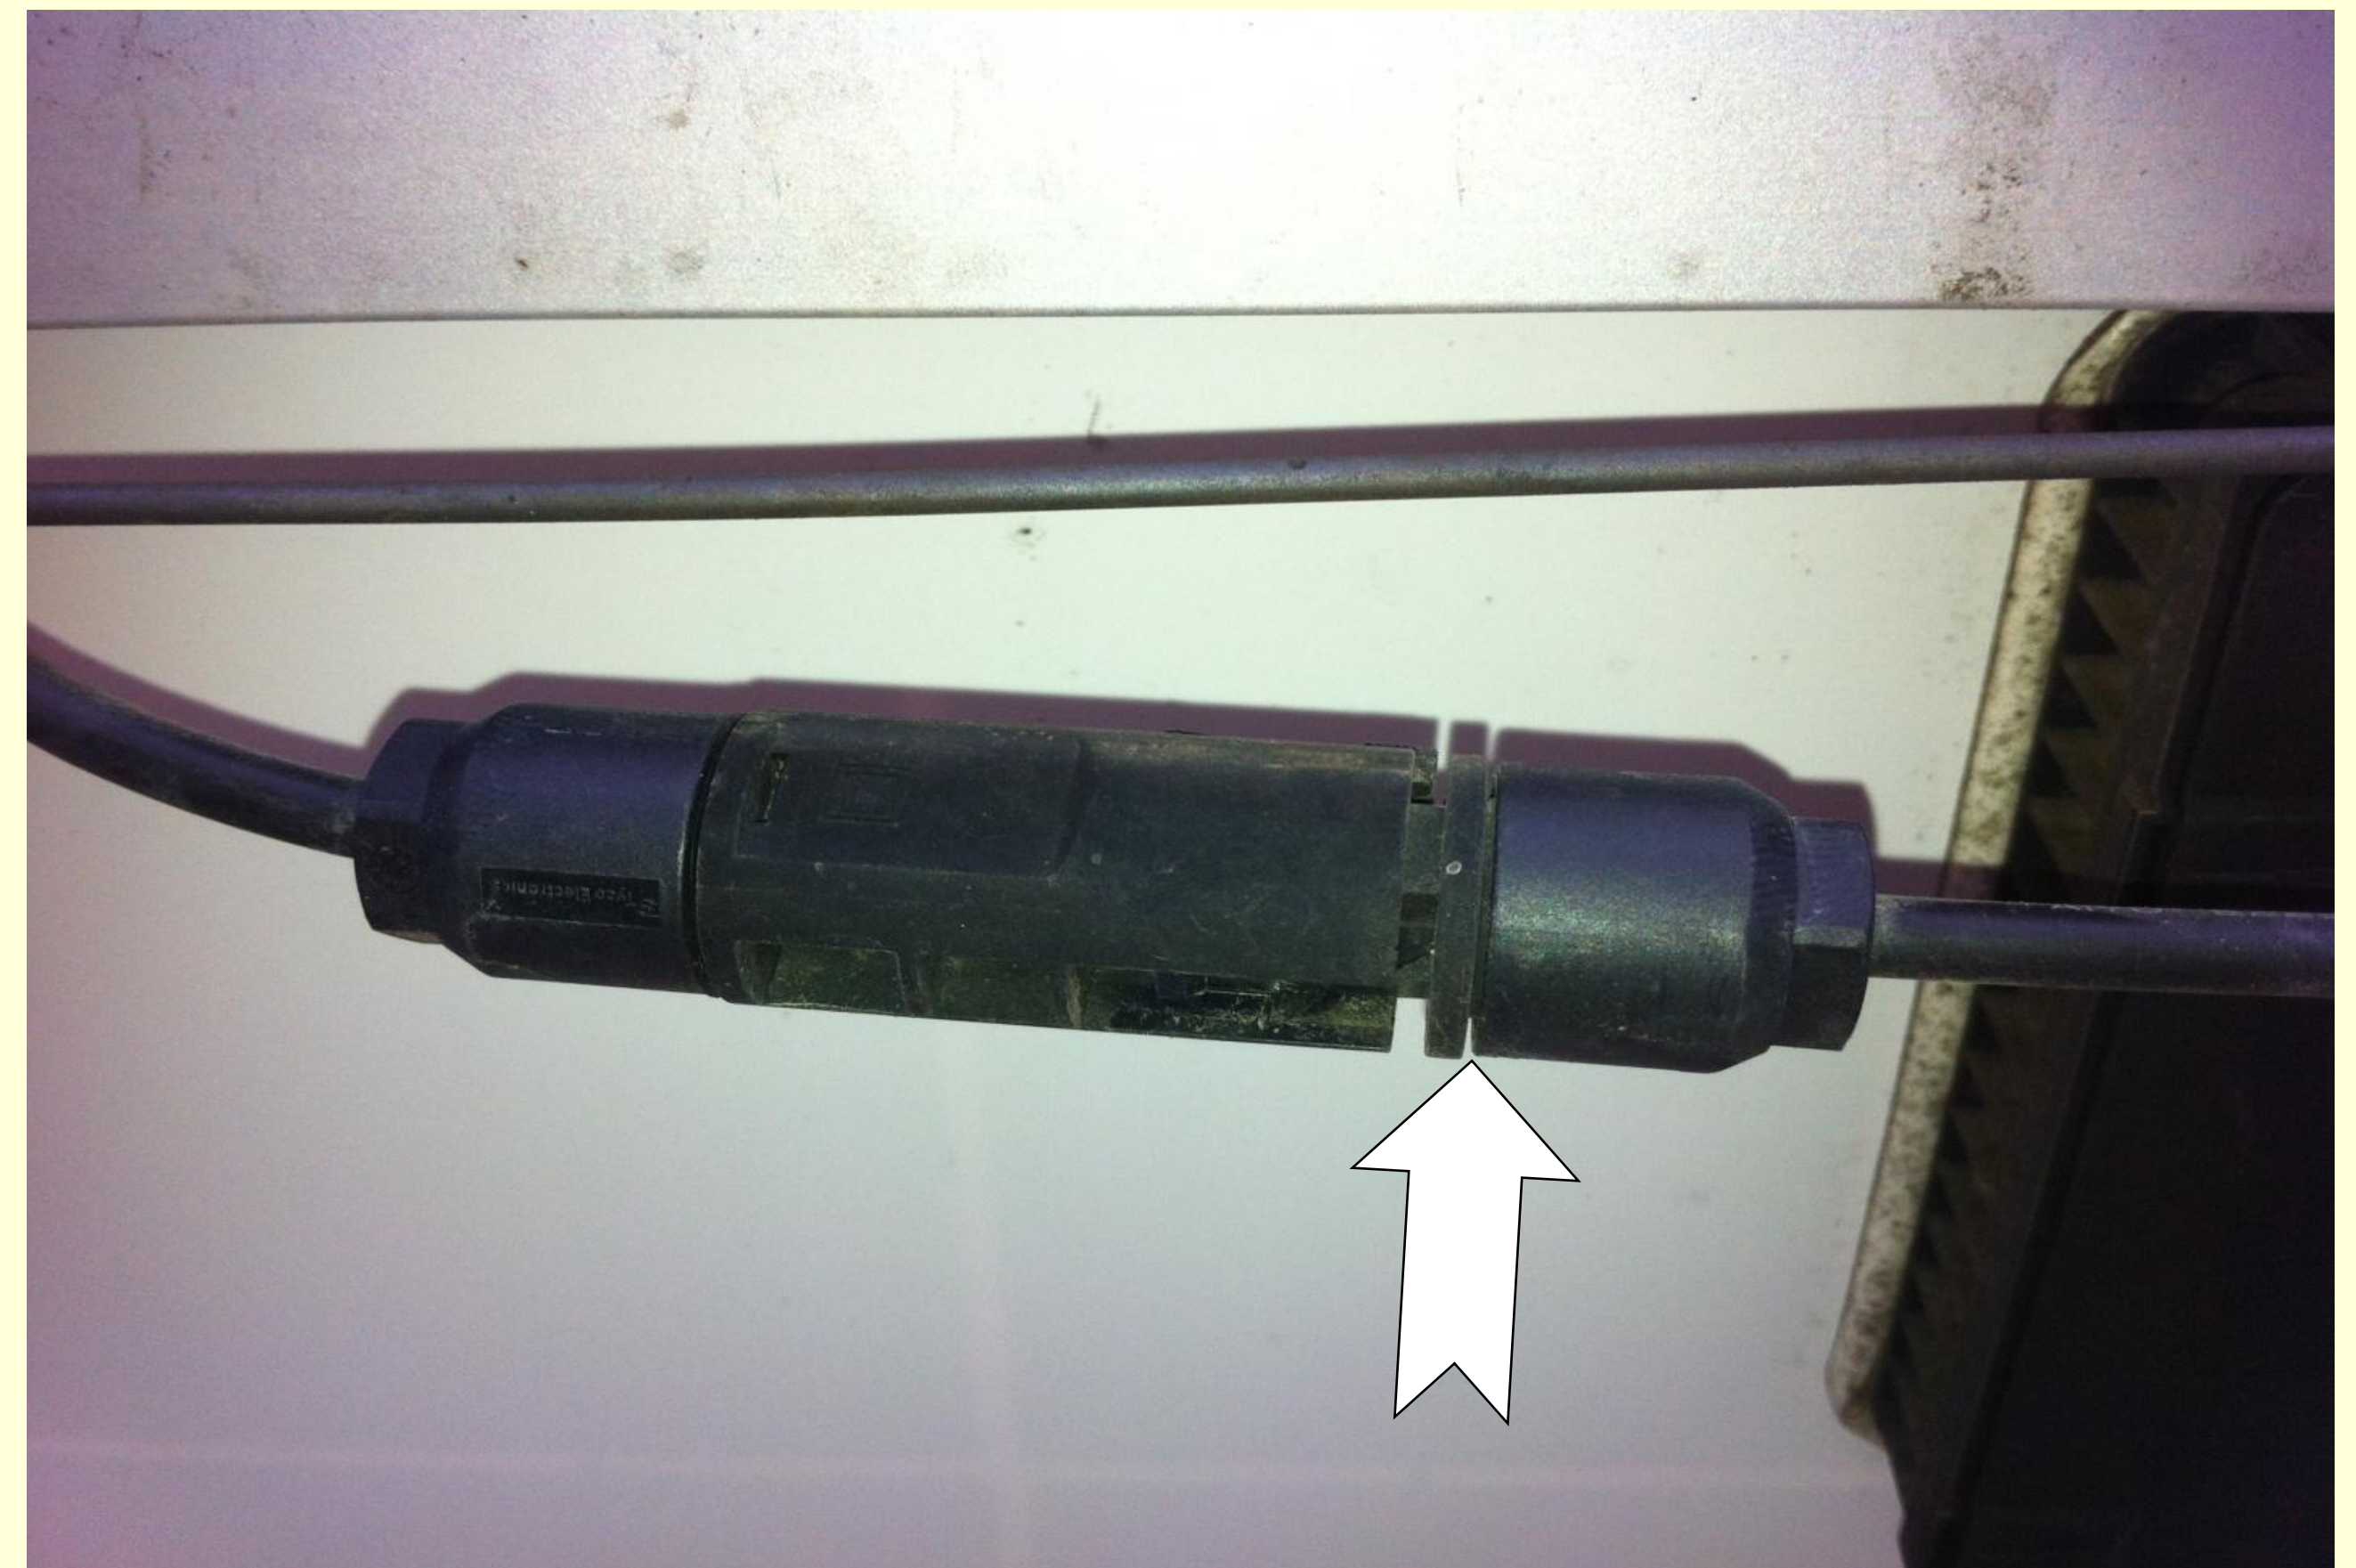
3. Gap of 2-3 mm opens up between mating connectors without any obvious external damage, external stress or fracture in latches
