ARIZONA STATE UNIVERSITY  
**PHOTOVOLTAIC RELIABILITY LABORATORY**

## **Failure and Degradation Modes of PV modules in a Hot Dry Climate: Results after 12 to 26 years of field exposure**

**Mani G. Tamizh-Mani  
Joseph Kuitche  
&  
Research Students of ASU-PRL**

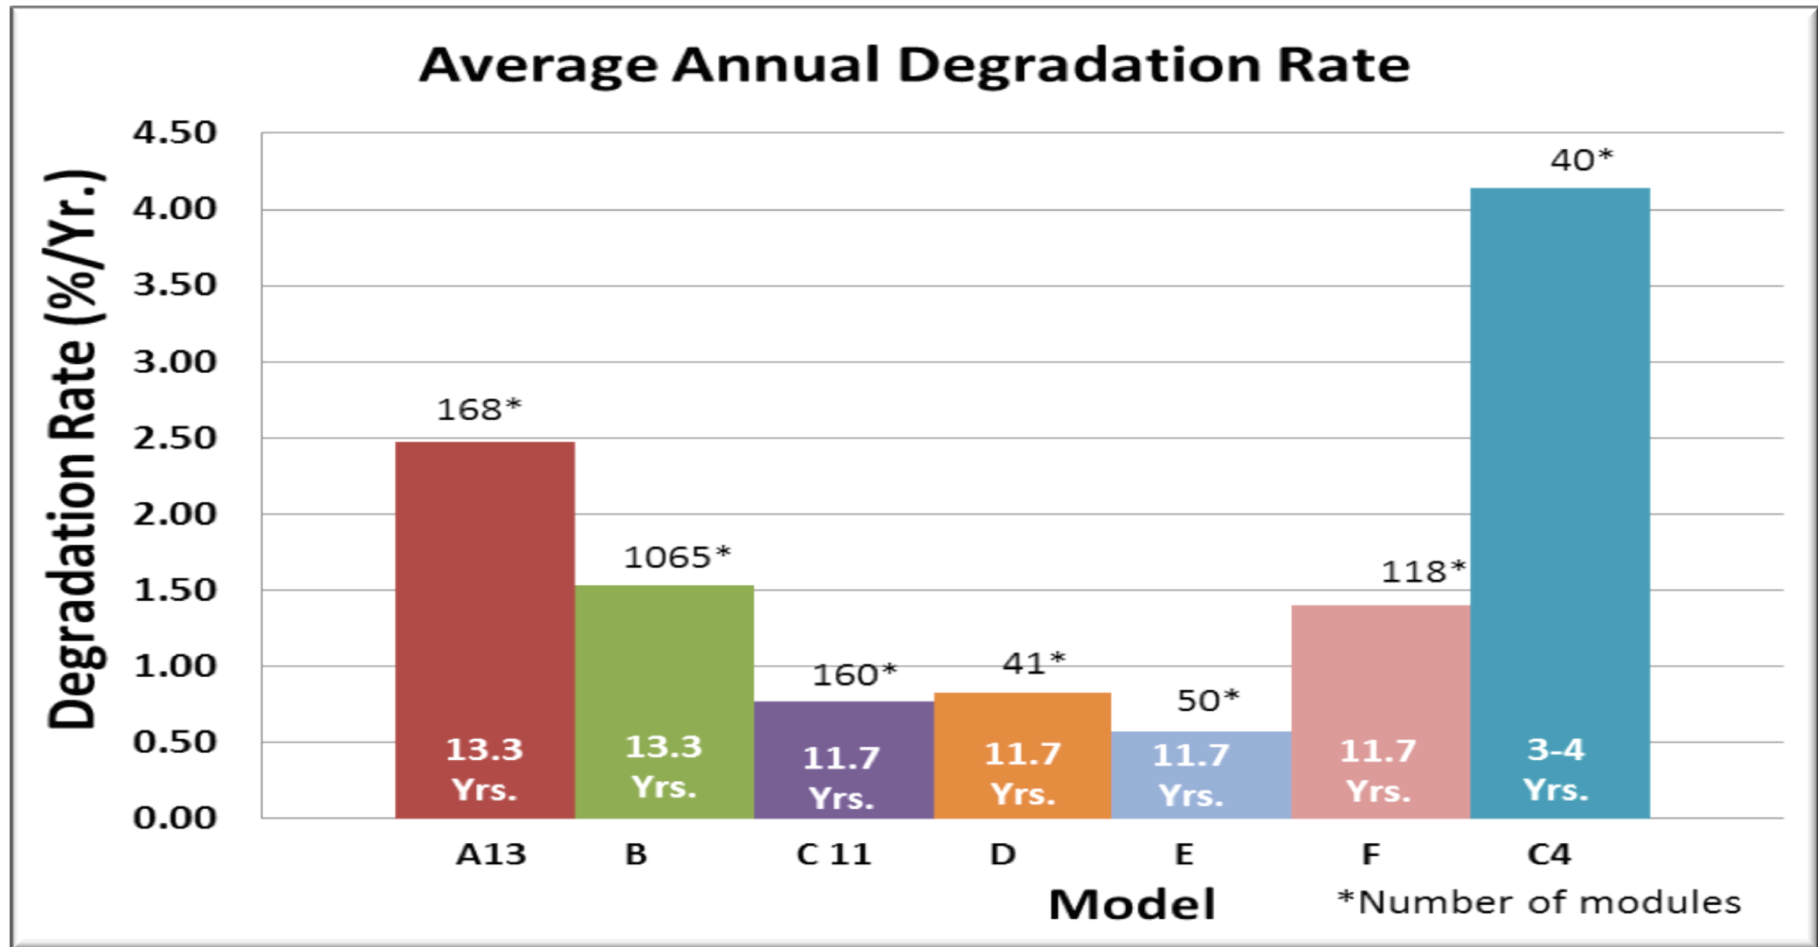
C4 = Replaced modules under warranty

Power degradation appears to be primarily due to **current drop (encapsulant browning)** and **fill factor drop** (series resistance increase due to **thermo-mechanical fatigue of solder bonds**)

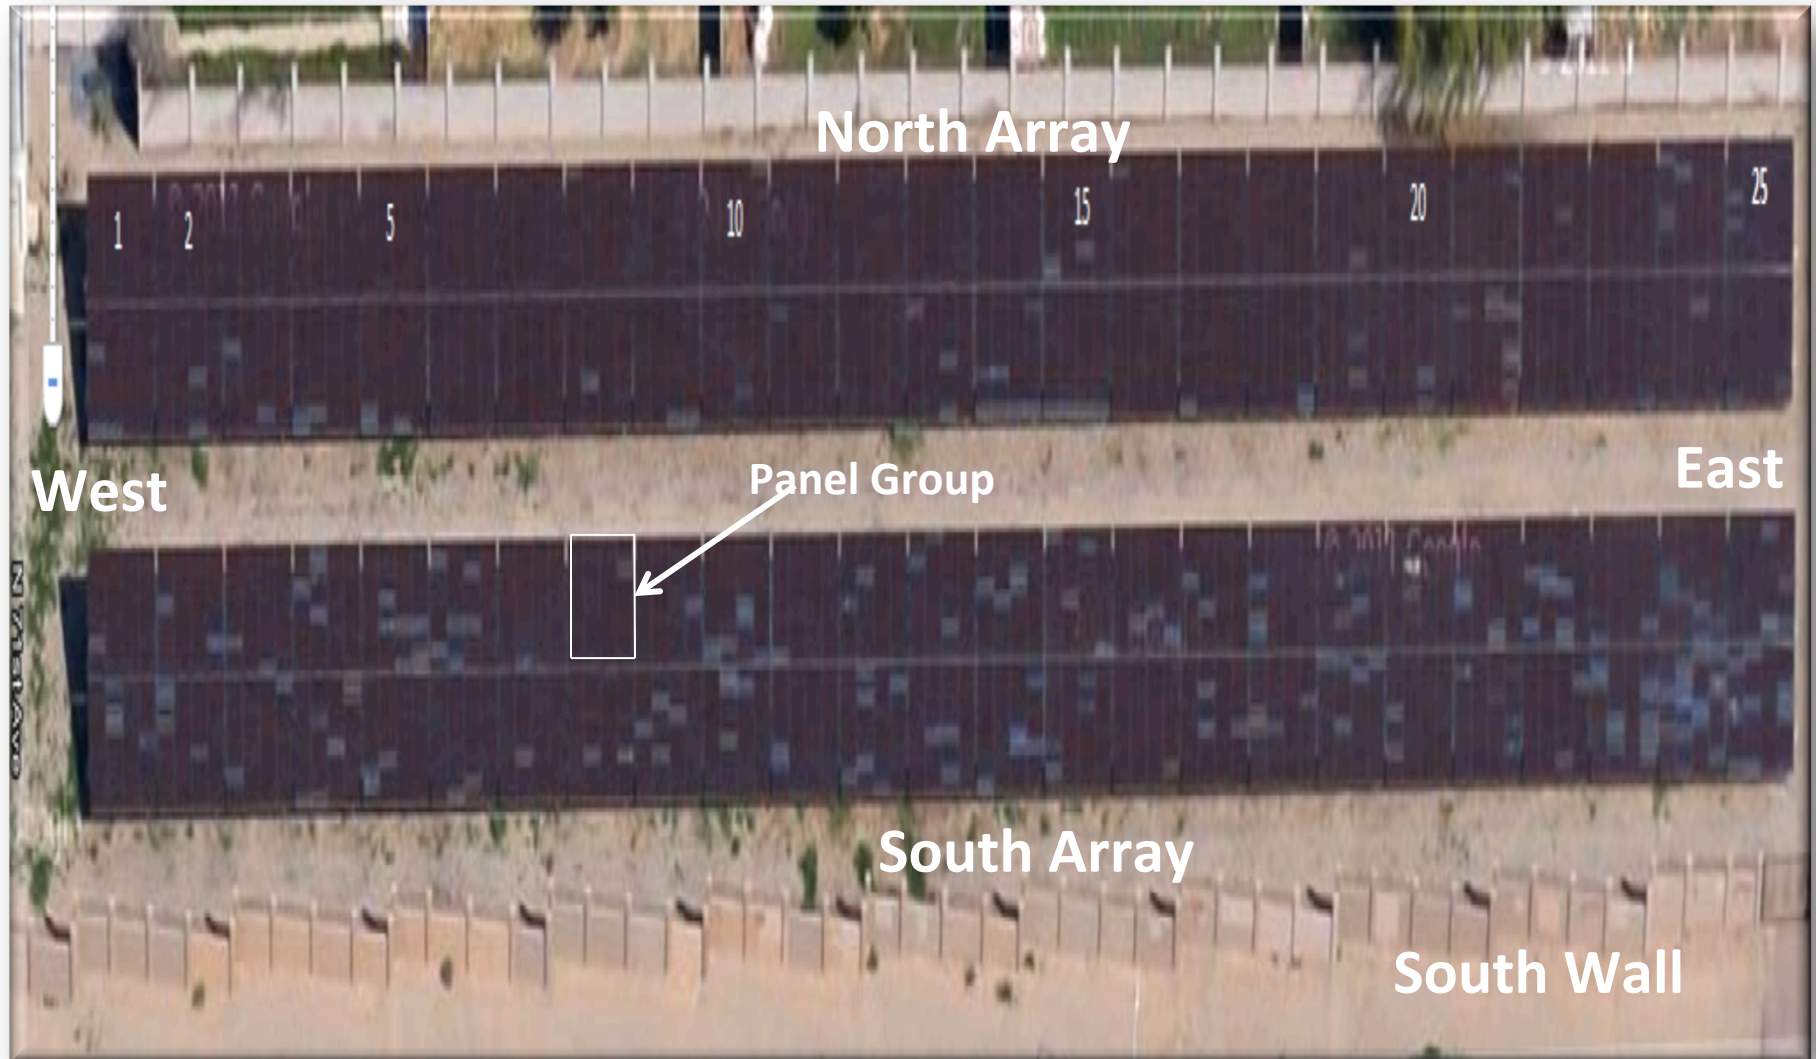
**4000 Modules = 100 Panel Groups (4 panels per group with 10 modules in each panel)**

**Note: White spots on the photo are due to the replaced modules or modules with glass cracks leading to encapsulant bleaching. Modules were often replaced due to vandalism (stone throwing across the south wall)**

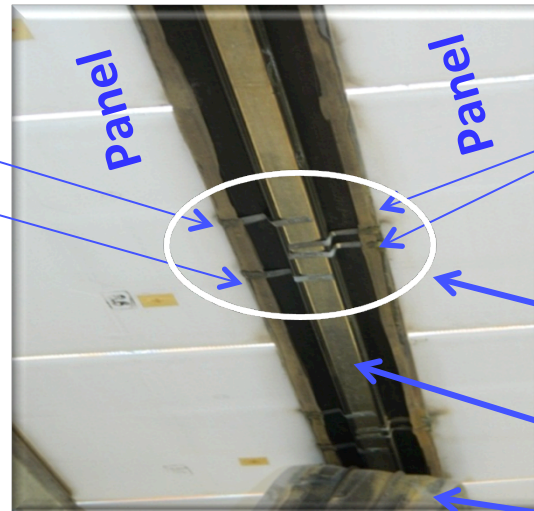
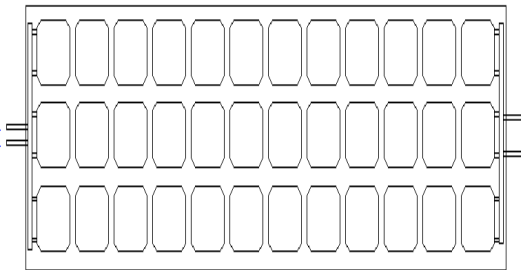
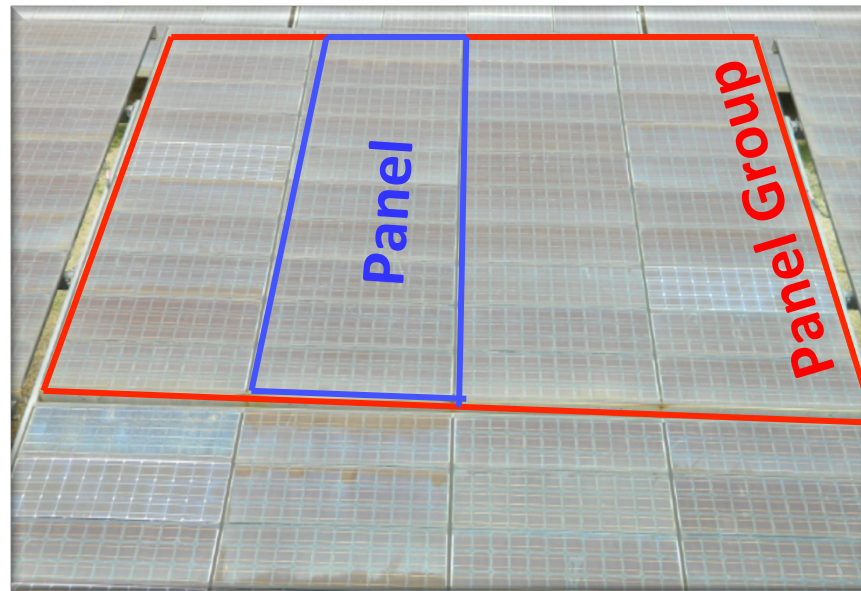
**Note: OUTDATED CABLIG METHOD**

- **No module cable**
- **No module connector**
- **Non-cell interconnect ribbons are directly welded on inter-panel busbar**

**Non-cell interconnect ribbons**

**Inter-Panel Busbar**

**Plastic cover to protect busbar and interconnects (leaky cover; corrosion)**

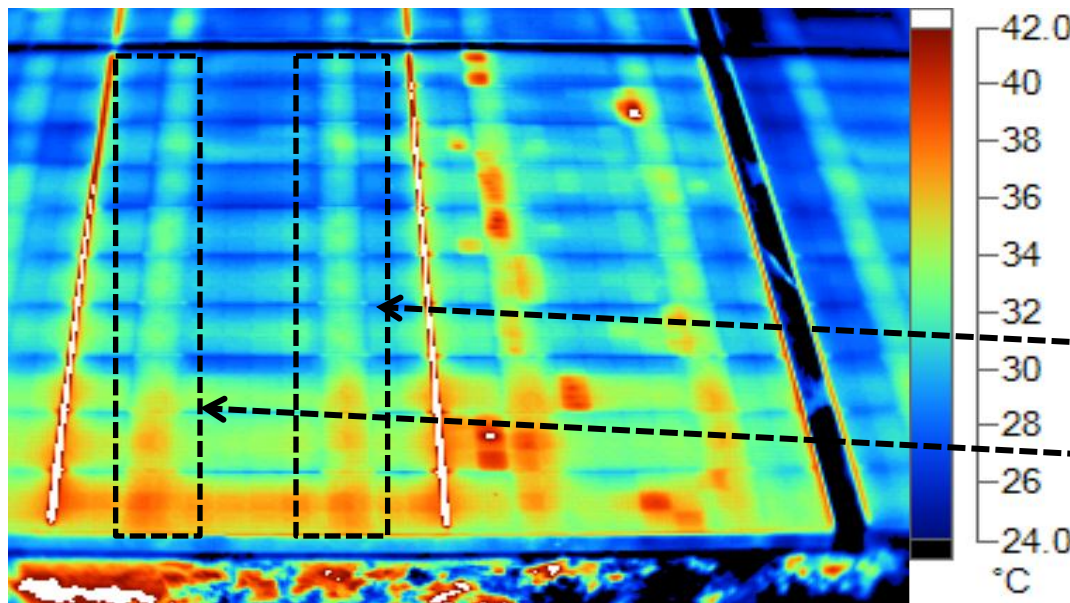
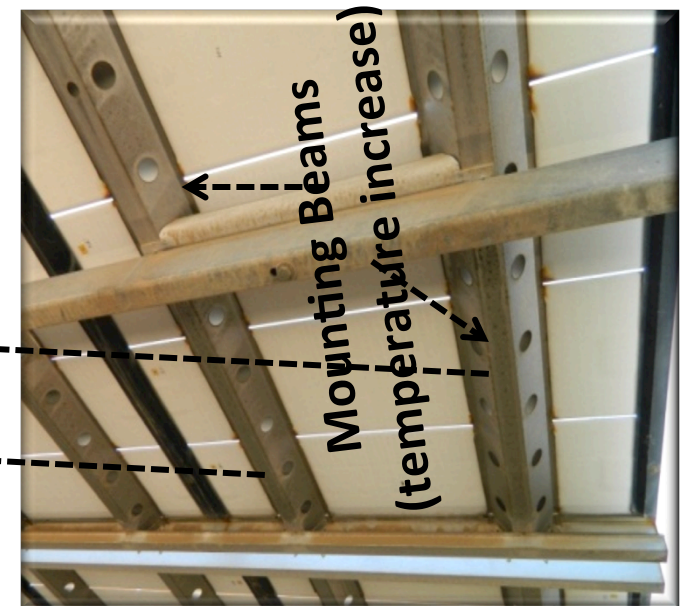
- Infrared imaging
- Hotspots

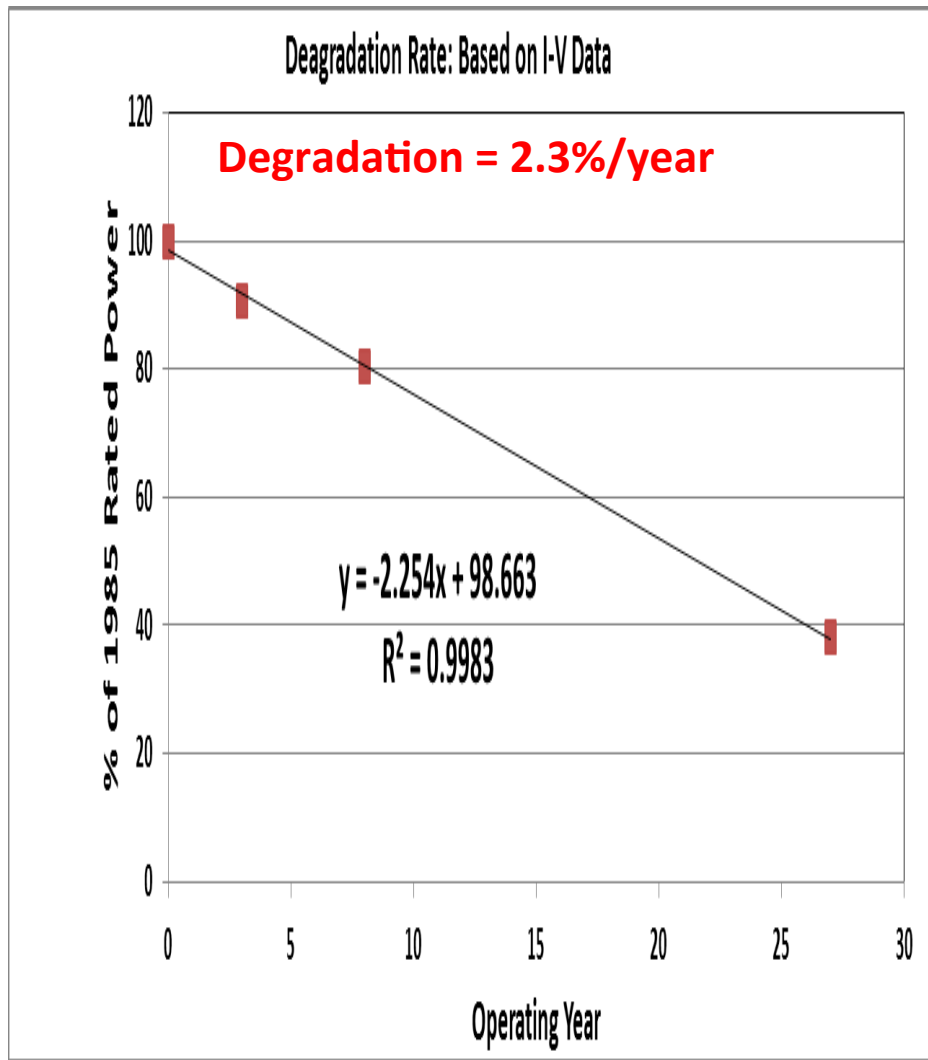
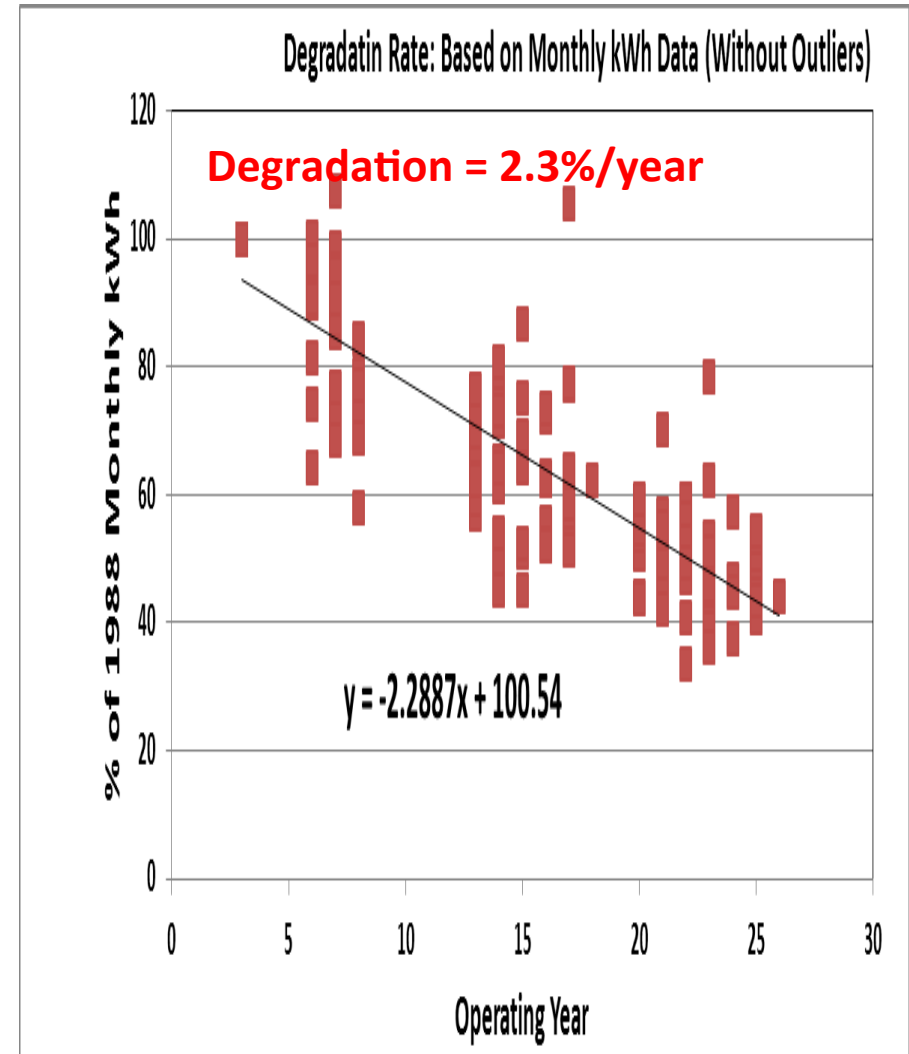
**Currently, the plant is operating at about 40% of its rated capacity!**

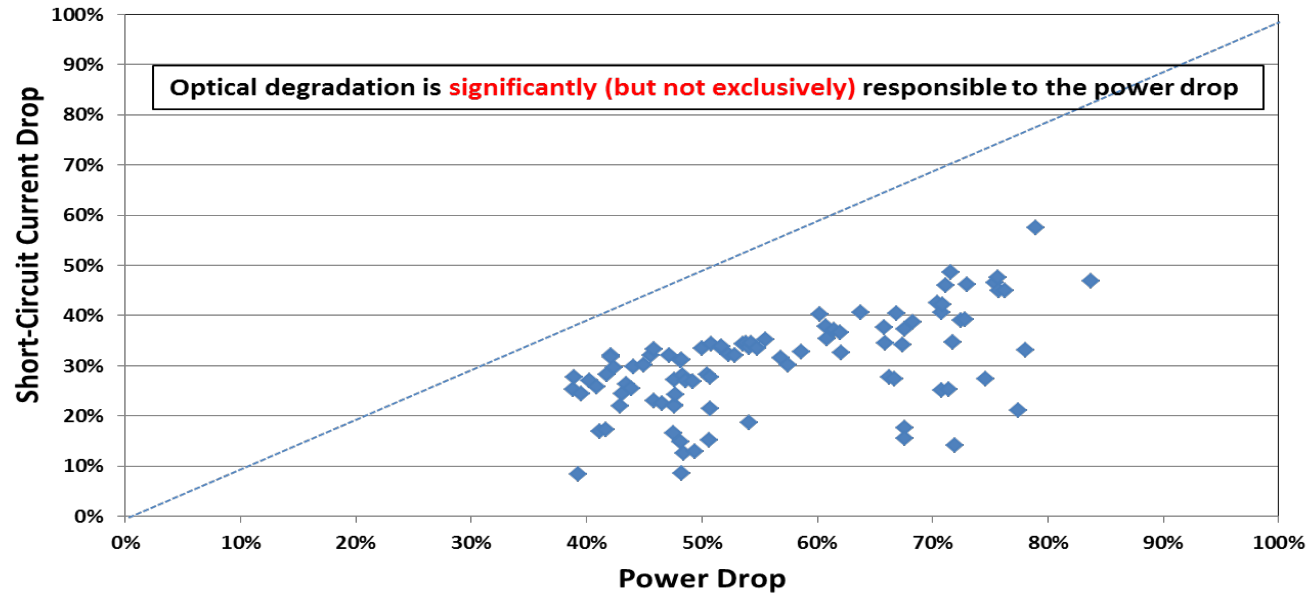
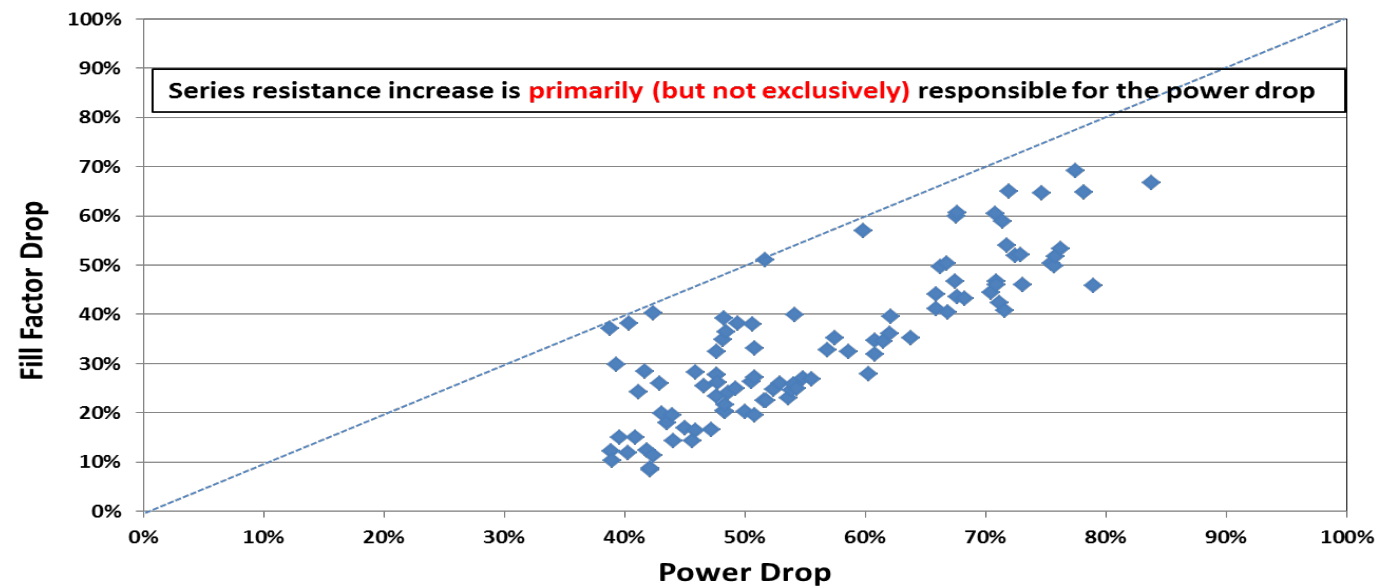
## Site 2: Results – Power loss is significantly due to current loss (encapsulant browning) and primarily due to FF loss (solder bond fatigue)

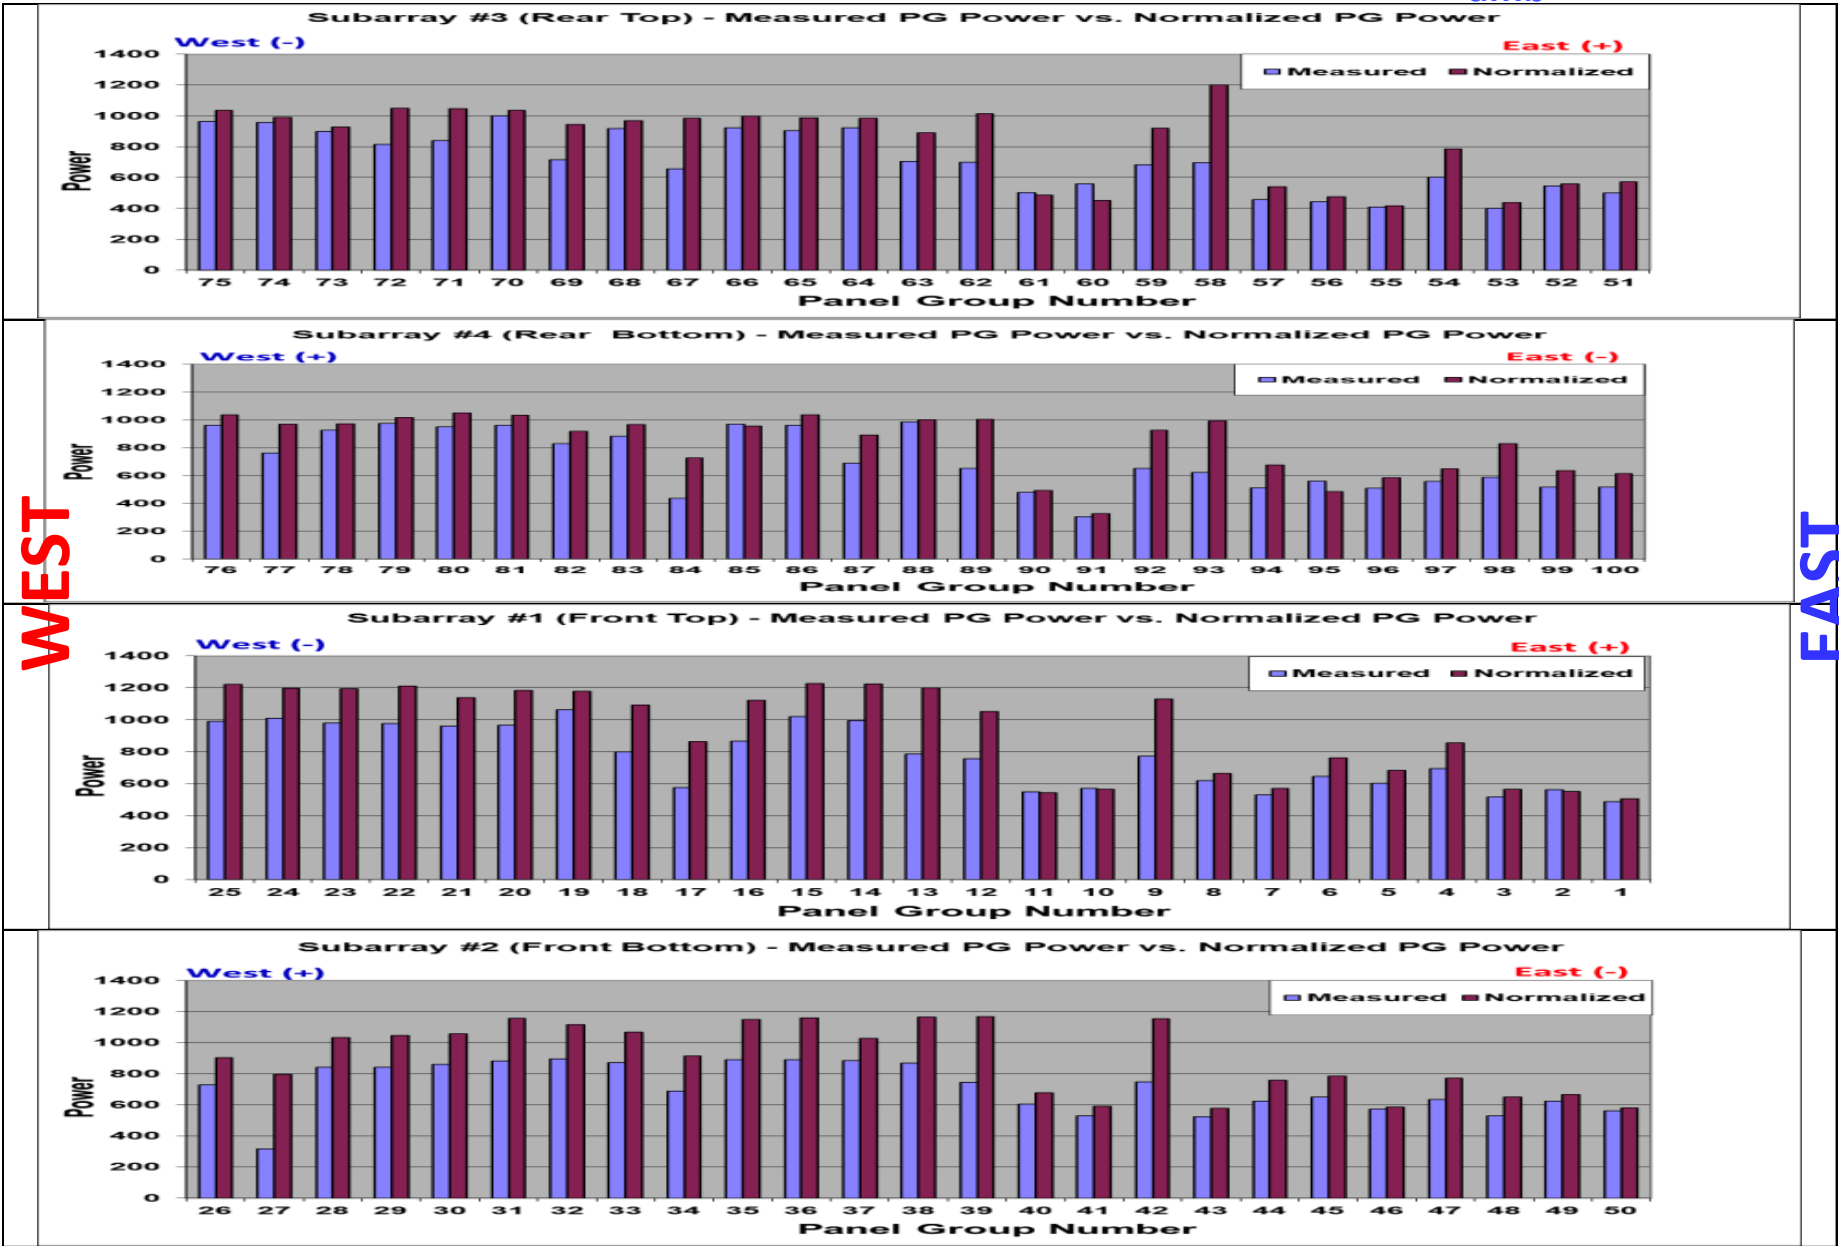
Site 2: Results – East array degrades at much higher rate than west array!!  
Wind direction effect?? (S-W wind direction when  $T_{amb} > 40^{\circ}\text{C}$ )
