Delamination failures in long-term field-aged PV modules from point of view of encapsulant

Tsuyoshi Shioda

Mitsui Chemicals, Inc.

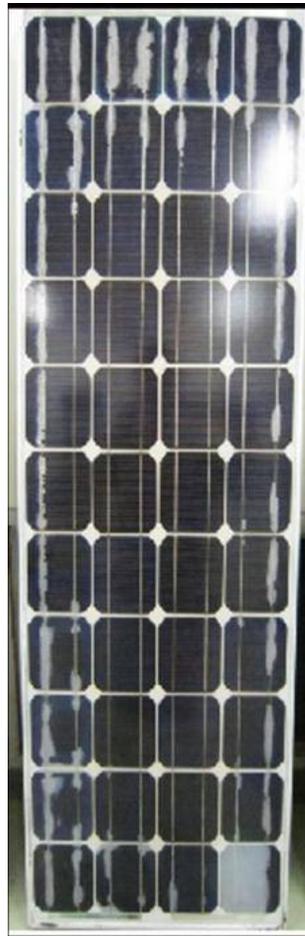
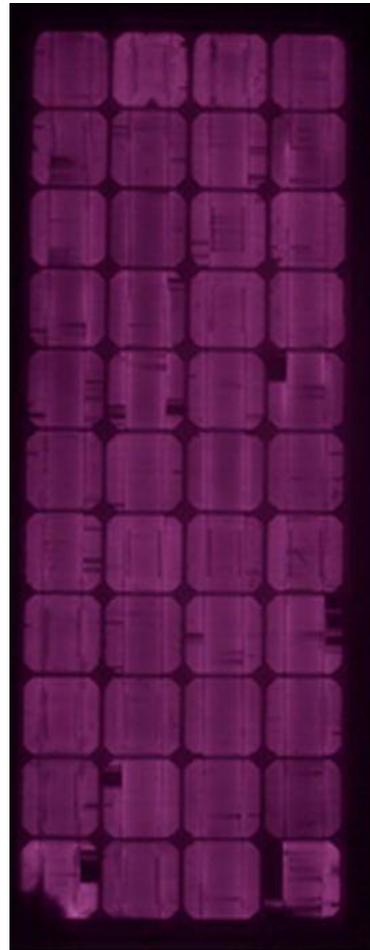
Manufacturer A
Module “A”

1. Delamination is mainly observed in the vicinity of interconnectors on cells.
2. Delamination is observed at the outer portions in a plane of the PV module.
3. We can not see a clear correlation between delamination failure and dark portions in EL images.

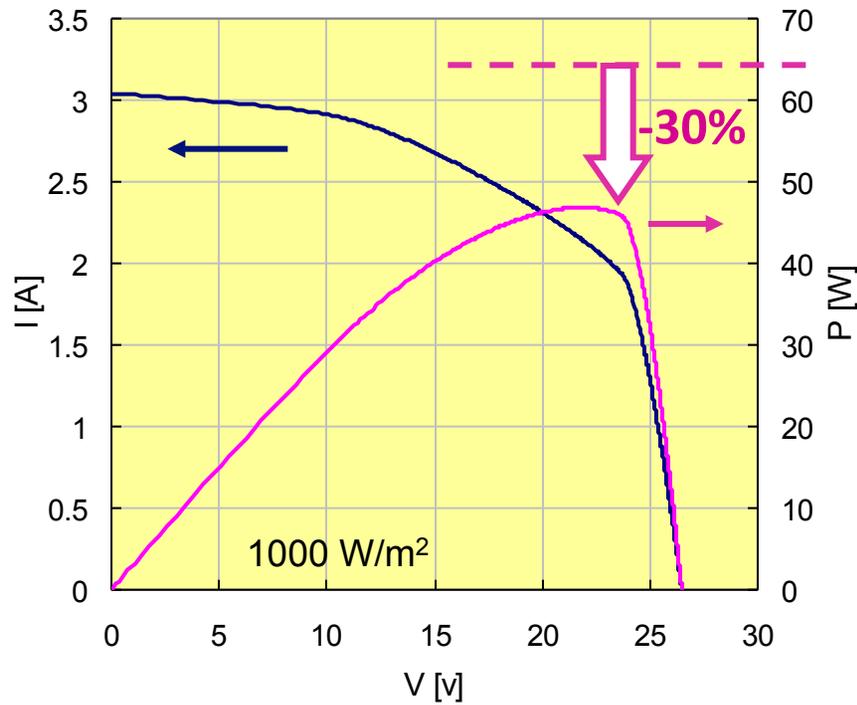
Module "A"

Decreases in Isc by 13% and FF by 17%

✓ Decrease in Isc mainly depends on discoloration of EVA and delamination.

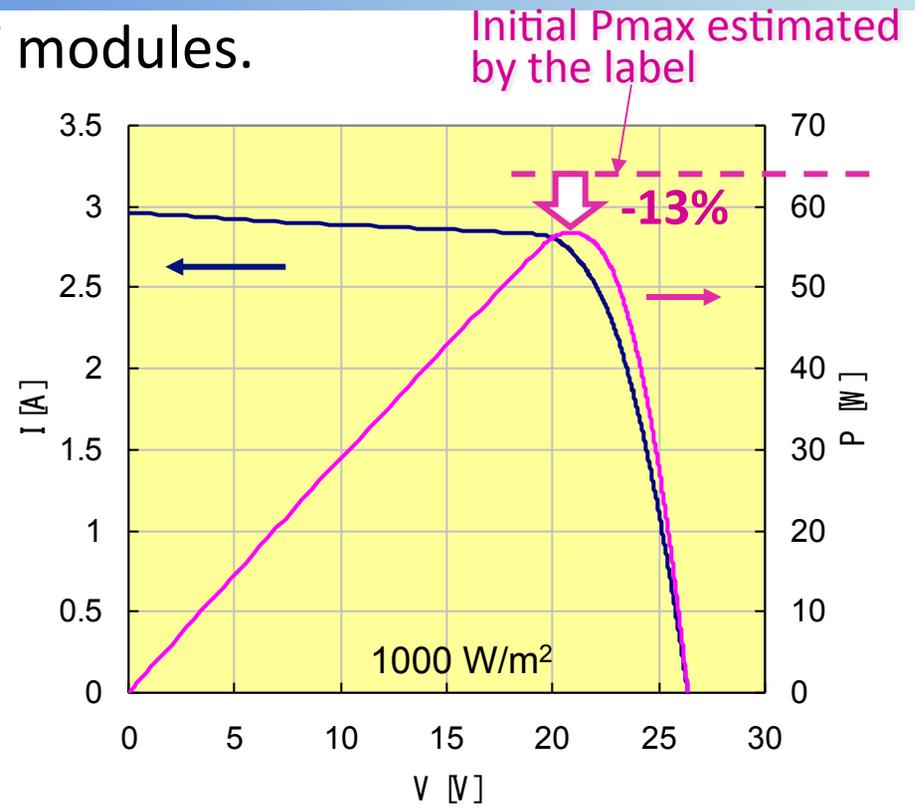
Module "B"

Decrease in Isc by 14%

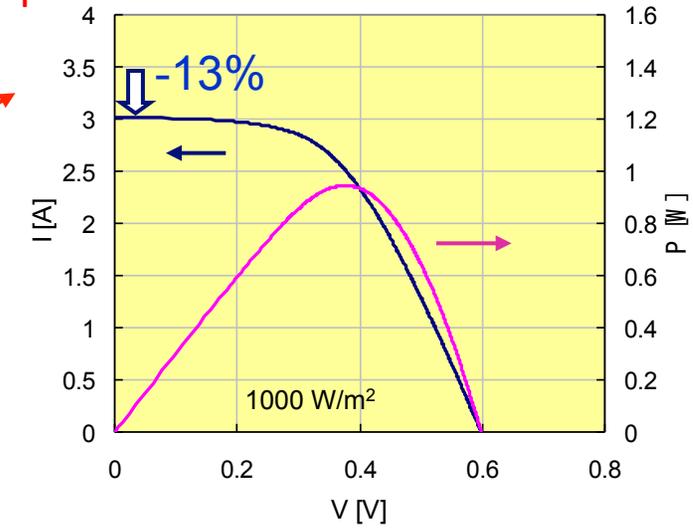
partial delamination

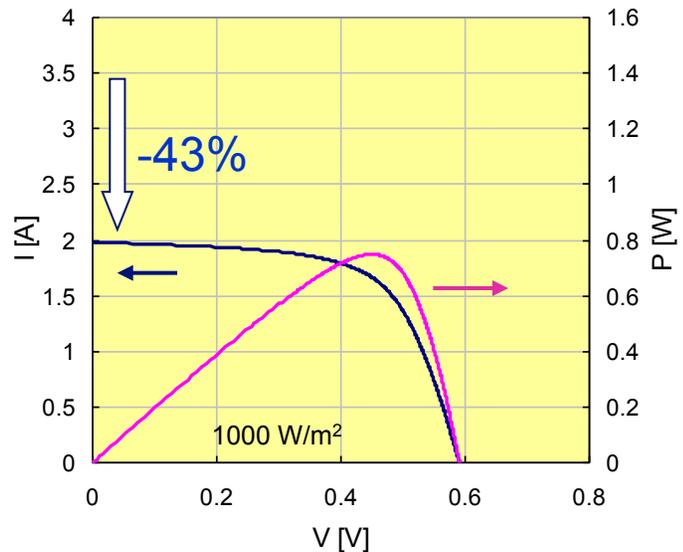
Large delamination

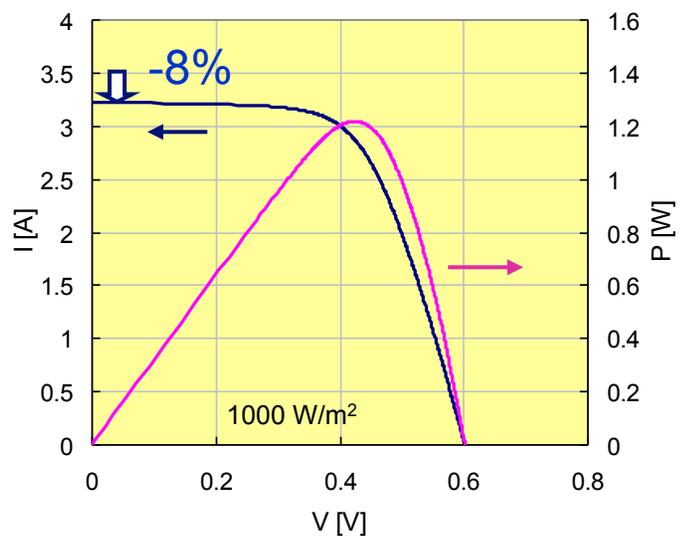
No delamination

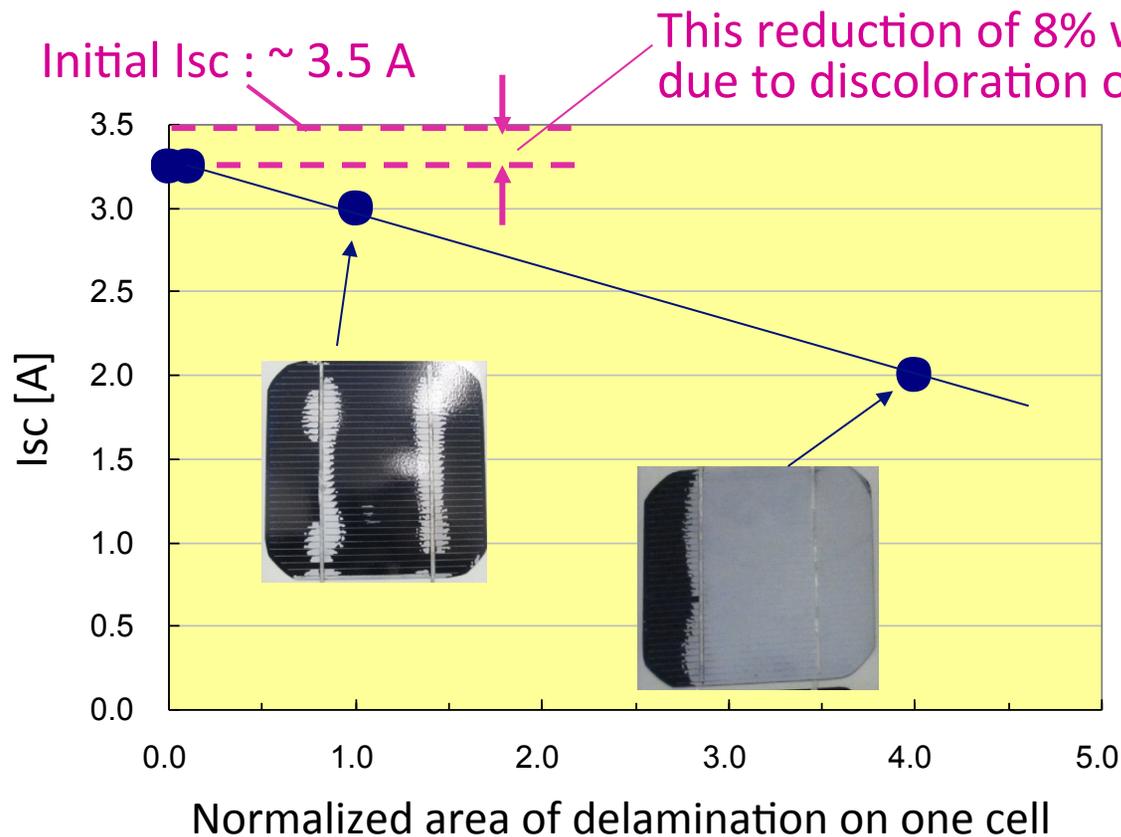
✓ Delamination area was estimated roughly by image processing for each cell. We estimated Isc change as a function of delamination area.

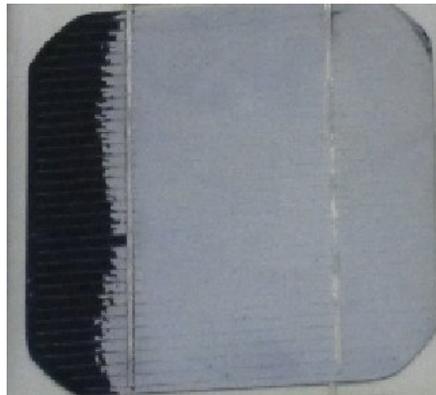
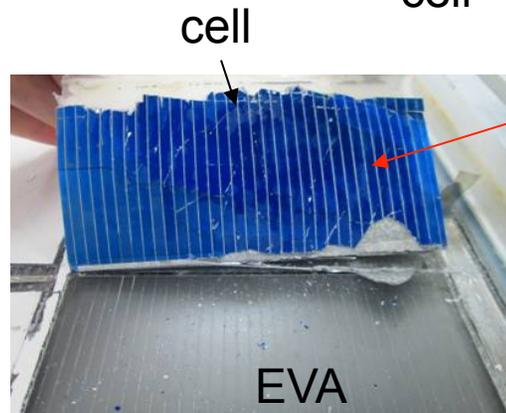
Cross-sectional view by SEM

We confirmed that the surface layer of the cell was **TiOx** deposited as an AR-coating of the cell using XPS measurement.

Delamination was observed at the interface between EVA and TiOx.

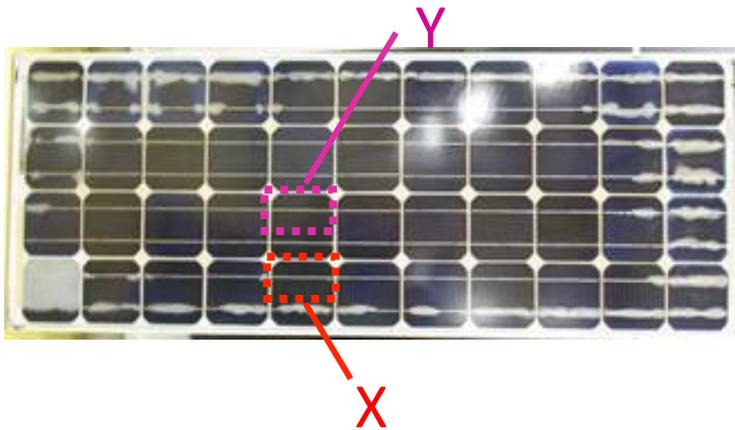
When we attempted to separate a cell from EVA/Glass, a cell broke into bits due to brittleness of a cell.

- ✓ To separate a cell from glass side EVA at the **X** is **easier** than that at the **Y**.
- ✓ The stress at the **X** is **higher** than that at the **Y**, because the **X** is **outer** position as compared to the **Y** in a plane of the PV module.

- ✓ We speculate that delamination is induced by weakening chemical adhesion (led by use of TiOx) and high strain at the interface.
- ✓ We should confirm change of performances of EVA encapsulant.

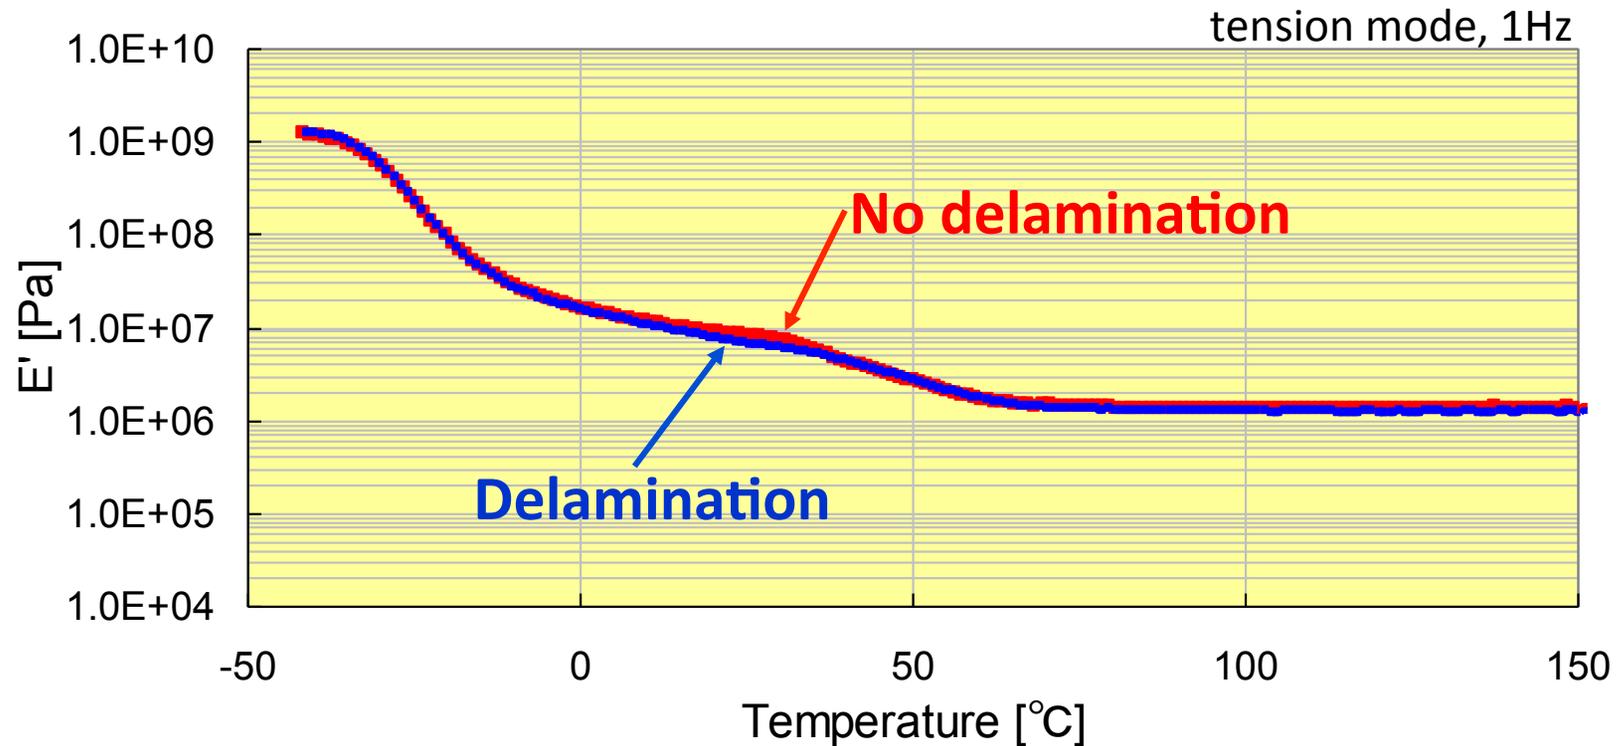
✓ There was no difference between E' for delamination and non delamination.

✓ We can not see mechanical degradation of both these EVA samples.

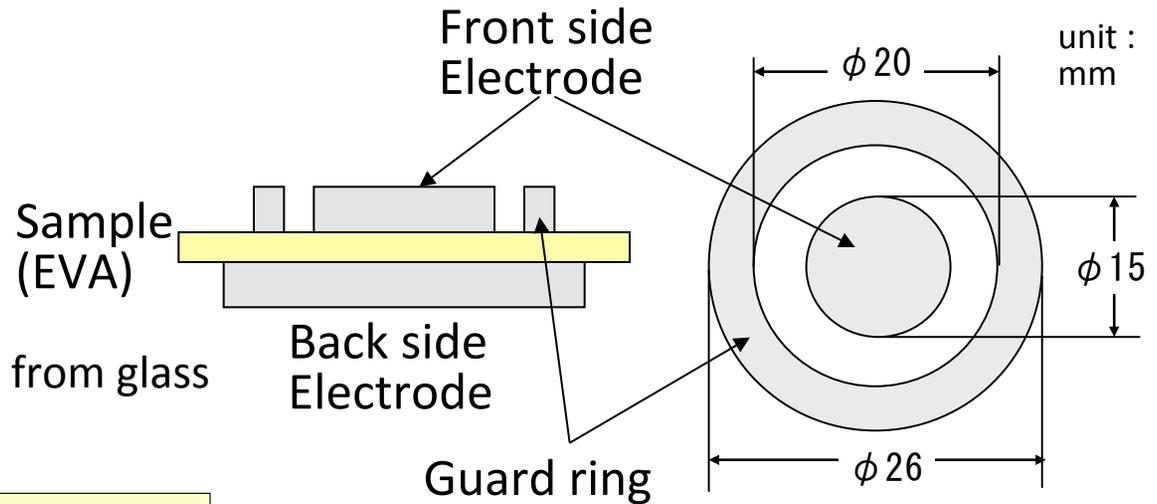
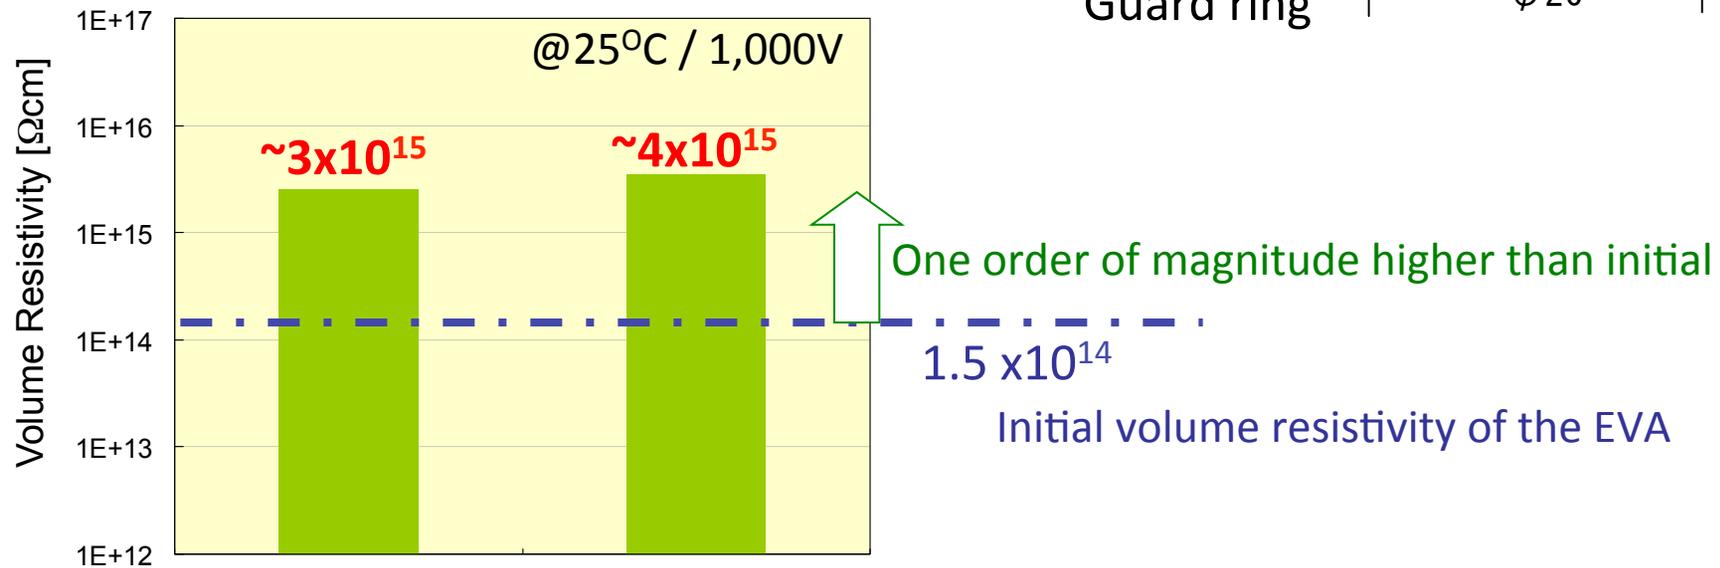
✓ There was no difference between volume resistivities of EVA for delamination and non delamination portions.

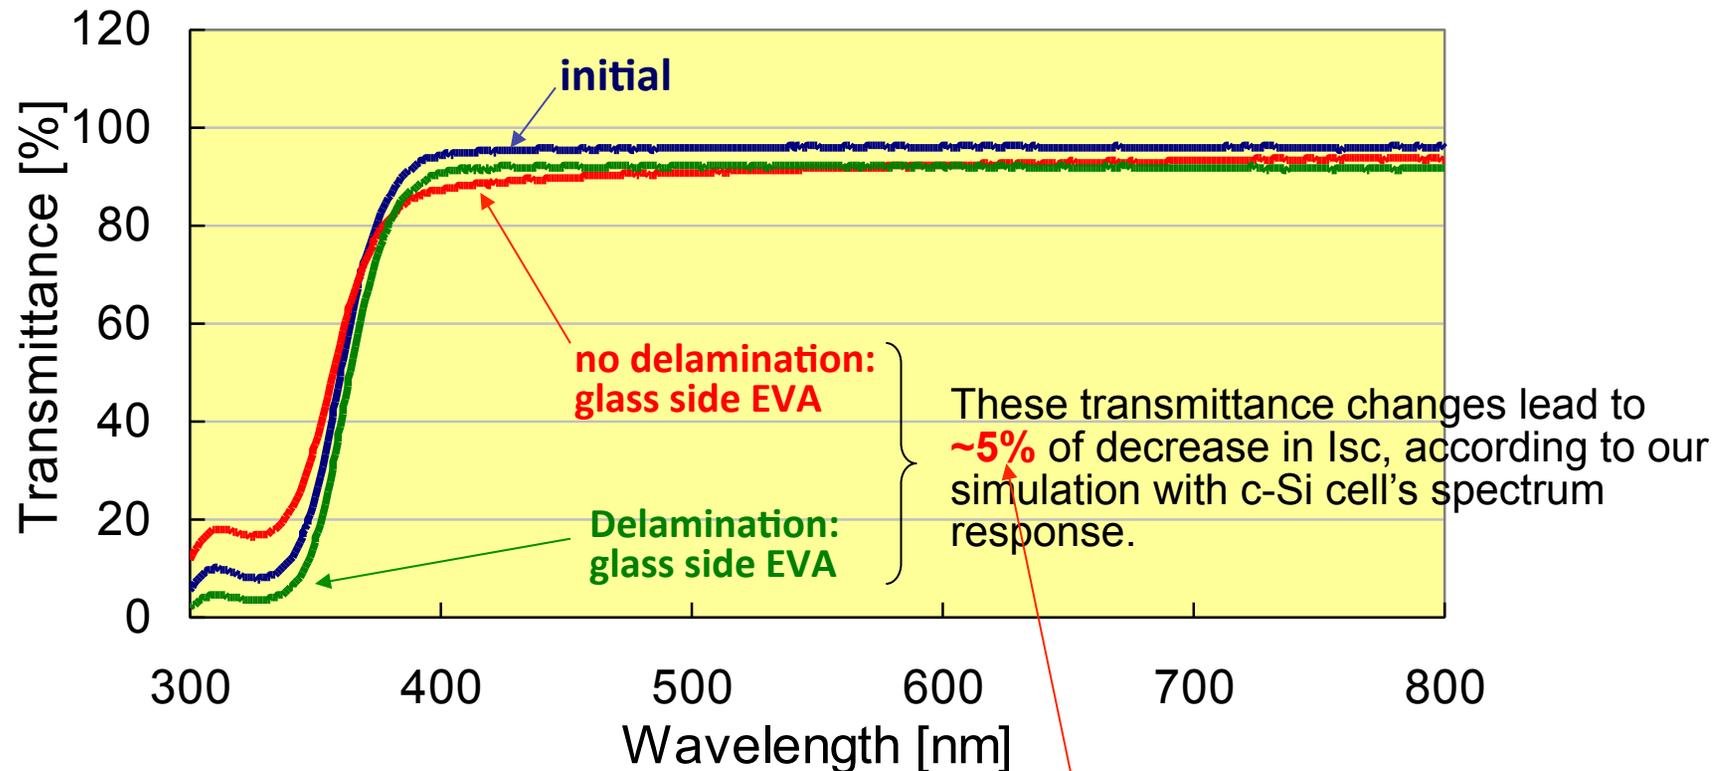
We have observed transmittance spectra of glass side EVA for delamination and no delamination portions and confirmed high transmission over 90%.

$\sim 5\%$ would be underestimated value because of thinner sample than actual encapsulant layer. More evaluation is necessary.

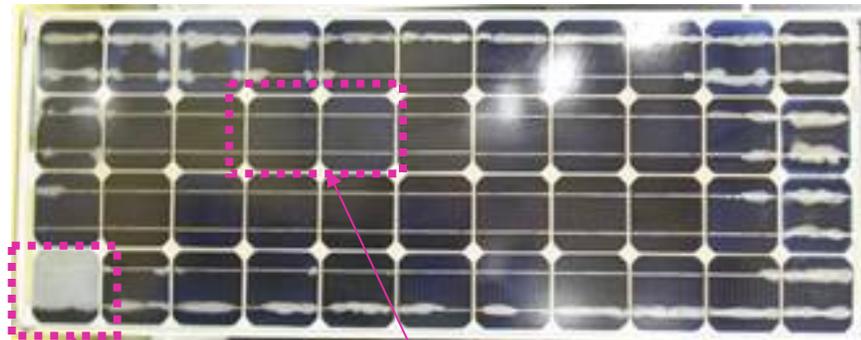
- ✓ We observed similar amount of free acetic acid to that for other aged PV modules we already reported.
- ✓ There was no difference between the amounts for delamination and no delamination portions

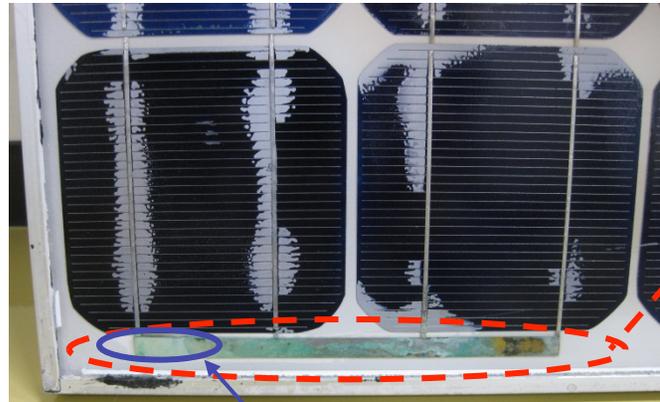
closeup picture

Patina

Severe degradation of copper

A solder layer disappeared.

A part of Copper ribbon disappeared.
= No electrical conduction

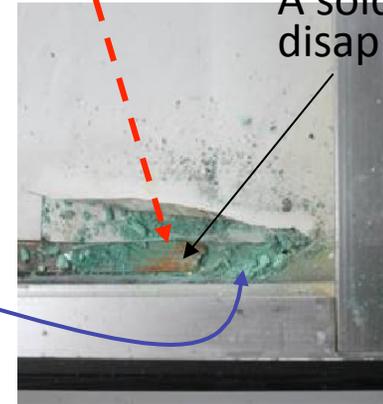
Backsheet/EVA were cut at the bus-bar portion.
We observed the corroded bus-bar.

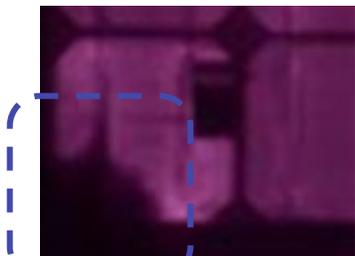
✓ Adhesion strength among inner layers of the backsheet "TAT" was extremely low.

We think that this corrosion corresponds to dark portion of the EL image

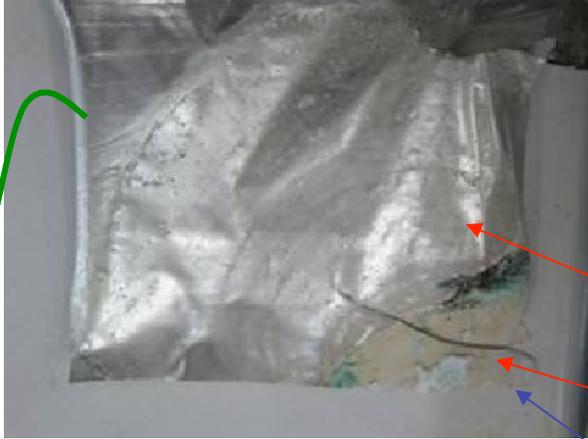
Backside of the module at corrosion portion

water stain like an arc
 $Al(OH)_x, Al_xO_y$ } evidence of water "liquid" ingress

Inner Al layer of backsheet (EVA side)
Corner of Al frame side

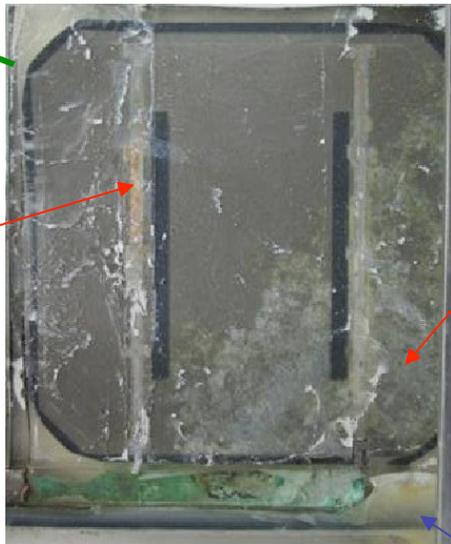
Severe corrosion of Al layer

We can see clearly "copper". (= coated solder disappeared.)

Backside of the cell
Corner of Al frame side
