LED WATCH

LONG-TERM PERFORMANCE IN THE ARIZONA DESERT

An update on the Yuma pilot project findings

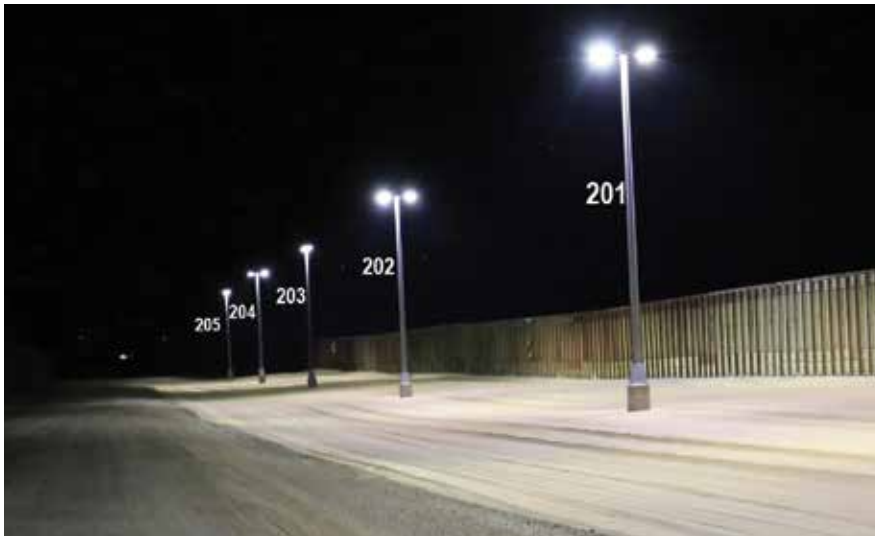
This photo was taken looking east from the area near pole 201 in September 2016. The second-generation luminaires installed in September 2016 as part of the full installation are on poles 201 and 202. The thermocoupled second-generation luminaires installed in September 2015 are on pole 204. The first-generation luminaires installed in February 2014 are on poles 203 and 205. Visible in this photo is a cooler color of sand near poles 201 and 202, and a warmer color of sand farther from the poles. This photo also shows the darkness surrounding pole 203 due to the depreciated output of its luminaires; the area around Pole 205 is relatively dark for the same reason, but also because it is the last pole in this 7.2-mile stretch of border east of the POE.

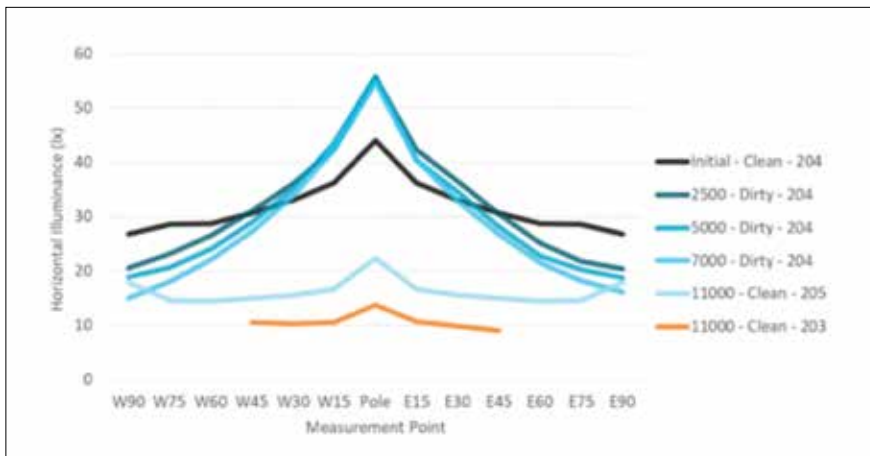
The distribution of light from the LED luminaires changed in the first 2,500 hours of operation, with illuminance values measured nearest to the pole increasing, while the greatest decreases were at the points farthest from the pole. This

distribution trend persisted after 5,000 and 7,000 hours of operation, along with an overall decline in measured illuminance. While the cause of these changes is unknown, it was expected that dirt depreciation was the main culprit. After the 7,000-hour measurements, the two luminaires on the measured pole were removed and tested at a nearby photometric laboratory and then shipped to the luminaire manufacturer's photometric laboratory for additional photometric testing. The testing confirmed the considerable effect of dirt not only on lumen output, but also on the distribution of light exiting the luminaire.

the other two poles, since the first-generation luminaires had been removed from the pole that had originally been measured. The measured illuminance at 11,000 hours had decreased by more than 50 percent compared to the initial illuminance measurements in February 2014. The cause of this unexpected result is still being investigated.

Measured illuminances along east-west line centered at pole 204 at four different measurement times, and for poles 205 and 203 at 11,000 hours. The trial installation luminaires were initially clean, and then cleaned again at 11,000 hours. The numeric values in the labels along the horizontal axis indicate the distance from the pole in feet, and the letter indicates the direction (east or west) from the pole. Illuminance values were normalized for a 25 deg C (77 deg F) condition.
