Mexican Hat, Utah, Disposal Site Disposal Cell Evaluation Information Sheet

This information sheet provides information about observed disposal cell conditions and anomalies of the **Uranium Mill Tailings Radiation Control Act of 1978 Title I processing site at Mexican Hat, Utah**. This site is managed by the **U.S. Department of Energy Office of Legacy Management**.

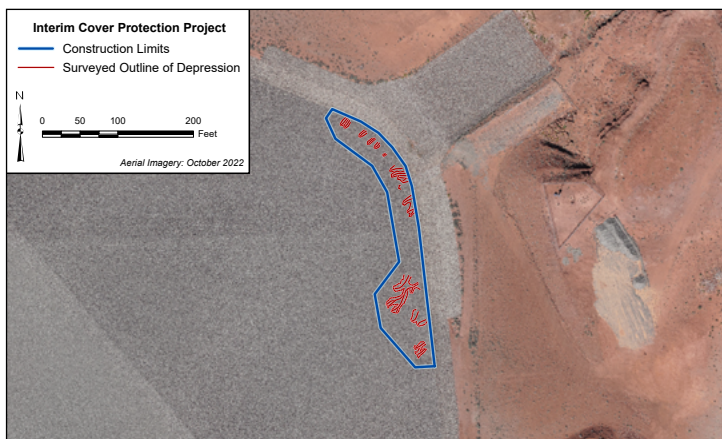
- Between April 2016 and August 2016, additional surface depressions were observed. Recommendations were made to remove surface riprap and investigate the extent and possible causation of the depressions. Radiological surveys at the areas of concern were performed and no elevated readings were detected relative to background. This provided evidence that the radon barrier remained intact, and radioactive materials were not exposed.

Depression Features on Northeast Side Slope and Approximate Area of Interim Cover Protection Area.

- Replacement of a 20,000-square-foot area of the northeast side slope, where depressions were detected by LiDAR with an Interim Cover Protection (ICP), which consisted of IRBP in degraded radon barrier areas, replacement of the existing bedding layer with a bedding layer that met original design specifications and then re-covered with the original riprap material.

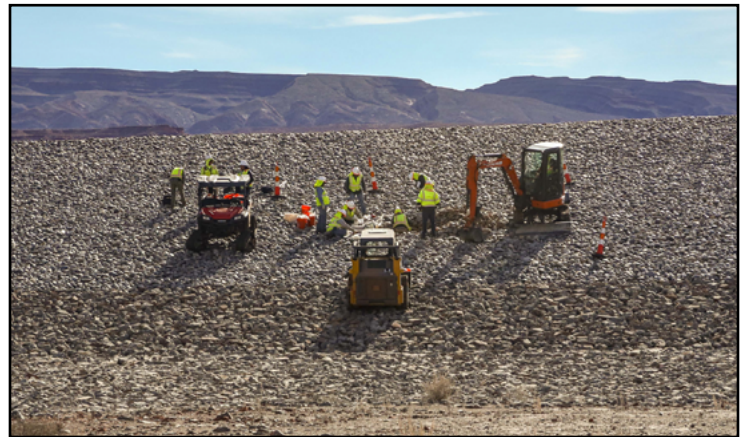
radiological surveys conducted in September 2017 reconfirmed scans in the area of concern were not elevated relative to background levels. Manual excavations of depression areas were conducted in December 2017 by the Navajo Nation Uranium Mill Tailings Remedial Action/Abandoned Mine Lands Department to determine the linear depression scale. A void was detected during that investigation, appearing to run below the bedding layer and in the top of the radon barrier layer. Radiological surveys at seven different locations — upwind, downwind, at the re-excavated void, and at other areas along the disposal cell — were performed and no elevated readings were detected relative to background. The radon barrier appeared to be intact and no radioactive materials were exposed.

Mexican Hat Test Pit.

- Throughout January 2018, 13 test pits were manually excavated, comparing cover material to the original engineering specifications and performing additional radiological surveys. During these investigations, additional voids and depressions were detected, as well as apparent erosion of the radon barrier at three test pit locations. No elevated radiological readings relative to background were observed. Additional radiological surveys were conducted in April 2018 and no elevated readings were detected relative to background. Other April 2018 activities included the annual site inspection, an aerial baseline survey, a light detection and ranging (LiDAR) terrestrial survey, a settlement plate survey, and a semiannual radiological survey. No additional depressions were detected during the annual inspection and data from the aerial survey and LiDAR terrestrial survey provided a baseline for possible future changes in surface observations. Settling was not apparent based on the settlement plate survey. An August 2018 rain event triggered a LiDAR terrestrial survey; no changes in depressions were observed.

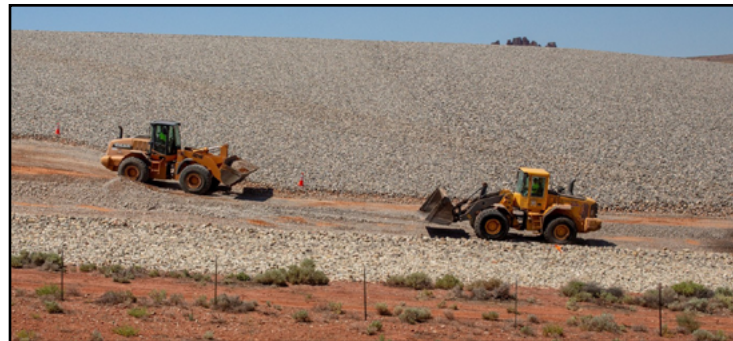
- No additional depressions were identified during the 2020 or 2021 annual inspections.
- Workers reported, during the 2022 annual site inspection, one new depression feature on the top of the northeast side slope. Additional site visits in 2022 and 2023 noted new depressions, and flowing water under the rip rap was observed on the north side slope.

Mexican Hat Disposal Cell During the Interim Cover Protection Project.
