**Type A Accident  
Investigation Report**

**June 7, 2004**

**Construction contractor  
electrical accident at  
double-circuit structure 38/1,  
Watertown-Granite Falls  
230-kV Transmission Line**

**East of Watertown,  
South Dakota**

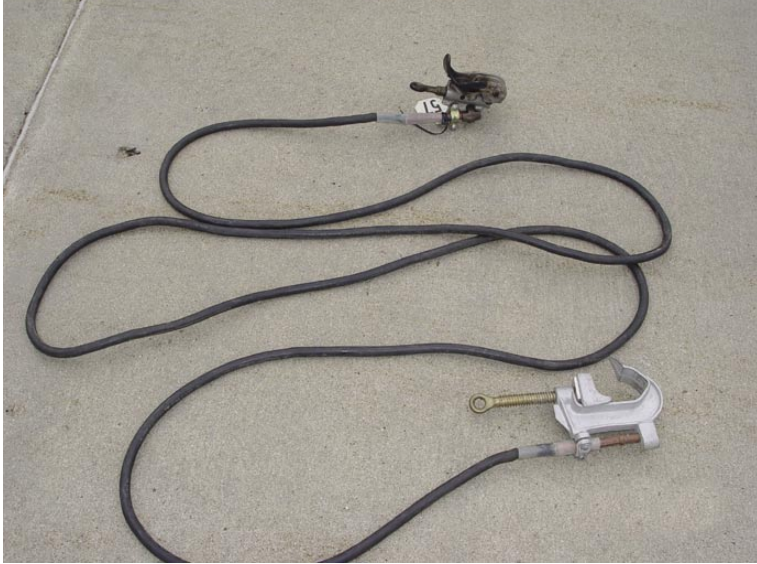
The Board determined that the direct cause of the accident was that the victim disconnected the "cold end" of a protective ground while the other end of the ground was still connected

**Figure 1:** Ground lead (2/0 cable, 20 feet, 6 ½ inches long) that was connected between the A phase of the Watertown-Granite Falls 230-kV transmission line and the steel at Structure 38/1. At the time of the accident, the victim disconnected the “cold end” while the “hot end” was still connected to the A phase conductor. This type of grounding assembly is designed for bus-bar or phase-to-phase grounding applications.

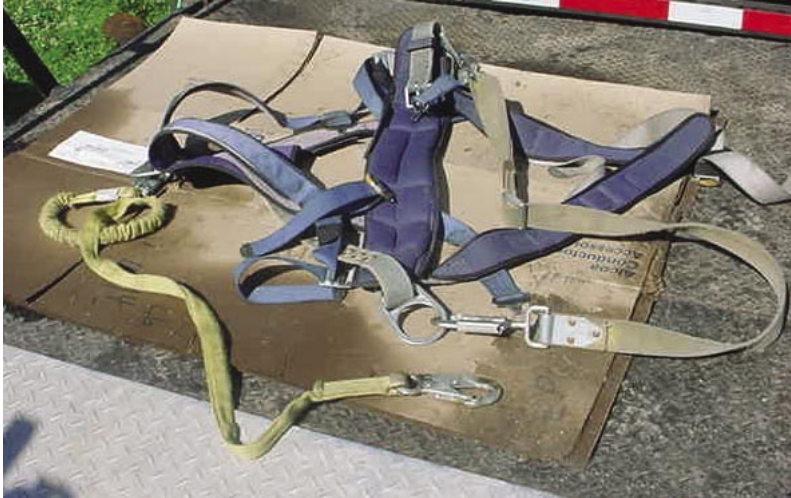
**Figure 4:** Harness, body belt and lanyard worn by victim at the time of accident.

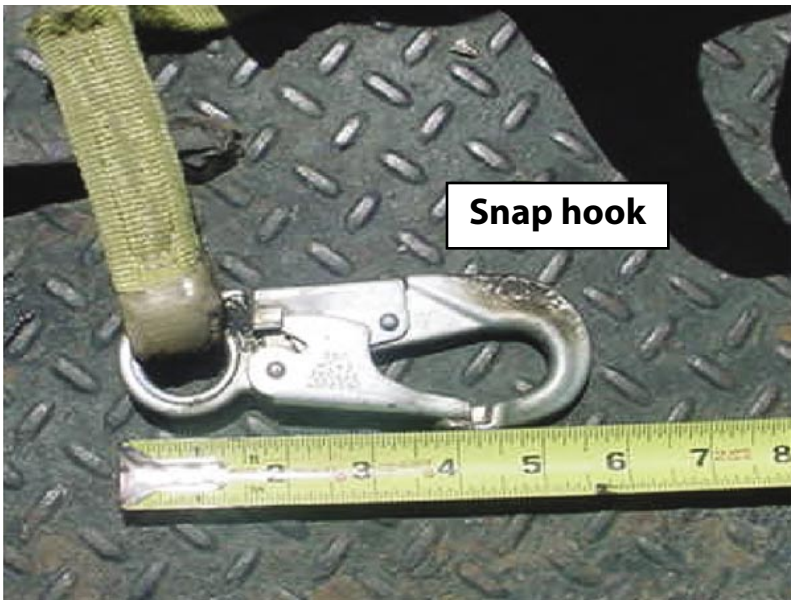
**Figure 5:** Lanyard snap hook used by the victim to loosen the "cold-end" clamp.

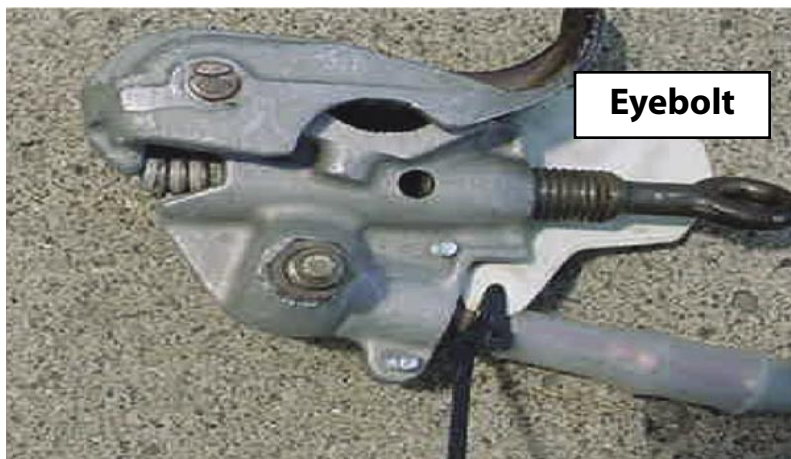
**Figure 6:** Eyebolt of "cold-end" clamp where victim attached the lanyard snap hook to loosen the ground connection.

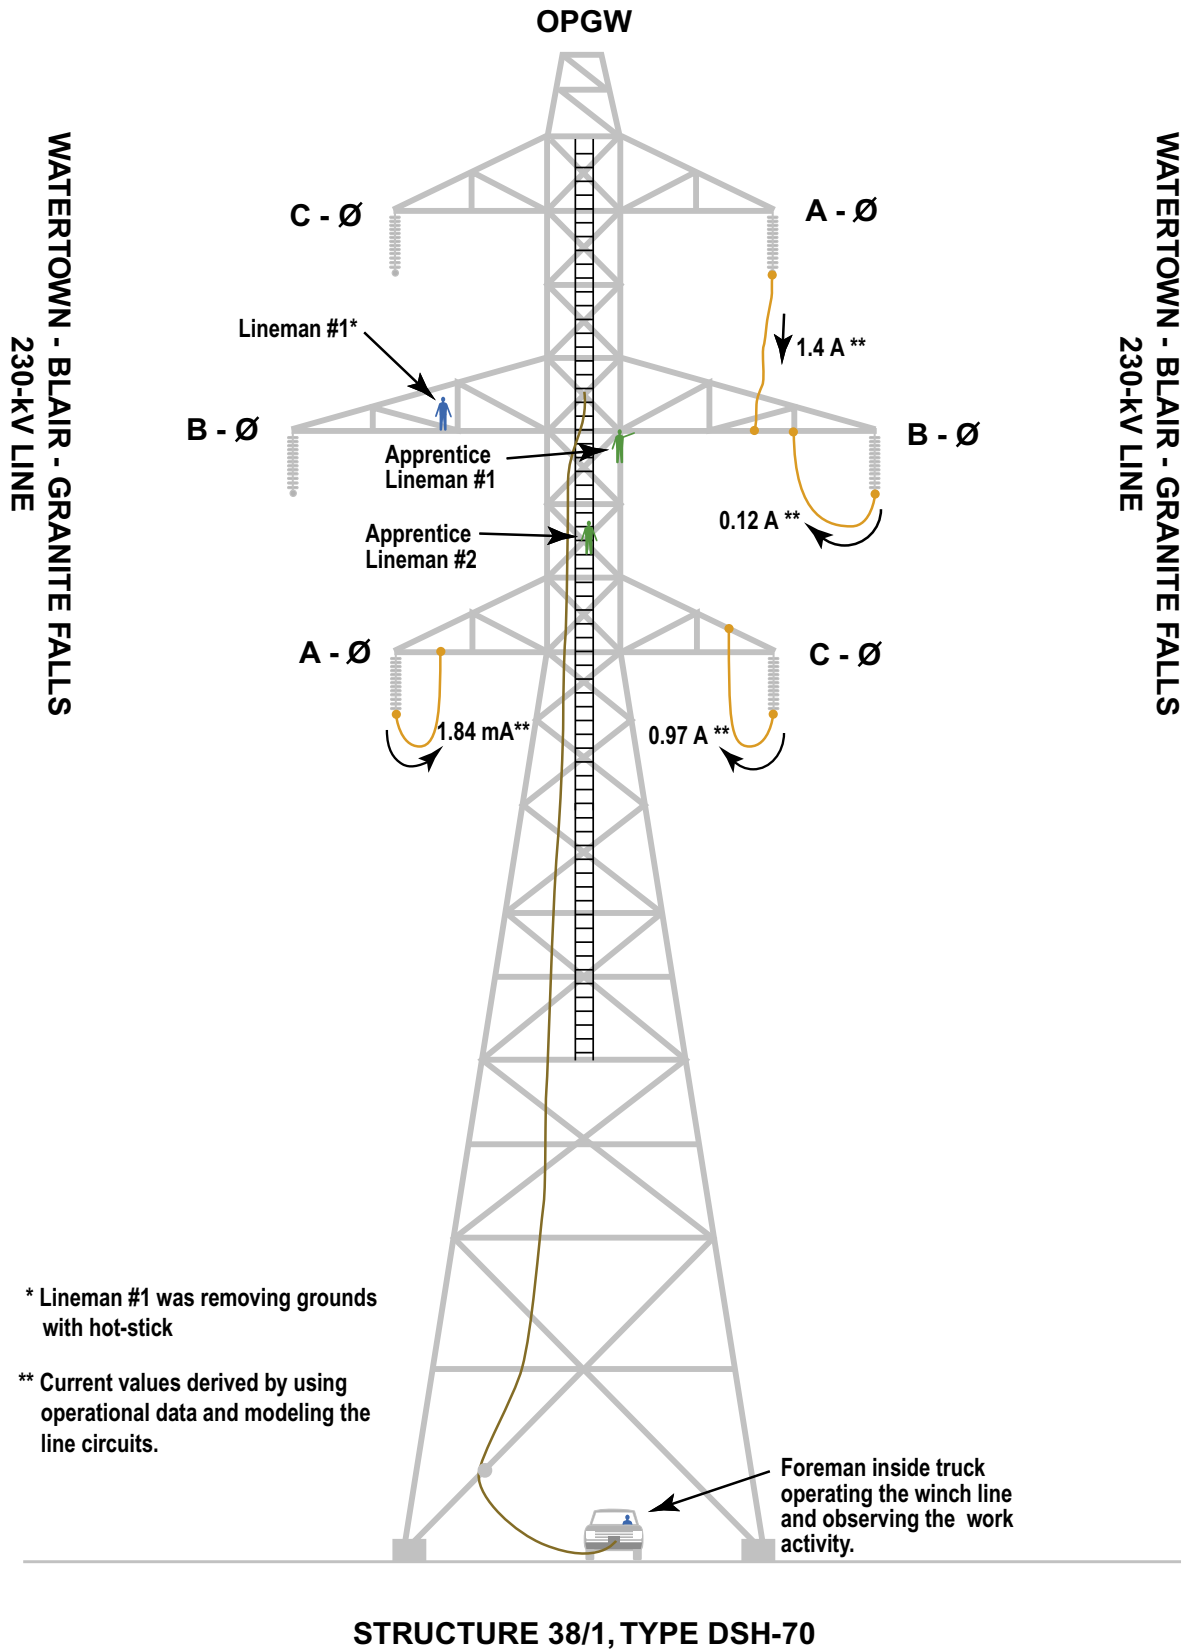
## APPROXIMATE LOCATION OF GROUND LEADS AND PERSONNEL JUST PRIOR TO TIME OF WORK CREW CHANGE

\* Lineman #1 was removing grounds with hot-stick

\*\* Current values derived by using operational data and modeling the line circuits.
