Level I Accident Investigation Report

Fatal Fall Dworshak-Taft # 1 500 kV Line, September 20, 2012

**Report Date:
November 30, 2012**

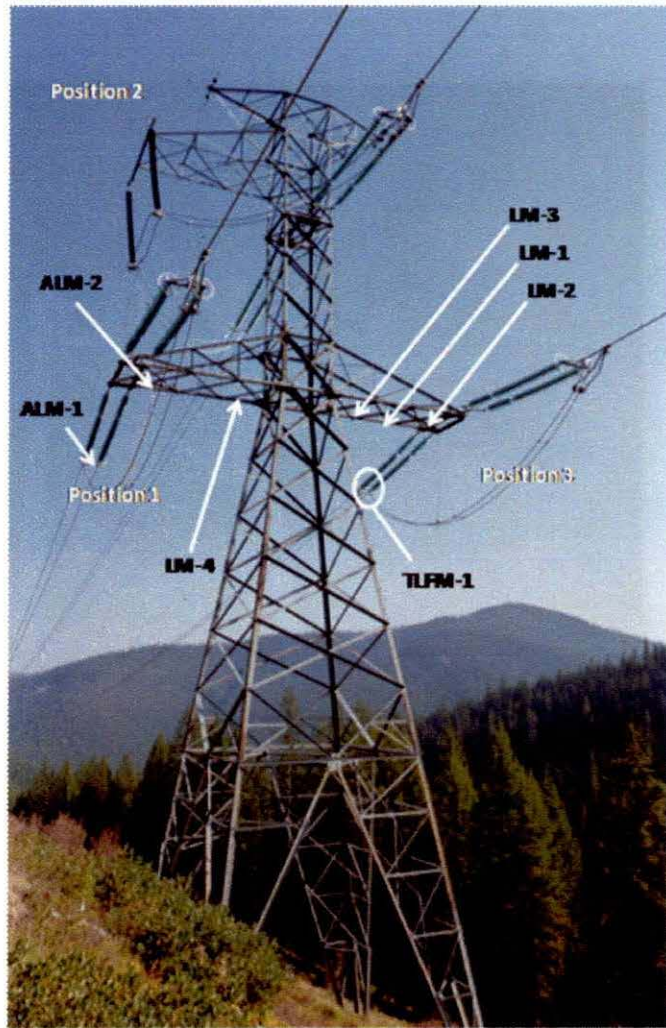
Figure 3: Location of Workers in Tower 83/4

The crew then repositioned, belted-in on the tower in anticipation of the platforms being flown in. LM-1, LM-2, and LM-3 were on the arm at Position 3 AHOL, approximately 83 feet above the ground, with TLFM-I on the wire. LM-2 was at the very outer edge with LM-1 to his left and LM-3 on LM-1's left. LM-3 was the radio man for the day's work. On Position 1 AHOL, ALM-1 was on the wire with LM-4 and ALM-2 in the tower.

At approximately 1055, the call was made to the fly yard to have the helicopter deliver the first platform to the crew on the tower. While waiting for the platform, LM-1 and LM-2 asked LM-4 to confirm how the platforms were to be connected to the tower. LM-4 unbelted and repositioned from Position 1 over to Position 3 to further discuss with LM-1 and LM-2 how the platform was to be attached to the tower. In doing this, LM-4 had to move around LM-3 twice, once going out to where LM-2 was and once more to return to Position 1. Shortly after LM-4 returned to his work location and belted in, the platform arrived.

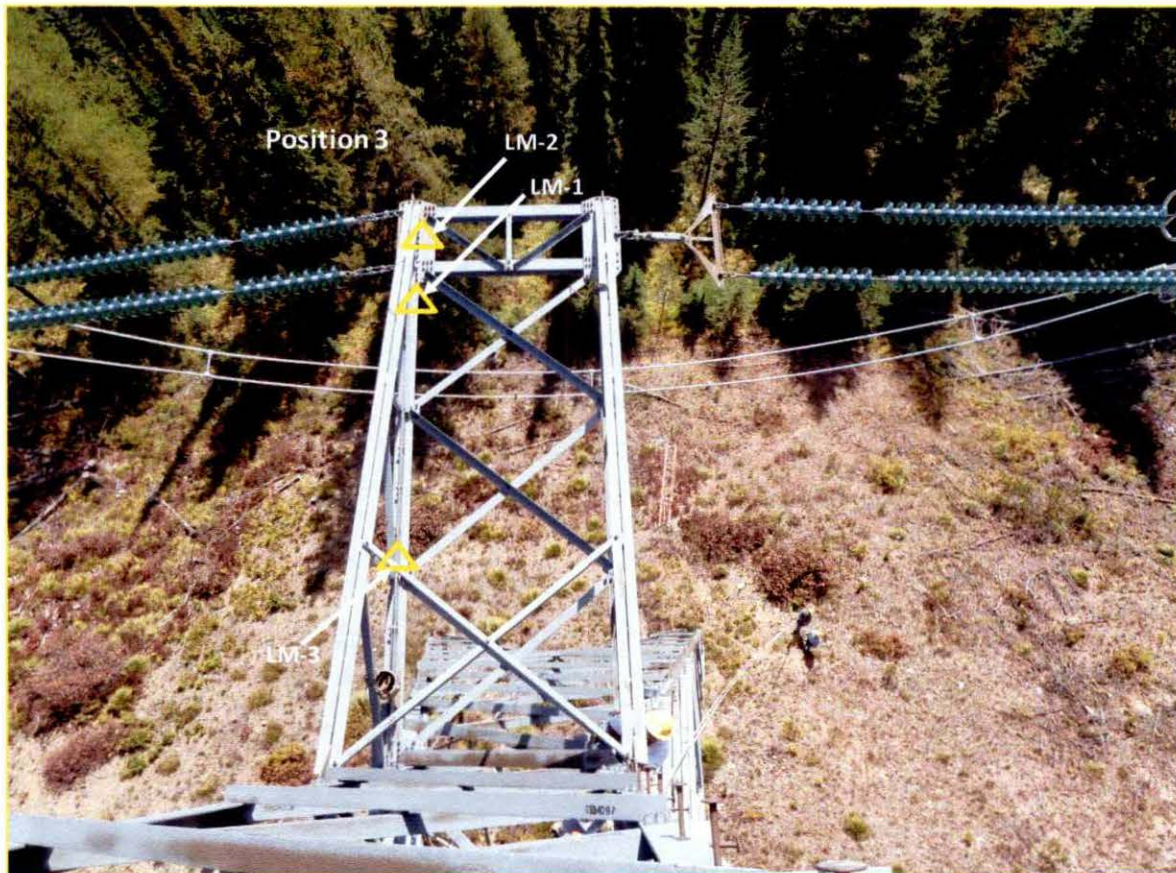
Figure 4: 83/4 Tower Arm

The Board concluded, based upon the available evidence, that the Direct Cause of the fall was LM-1's loss of contact with the tower while being unbelted and changing positions on the tower.

The Board determined the Root Cause of the fatal injury was not using the fall protection function (safety strap) incorporated into the safety harness to remain attached to the tower. However, it must be emphasized that changing locations unattached is a common practice and is in compliance with BPA's work rules and policies, and OSHA regulations.

When the platform was being lowered down to Position 3, it was parallel to the line. As the platform approached the tower, it rotated approximately 90 degrees. The platform was then somewhat perpendicular to the line with one end between the insulator string and the jumper.

Recommendation: BPA shall review the current rules, standards, and policies to determine if the Agency should adopt a 100 percent fall protection requirement.
