Accident Investigation Report

Fall Injury Accident at the Savannah River Site on July 1, 2011

August 8, 2011

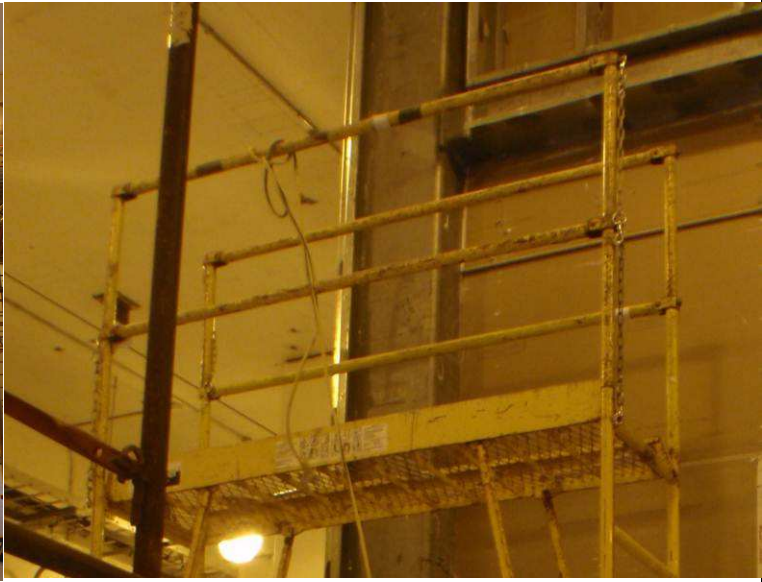
**Figure 2-22: Tele-Tower@ A
Safety Chains unhooked**

Conditions found in the PAV	Requirements Note: Requirements may be paraphrased for brevity.			Source of Observation
PAV	OSHA	SRS	Telpro Inc.	
<p>: Safety chains not in place while worker on platform.</p> <p>{“TT-A”}</p>	<p>29 CFR 1926.451(g)(1)-</p> <p>Each employee on a scaffold more than 10 feet (3.1 m) above a lower level shall be protected from falling to that lower level.</p> <p>Paragraphs (g)(1)(i) through (vii) of this section establish the types of fall protection to be provided to the employees on each type of scaffold. Paragraph (g)(2) of this section addresses fall protection for scaffold erectors and dismantlers.</p>	<p>8Q-16 Rev.12, Pg 10, E.16 The last person to ascend the scaffold closes the ladder access gate, chain, or sliding bar, where provided, to complete the scaffold handrail system.</p>	<p>Model 1101, Pg 7, Step 11- Attach all four safety chains between the guard rails on each end.</p>	<p>Per Accident Investigation Team scene inspection.</p>

The worker could have been affected by an overhead cable that was located near the west ladder of the scaffold. All four safety chains at the platform edges were unhooked indicating the IW may have been exiting the scaffold. The overhead cable within 15” of the end of the platform (possible interference to egress) is the item that may have contributed. The cable height was 63” above the working platform. This would have been about chin high to the IW while standing on the platform.

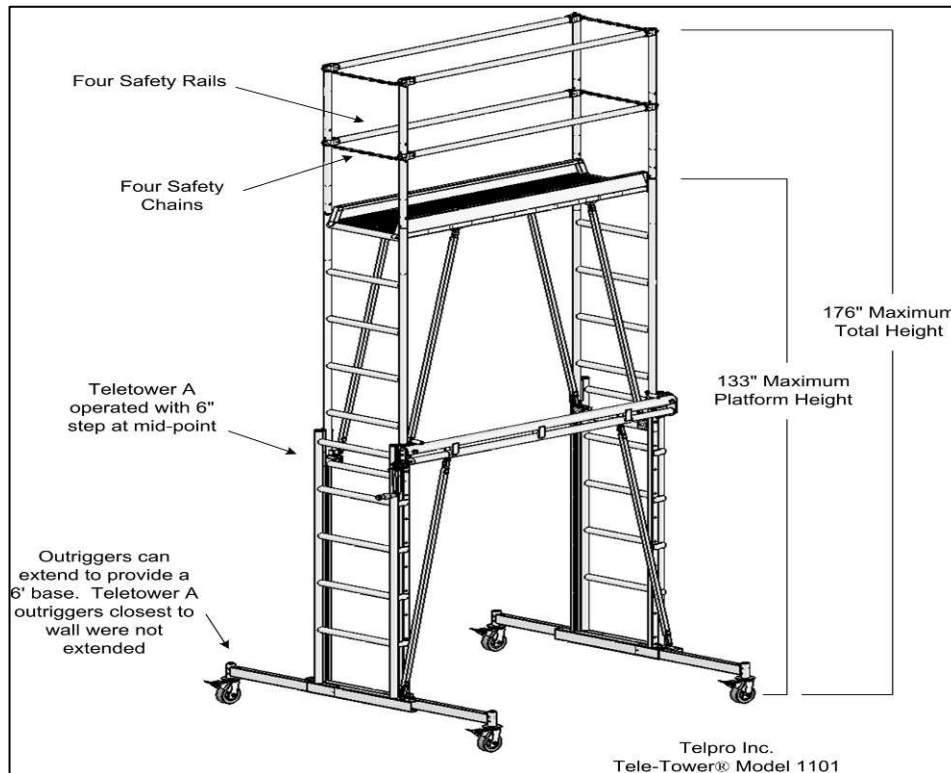
Figure 2-44: Tele-Tower® "A"

The Board examined Tele-Tower® "A" and noted the following:

Gypsum wallboard had been removed from above the 8’ 6” level to the ceiling – a distance of approximately 16’. In the wall area near Tele-Tower® “A” (the area of the fall injury) the 9-1/4” metal cavity studs had been completely removed leaving the remaining (back side) wallboard unsupported.

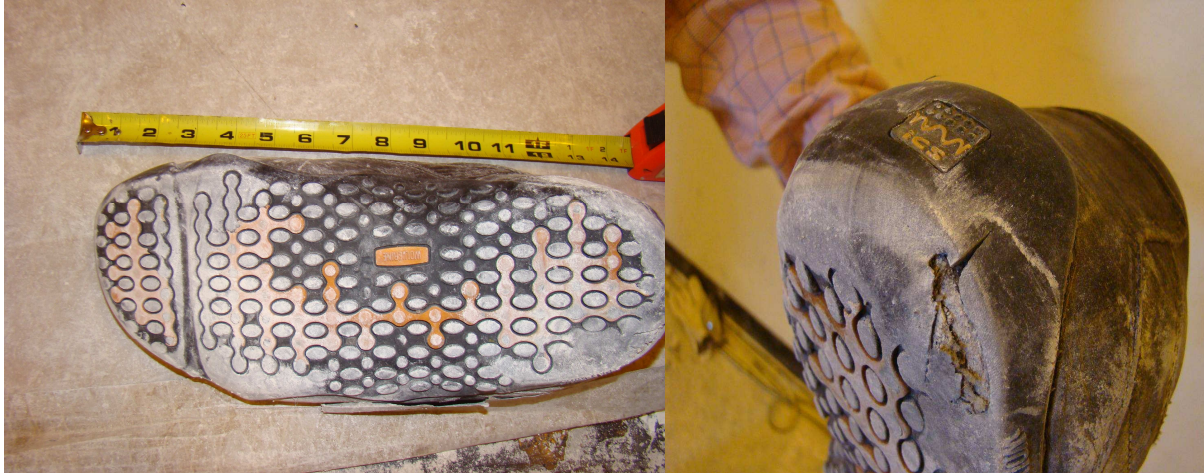
The Board examined the IW’s shoes and noted the following: The work shoes were worn and in questionable condition. Sides of the shoes were broken down. The right shoe had a piece of the heel missing and a slice mark and showed considerably more wear than the left. The uppers were constructed of soft leather and the soles were soft rubber. The shoes had no American Society for Testing and Materials (ASTM) or American National Standards Institute (ANSI) label.

Figure 2-55: Pictures of IW's footwear

The activity of the IW at the time of the injury only required sturdy work shoes/boots as indicated by the Work Package. The shoe has no ANSI or ASTM rating per manufacturer's information or found on the shoe itself. The soles of the shoes are soft rubber. But, most critical was the condition of the soles of these shoes; they showed obvious wear particularly on the right foot at the heel's right side a $\frac{3}{4}$ " split limiting the grabbing ability on that portion of the heel. The shoe does not have a definite heel separate from the sole or a raised heel distinct from the rest of the sole. In addition, previous activities by the majority of the work crew included potential material falling on toes and use of tools that should have required safety shoes. i.e. handling/using a reciprocating saw, handling wallboard pieces of 25 or more pounds at heights, and the need for good slip resistant footing to work in settled wallboard dust.

<p>The company construction management (CMP11-1.1, Rev 5) policy and the AHA failed to identify the appropriate work shoes for the activity.</p> <p>The selection and condition of the IW's footwear was not appropriate for the work environment.</p>	<p>SRNS needs to evaluate and modify (with justification) construction management procedures and AHA process for specifying proper footwear for construction activities in consideration of the abrasion, impact hazards of falling objects, slip hazards and sole penetrations encountered during construction activities.</p> <p>SRNS need to ensure workers are complying with the requirements for proper footwear in construction areas.</p>

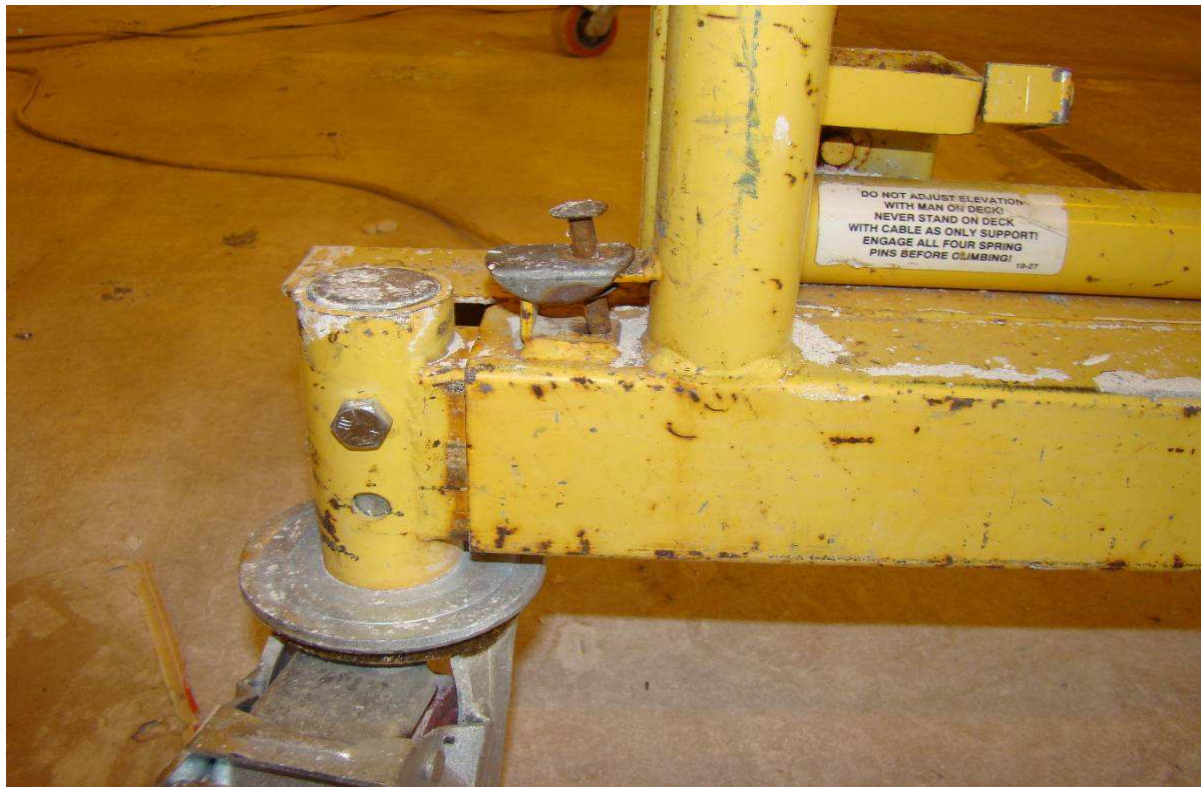
Deficiencies attributed to the Competent Person inspections of scaffold erection and/or modification and User inspections indicate that these were not completed as required at the beginning of shift, subsequent to a modification, or prior to use. The noted deficiencies include the loose wing nuts, non-uniform ladder spacing, locking pins not engaged for wall side outriggers (which were completely in to accommodate work close to the east wall), etc. Each of these issues places the stability of the Tele-Tower® in question. It should be noted that the narrowness of the Tele-Tower® work platform itself and its construction, as erected according to manufacturer's instructions, even when space allows for full outrigger extension, is not as stable as other available options.

Figure 2-66: Example of locking pin not properly engaged on Tele-Tower® B

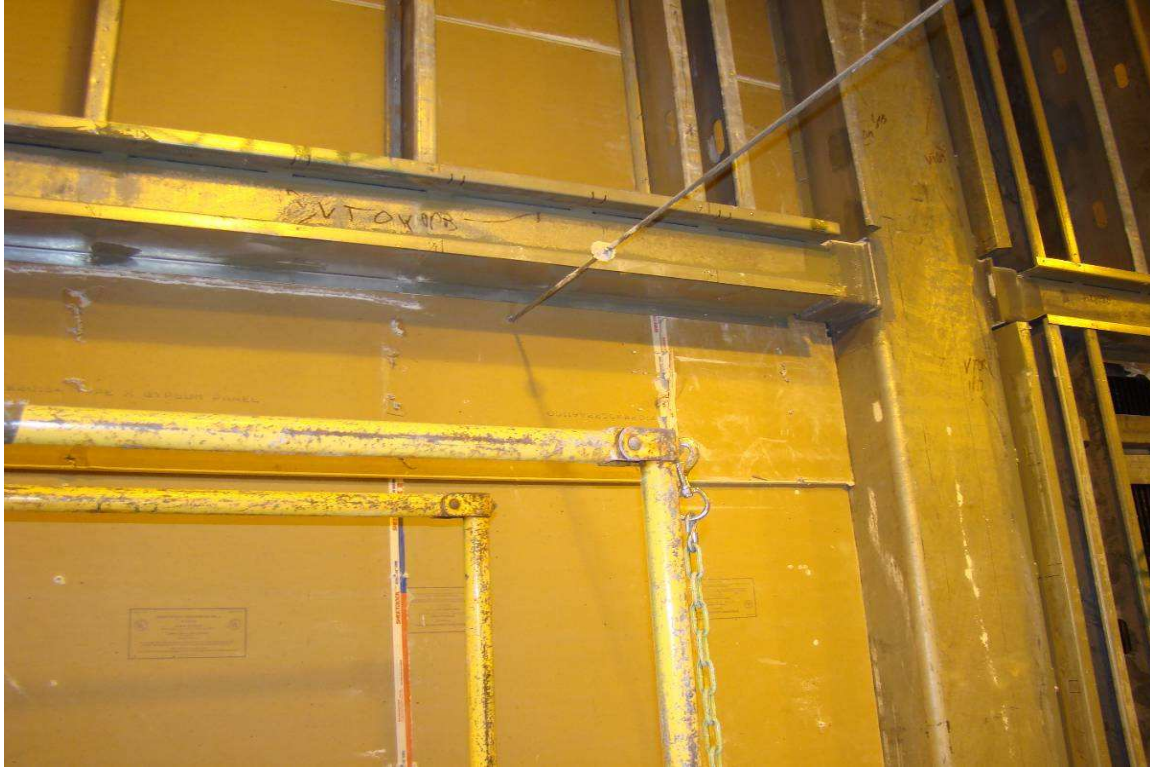
Figure 2-77: Cable near end of scaffold where IW fell
