Type B Accident Investigation Board Report

**October 9, 2009
Employee Injury at Building 1005H
Upton, New York**

December 2009

**Brookhaven Site Office
U.S. Department of Energy**

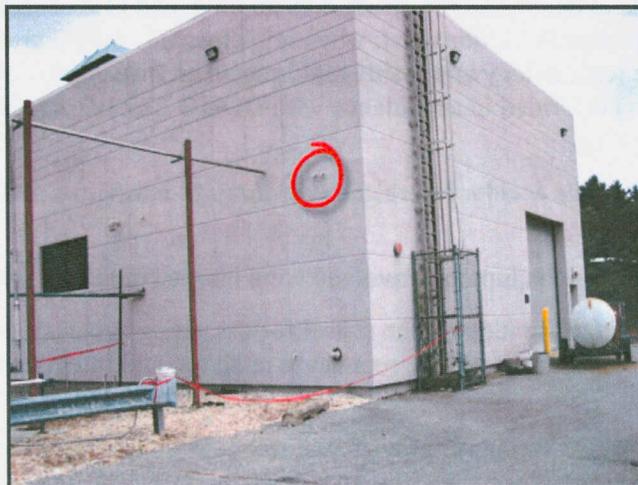
Figure 1-4. Vents on north side of 1005H

The first step of the regeneration process is to vent the trapped high pressure helium left inside the system when it was isolated. This is done with a digital valve. Venting makes a loud noise. After venting, the adsorber is warmed with heated nitrogen gas. Because the adsorber is initially cold, the nitrogen gas that vents from the system is cold and can create a vapor cloud (Figure 1-5). After

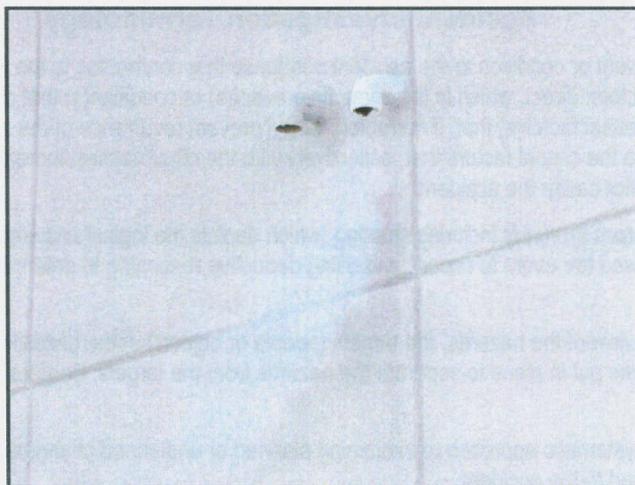
Figure 1-5. Vapor plume from venting

Shortly after the Lead Rigger passed under the exterior vents, the Cryogenic group began the venting process. The sound of the helium venting (>140 dBA) startled the Lead Rigger and he ran east along the north side of the building (Figure 2-3). The area was covered with gravel. As the Lead Rigger ran, his legs stopped functioning and he fell forward onto his knees.

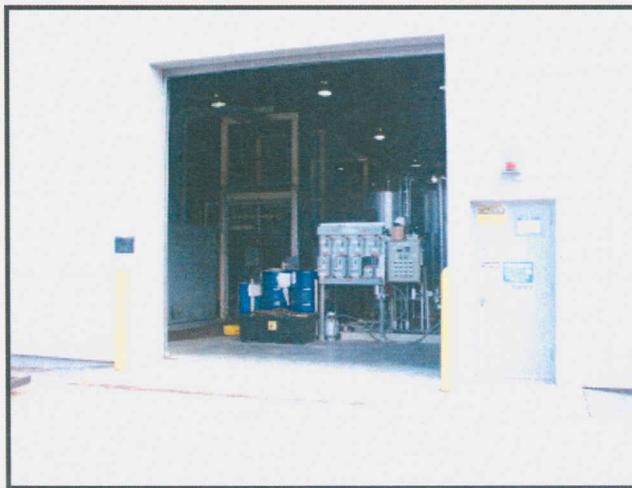
Figure 2-1. West Roll-Up Door and Man-Door

Building 1005H is normally an unoccupied building due to the hazards within the building. The Cryogenics Group requires personnel to notify the Cryogenic Control Room prior to entry. This requirement was posted on a sign on some of the doors to the building; however, the sign was not

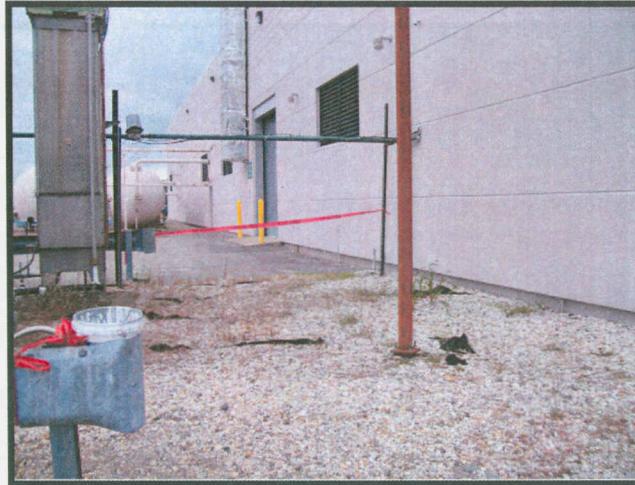
Figure 2-3. The Accident Scene

When they heard the noise in the vicinity of their co-worker, the other two Riggers, who were standing by the escort van on the west side of the building, proceeded to the north side of the building. There they observed the remaining vapor exiting the vent and the Lead Rigger crawling toward the asphalt pad on the north side of the building. Once they reached the Lead Rigger, they attempted to help him to his feet. At this point the Lead Rigger realized that his legs would not support him and asked to be lowered back to the ground. His co-workers attempted to call the BNL emergency number on his Nextel cellular phone. They were unsuccessful in doing so because they were not familiar with the operation of his phone. They called the Rigging Supervisor using the walkie-talkie function of the phone and requested that he contact emergency services. Emergency services received the call at approximately 2:20 p.m. and responded within five minutes. The Lead Rigger was transported to the hospital. He sustained cuts, abrasions and bilateral quadriceps tendon ruptures in his legs.

Direct Cause	The direct cause was the unanalyzed loud sound produced by the Cryogenic venting process.	Legacy buildings need to be analyzed for all hazards. Building Managers need to be completely familiar with the operations of buildings for which they are responsible.	JON-4
