Type B Accident Investigation Board Report
Employee Puncture Wound at the F-TRU Waste Remediation Facility
June 14, 2010

September 2010
U.S. Department of Energy
Savannah River Site

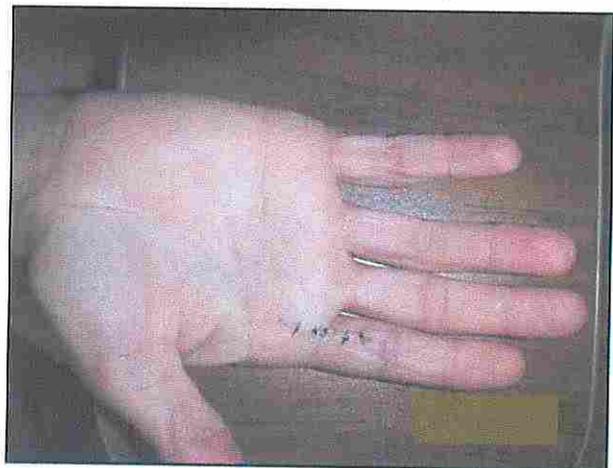
Figure 2-1. Technician’s Hand after Third Excision

needed and should be performed by a designated off-site specialist. The off-site specialist arrived at N Area medical at approximately 1715 hours. The second excision was performed at approximately 1815 hours, after which three stitches were applied to the wound area and WRT-1 was transported back to the Whole Body Count facility. A third ten-minute wound count began at approximately 1842 hours. Information provided by a SRNL evaluation of the extracted material indicated that approximately 3,200 dpm was removed during this excision. At this time, the need to collect every urine void was discussed with WRT-1. WRT-1 was provided the materials needed to collect bioassay samples and released to return to his local residence. On Day 9, a third excision was performed by the off-site specialist at N Area medical. This excision resulted in the removal of approximately 3,800 dpm from the wound area according to SRNL evaluation of the extracted material. No further excisions were performed because the results showed only a small amount of activity was removed and the specialist determined that additional excision could result in damage to the tendon sheath and/or neurovascular bundle (Figure 2-1).

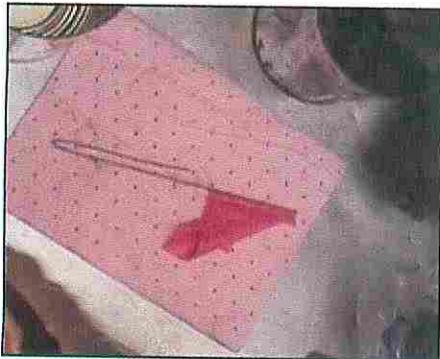
Figure 2-3. Modified Survey Flag

In addition to the use of different methods of installation, the Board found that survey flags were modified (i.e., cut) by personnel in the field without an understanding of the potential hazards presented by this action. The flags were cut to reduce the height of the flag protruding from the can. As manufactured, the survey flags measure 20-3/4 inches in length.

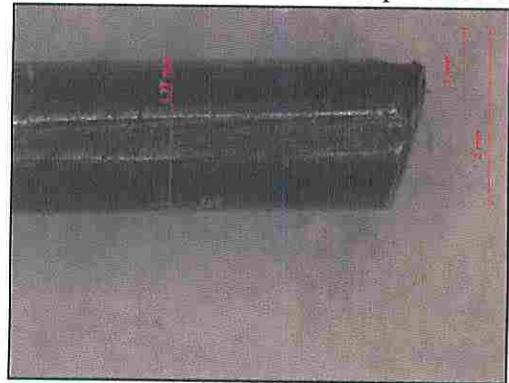
Figure 2-2. Survey Flag Tip

- The survey flag used as the hole indicating device that caused the puncture wound in this accident was 16.625 inches in length and 0.068 inches in diameter.

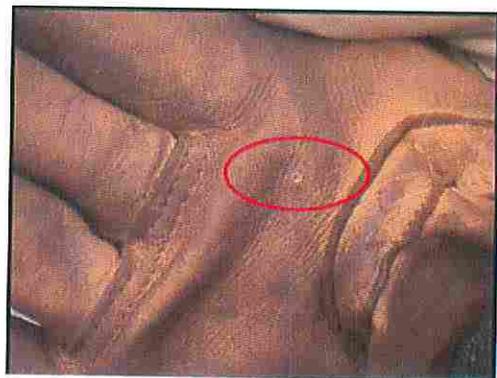
Figure 2-4. Lineman's Glove

The leather lineman's glove was inspected to determine the location of the hole, observe for chemical and physical damage, and to determine whether the flag caused the puncture hole. The glove was also sent to SRNL for analysis to determine whether the glove had been subjected to degradation from chemical and radiation exposure. The Board observed that the location of the puncture hole in the glove was in the palm just below the right index finger (Figure 2-4). The glove was heavily soiled/stained. There were no signs of additional punctures, cuts, or abrasions on the glove. An attempt was made to insert the flag back into the puncture hole to ensure it was the item that caused the puncture, but this was unsuccessful due to difficulties the Technician had trying to use hand tools to hold the flag and glove. The glove was also turned inside out to observe the physical condition of the interior. The Board did not observe any obvious stains, markings, or signs of degradation.

- The middle finger of the lineman's glove was surveyed and found to contain transferable contamination levels of 36,000,000 dpm alpha on the palm side and 17,000,000 dpm alpha on the fingertip. The glove exhibited total activity of 5,600,000,000 dpm, with the majority of the activity due to Pu-238.

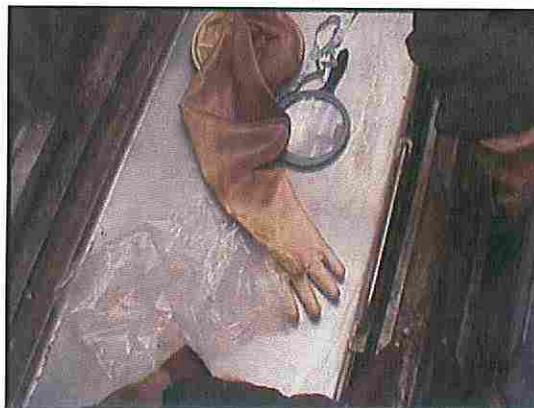
Figure 2-5. Enclosure Glove

The Enclosure glove was inspected to determine the location of hole, manufacturing specifications to verify thickness, and the physical condition of the glove (Figure 2-5). The puncture hole was difficult to locate due to its elasticity and was identified just below the right index finger. The glove exterior was white in the hand area that was covered with the lineman's leather glove. Above that area the glove was discolored (brownish). The glove appeared to be heavily used but the Board did not observe any obvious signs of degradation. The inside portion of the glove was blue. This glove was determined to be a 20 mil glove.

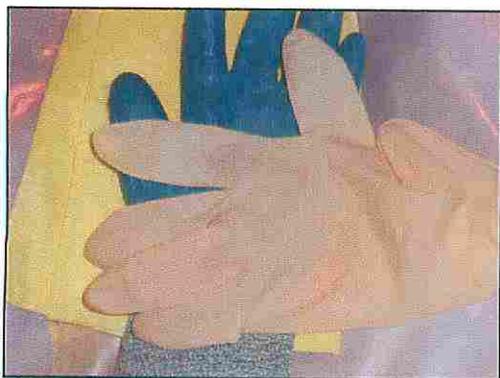
Figure 2-6. Punctured Surgical Glove

two pairs of surgical gloves. Only one of the two pairs was found in the examination of evidence.) Both the surgical glove and the cotton liner were punctured in the right index finger near the palm. The surgical glove had a stain approximately one-half inch in diameter at the puncture site inside the glove (Figure 2-6). The punctured cotton liner was heavily stained with what appeared to be blood. The Board also observed an additional four pairs of surgical gloves that were collected along with the punctured glove. One of these additional surgical gloves had a small stain located in the palm but no puncture. A leak test was performed in an attempt to identify a small hole in these additional pairs of gloves, but no leakage (puncture) was observed.

The Board concluded that WRT-1 was not wearing all of the prescribed PPE required by the RWP.

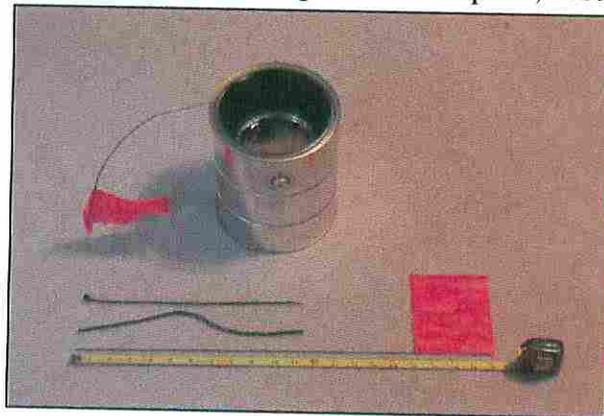
Figure 3-1. Hole Indicating Devices

Several different types of hole indicating devices were used by personnel during the TRU waste remediation work. The Technicians initially used nylon wire tie, but management presumed that the nylon could not be identified by RTR and the WRTs began using stranded wire. The ends of the stranded wire were later recognized as sharps by workers and use of the wire was replaced with survey flags (Figure 3-1). The Board found that no formal hazards analysis had been conducted for use of any of these hole indicating devices prior to their introduction into the Enclosure. When the survey flag was selected as the hole indicating device on April 7, 2010, project management informally reviewed the use of the flag and considered its hazards and associated controls to be "bounded" by the existing AHA. However, using "bounding conditions" is not recognized by SRNS Manual 8Q Procedure 122, *Hazard Analysis*, as a method of adequately analyzing hazards and identifying appropriate controls for performing work.

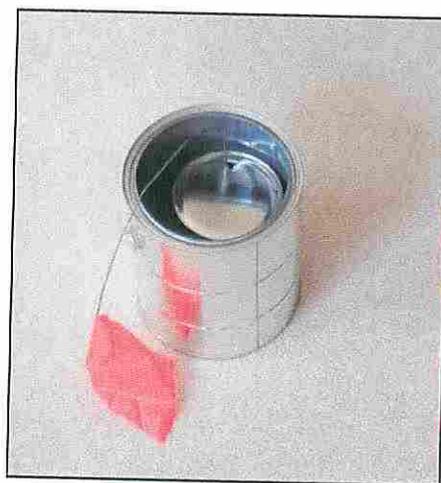
Figure 3-2. Method of Inserting Survey Flag as Hole Indicating Device

The Technicians were informally trained (via demonstration) to hold the survey flag at the midpoint with their hands, insert the flag downward into the can, and bend it over at the top of the can (Figure 3-2). However, the Board found that at least five alternative methods of installing the flag were performed by Technicians without analysis of the hazards. Various methods were developed by the Technicians to ensure the flags did not fall out of the cans and could be identified during subsequent RTR.

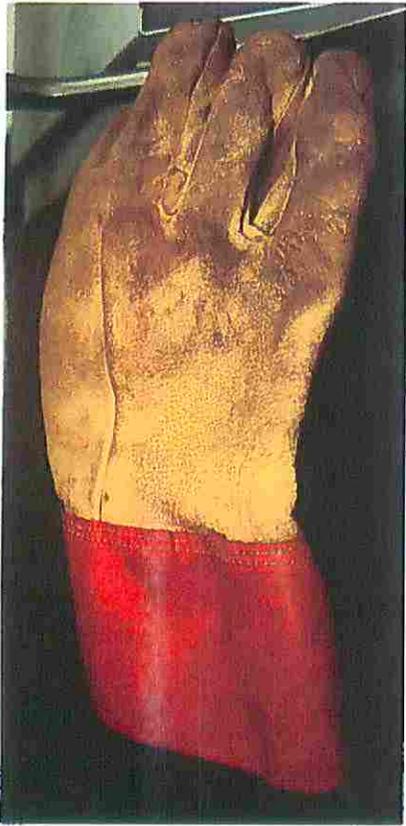
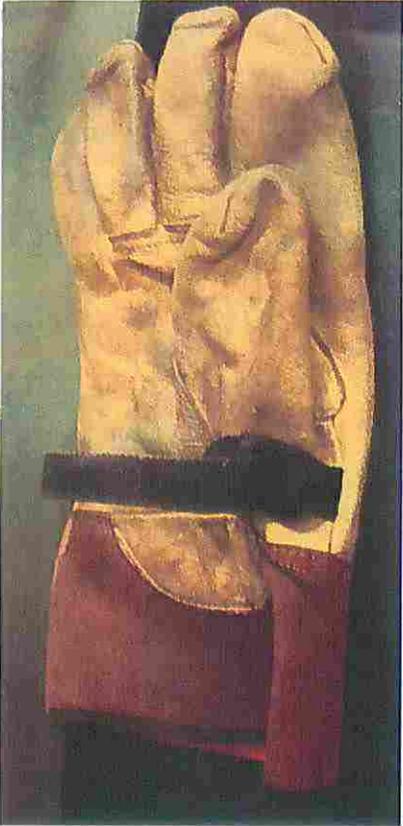
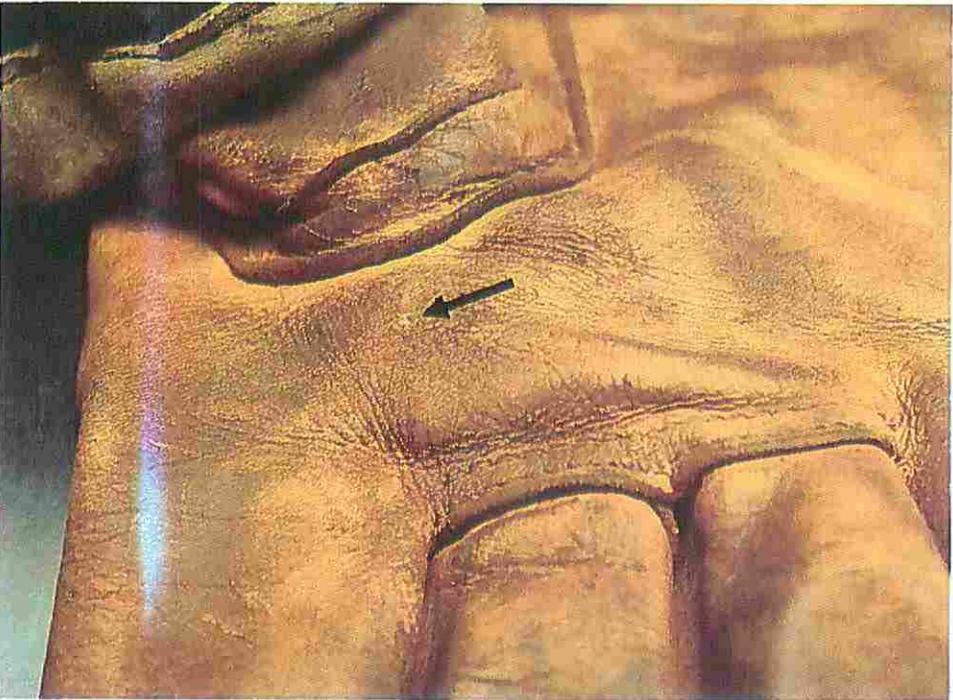
Figure 2. Punctured overglove received for examination (a, b) with detail of puncture location in palm (at arrow) (c)

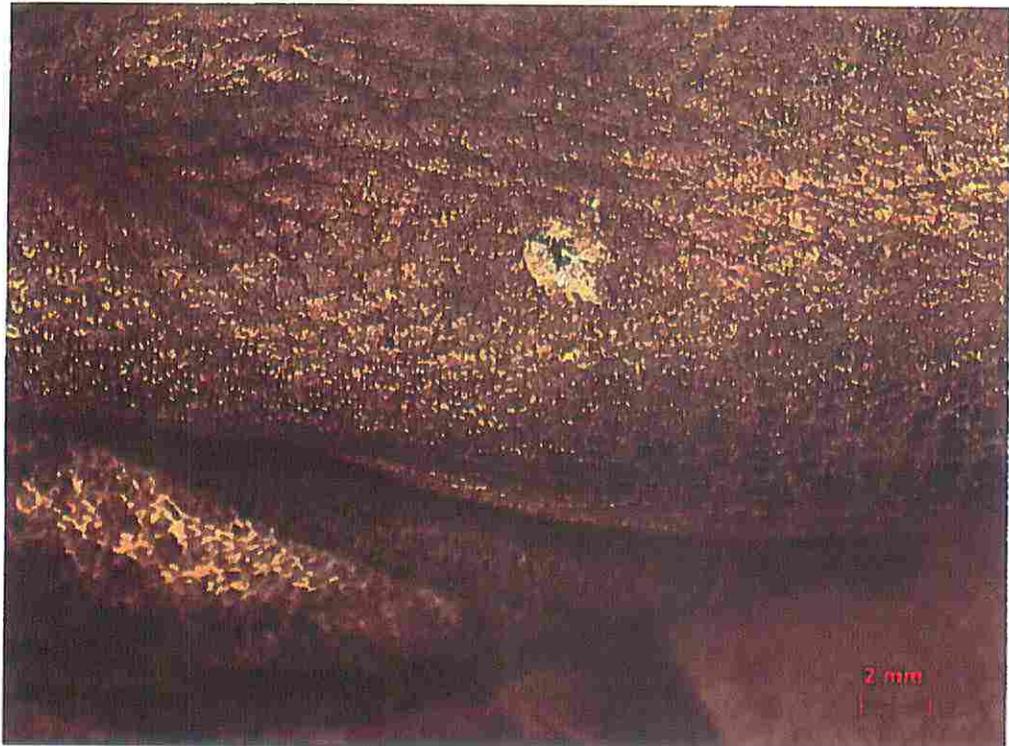
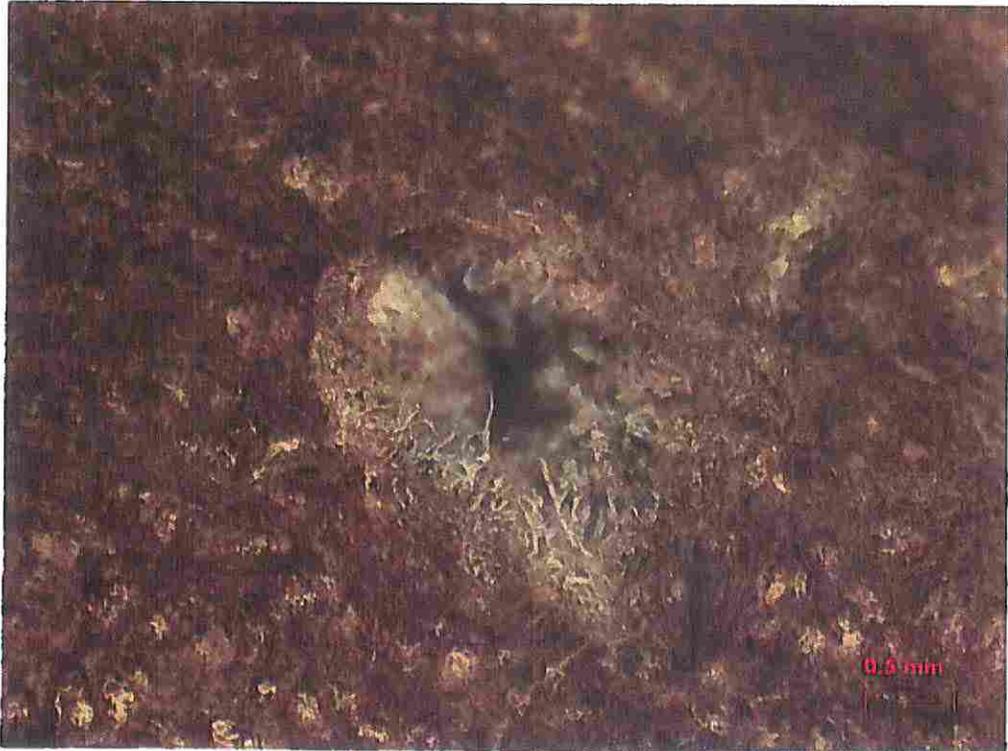
Figure 3. Stereo micrographs of puncture, exterior surface, originally taken at 5X (a) and 25X (b)

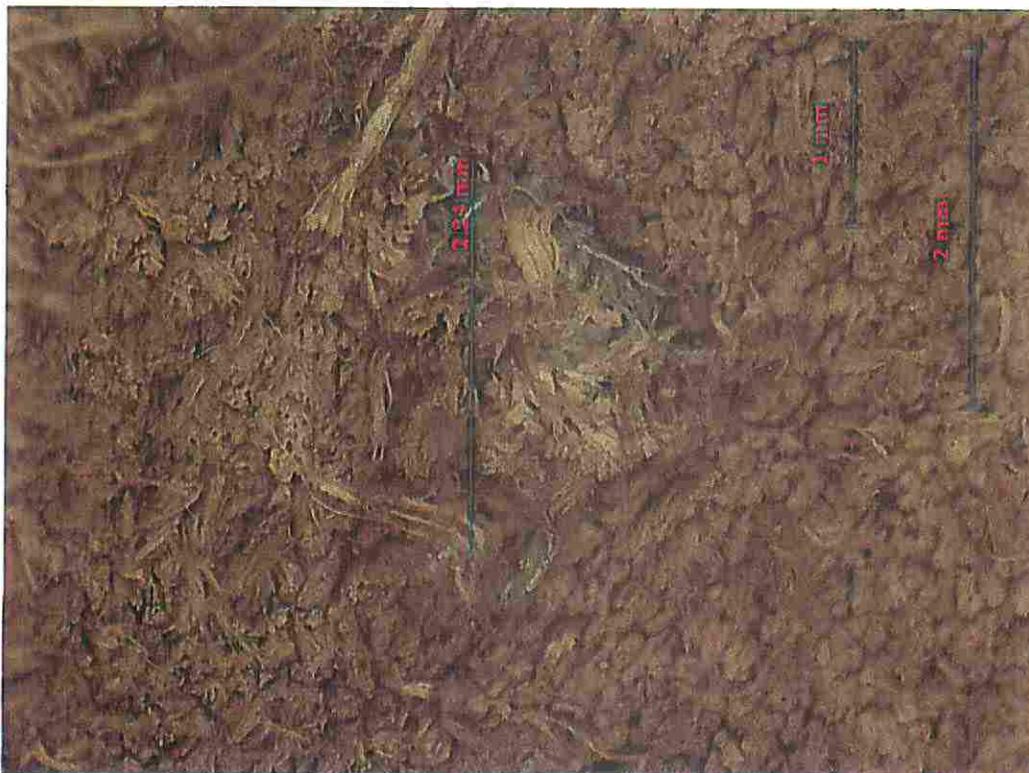
Figure 4. Stereo micrographs of puncture, interior surface, originally taken at 5X (a) and 25X (b)

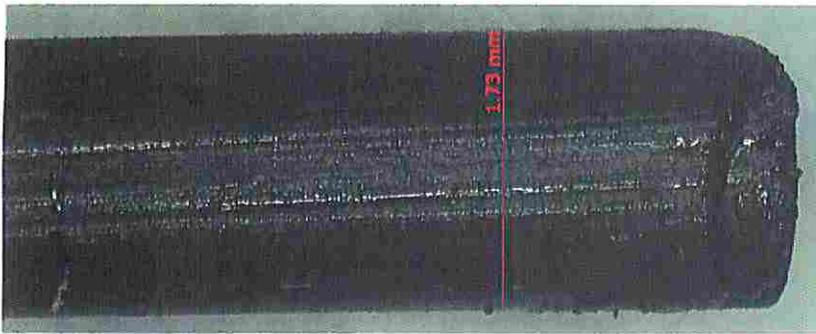
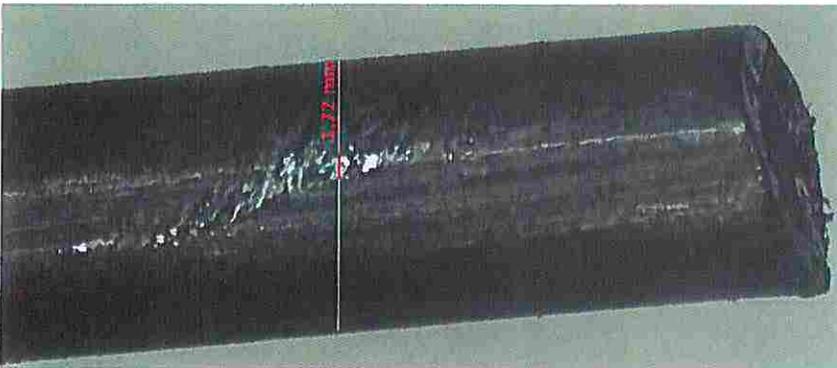
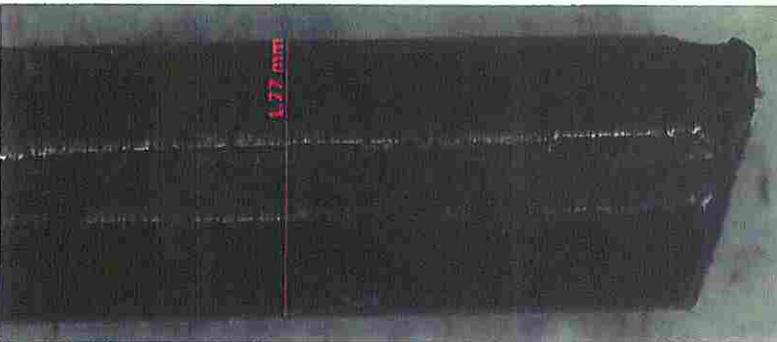
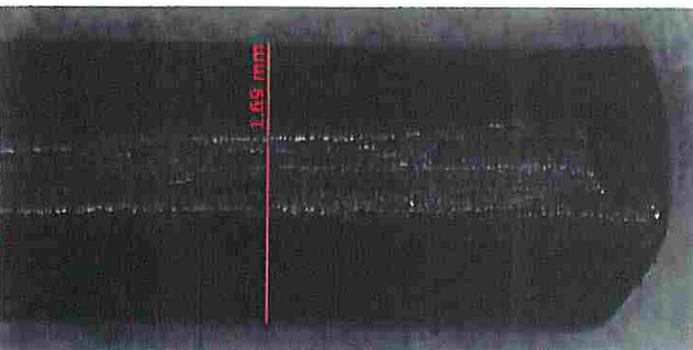
Figure 8. Thickness measurements of HID, at 4 locations near tip ~90 degrees apart. The slight angle on the end of the wire is best noted in (c).
