OE-3: 2012-05

August 2012

Safety Concern: Occurrences of Crushing Injuries To Operators of Industrial Equipment

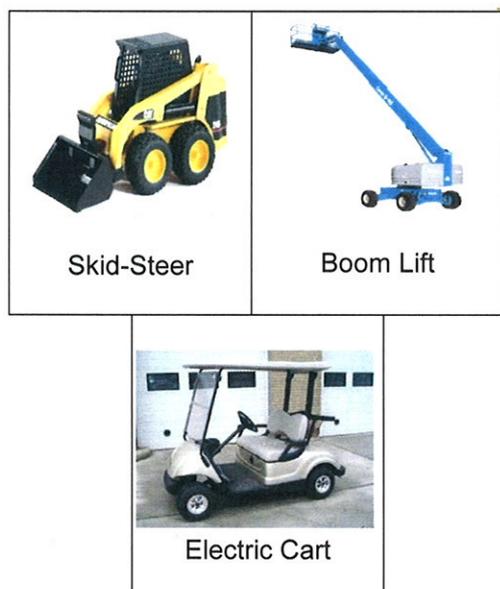
This Operating Experience Level 3 (OE-3) document provides information about a safety concern related to the dangers of crushing injuries faced by workers who operate various types of equipment, including electric carts, skid-steers, and lift equipment (Figure 1).

Figure 1. Equipment involved in worker injuries reported through the Occurrence Reporting and Processing System
