# **Level I Accident Investigation Report**

## **Tice Electric Company Employee Fatality near Patrick's Knob Radio Station, October 1, 2013**

**Report Date:  
November 22, 2013**

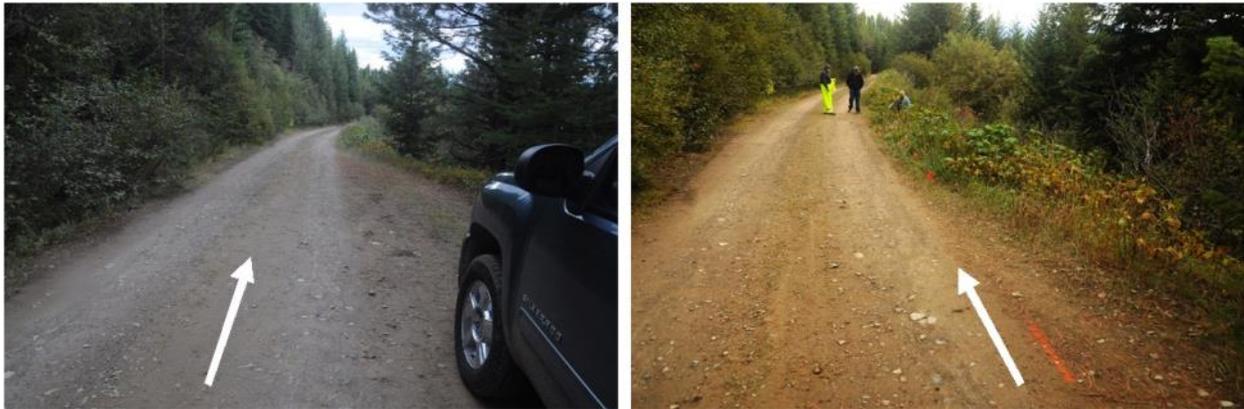
**Figure 5: Direction of Travel of the Gradall on Forest Service Road 7592 (Patrick's Knob Road)**

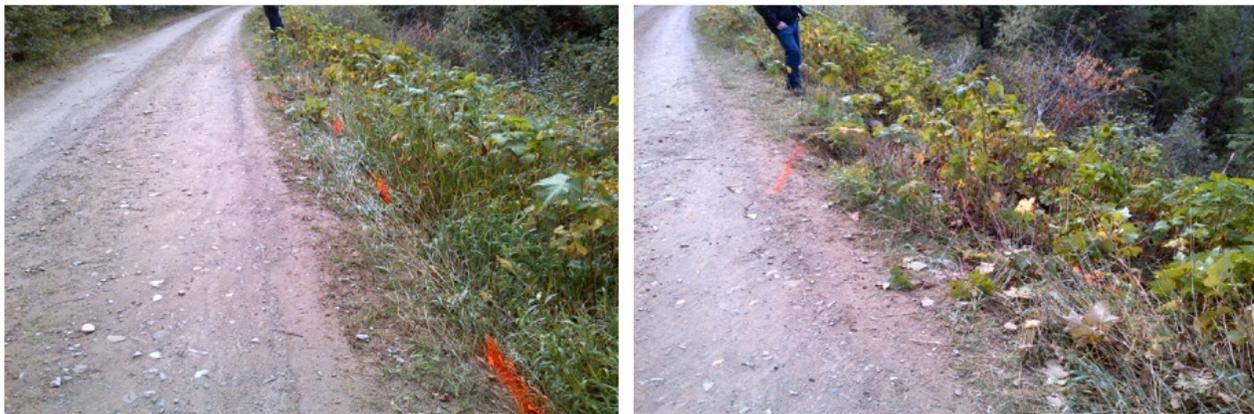
**Figure 6: Forest Service Road 7592 Marked Indicating Tire Tracks Leaving Roadway to Point of Rollover**

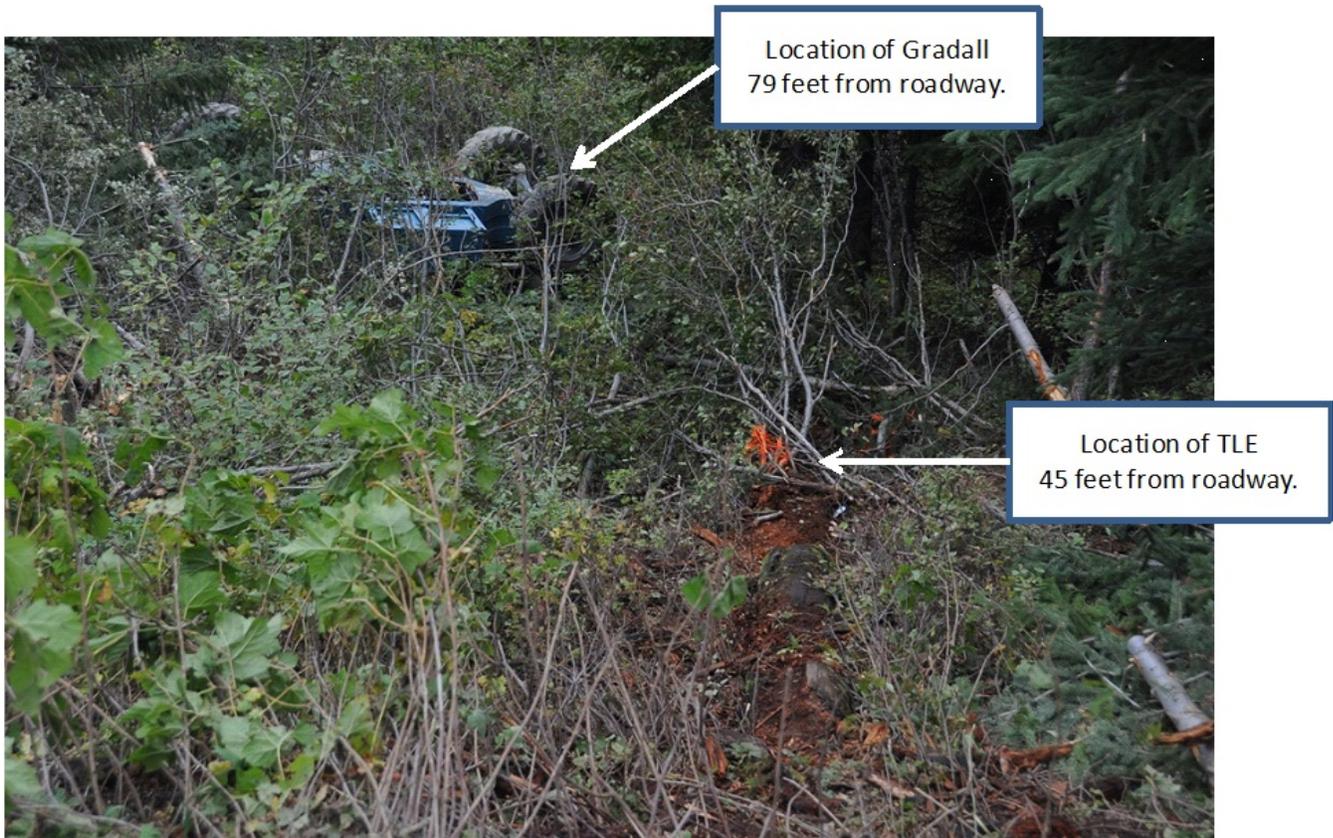
**Figure 7: Positions of TLE and Gradall on Hillside**

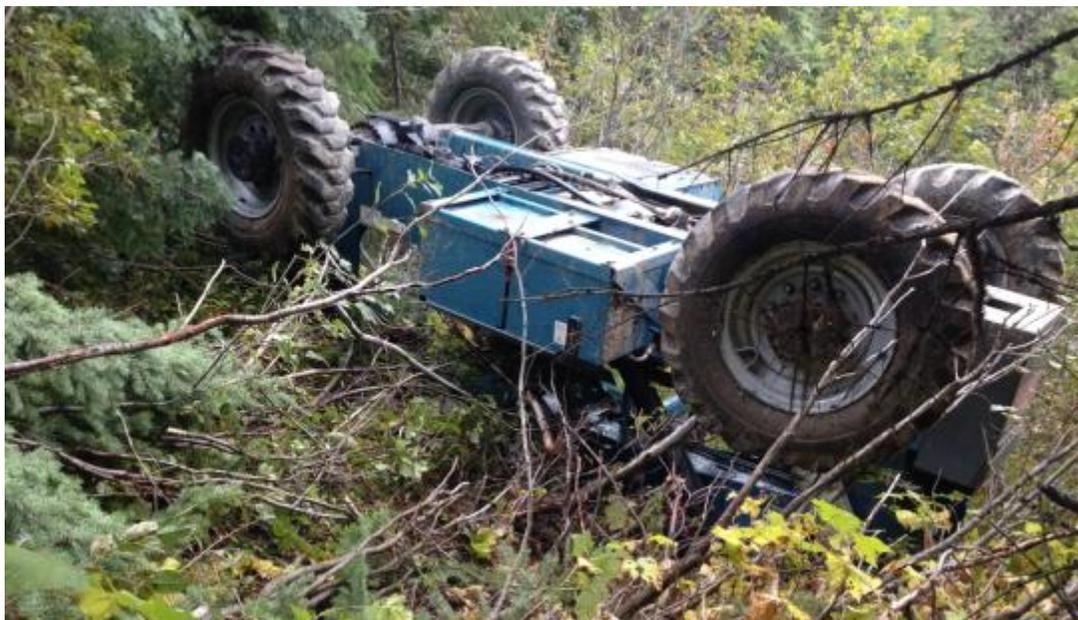
**Figure 8: Gradall Position down the Hillside**

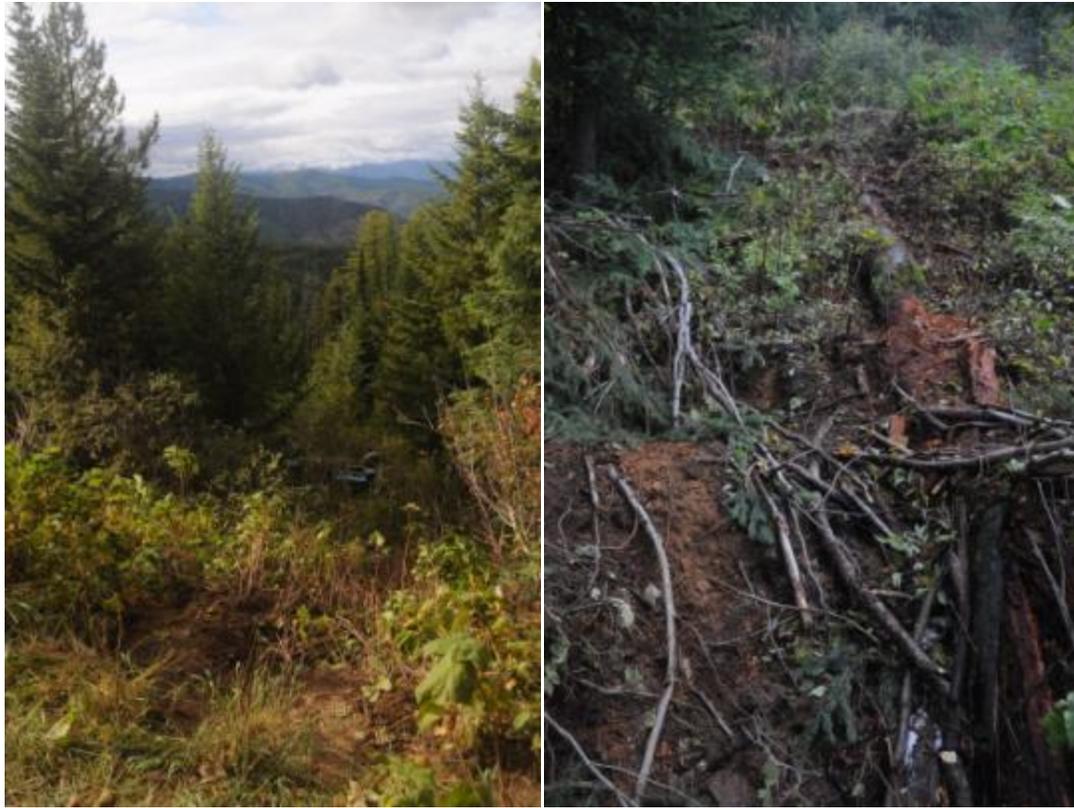
**Figure 9: The Photo on the Left is the view from the Roadway to the Location of Gradall on the Hillside; the Photo on the Right is from the Location of Gradall up to Roadway**

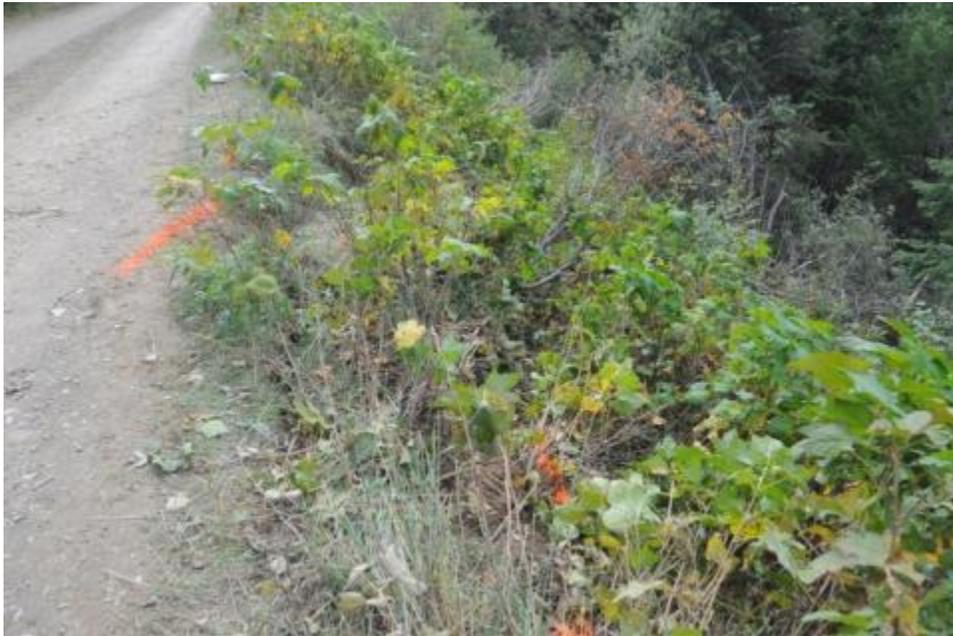
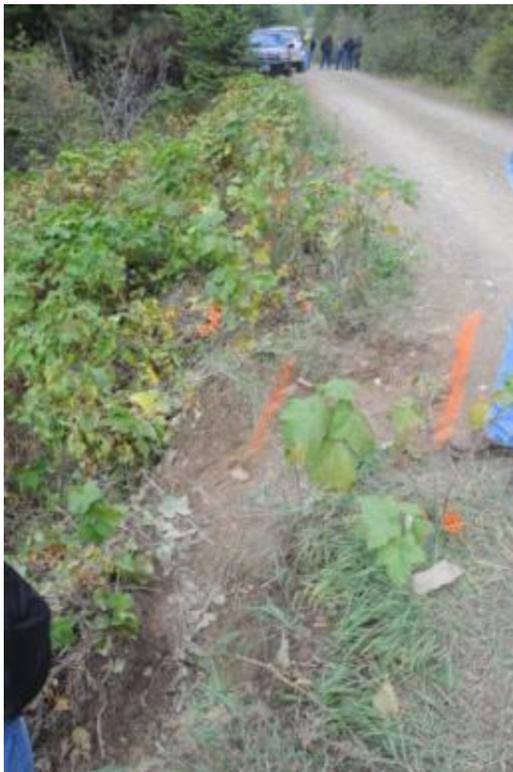
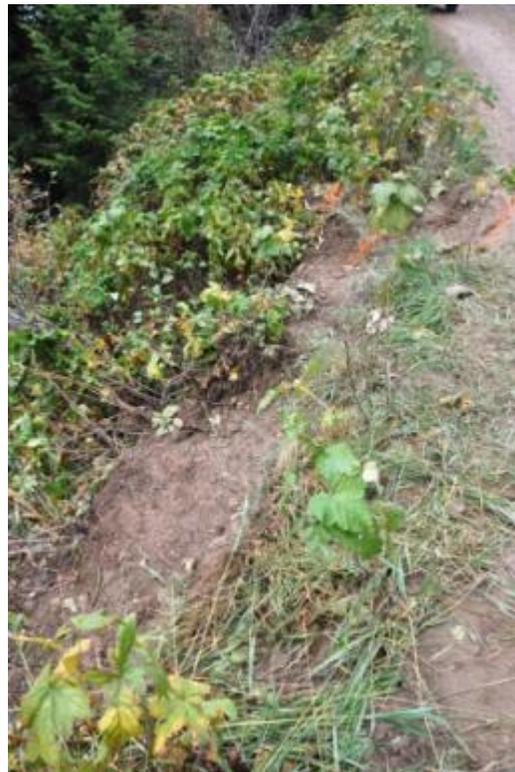
**Figure C-1: Additional Markings of Gradall Track Direction off the Side of the Roadway**

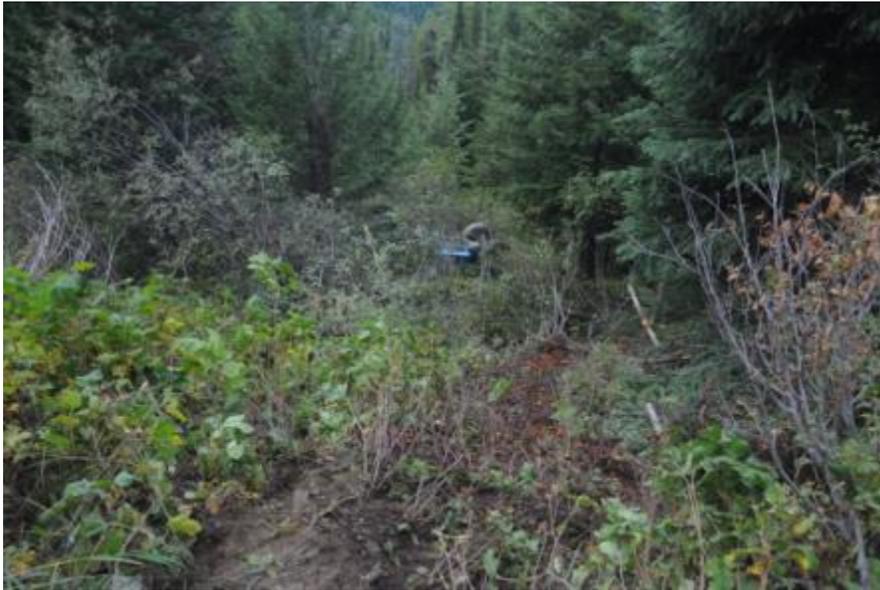
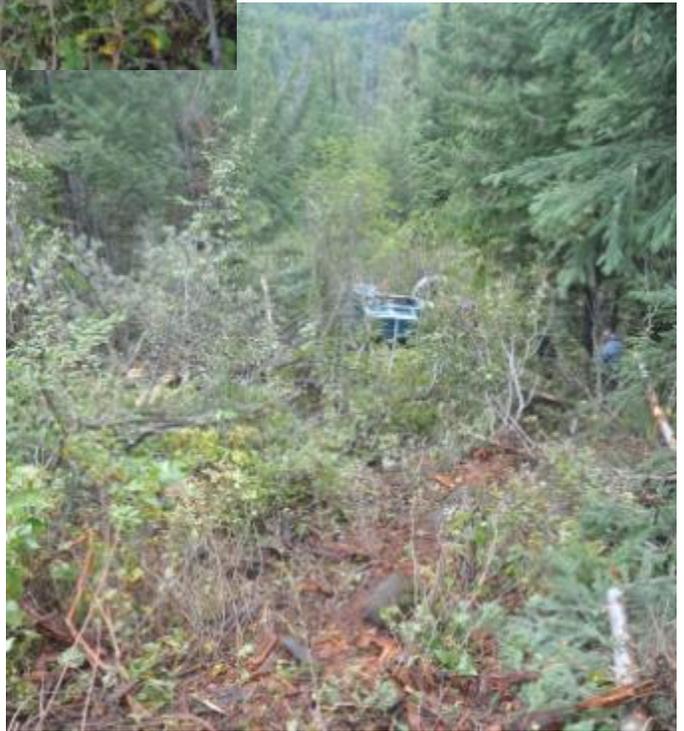
**Figure C-2: Views of Gradall on the Hillside**

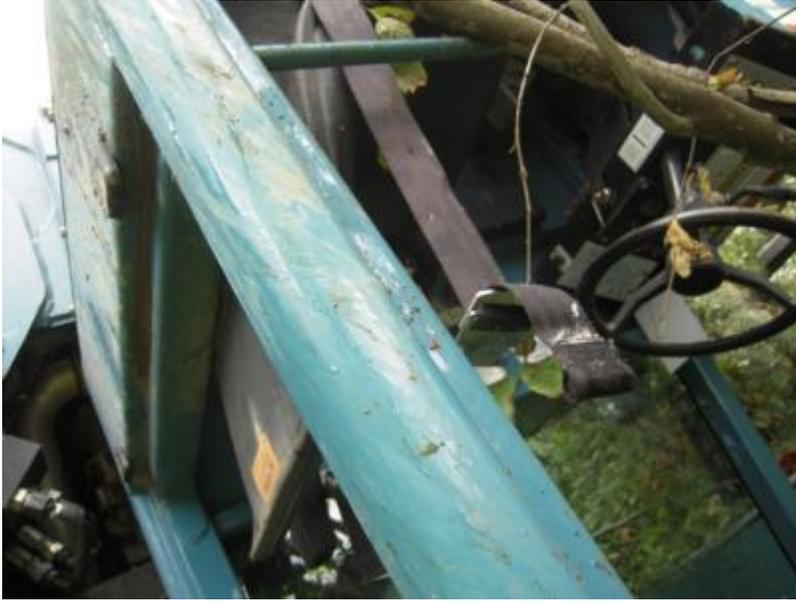
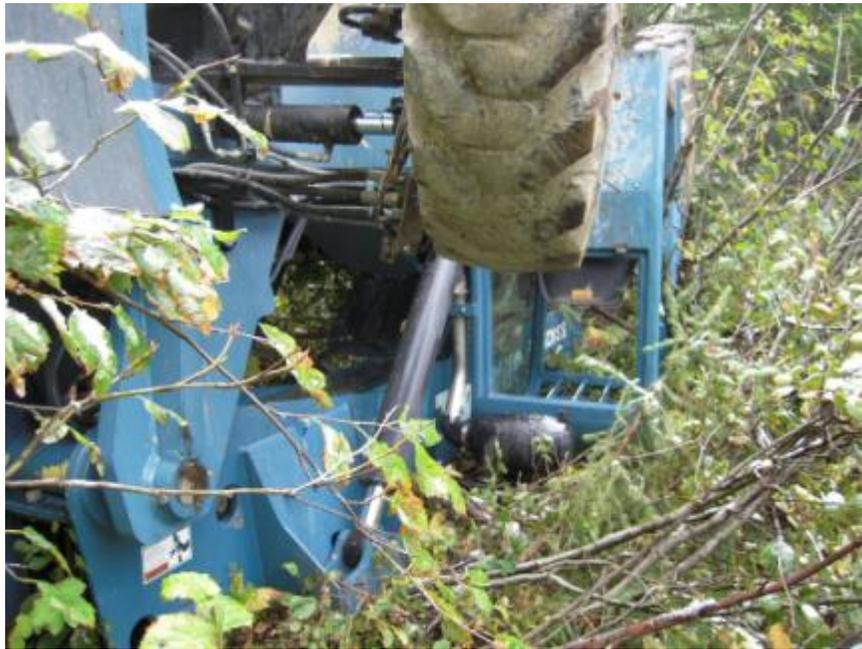
The Gradall was equipped with a Roll Over Protection Structure (ROPS) and included the safety restraints as part of the ROPS System. Following the accident, the Gradall ROPS was inspected by BPA and it was determined that there was no structural damage to the ROPS. The Board reviewed all available evidence and the scene but could not determine any explanation for the Gradall to have left the roadway. However, the Board determined that if the seatbelt had been in use during the rollover and TLE stayed within the ROPS, the fatal injuries may not have occurred as the ROPS was found to be intact and fully functional.

**Figure C-3: Views of Damage to the Gradall**

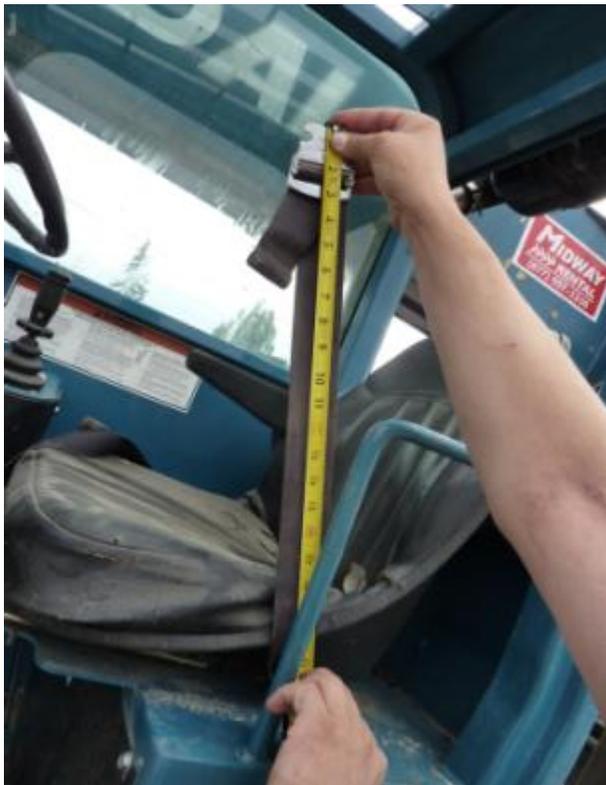
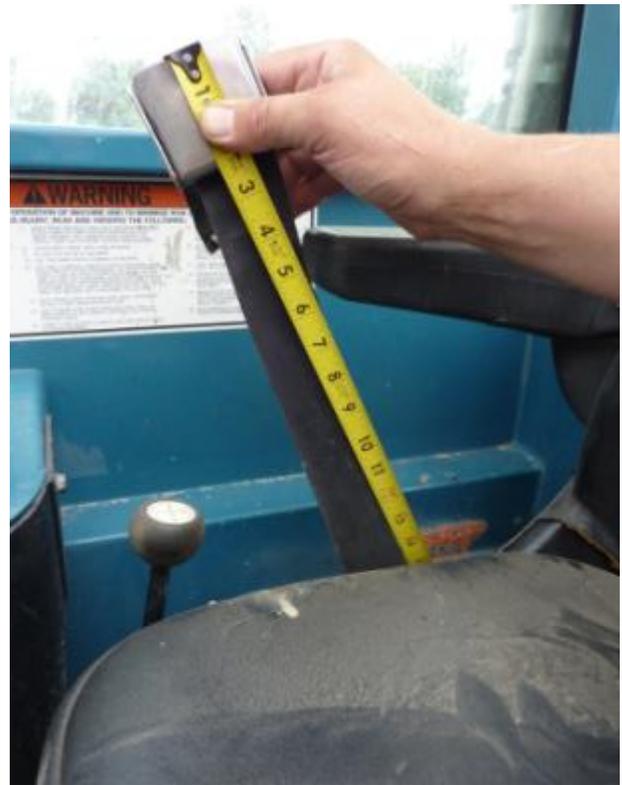
**Finding 3:** Use of seatbelts while operating the Gradall Material Handler is undetermined.

**Figure C-5: Measurements of Gradall Seat Belt**
