Moisture Problems in Manufactured Housing

Manufactured homes are affordable to many. A study points the way to making them healthy by dealing with moisture problems.

by Neil Moyer

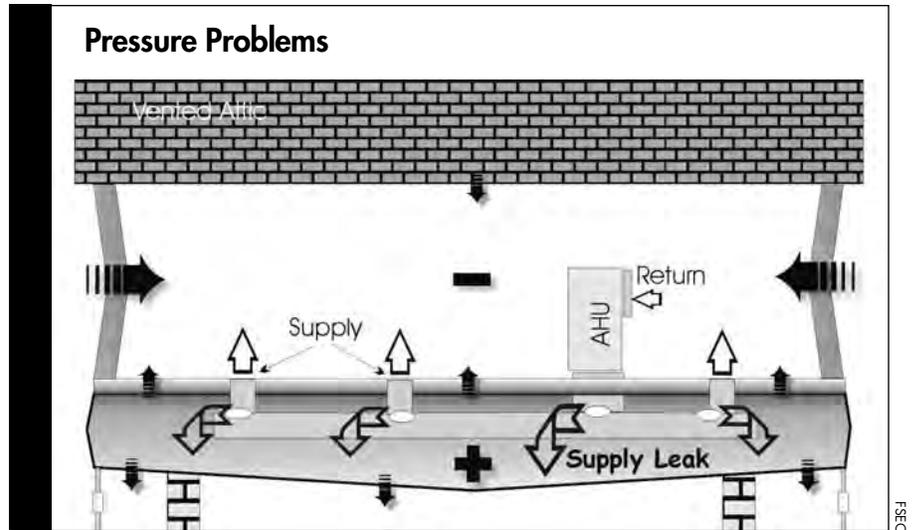
other connection points in the ductwork. When the AHU moves air through the ducts located under the floor, some of it leaks into the belly and eventually to the outside through tears in the belly board (see Figure 1). This loss of air creates a negative pressure inside the house and a positive pressure in the belly, because the return, being located in the home, has no such leakage. The negative pressure draws outside or attic air into the house through the numerous cracks and crevices connecting the inside of the house to the outside or to the attic. If this outside air is cold and dry, as it is in the winter-time in the northern United States, it will increase heating energy use and occupant discomfort. This situation will not rot a home in a northern

Figure 1. Supply leaks can cause positive pressures in the belly of manufactured homes. The resulting negative pressure in the living space can draw in moist air from the outside.

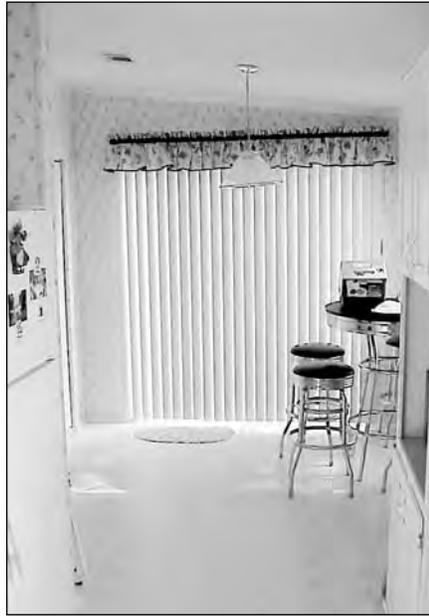
A pattern of floor moisture and staining problems appears when the duct system is located overhead, in an attic space. We found stained and warped vinyl-covered floors in areas under the ceiling registers. The areas that were being washed by cold air from the supply reg-

isters showed the worst staining. It is reasonable to assume that areas being washed by the supply air will tend to be cooler than other areas. This cooling of the floor surfaces creates temperatures below the dew point temperature of the crawlspace and condensation occurs.

This kitchen has a vinyl floor covering and an overhead supply register. Mold can occur under the vinyl that is washed by cold air from the register.

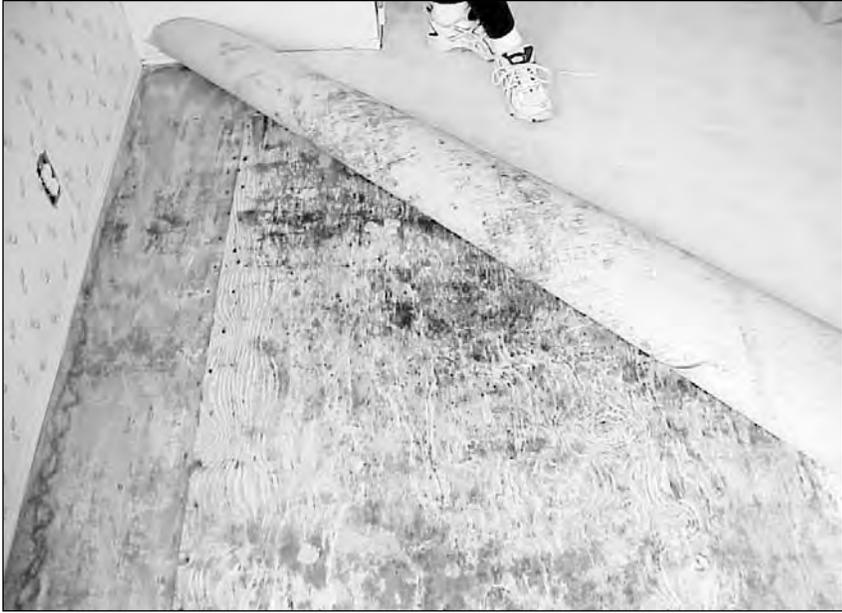
Homes with vinyl floor coverings, where the vapor retarder is located on the interior surface, have similar problems. However, we saw moisture problems only in the houses with overhead duct systems. We believe (testing to verify this is ongoing) that the cool air from the supply registers is being blown down to the floor and is cooling the surfaces below the outside air dew point. The solution so far has been to replace the current unidirectional registers with multidirectional ones. In addition, the belly board is sealed to reduce crawlspace vapor intrusion. (Sometimes the skirts are vented, according to homeowner acceptance and current local venting practices.)

Vinyl flooring in manufactured homes can cause moisture damage, since the low moisture permeability of vinyl can lead to condensation.
