# Statue of Liberty: A Risk Analysis

Bruce Campbell, FSFPE  
*VP – DOE Services*

National Park Service

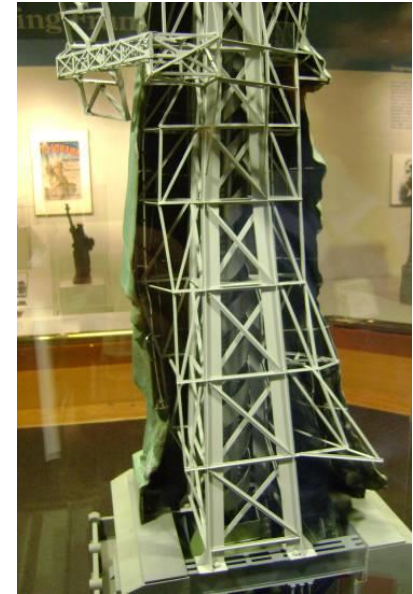
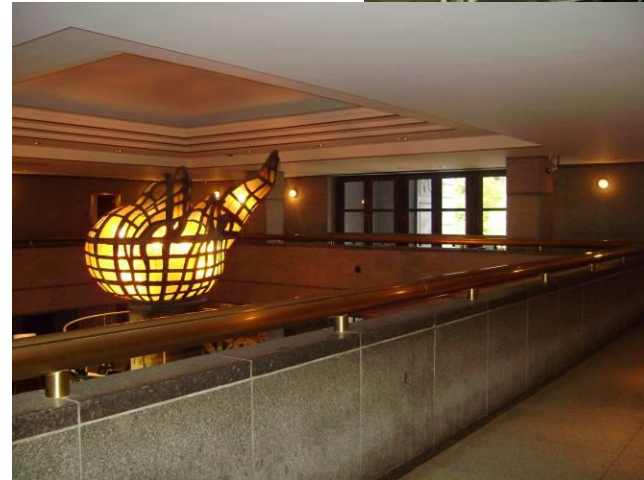
## Construction Features

- Statue construction is not compliant.
  - Copper on unprotected iron skeleton
  - Fire resistive construction required
- Vertical openings are not compliant.
  - Main lobby area
  - West lobby stair (open at 2P)
  - Pedestal core (1P-6P)
  - Statue (7P-Crown)

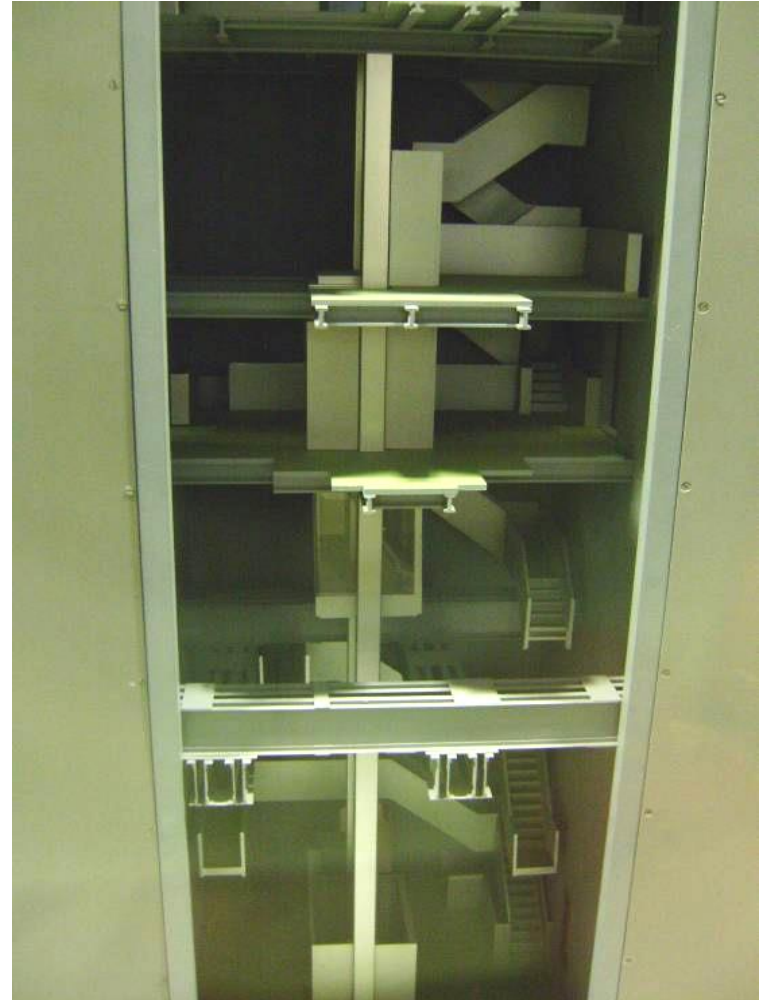
## Pedestal Core

- 6-story vertical opening containing all egress stairs from upper levels.
- Potentially meets intent of codes for shaft requirements.
  - Does not comply with requirements for exit enclosures.

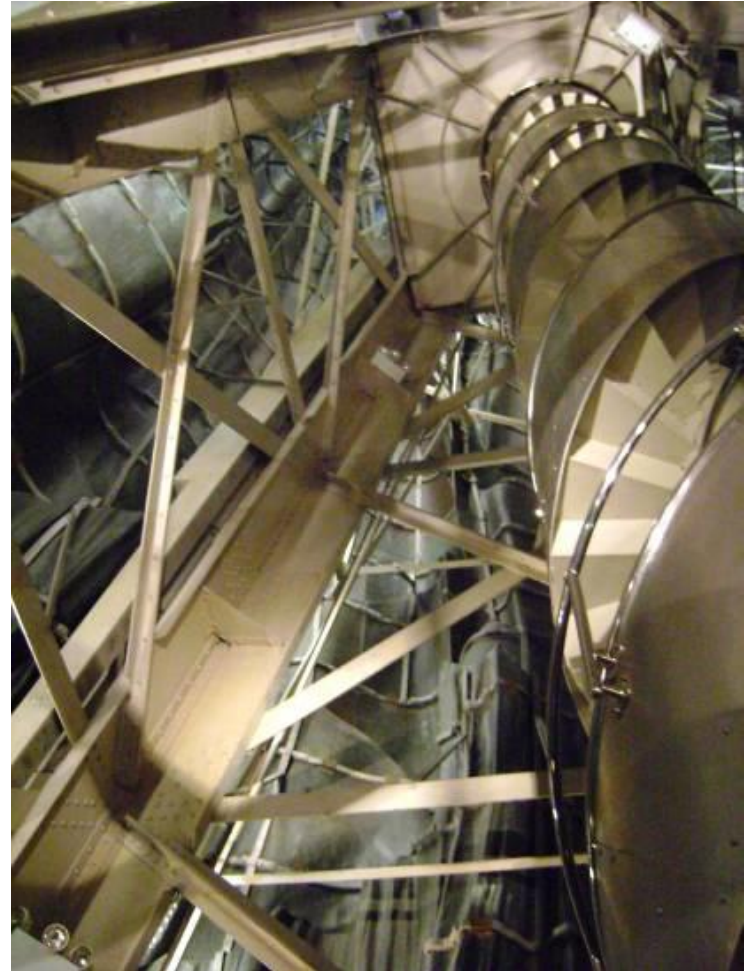
## Statue (7P – Crown)

- Codes do not specifically address.
- Potentially classified as mezzanine.
  - Common path of travel >75 ft.
  - Enclosed stair or 2 means of egress.

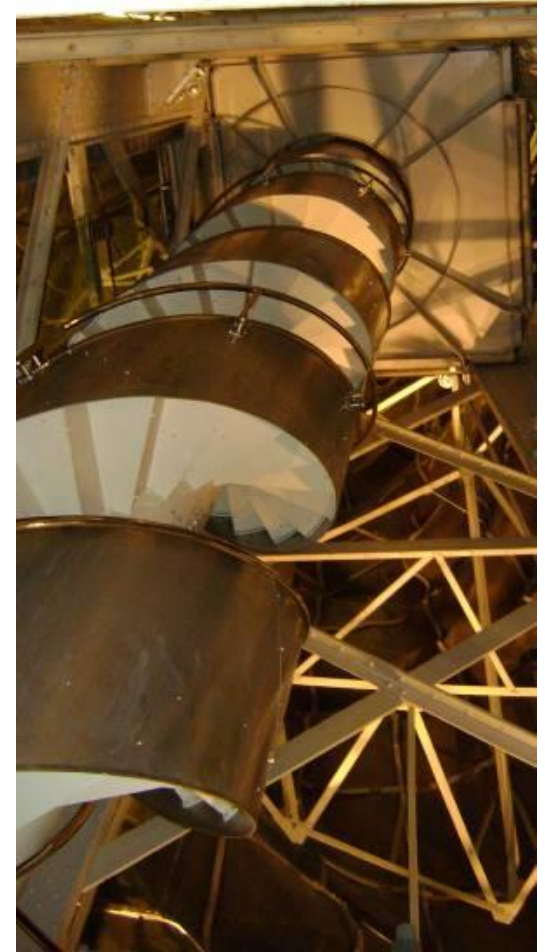
## Egress Components – stairs, doors, ramps

- Most stairs-noncompliant
- Several egress doors-noncompliant
- Ramp at sally port exit-noncompliant
- Unique issues-stair / door to Level 7P and double-helix stair to Crown
  - Two intertwined spirals; one leads down the other goes upwards

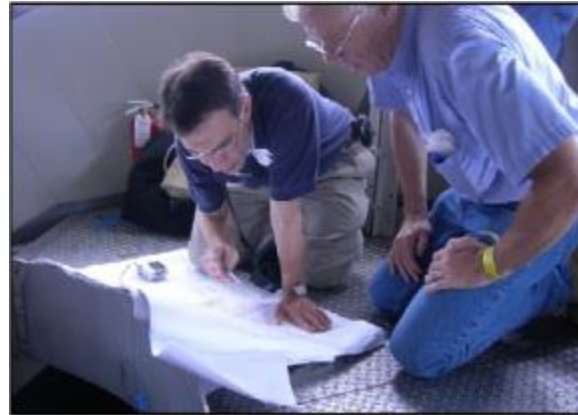
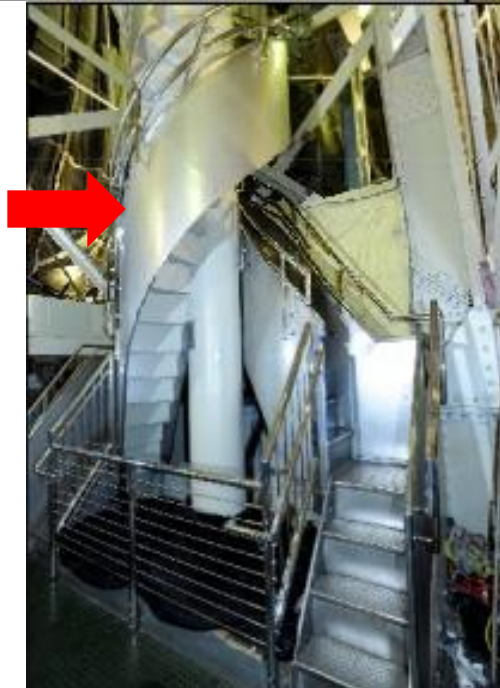
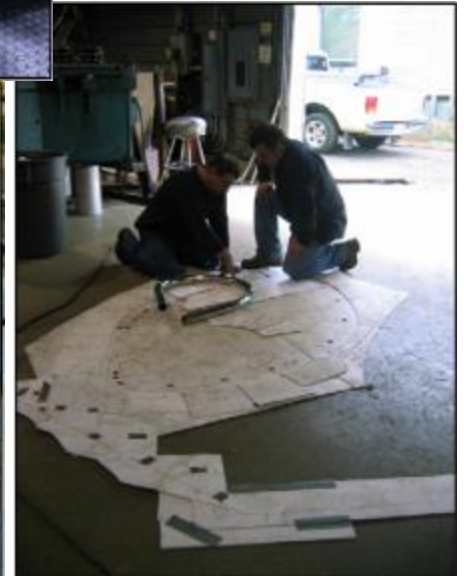
- Improvements were made to the helical stair to allow guided tours to the crown.
  - New construction basically separates each floor of Pedestal into two separate stairs and an elevator lobby.
  - Crown was re-opened to public on July 4, 2009.
- The Statue of Liberty was closed for renovations to the pedestal.
  - Re-opened – July 4, 2013

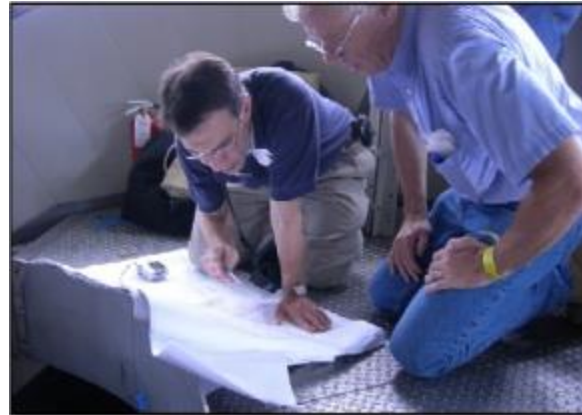
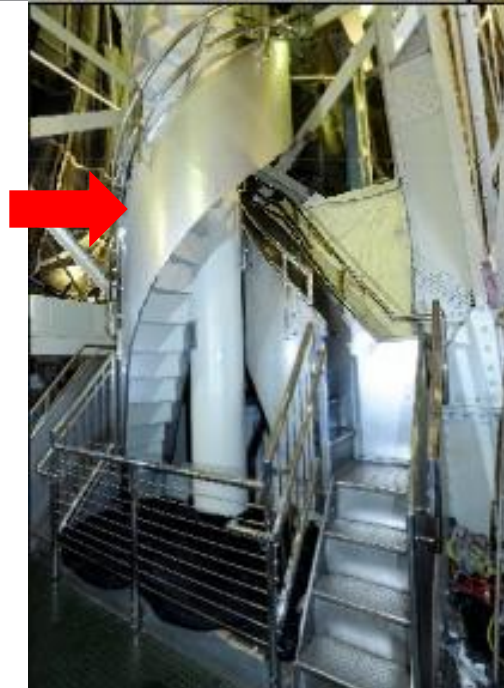
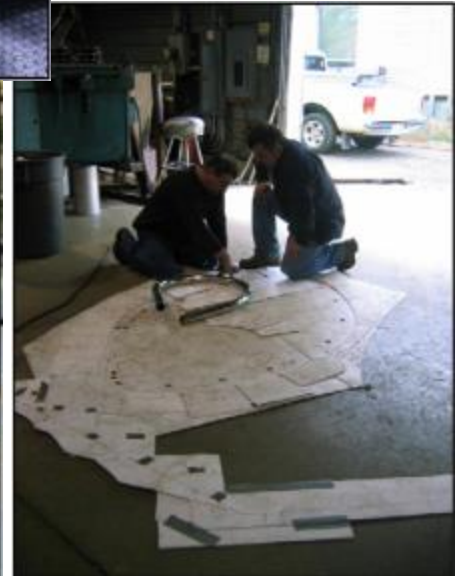
- New construction included fully compliant sprinkler system and standpipe in Pedestal. The Statue is still unsprinklered, with the exception of the two upright heads in the Crown which were reconnected during the new construction.
- New code compliant fire alarm system throughout the Pedestal. Analaser air sampling reconnected and corrected.
