# U.S. Department of Energy Office of Environmental Management

## Accident Investigation Report

### Phase 1

## Radiological Release Event at the Waste Isolation Pilot Plant on February 14, 2014

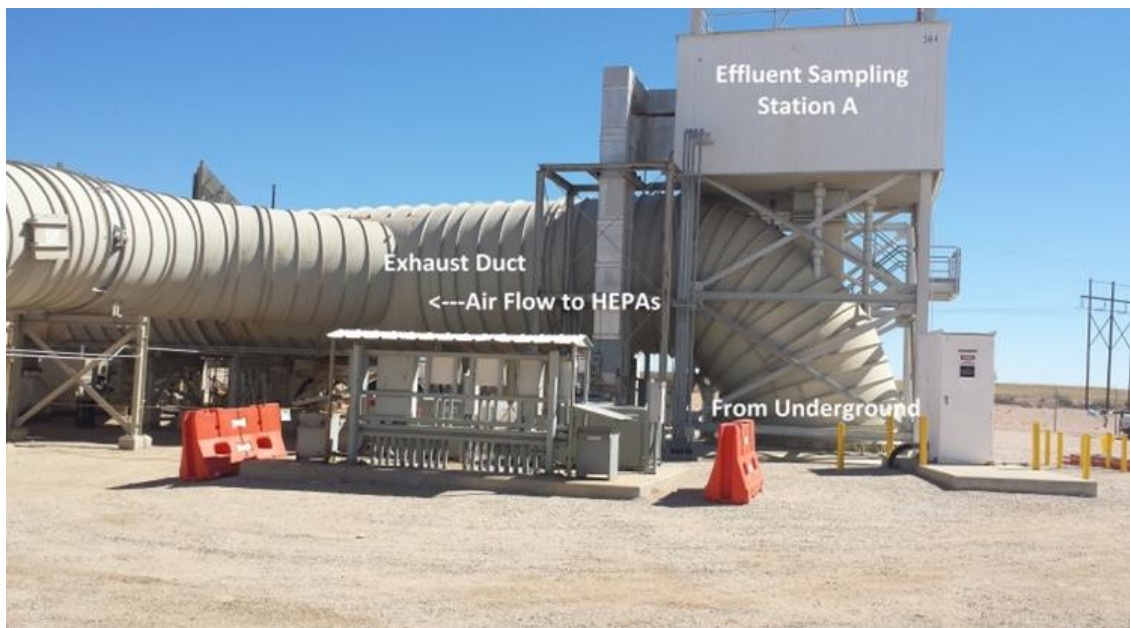
**Figure ES-2: Exhaust Air Shaft and Effluent Sample Station A**

On Saturday, February 15, 2014, the filters were counted at 0715; the RCM reported 4.4 million disintegrations per minute (dpm) alpha contamination on the filters from the effluent sample station upstream from the HEPA filters (Station A) (Figure ES-2). Preliminary data indicated the presence of TRU materials.

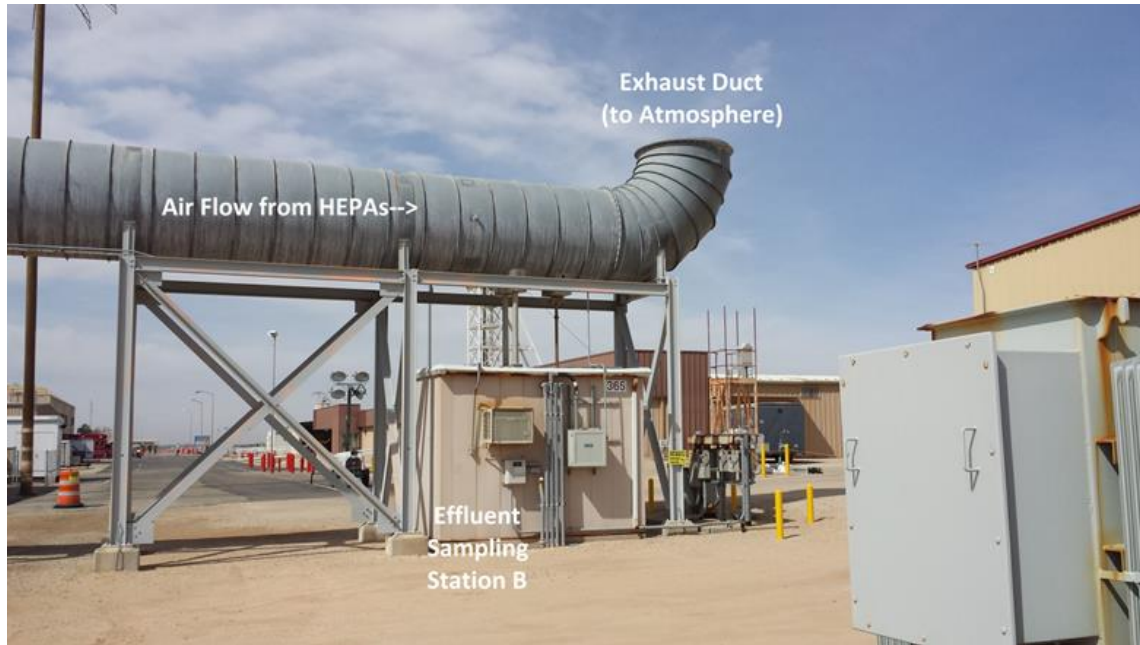
**Figure ES-3: Station B and Exhaust Duct**

Results from analysis of filters from the effluent sample station downstream of the HEPA filters (Station B) and at the discharge point to the atmosphere (Figure ES-3) were reported at 0915 and indicated 28,000 dpm alpha and 5,900 dpm beta contamination. This was the first indication that there was a release of contamination downstream of the HEPA filters to the environment.

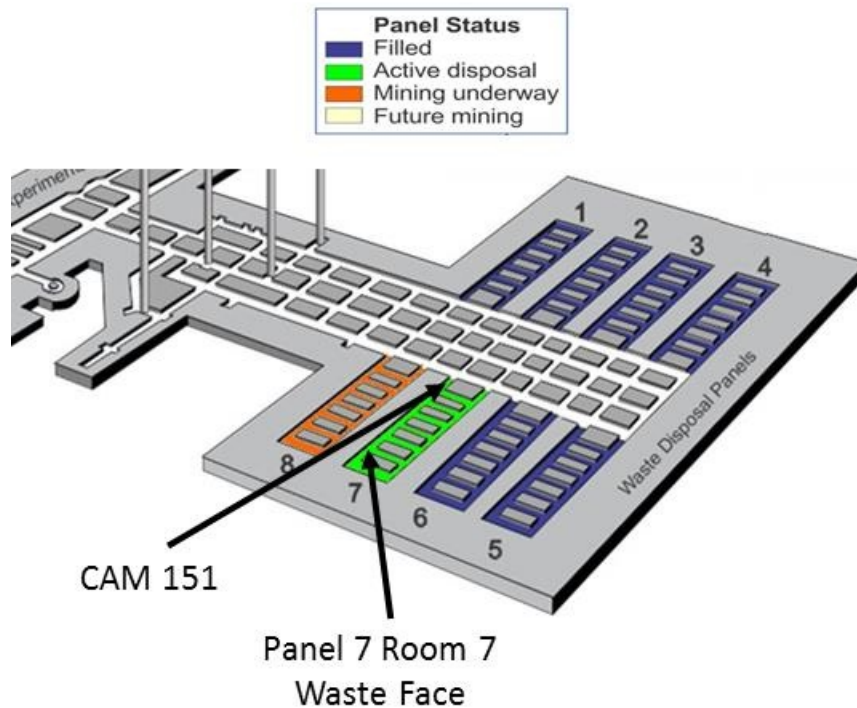
**Figure 3: Location of Panel 7 and CAM-151**

The WIPP U/G consists of the waste disposal area, construction area, north area, and Waste Shaft station area. The location of the suspected waste container breach at Panel 7 and CAM-151 are shown in Figure 3.

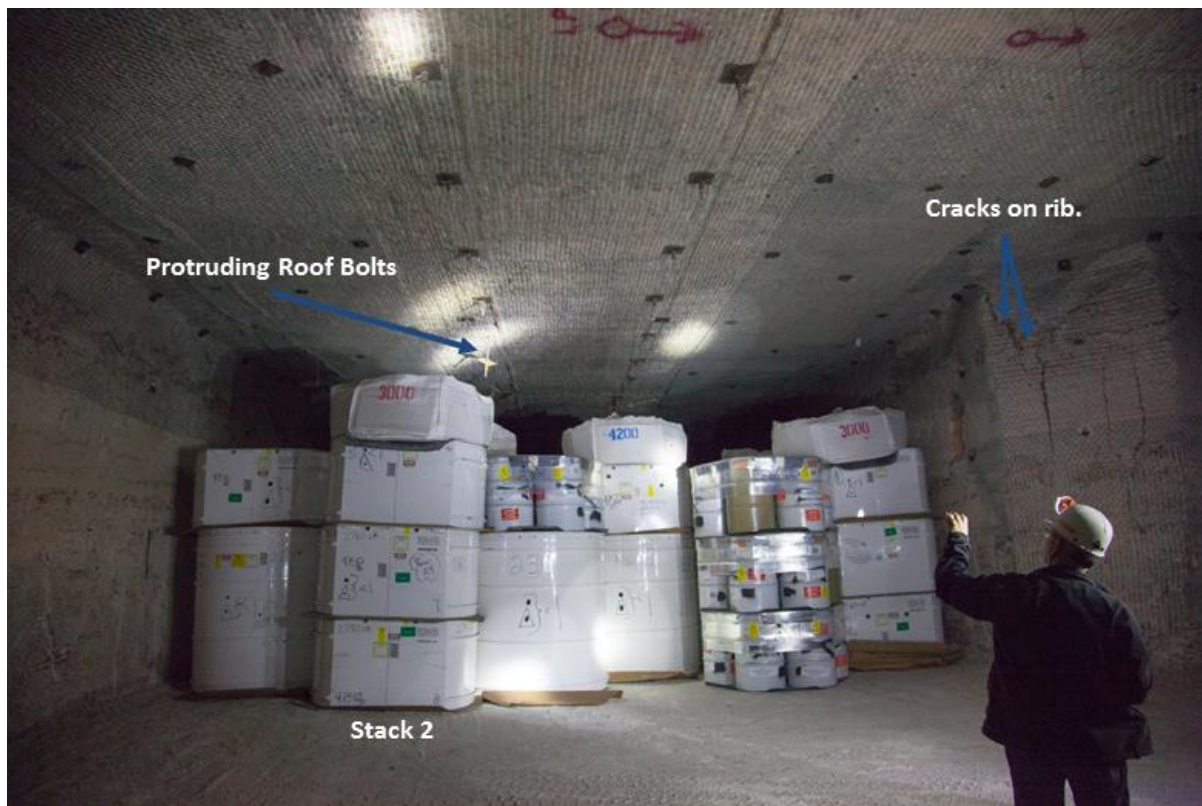
**Figure 6: Active Waste Face at Panel 7 Room 7**

Following a fire involving a salt haul truck on February 5, 2014, all U/G waste handling activities were suspended pending completion of a DOE Accident Investigation, implementation of critical corrective actions, and development of a recovery plan. A series of entries to the U/G were made to evaluate the fire scene and collect information in support of the Board. On February 10 and 12, two broken roof bolts were found near the mid-pillar of Panel 7 by NWP. This condition was reported to the Mine Maintenance Engineer. On February 13, members of the Board investigating the salt truck fire were in the U/G and observed these same roof bolts and reported protruding roof bolts from the back in Panel 7.

Figure 6 shows cracks in the rib behind mesh and with rock bolts, right side of photo. Figure 6 also shows an area where possible heaving of the bottom has taken place under the second stack of TRU waste on the left side of the photo. Two broken and loose roof bolts above Stack 2 on the left side.

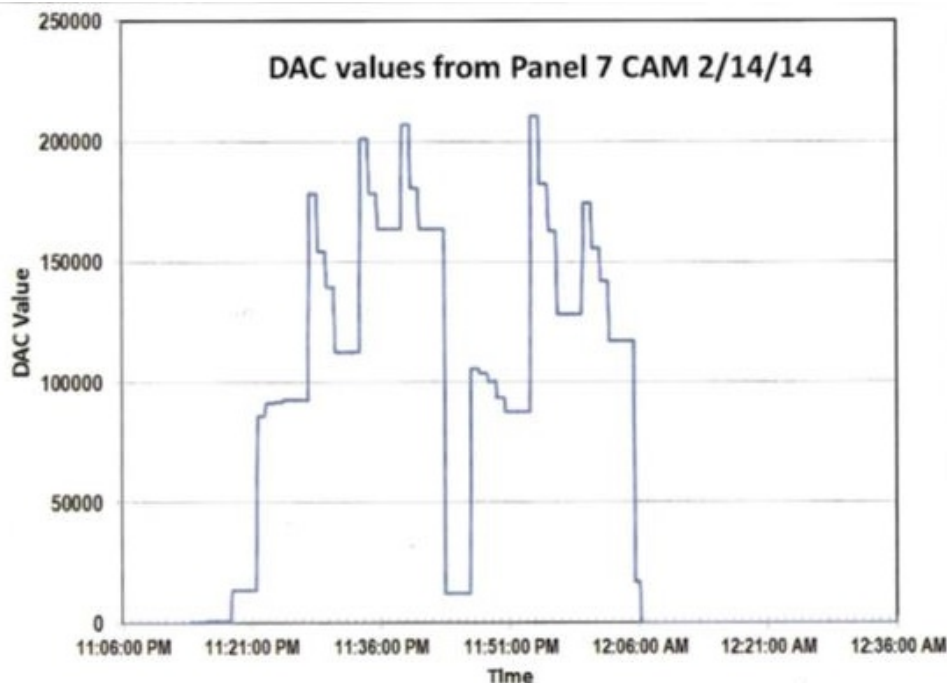
Figure 7: CAM-151 CMS

On February 14, 2014, at 2313, a “HI RAD” alarm from CAM-151 (U/G, monitoring the Panel 7 exhaust drift) was received on the CMS. The “HI RAD” setpoint for this CAM is 30 Derived Air Concentration (DAC) for alpha and beta contamination. Approximately one minute later, a “HI-HI RAD” alarm from CAM-151 was received on the CMS. The “HI-HI RAD” setpoint is 50 DAC. The CMS indicated that the CAM reading was 332 DAC. Figure 7 provides a graphical representation of CAM readings during the event.

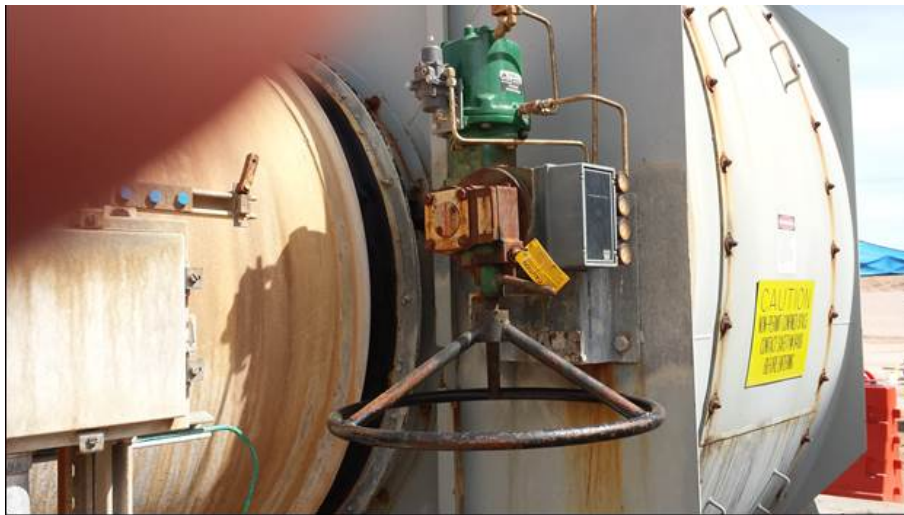
**Figure 11: 860 Vortex Manual Hand Wheel**

- Approximately ten years ago, the facility experienced issues associated with the actuation of the vortex dampers to the 860 fans. Automatic operation of the vortex dampers relied on input from a flow sensor. The flow sensor was failing when exposed to the harsh conditions and prevented the vortex actuator from operating properly preventing the automatic opening of the damper during fan startup. As the condition persisted, a work-around was implemented requiring an operator to be dispatched to open the damper manually at the fan inlet to allow fan startup. (Figure 11)

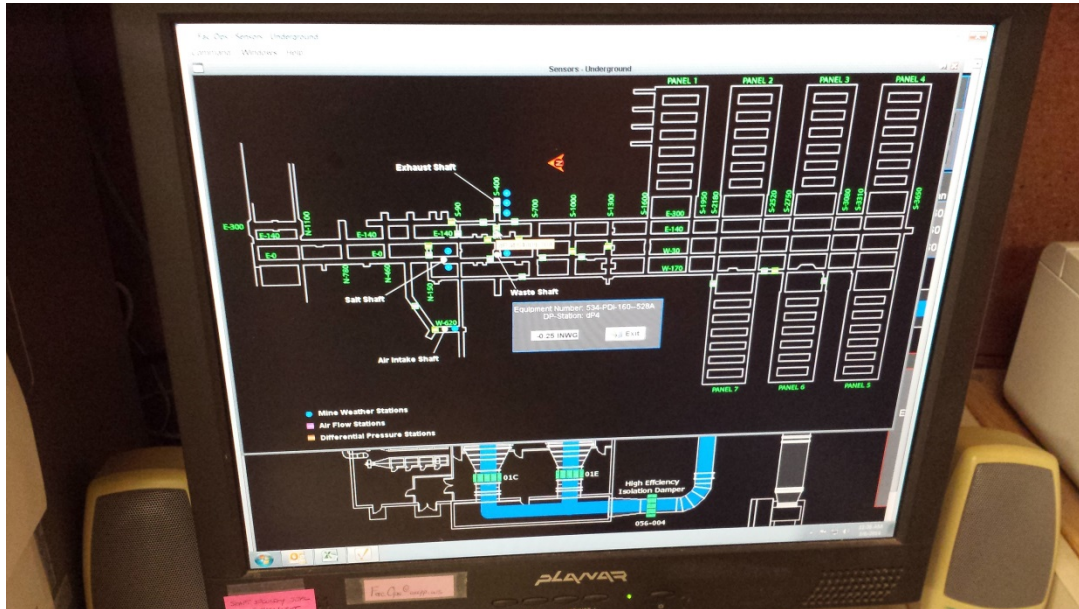
**Figure 12: CMS Illustration of Airflow Path**

- The CMS display indicates that fan 41-B-700B has an open flow path although the fan is secured and the dampers are closed.
- The CMS has not been updated to reflect the current underground configuration with new construction of Panel 8 and adjacent bulkhead locations. (Figure 12)

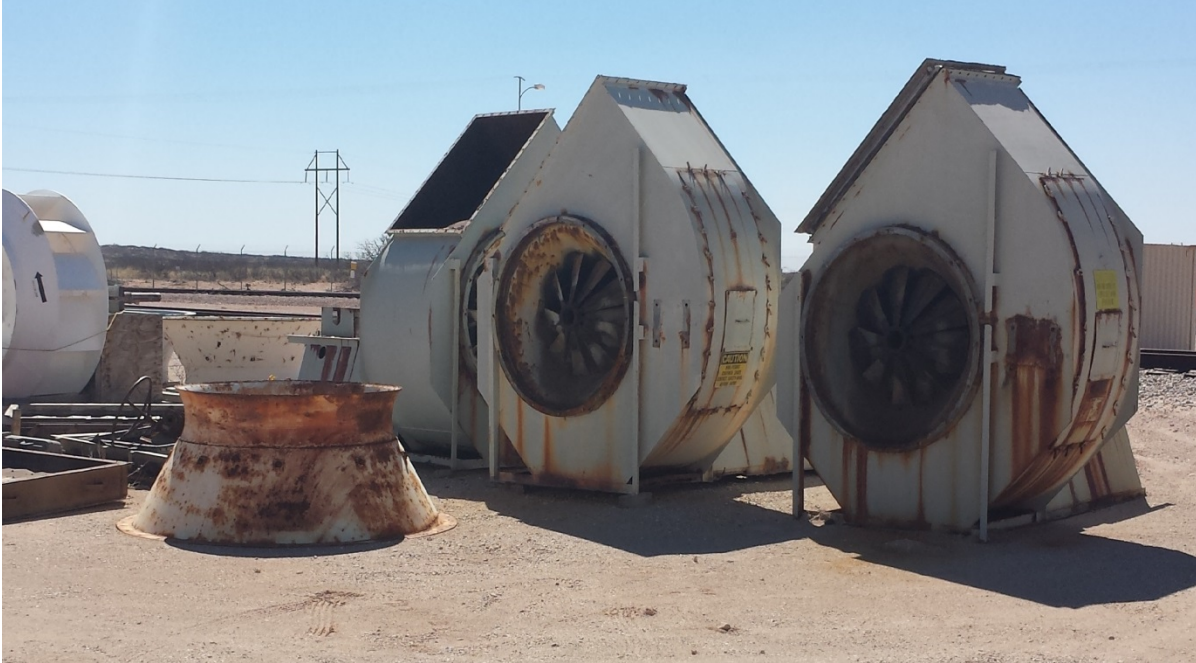
**Figure 20: 700 A and 700 B Removed**

Main exhaust fan 700B has been out of service since May 2013 due to issues with the actuators on the isolation dampers. Main exhaust fan 700 A has been out of service since January 2014 due to bearing issues. Current plans are to replace all the major components, i.e., bearings, shaft, rotor, etc. Both fans are currently out of service. (Figure 20)

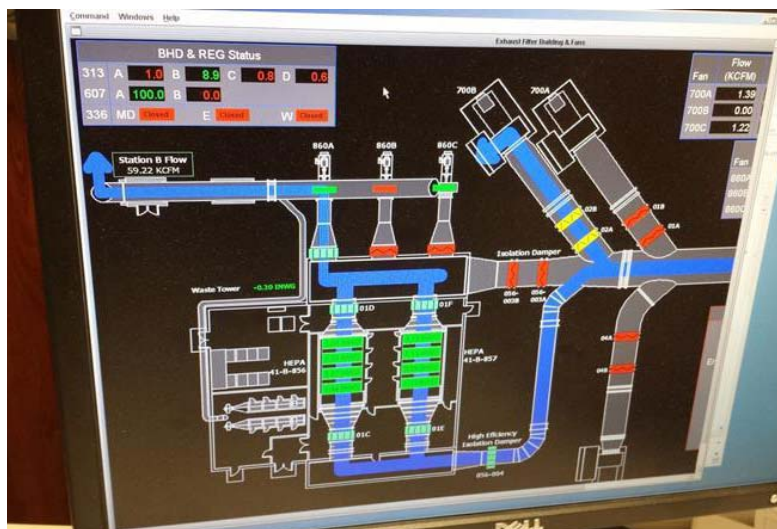
**Figure 21: Central Monitoring System (CMS)**

Additionally during the investigation, several sensor malfunctions were noted while observing the CMS. Examples include an airflow sensor in the underground that was indicating in excess of a 100,000 cfm flow, which should have been very low (approximately 5000 cfm). Another example includes the airflow through fan 700A, which is indicating greater than 150,000 cfm even though the fan was secured and the isolation dampers closed. Also, the CMS display indicates that the 700B fan is operating (open flow path) when the fan is secured and the dampers are closed. Additionally, the CMS has not been updated to reflect the current underground configuration with new construction of Panel 8 and adjacent bulkhead locations. (Figure 21)
