Long-Term Evaluation of SSL Field Performance in Select Interior Projects

February 2017

Pacific Northwest National
Laboratory

PNNL-26145

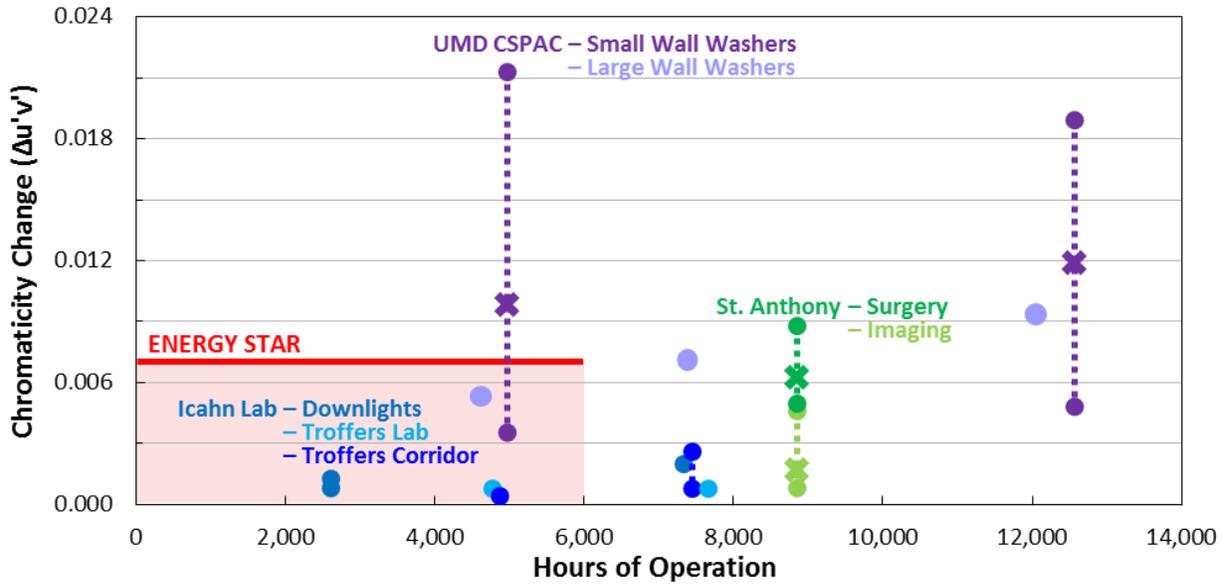
Figure ES-1. Overall chromaticity change for UMD CSPAC wall washer retrofit kits, Icahn Lab troffer and downlight retrofit kits, and St. Anthony replacement lamps based on the hours of operation at the time the measurements were collected. The average chromaticity change is marked by an X, while the minimum and maximum values are marked with circles, connected by a dotted line. If the range in performance is small, the average may not be marked and the circles may overlap.

For all measurement times, each site has measurement points that are below the red horizontal line in Figure ES-1, indicating the chromaticity change is less than the ENERGY STAR standard of 0.007. (This standard was used as a reference for comparison; the product manufacturers did not necessarily claim that their products met this standard.) The retrofit products in UMD’s CSPAC exhibited substantially greater color shift than the other products; most of the measurement points are above the 0.007 line. After the third round of measurements (at least 12,000 hours of operation), the small wall washer products had an average $\Delta u'v'$ value of 0.0118 compared to the initial set of measurements. Although the chromaticity shift measured for the LED retrofit kits at the UMD’s CSPAC was greater than expected, the fact that the products have operated for more than 17,000 hours without any required maintenance satisfied the project goals for the university. The incumbent halogen lamp system would have required numerous lamp replacements during the same period, with much greater energy use.

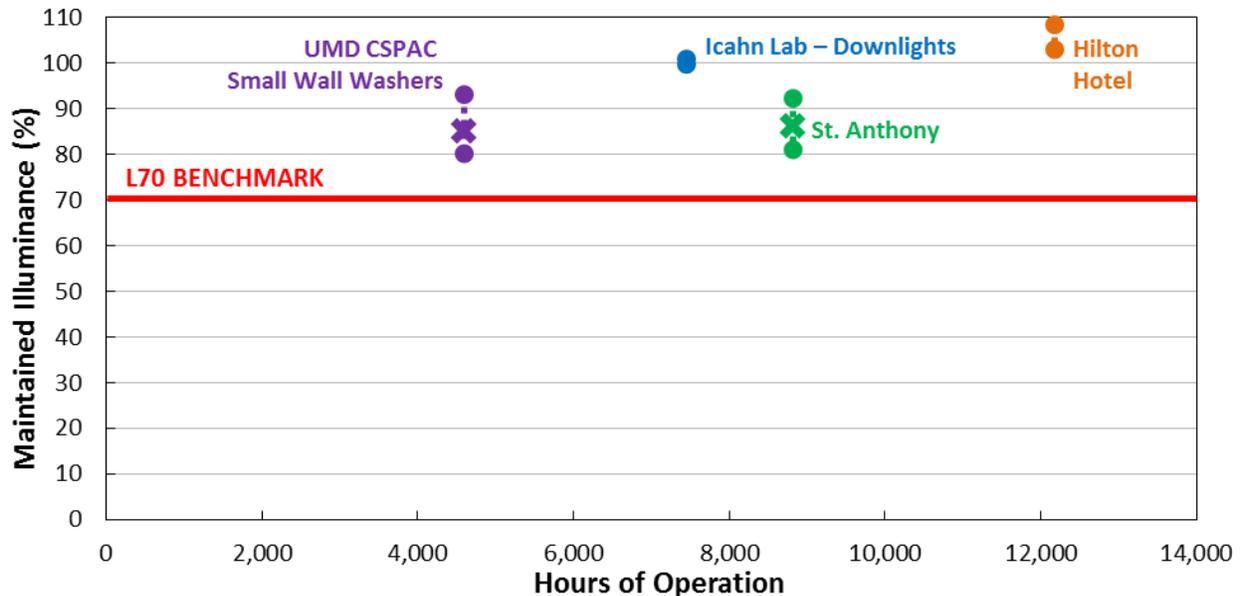
Figure ES-2 shows the overall maintained illuminance for each of the sites based on the estimated hours of operation at the time measurements were collected. At the Hilton Hotel, the LED downlights provided sufficient lighting to satisfy IES task requirements after both sets of measurements, and all maintained illuminance values were significantly greater than the benchmark 70%; in fact, all of the values increased. In comparison to other downlight options, CFLs typically have a 10,000 hour rated life; thus, at least half of the lamps would have been expected to be replaced within the first 12,100 hours of data. At the Icahn Lab, illuminance levels after 7,400 hours of operation were also the same if not slightly greater than the initial levels with a maintained uniformity ratio. The average illuminance for the integral LED lamps at St. Anthony Hospital decreased but still met the relevant IES requirements after 8,800 hours. While the illuminance produced by the retrofit kits installed in

Figure ES-2. Overall maintained illuminance for the Hilton Hotel new downlights, UMD CSPAC wall washer retrofit kits, Icahn Lab downlight retrofit kits, and St. Anthony replacement lamps based on the hours of operation at the time the measurements were collected. The average maintained illuminance percentage is marked by an X, while the minimum and maximum values are marked with circles, connected by a dotted line. If the range in performance is small, the average may not be marked and the circles may overlap.

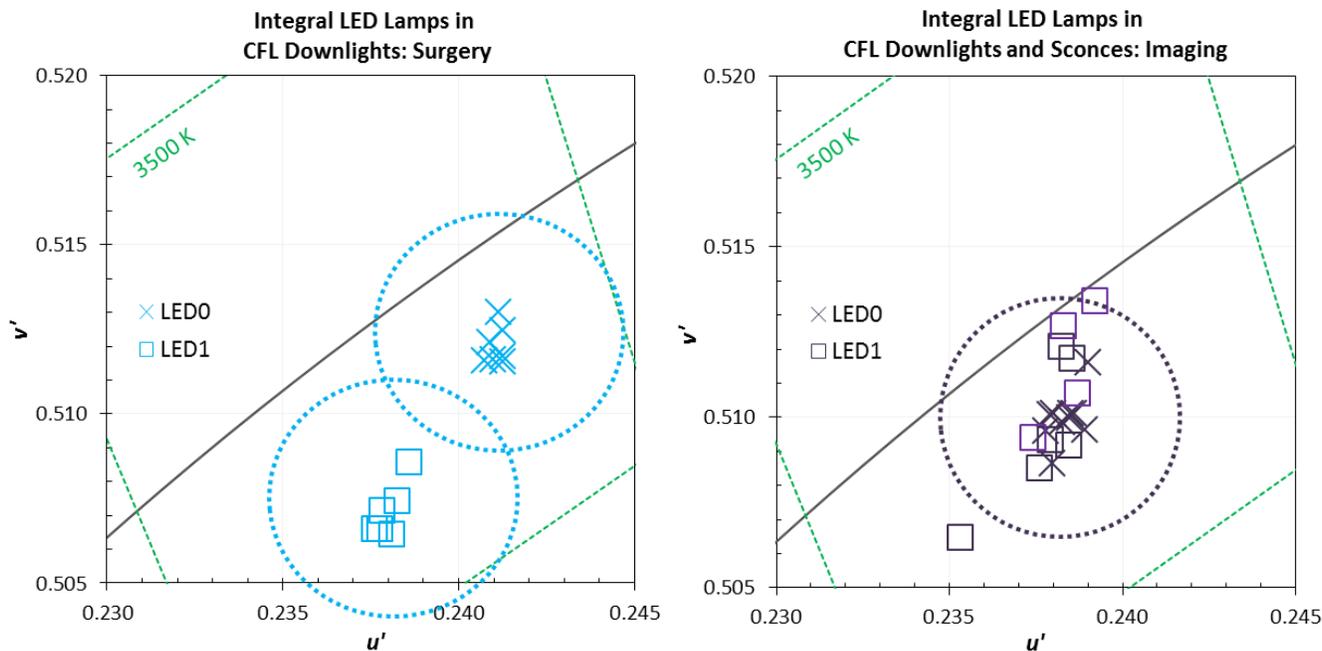
Figure 2. Chromaticity coordinates for 7 downlights in a surgery waiting area (left) and 10 fixtures in the imaging changing rooms (right) at St. Anthony Hospital plotted on 1976 CIE uniform color space (UCS) (u' , v') chromaticity diagram with MacAdam ellipses. The circles have a radius of 0.0035 in the (u' , v') chromaticity diagram to approximate a 3.5-step MacAdam ellipse, where the step size refers to the distance from the center of the ellipse to the perimeter. The circles are centered on the average u' and v' coordinates for each set of measurements. For the surgery downlights, the tight clustering of the chromaticity coordinates at each of the two measurement times shows that, although the average chromaticity shifted over time, it shifted consistently among the luminaires measured and remained within the 3500 K ANSI bin.¹² Unlike the downlight luminaires in the surgery waiting area, the LED1 measurements for the downlight and sconce luminaires in the imaging rooms are not tightly clustered; instead, the follow-up measurements indicate a range in color performance, with a spread that is greater than seven steps (i.e., outside of a 3.5-step ellipse). Despite this variation, all of the fixtures remained within the 3500 K ANSI bin.

For the six downlights and four wall sconces in the imaging rooms (right graph, Figure 2), the average $\Delta u'v'$ from the initial to follow-up measurements was 0.0017 and the maximum was 0.0045, well within ENERGY STAR requirements. In terms of $\Delta u'v'$, these fixtures are shifting less in chromaticity over time than those in the surgery waiting area, perhaps because they have operated for fewer hours since the area is individually controlled and the lights are turned off after hours. However, they are not shifting as homogeneously as the waiting area, thus their color difference may be more noticeable. The variability in fixture types and corresponding measurement techniques are also possible (even likely) explanations for the differences from the surgery area.

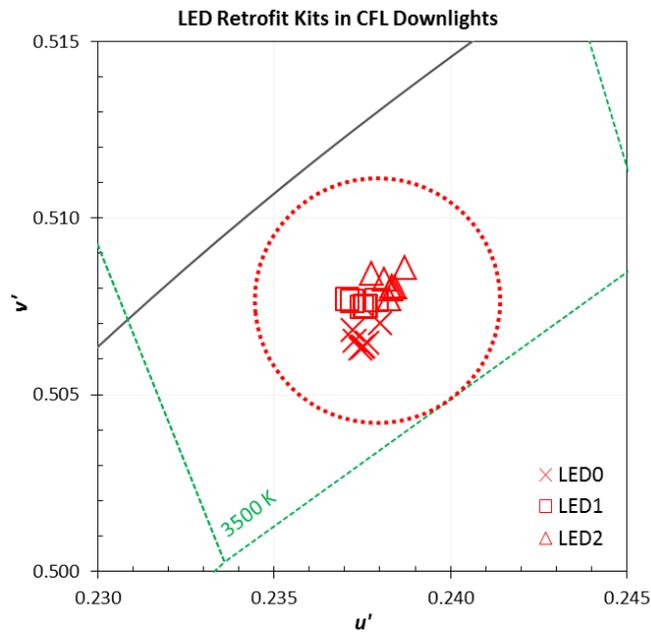
The average CCT changed from 3496 K initially to 3454 K after 7,400 operating hours, and the average D_{uv} changed from -0.0036 to -0.0030. These changes in CCT and D_{uv} are very small, likely within the measurement uncertainty, and would probably not be noticed by most building occupants. The $\Delta u'v'$ values were, on average, 0.0010 after 2,600 hours and 0.0018 after 7,400 hours, confirming that the color properties have remained stable. Figure 3 shows the u' and v' chromaticity coordinates of the seven downlights at each of the three measurement times. The graph illustrates that the chromaticity changes are small.

Figure 3. Chromaticity coordinates for the LED downlight retrofit kits in the Icahn Lab plotted on 1976 CIE uniform color space (UCS) (u', v') chromaticity diagram with MacAdam ellipses. The diagram shows the coordinates for the seven measured downlights at each of the three measurement times, in relationship to the ANSI bin for 3,500 K products. The circle has a radius of 0.0035 in the (u', v') chromaticity diagram to approximate a 3.5-step MacAdam ellipse, where the step size refers to the distance from the center of the ellipse to the perimeter. The circle is centered on the average u' and v' coordinates. The tight clustering of the chromaticity coordinates at each of the measurement times shows that all products remained fairly well grouped.

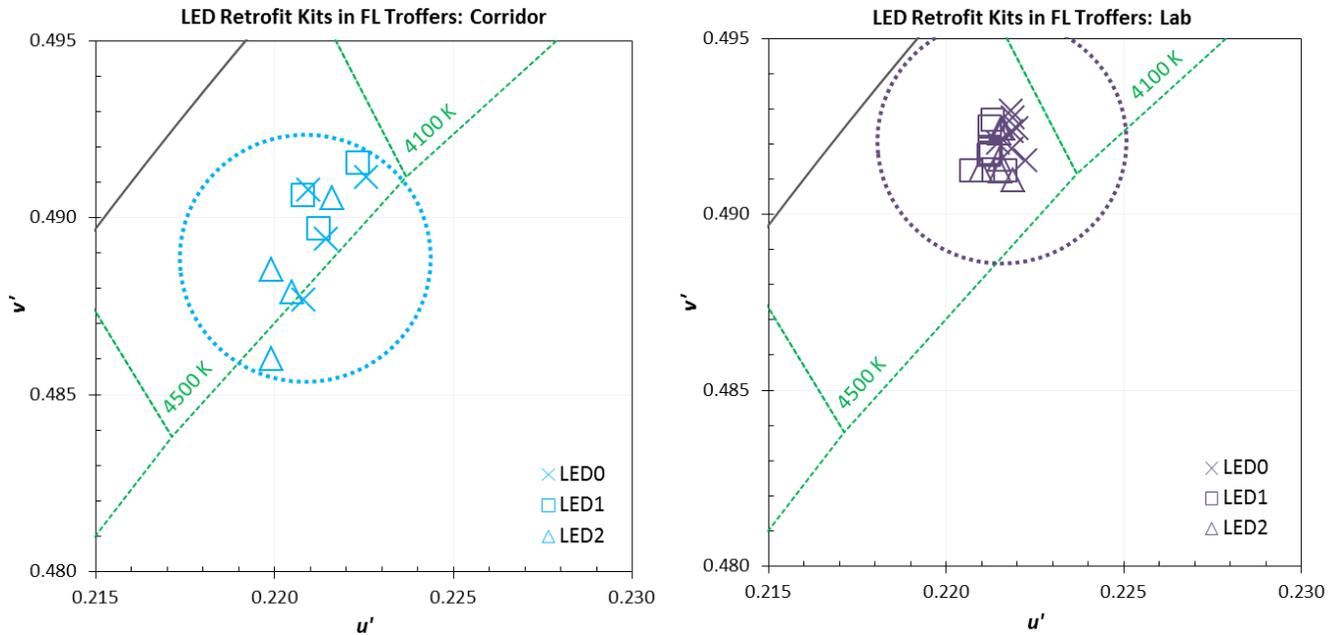
Figure 4 illustrates the shift in chromaticity for the troffer retrofit kits in the corridor luminaires (left) and the lab luminaires (right). The $\Delta u'v'$ values for both sets of fixtures after 7,400 hours were below the ENERGY STAR specification of 0.007, but there was a greater shift in chromaticity for the corridor luminaires.

Figure 4. Chromaticity coordinates for the LED troffer retrofit kits in the Icahn Lab plotted on 1976 CIE uniform color space (UCS) (u', v') chromaticity diagram with MacAdam ellipses. The diagram on the left shows the coordinates for the corridor luminaires at each of the three measurement times, while the diagram on the right is for the lab luminaires. The circles have a radius of 0.0035 in the (u', v') chromaticity diagram to approximate a 3.5-step MacAdam ellipse, where the step size refers to the distance from the center of the ellipse to the perimeter. The circles are centered on the average u' and v' coordinates for each set of measurements. The circles indicate that for both sets of luminaires, the shift in chromaticity is within seven steps. The lab hours are assumed to be less than those in the corridor, which could explain the more tightly grouped performance in the diagram on the right.

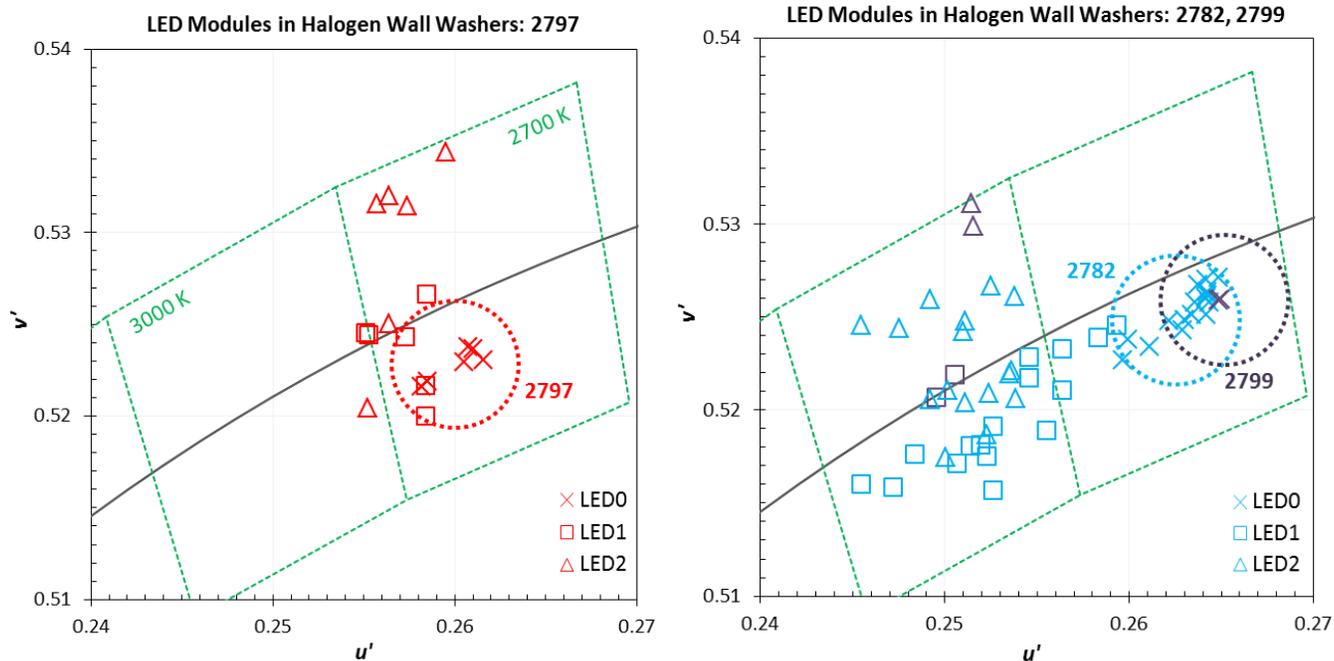
The small wall washers had an initial average CCT of 2718 K with a range of 167 K and an average D_{uv} of -0.0017; after 4,600 estimated operating hours, these luminaires had an average measured CCT of 2927 K with a range of 402 K and an average D_{uv} of -0.0015. The third set of measurements, after an additional 7,400 hours (12,000 hours total), revealed an average CCT of 2930 K with a range of 383 K and an average D_{uv} of -0.0016. The CRI and R_9 values remained relatively consistent, as delineated in Table 5. However, the chromaticity shift, $\Delta u'v'$, ranged from 0.0033 to 0.0212 after 4,600 operating hours with 16 modules exceeding the ENERGY STAR maximum of 0.007; $\Delta u'v'$ ranged from 0.0046 to 0.0187 after 12,000 hours with all but three of the 24 modules exceeding 0.007. For the large wall washers, the average CCT increased from 2701 to 2801 K, with the average D_{uv} changing from -0.0028 to 0.0038. The chromaticity shift ($\Delta u'v'$) ranged from 0.0049 to 0.0081 after the first follow-up measurements and increased to 0.0092 after 12,000 hours. Figure 5 and Figure 6 show the chromaticity coordinates for the light exiting the small and large wall washers at the three different measurement times. After the second round of measurements (LED1), the small wall washers in hallway 2782 and area 2799 were generally shifting toward blue, while those in hallway 2797 remained relatively stable. Despite the initial blue shift, the third round of measurements (LED2) indicated a yellow shift, shown more clearly in Figure 5. The large wall washers in hallway 3797 (Figure 6) indicated trends similar to those in hallway 2797.

Figure 5. Chromaticity coordinates for the small wall washers at UMD CSPAC plotted on 1976 CIE uniform color space (UCS) (u',v') chromaticity diagram with MacAdam ellipses. The diagram on the left shows the chromaticity coordinates of the light exiting the wall in hallway 2797 while the diagram on the right is for hallway 2782 and area 2799. In August 2014, the six modules in hallway 2797 (graphed on the left) had been operating for 700 hours whereas 18 of the modules in hallway 2782 and area 2799 (on the right) had just been installed. The circles have a radius of 0.0035 in the (u', v') chromaticity diagram to approximate a 3.5-step MacAdam ellipse, where the step size refers to the distance from the center of the ellipse to the perimeter. The circles are centered on the average u' and v' coordinates for each set of measurements.

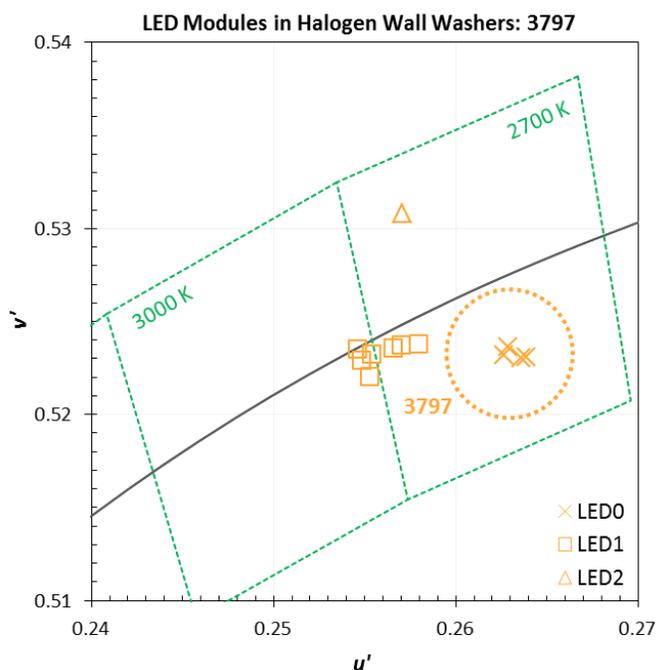
Figure 6. Chromaticity coordinated for the large wall washers at UMD CSPAC plotted on 1976 CIE UCS (u',v') chromaticity diagram with MacAdam ellipses. The diagram shows the chromaticity coordinates of the light exiting the wall in hallway 3797. In August 2014, two modules were installed in one fixture; the rest were installed in March 2015 with follow-up measurements taken in March 2016.

The 3.5 step MacAdam ellipses indicate that the products generally shifted more than the diameter of the ellipses (seven steps) from the original measurements and also inconsistently, causing noticeable color differences. The color shift crossed the blackbody in both directions, indicated by the negative and positive D_{uv} values, which visually manifest as pink and green tints (demonstrated in the photo in Figure 7).

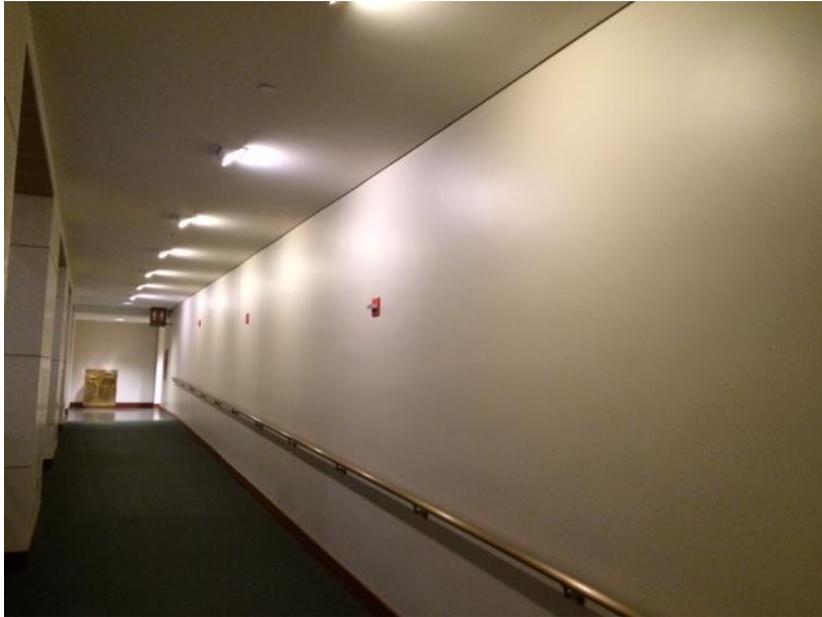
Figure 7. Disparity in color shift shown in a photograph taken during the LED2 measurements. Note: While photographs do not ensure exact replication of the conditions, this image gives an idea of the noticeable color difference.

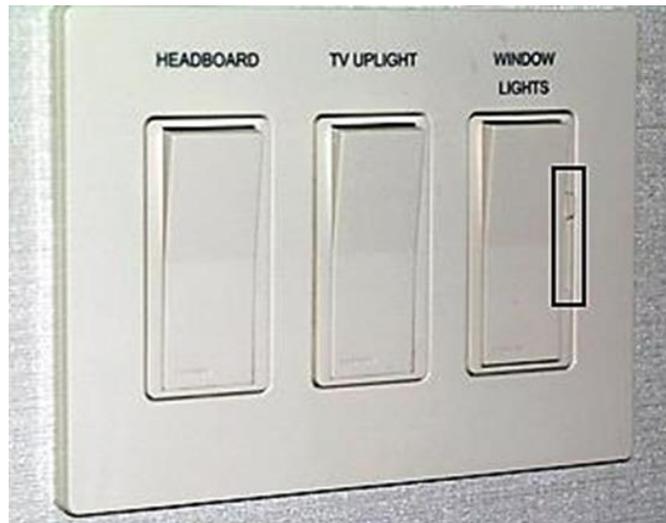
Dimming controls are the only element of the LED lighting solution that has caused guests to complain. Guests occasionally are confused about the dimming capability, maybe because the slide dimmer that controls the downlights in the seating area is relatively small and located alongside a conventional rocker switch (see Figure 8). Hilton staff believes that a different style of dimmer with more obvious functionality would make it easier for guests to adjust the lighting.

Figure 8. Lighting controls in the guest rooms at the Columbus Downtown Hilton. The switch marked “Window Lights” controls two LED downlights with an on/off rocker switch and a small slide dimmer located next to the rocker switch (outlined in a box in the photo). Some guests are confused by the controls and do not understand the dimming functionality and control.

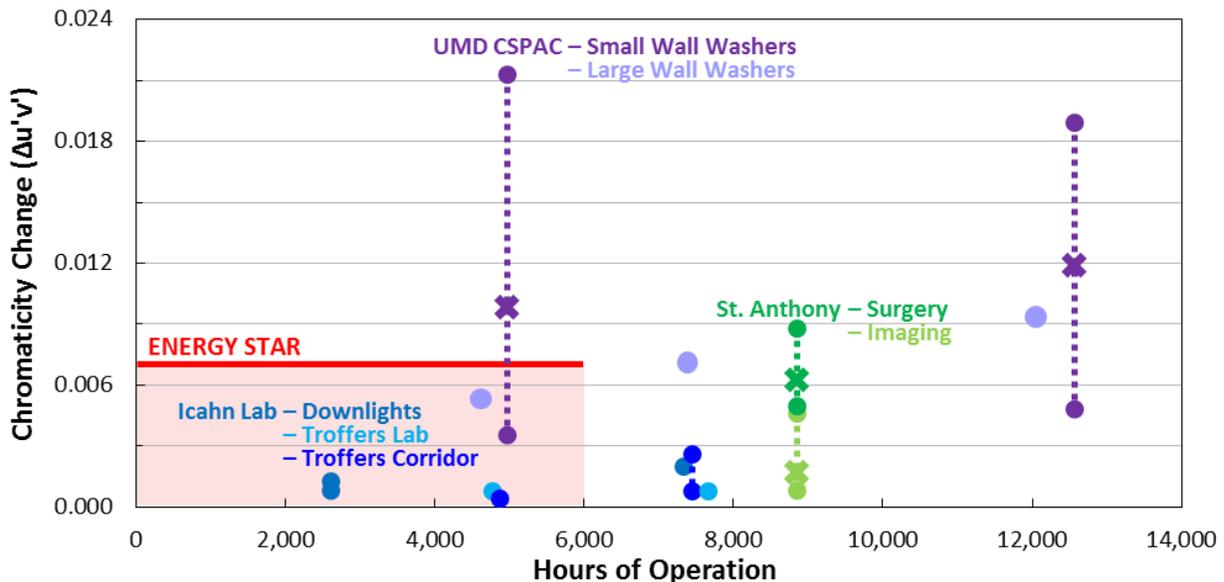
Figure 9. Overall chromaticity change for UMD CSPAC wall washer retrofit kits, Icahn Lab troffer and downlight retrofit kits, and St. Anthony replacement lamps based on the hours of operation at the time the measurements were collected. The average chromaticity change is marked by an X, while the minimum and maximum values are marked with circles, connected by a dotted line. If the range in performance is small, the average may not be marked and the circles may overlap.

For all measurement times, each site has measurement points that are below the red horizontal line in Figure 9, indicating the chromaticity change is less than the ENERGY STAR standard of 0.007. The ENERGY STAR criterion is perhaps the only defined criterion for chromaticity shift. It is a reasonable starting point, but may not be strict enough to ensure very high-quality lighting, especially since the lifetimes of LED products routinely far exceed 6,000 hours. This level of difference is readily noticeable in many interior lighting settings, if two lamps with that level of difference are viewed simultaneously and in relative proximity. However, if all the lamps in a room undergo a change of that magnitude—and in the same direction—over the course of several years, the occupants may not detect that the lighting has changed, at least not until one or more of the lamps is replaced.

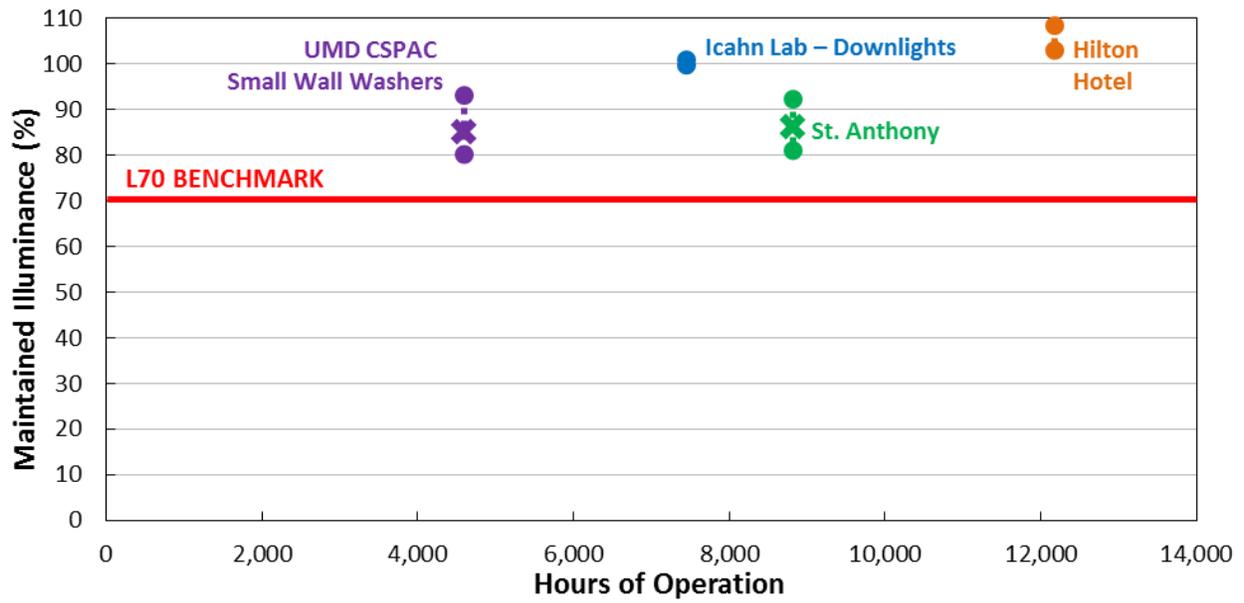
Figure 10 shows the overall maintained illuminance for each of the sites based on the hours of operation at the time measurements were collected. At the Hilton Hotel, the LED downlights provided sufficient lighting to satisfy IES task requirements after both sets of measurements; all maintained illuminance values were significantly greater than the benchmark 70%; in fact, all of the values increased. In comparison to other downlight options, CFLs typically have a 10,000 hour rated life; thus, at least half the lamps would have been expected to be replaced within the first 12,100 hours of data. At the Icahn Lab, illuminance levels after 7,400 hours of operation were also greater than the initial levels with a maintained uniformity ratio.²¹ The average illuminance for the integral LED lamps at St. Anthony Hospital also still met the relevant IES requirements after 8,800 hours.²² While the retrofit kits installed in UMD's CSPAC varied in performance, the illuminance was above 70% of initial after an estimated 5,000 operating hours.²³ Although additional illuminance data was not collected, after 17,000 hours of operation only one of the 135 modules may need to be replaced, whereas the incumbent halogen lamps with a 1,500 hours rated life would have been replaced 11 times within the first 17,000 hours. Thus, from an energy and maintenance savings standpoint, the conversion was worthwhile.

Figure 10. Overall maintained illuminance for the Hilton Hotel new downlights, UMD CSPAC wall washer retrofit kits, Icahn Lab downlight retrofit kits, and St. Anthony replacement lamps based on the hours of operation at the time the measurements were collected. The average maintained illuminance percentage is marked by an X, while the minimum and maximum values are marked with circles, connected by a dotted line. If the range in performance is small, the average may not be marked and the circles may overlap.
