SSL EVALUATION

Area Lighting Yuma Sector Border Patrol Area, AZ

A unique GATEWAY evaluation on a stretch of border between the U.S. and Mexico looked at how high-flux LED lighting performed over nearly four years in a high-temperature environment.

DOE/EE-1780 · April 2018

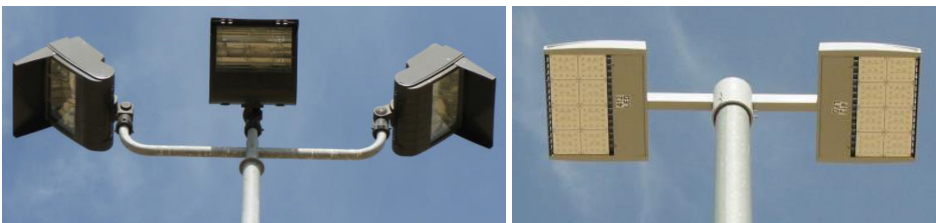
Incumbent QMH luminaires (left) and LED luminaires (right). Because pole diameter narrowed as the height increased, a custom tenon was necessary to fit the diameter of the pole after it was shortened.

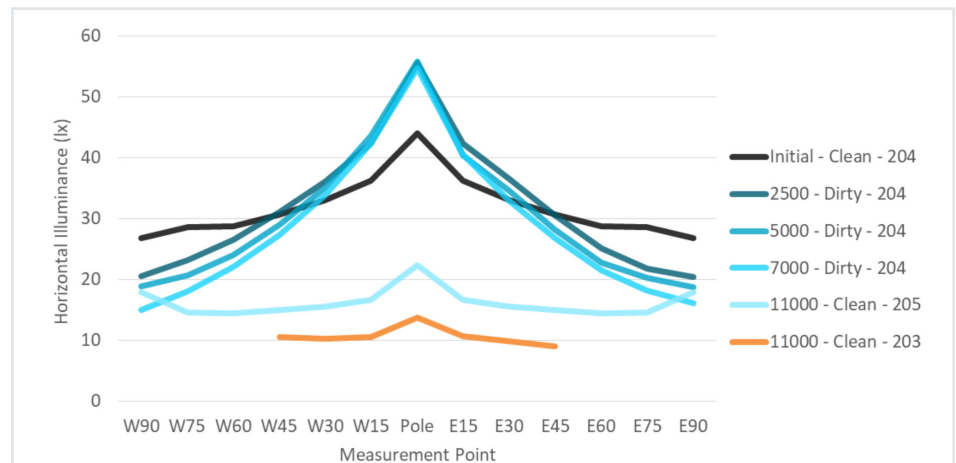
these luminaires in a clean state at 11,000 hours was found to have decreased by more than 50% compared to initial measurements after installation. While several possible reasons for this unexpected result are explained in the report, the root cause remains unknown.

Illuminance levels produced by the first-generation luminaires decreased dramatically between 7,000 and 11,000

Measured illuminances along east-west line centered at pole 204 at four different measurement times, and for poles 205 and 203 at 11,000 hours. The trial installation luminaires were initially clean, and then cleaned again at 11,000 hours. The numeric values in the labels along the horizontal axis indicate the distance from the pole in feet, and the letter indicates the direction (east or west) from the pole. Illuminance values were normalized for a 25 °C (77 °F) condition.

operating hours. The root cause for this is not known at this time. It may be that the causes were related to the unique conditions of the trial installation of first-generation luminaires, but it also may be that the high-temperature environment contributed to these effects.

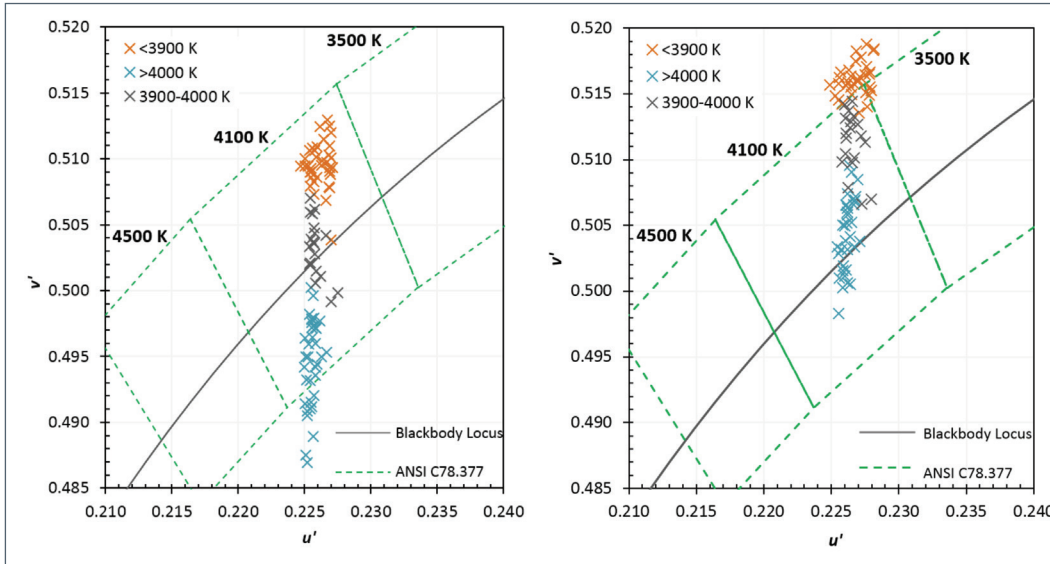
Second-generation LED lighting system chromaticity: initial (left) and 4,000 hours (right). The chromaticity coordinates are plotted on the CIE 1976 Chromaticity Diagrams (u' , v'). The diagrams are scaled to isolate the 4100 K range of the ANSI C78.377-2017 bin, outlined in green. Colored data points represent the initial CCT values: orange < 3900 K, 3900 K ≤ gray ≤ 4000 K, blue > 4000 K.

Over 4,000 hours of operation, the measured spectral power distributions (SPDs) and related color characteristics for the second-generation luminaires changed to a greater extent than expected. The high-temperature environment in Yuma may have caused, or at least contributed to, these effects, although luminaire design characteristics can also contribute to accelerated shifts in SPD.

The second-generation luminaires exhibited color-over-angle variability that produced noticeable color differences on the illuminated sand beneath the system. Determination of SPD and related color metrics at different angles is not currently included in standardized
