Tribal Renewable Energy - Final Report

Project Title: Uk'e koley (*No Footprints*) Project

Through this award an Energy Audit and Renewable Energy Strategy Report for 14 Tribally-Owned Buildings of the Chickaloon Village Traditional Council was produced. This document included energy, heating and pollution audits; tips on how each location might be more energy efficient with the existing infrastructure; renewable energy assessment for the Tribal buildings; economic analysis of the costs of retrofitting Tribal buildings; and a conceptual design for retrofitting Tribal buildings. Also an Energy Efficiency Upgrade Cost Assessment was calculated including a cost benefit analysis of adding renewable energy systems to heat several Tribal buildings at one site. Finally, the third main result of this award was the Tribal capacity building and subsequent management of the Tribal alternative energy systems already in place, including securing a net metering agreement between the regional electric cooperative and the Tribe. This agreement required the electric cooperative to credit the Tribe for any power produced by one of the Tribe's existing solar arrays and used by the grid.

FINAL REPO

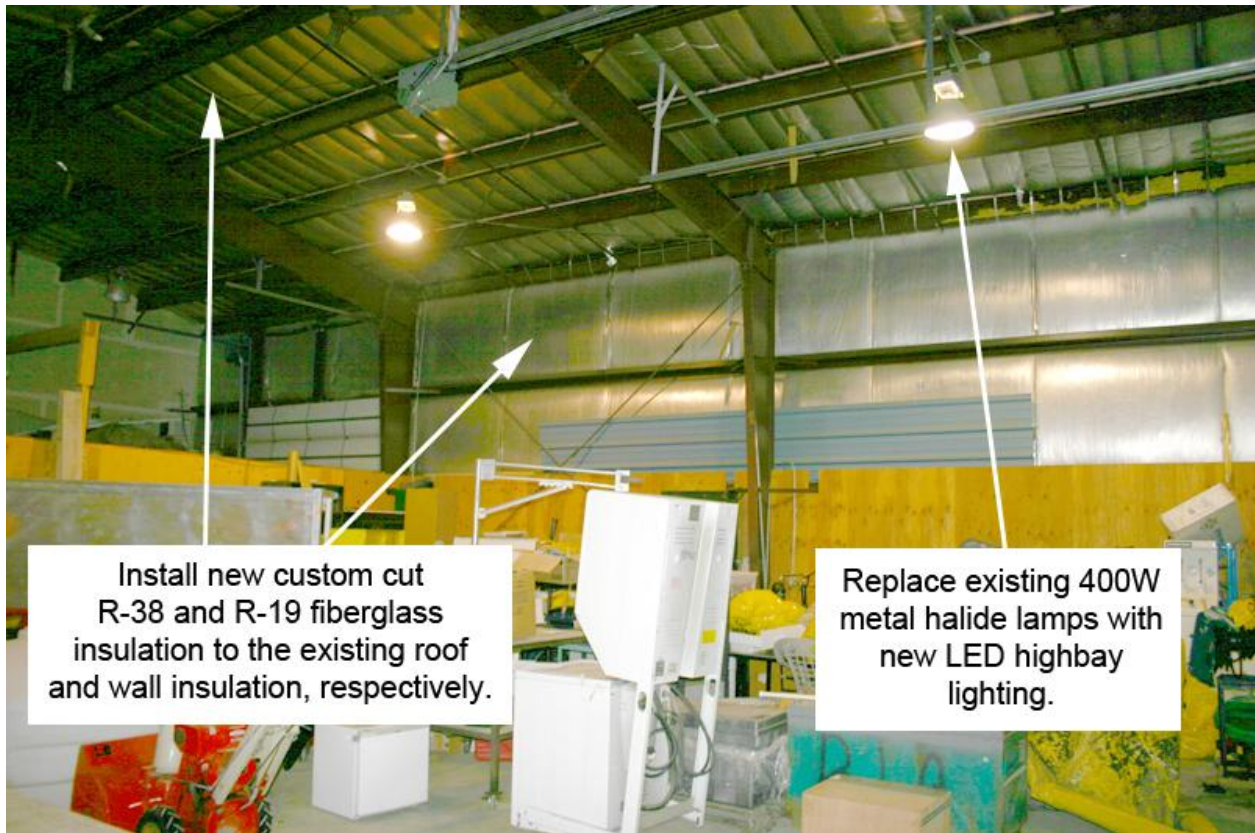
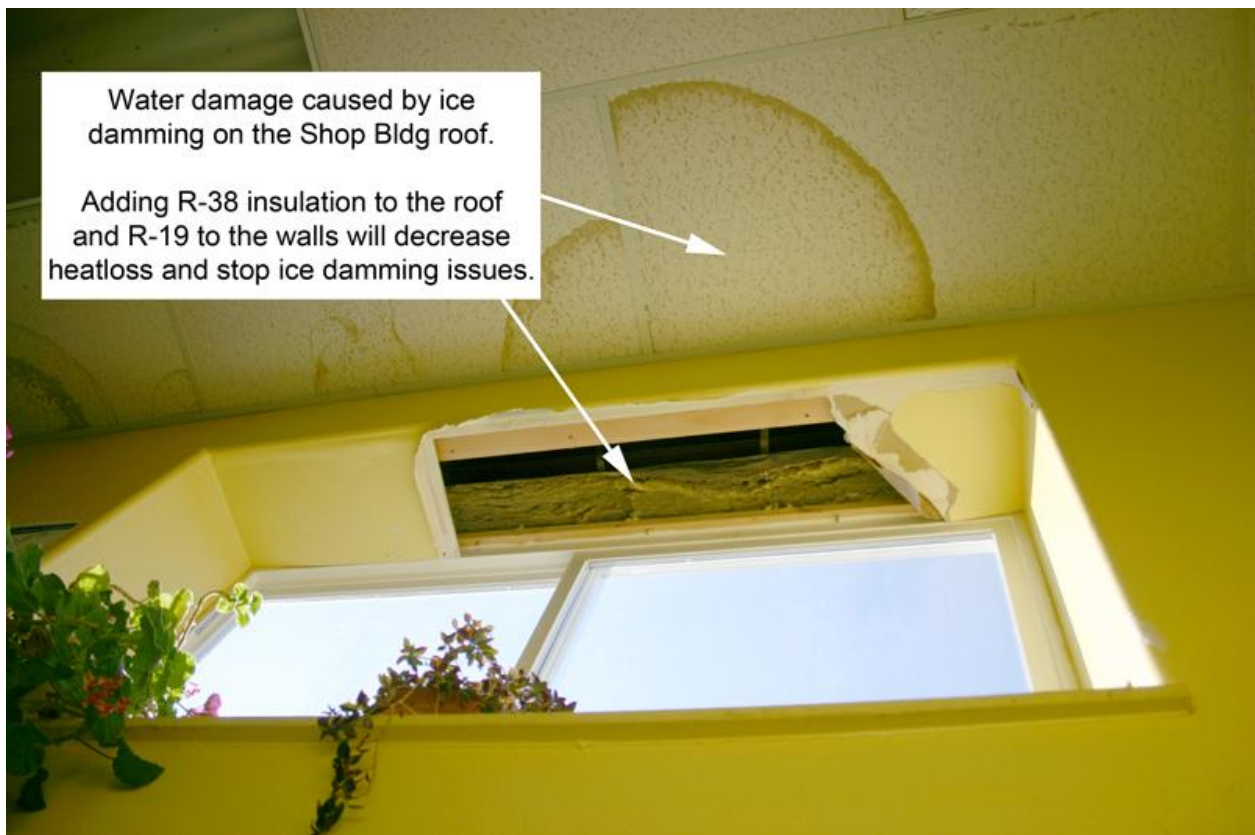
1.1. RECOMMENDATIONS FOR BUILDING ENVELOPE

Building Insulation: The Shop Bldg is significantly under insulated in the roof, walls, foundation walls and floor slab, compared to the current BEES standards. The building was built when energy was much cheaper than it is today, and it was not insulated to the current insulation standards. Due to its under insulated roof, the building has been experiencing major ice damming issues that have caused water damage on the southeast side of the building.

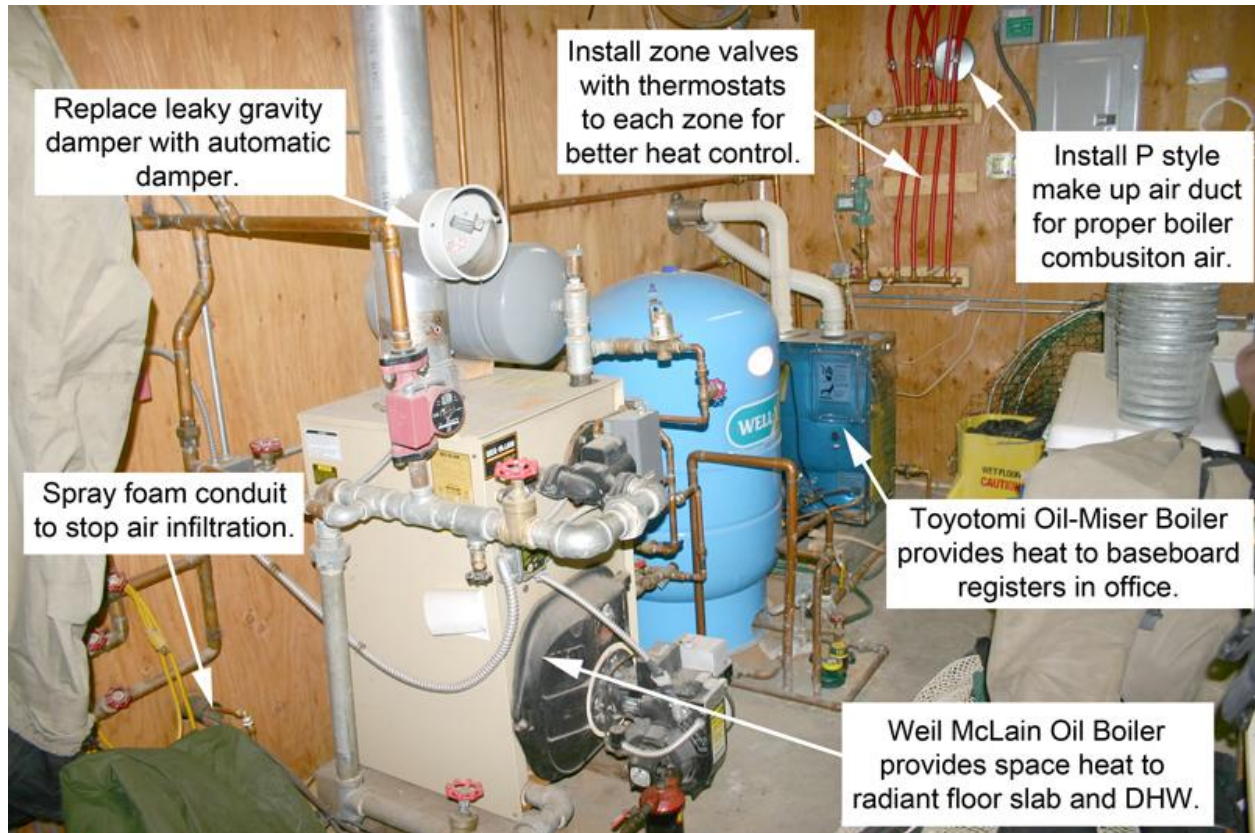
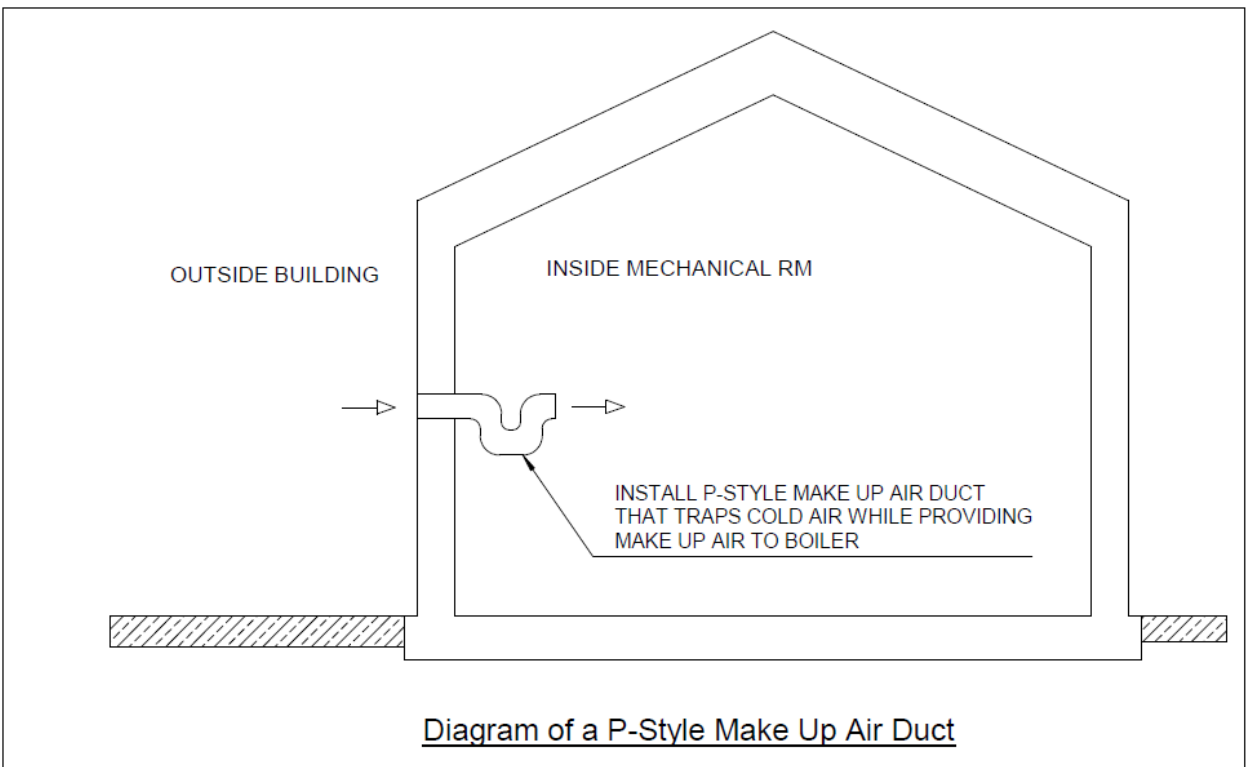
1.2. RECOMMENDATIONS FOR MECHANICAL EQUIPMENT

Mechanical Equipment: There are two oil boilers that provide heat to the shop building. The original Weil-McLain Oil Boiler heats the large concrete radiant floor slab and also provides heat for the DHW in the building. The Toyotomi Water Heater was installed when the office space was built and heats four zones with baseboard registers. Both oil boilers have over 80% efficiency and appear to be working well.

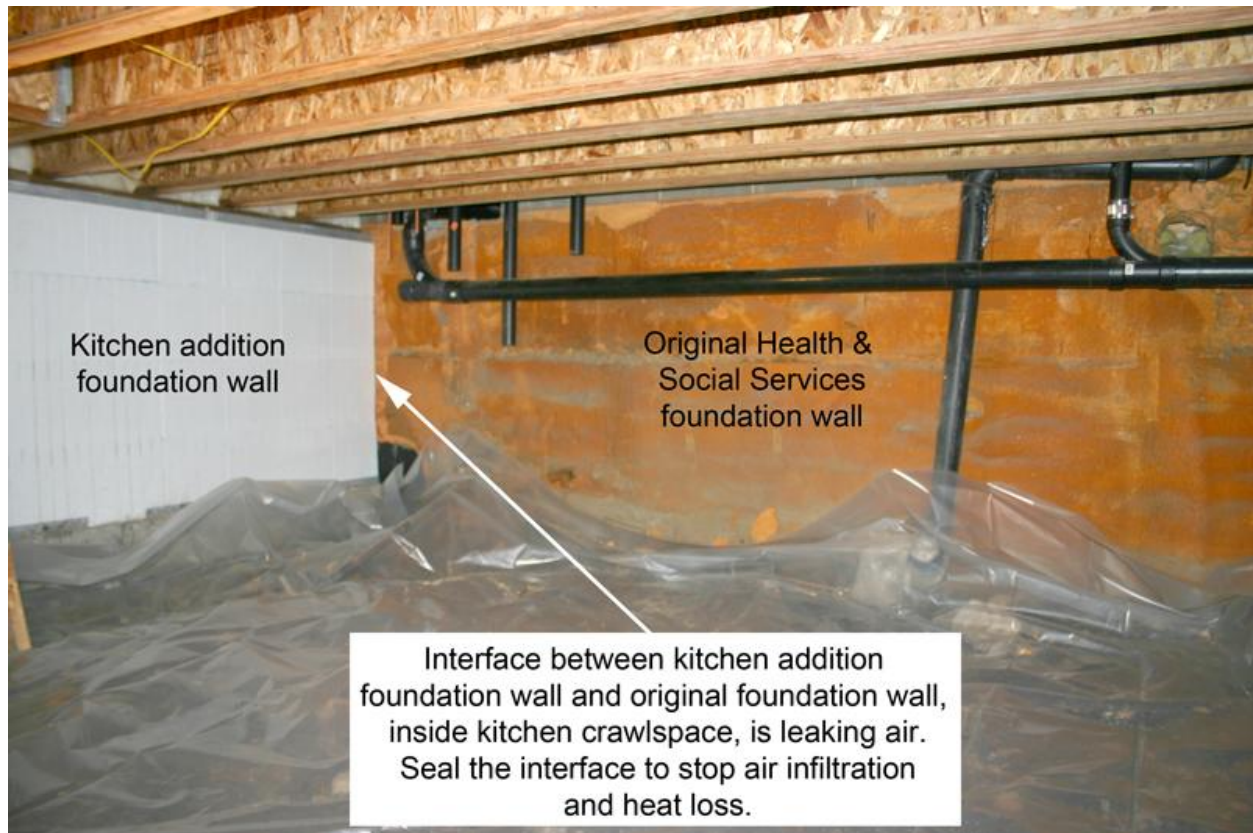
4.1. RECOMMENDATIONS FOR BUILDING ENVELOPE

Building Insulation: Overall, the building envelope is well insulated, except for the original building's foundation walls. The ceiling of the original building was recently remodeled with a proper R-38 roof and vapor barrier. The kitchen addition is constructed with proper insulation in the roof, walls and foundation walls. The original building's foundation wall insulation is below the BEES standard and energy savings could be made by upgrading this insulation.

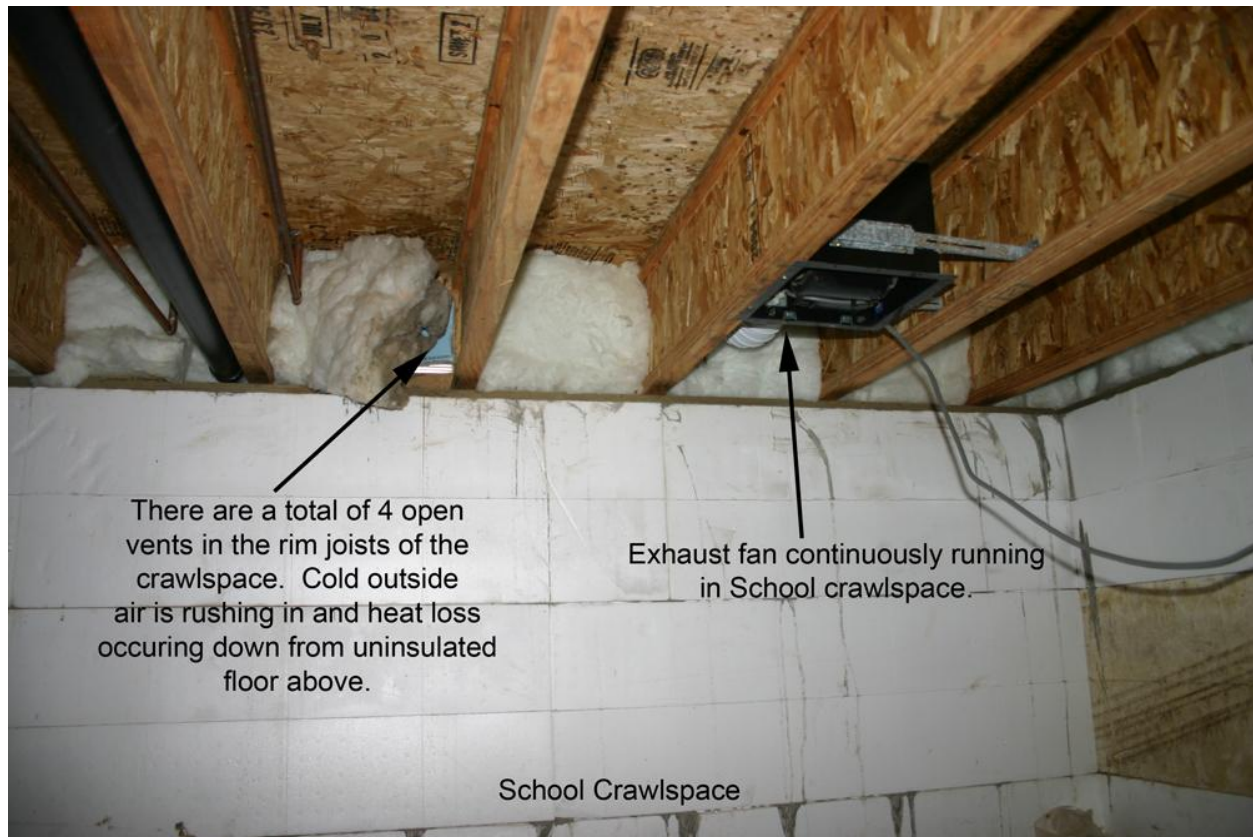
5.1. RECOMMENDATIONS FOR BUILDING ENVELOPE

Building Insulation: Overall, the building envelope is well insulated and well sealed, except for the crawlspace which has several large sources of air leakage.

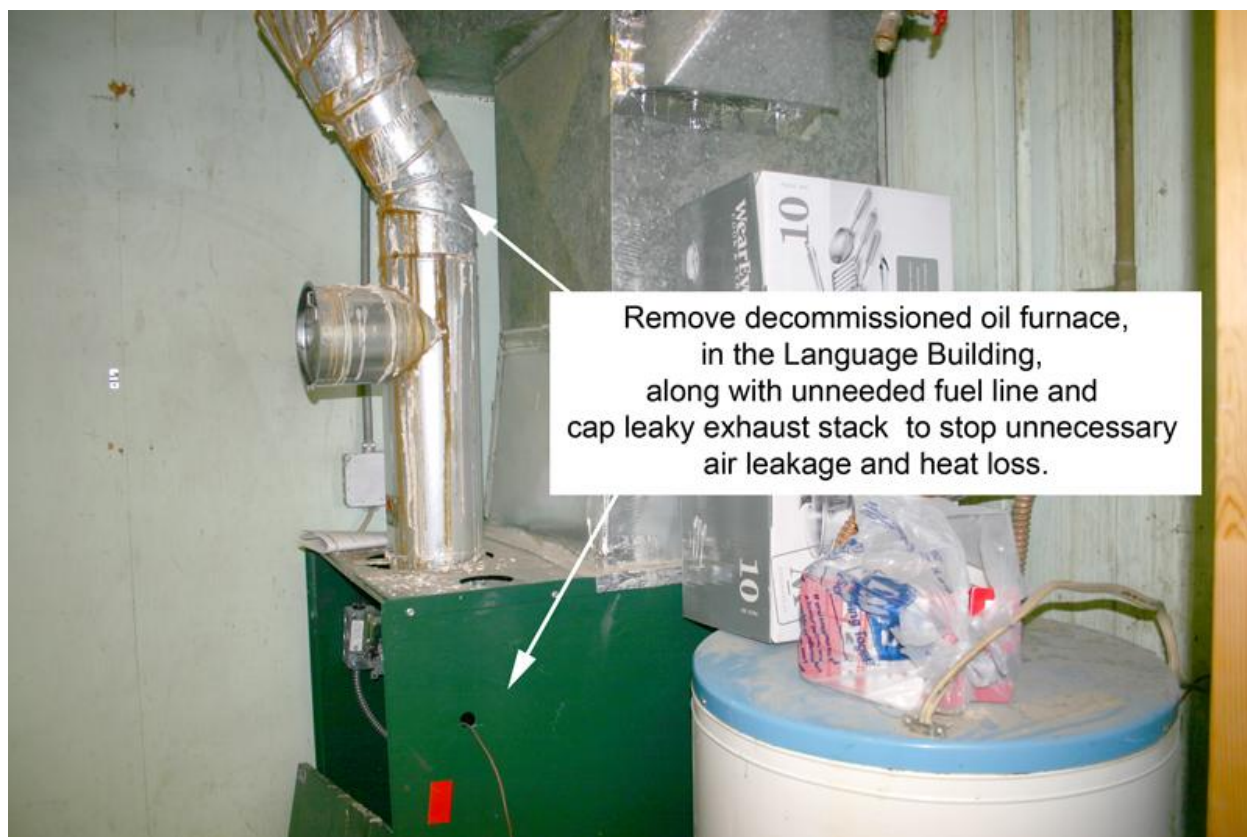
6.1. RECOMMENDATIONS FOR BUILDING ENVELOPE

Building Insulation: The existing insulation of the Language Bldg is significantly under the BEES insulation standards.
