OES 2019-02

June 2019

## The Importance of Reporting Near Misses

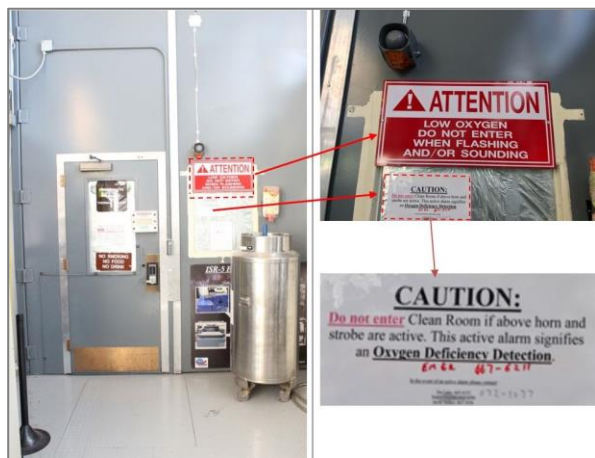
On September 13, 2017, a Subject Matter Expert (SME) entered a room at LANL while a low oxygen alarm was activated. The SME was responding to the alarm and, on arrival to the entrance of the room, identified a relief valve on the thermal vacuum system that was releasing liquid nitrogen inside the room. The SME isolated the relief valve by turning the supply valve off, placing the system in a safe configuration, and then left. The low oxygen alarm stopped sounding within 20 minutes of the SME isolating the relief valve. This was an incorrect response to the alarm. The SME exhibited a lack of adherence to and knowledge of the requirement that prohibited entry into the room during the activation of the low oxygen alarms. The low oxygen alarm posting in the room was located at a height of 11 feet--a height where it was not obvious to workers--and did not include any contact information. Additionally, the building emergency plan had not been updated to reflect the low oxygen alarm emergency response requirements for the room. Following this incident, a power disconnect emergency shut-off switch was installed next to the room entry door, which will close the main liquid nitrogen tank and the associated valves during an emergency. The sign was relocated to eye-level height and modified to include contact information (see photo 2). The building emergency plan was updated. Personnel were instructed to not enter the room when the low oxygen monitors are sounding an alarm, and a drill was conducted. A Lessons Learned article, ID: LANL-2017-945 was developed for this event. (ORPS Report NA--LASO-LANL-PHYSCOMPLX-2017-0001)

Photo 2. Images from Lesson Learned ID: LANL-2017-945, showing warning sign at entrance to laboratory
