OE-2: 2019-01

## Over-Pressurized Drum Event Involving Reactive Materials and Flammable Gases in Radioactive Waste

# Safety Alert

## Over-Pressurized Drum Event

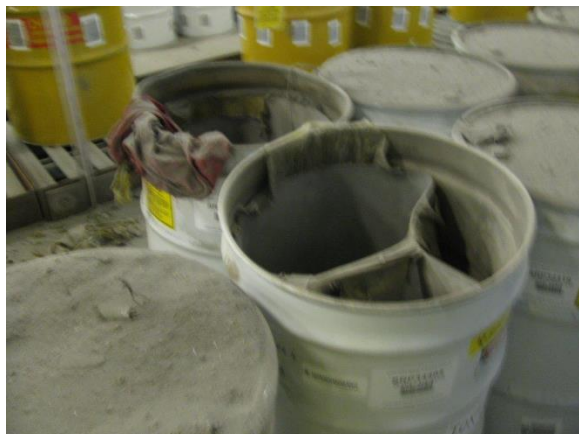
ARP V Drums

reentered the facility and discovered a total of four vented drums had experienced exothermic chemical reactions, ejecting their lids and partially ejecting the drum contents. The breaches resulted in TRU waste being spread throughout the ARP V operations area (a filtered, uncontaminated area normally occupied by workers), resulting in a radioactive high contamination area and an airborne radioactivity area.

The investigation identified the direct cause of this event as the breach of four suspect TRU waste drums in the ARP V building resulting from an oxidation reaction, initiated during drum waste repackaging during which waste containing reactive uranium was mixed with additional parent drum material and exposure to the ambient atmosphere. The initiating mechanism (heat source), based on sample results, was oxidation of the uranium metal, which then supported secondary chemical reactions (hydrolysis of beryllium carbide, which generated significant amounts of methane gas) that pressurized and breached the waste containers. [Based on analysis of the event
