OES: 2020-01

February 2020

ORPS Data Indicates Work Process Deficiencies at Active Deactivation and Decommissioning Projects

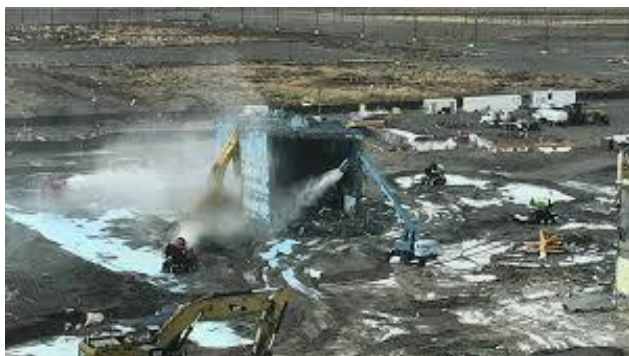
Photo 1. Demolition of the Plutonium Finishing Plant

From December 14-19, 2017, contamination was discovered outside posted radiological boundaries at the Hanford Site Plutonium Finishing Plant (PFP) demolition zone (see Photo 1), resulting in contamination to personnel and spread to uncontrolled areas.

Several factors contributed to the release and spread of contamination, including failure in expected performance with respect to decision making, rigorous use of processes, and work force communications. Significant factors included demolition activity rates exceeding work control specifications derived from computer modelling predictions of release plume migration, and diluting fixatives against manufacturer's recommendations when applying the contamination control agent at higher elevations at the Plutonium Reclamation Facility. Additionally, risks and

consequences associated with emerging and changing conditions were not adequately reviewed and evaluated, whereby the normalization of deviations became a recurrent, pervasive theme illustrated by the event.

The absence of negative performance indicators (e.g., detected airborne contamination), gave the organization a false sense of security, enabling it to increase the rate of demolition activities whose work control hazards were not adequately analyzed, documented, or controlled. (ORPS Report EM-RL--CPRC-PFP-2017-0018)

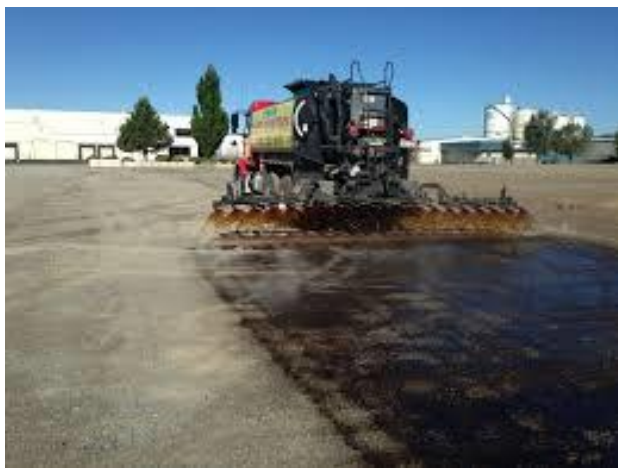
Photo 3. Application of dust palliatives for dust suppression

On the morning of March 31, 2016, during the performance of a routine boundary survey of an outdoor concrete pad on the northeast corner of C-333 (which was posted as a Contamination Area, or

CA) at the Paducah Gaseous Diffusion Plant, several small areas of contamination were discovered on gravel and tar outside the boundary. Total contamination up to 950,000 dpm/100 cm² beta/gamma was discovered. Total alpha contamination was less than the administrative limits (the limits are 5,000 dpm/100 cm² total beta/gamma

and 1,000 dpm/100 cm² total alpha). The source of radioactive contamination was determined to have come from the maintenance and storage of contaminated items between 1952 and 1990, which spread from the pad to the surrounding area. After site characterization identified an area of outdoor contamination, the concrete pad was posted for contamination between 1995 and 2004. In 2004, the surrounding area was sealed with gravel and tar (see Photo 3). When responsibility of the Paducah Gaseous Diffusion Plant was transitioned from the previous U.S. Nuclear Regulatory Commission licensee back to DOE, the pad area was posted as a CA. However, the radiological conditions of the pad and surrounding area were not completely identified, documented, or communicated by the transferring entity to DOE through routine surveys, historical evidence, etc. It was apparent that the material discovered outside the CA boundary came from deterioration of the sealant placed over the contaminated pad, and had spread outside the confines of the boundary, making it imperative to monitor the conditions of outdoor radiological areas for deterioration prior to completing the transfer of property to DOE. (ORPS Report EM--PPPO-FPDP-PGDPDEAC-2016-0004)

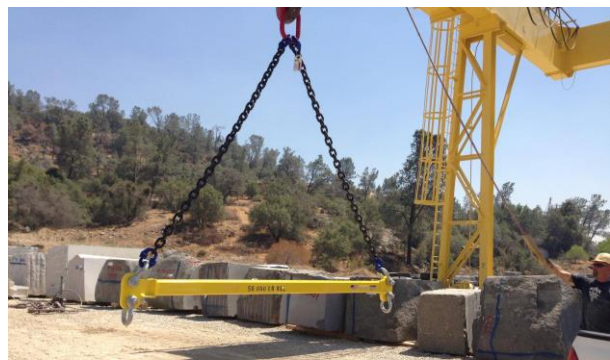
Photo 4. Example of a spreader bar used for hoisting and rigging

On July 26, 2018, a spreader bar (see Photo 4) was removed for use by another site contractor without project authorization from the Plutonium Finishing Plant (PFP) (212Z) lag yard storage area (posted Radiological Buffer Area, or RBA). Craft personnel from another site contractor had coordinated directly with a radiological control technician (RCT) to perform a radiological survey, and coordinated with Mission Support Alliance, LLC (MSA) teamsters to transport the

spreader bar for inspection and installation of inspection tags. However, the RCT surveyed a different spreader bar in the same area, not understanding which spreader bar was being requested for movement. On July 26, 2018, the spreader bar (that had not been surveyed) was loaded onto a flatbed truck and exited the PFP RBA via the normal access route and received the standard tire surveys (hand and foot equivalent for RBA egress).

Upon exiting PFP on July 26, 2018, the teamsters drove the flatbed truck from PFP to Building 6290 (MSA Ironworker loft), where the spreader bar remained in the truck. On July 30, 2018, the truck containing the spreader bar was driven to Building 2355 Stevens Drive in Richland, Washington (an offsite facility) for an unrelated job task. The spreader bar remained in the truck at all times. The truck returned the same day to Building 6290. On July 31, 2018, the spreader bar was off-loaded into the Building 6290 yard. On August 6, 2018, the spreader bar was moved to the Building 6290 rigger loft high-bay (a non-radiological area), where it was inspected and tagged.

On August 7, 2018, due to an individual concern that the spreader bar had originated at the PFP facility, a radiological survey of the item was requested and performed. During the survey activity, one localized area of removable contamination was identified. The section of the bar was wrapped in plastic and placed into a Radiological Material Area.

This event illustrates the need to: (1) follow a formal process (including appropriate surveys) for removing equipment or material from an RBA, and (2) ensure proper communication, component identification, and control of equipment or material within radiologically controlled areas. (ORPS Report EM-RL--CPRC-PFP-2018-0006)
