Joint Investigation Report

**Sealed Source Recovery at the University of Washington
Harborview Training and Research Facility Results in
Release of Cesium-137 on May 2, 2019**

March 30, 2020

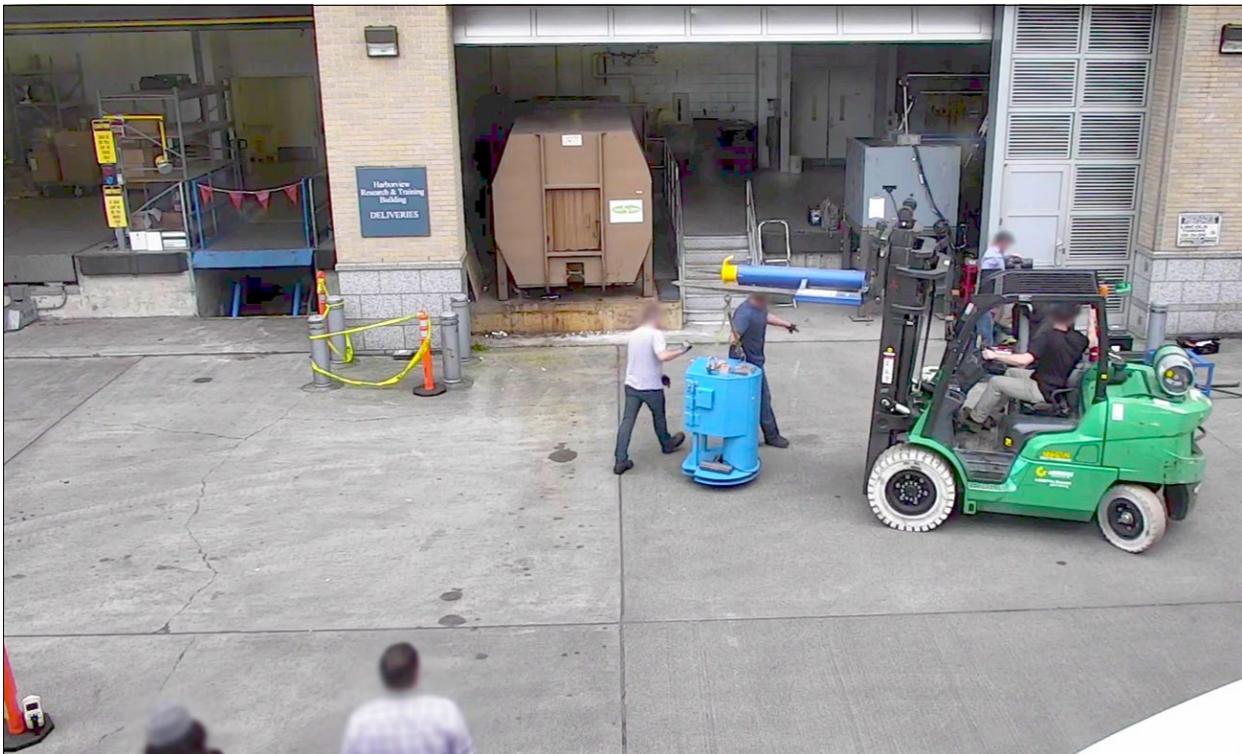
At 16:55 hrs., INIS workers prepared the irradiator for movement from its secure location in the HRT basement radiography room to the North loading dock by securing it to a Rol-A-Lift® set. At 17:00 hrs., INIS workers rolled the irradiator via the HRT freight elevator from the basement to the South loading dock on the second floor of the building. Utilizing a forklift with a lifting device attached to the tines, INIS workers rigged the irradiator from the top and transferred it to the North loading dock apron. A pallet jack was then used to complete the move of the irradiator to its position next to the MHC (Figure 8).

Figure 8: Movement of the Irradiator to the North Loading Dock

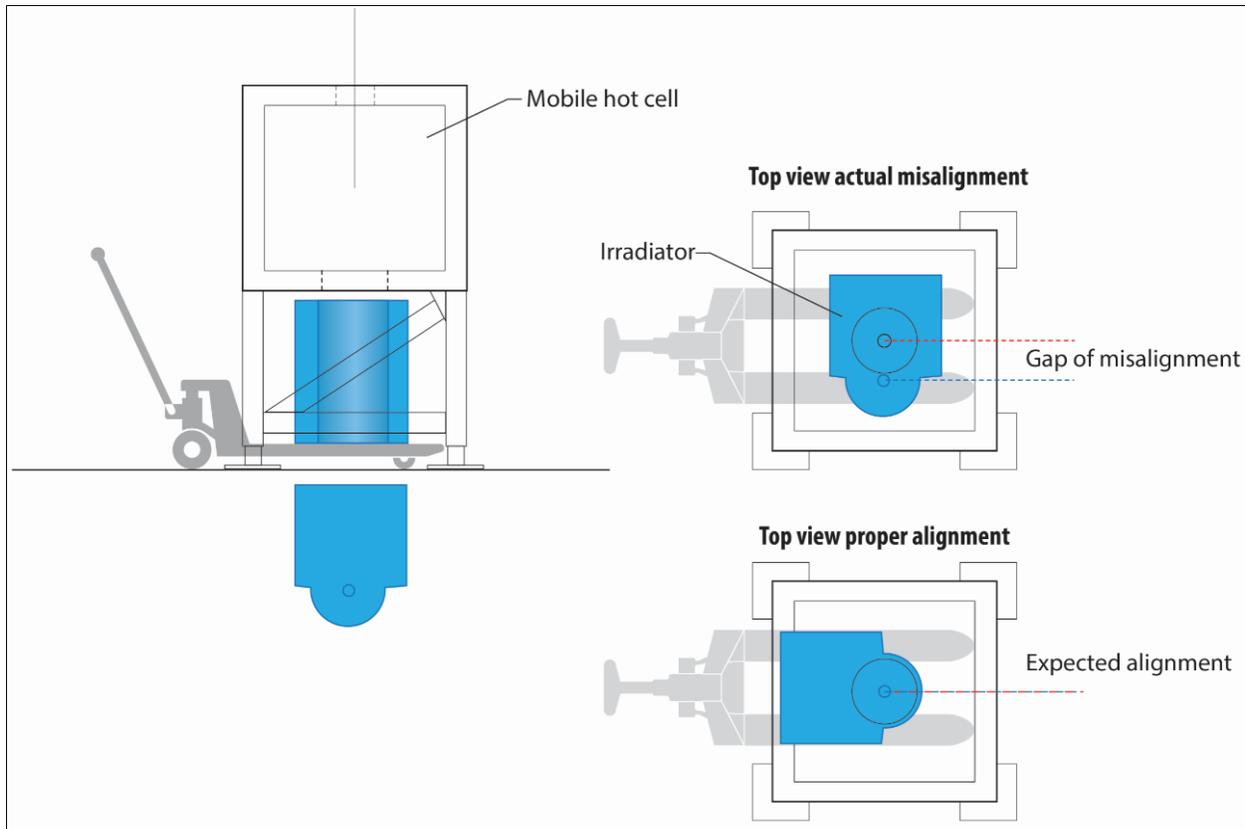
not prepared for grinding outside of the MHC. In addition, physical alignment was inhibited due to the orientation of the irradiator and placement of the MHC. This required several physical adjustments to fit the irradiator under the MHC. Due to the alignment of the irradiator under the MHC and also due to IDD kit remnants, the donut shield was not used. The donut shield is an integral part of the MHC bottom shielding configuration. Its absence left a void in the MHC bottom shielding (Figures 9 and 10).

Figure 9: Notional Drawing of Irradiator (blue) Alignment Beneath the MHC

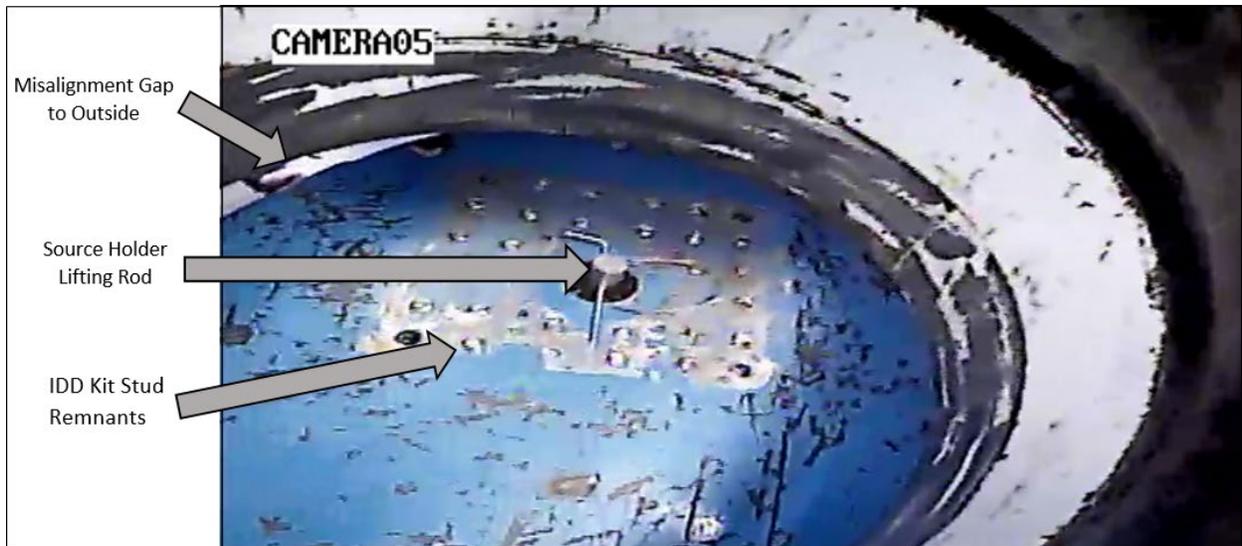
Figure 10: Image of Irradiator (blue) Beneath the MHC

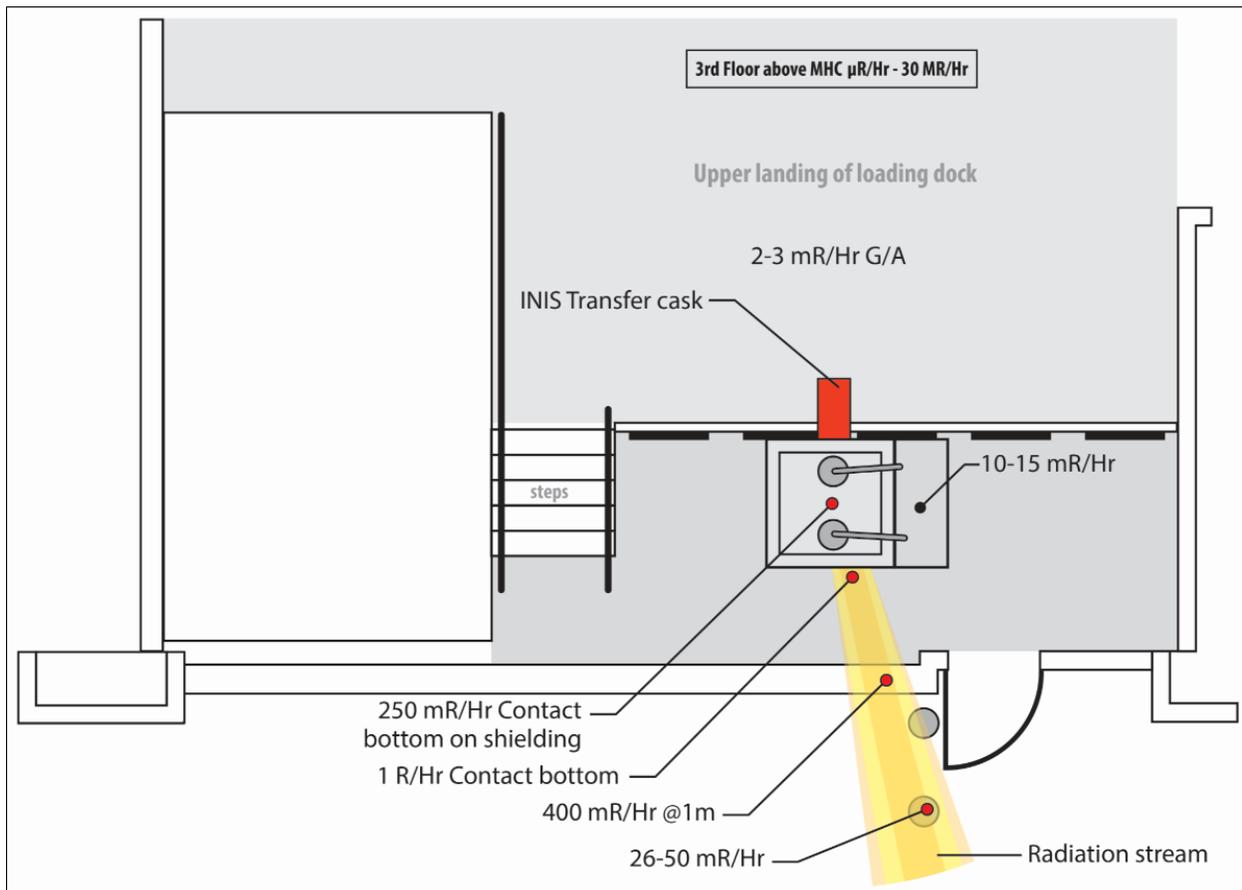
At 19:08 hrs., to partially mitigate the unexpected radiation stream coming from the bottom of the MHC, the decision was made to use a half-moon-shaped lead shield under the source assembly. The half-moon-shaped shield was used previously on top of a source assembly to mitigate the radiation effect on the cameras in the MHC.

Figure 11: Radiation Fields During Source Removal Operation

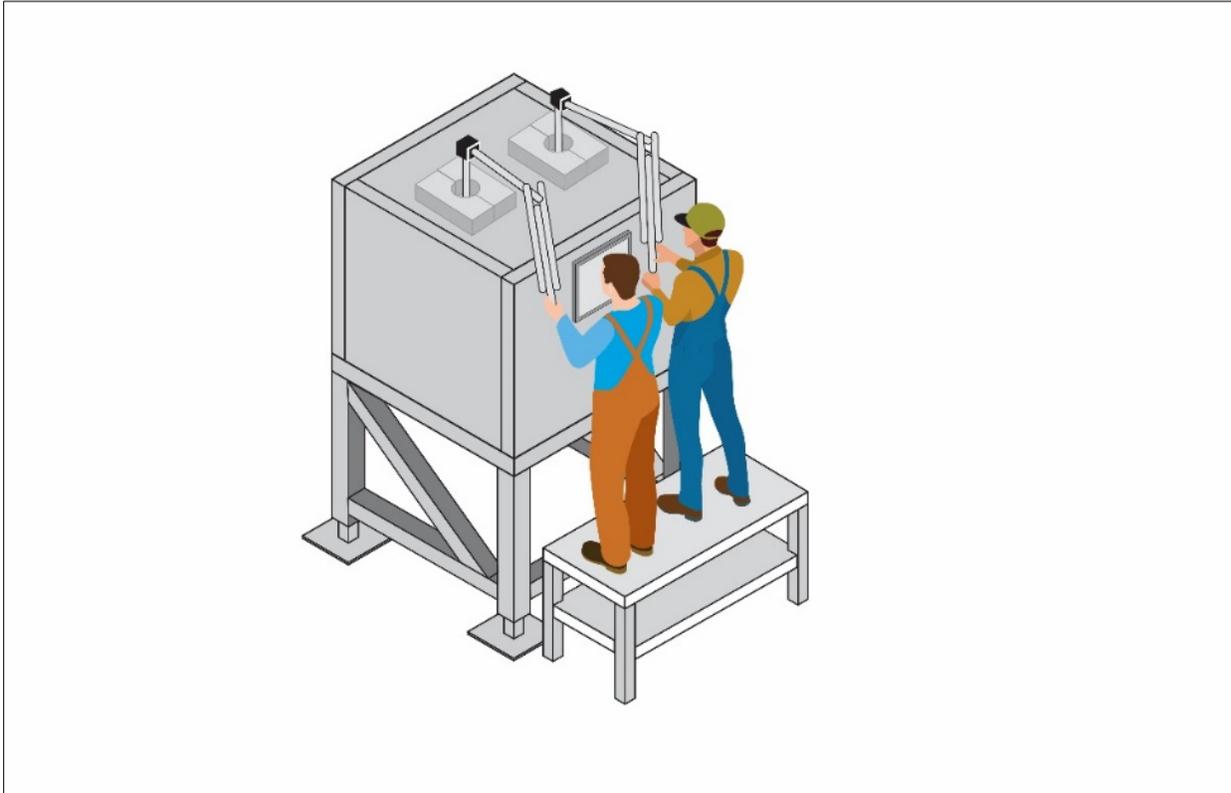
After INIS completed initial set-up operations and loaded the source holder into the MHC, they prepared to remove the source from the source holder (Figure 12). At 19:29 hrs., after approximately 12 minutes of manipulation, INIS positioned the source holder in the modified cut-off saw clamp and aligned the pin with the cut-off saw cutting blade.

Figure 12: Notional MHC Working Configuration

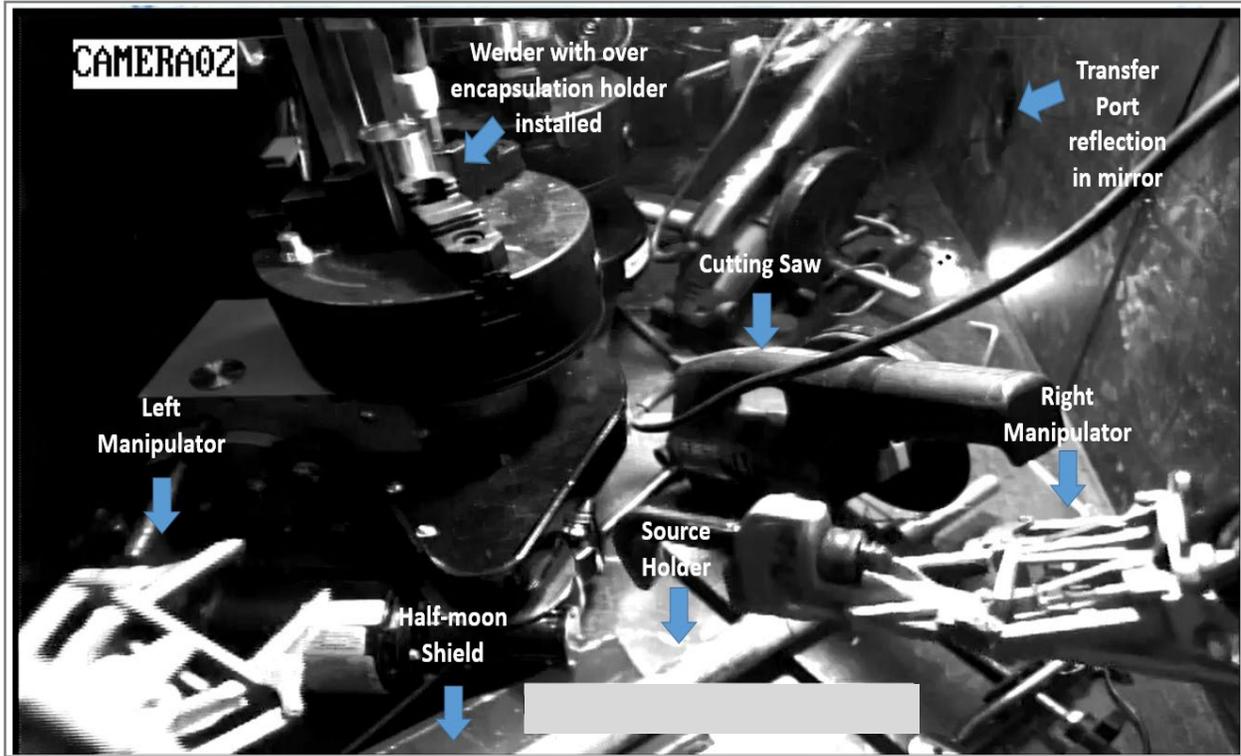
Using the set of five cameras and a video screen, the MHC operators used the Left Manipulator (LM) to rotate and position the source assembly beneath the cut-off wheel. The saw was operated with the Right Manipulator (RM). The lack of manual dexterity inherent in manipulator use reduced fine motor control and extended the time required for even simple tasks (Figure 13).

Figure 13: Operational Environment Inside MHC

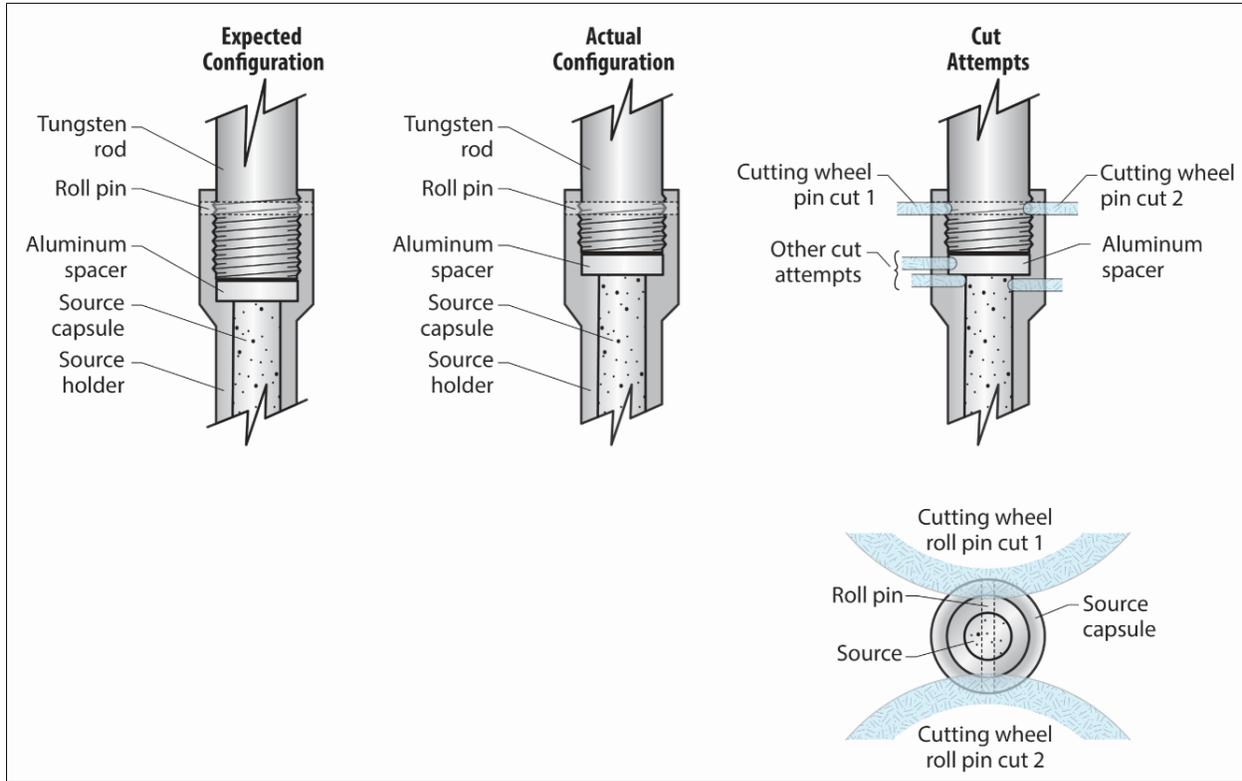
forensics¹ information and as-built drawings, the threaded portion of the tungsten rod for this source holder is 1/2", and an additional 1/4" aluminum spacer is between the rod and the source. Cuts on the aluminum tube extended to approximately 1 1/4" from the top of the aluminum tube (Figure 14).

Figure 14: Notional Drawings of Source Holder Configuration

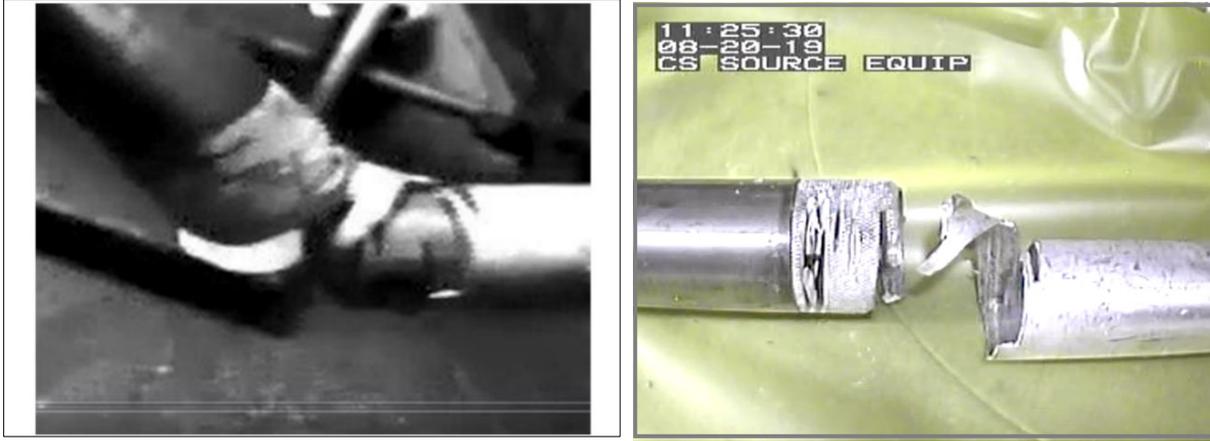
At 21:27 hrs., E1 lifted the source holder to place it in the transfer drawer and noticed movement between the source tube and tungsten rod. E1 worked the tube back and forth, and, at 21:28 hrs., the source tube separated at the cutting area (Figure 15). E1 used a hand-held video camera, held with the MHC manipulator, to inspect the capsule in the source holder and observed damage on the source capsule. At 21:29 hrs., E1 informed the RCO that the source may have been breached (Figures 15, 16, 17, and 18).

Figure 15: Source Holder Final Disassembly
Left View: MHC video. Right View: Forensic video.

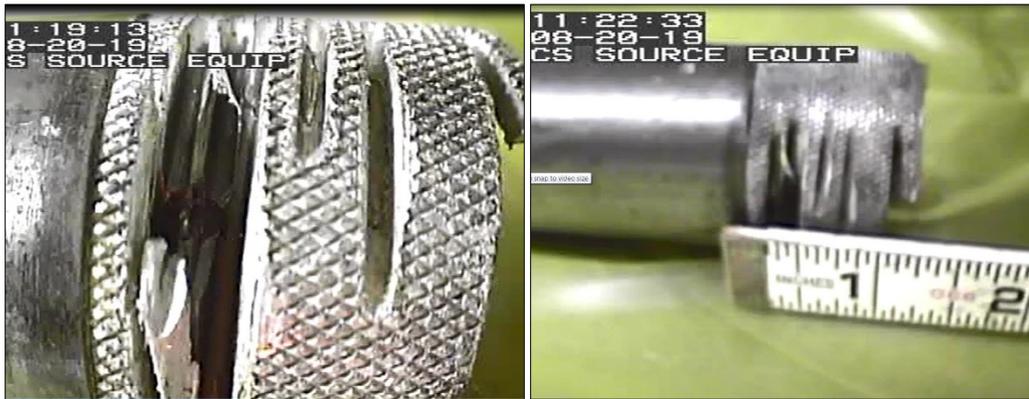
Figure 16: Cuts in the Vicinity of the Roll Pin – View 1 (left) and View 2 (right)

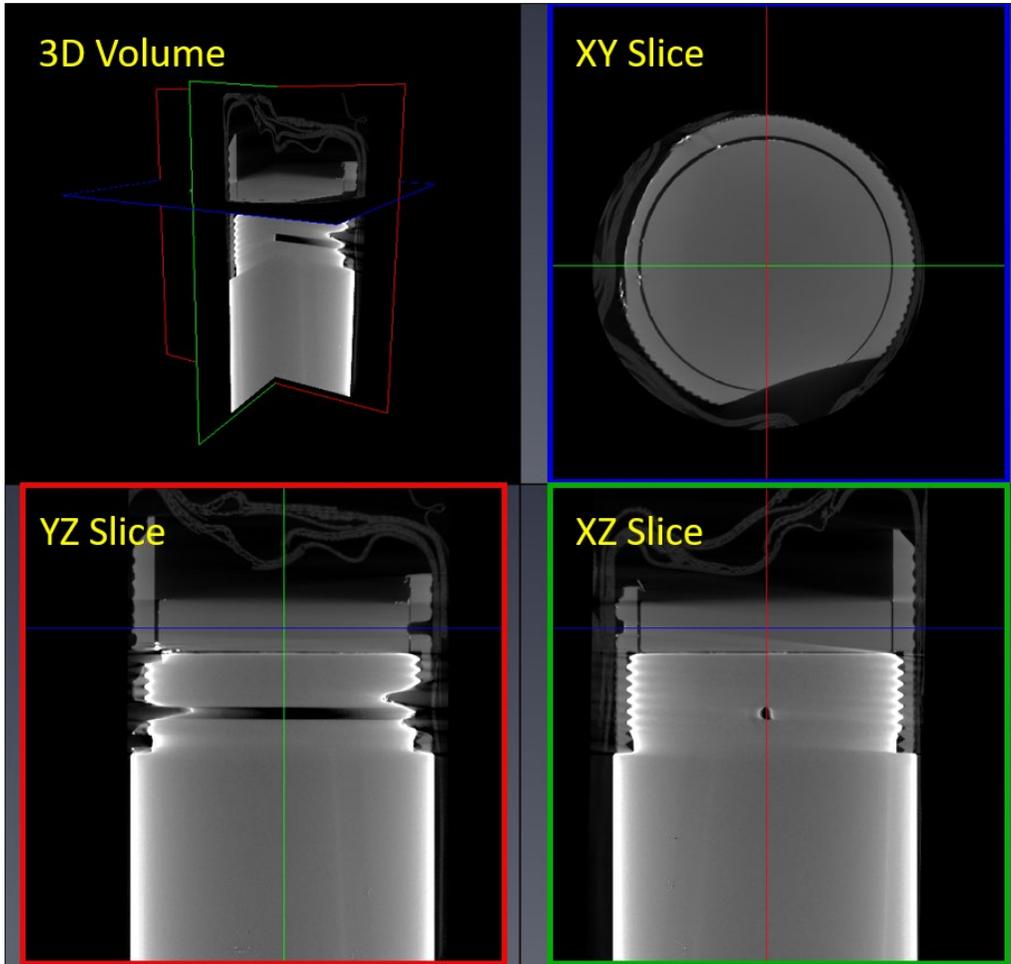
Figure 17: Tomographic Image of the Tungsten Rod

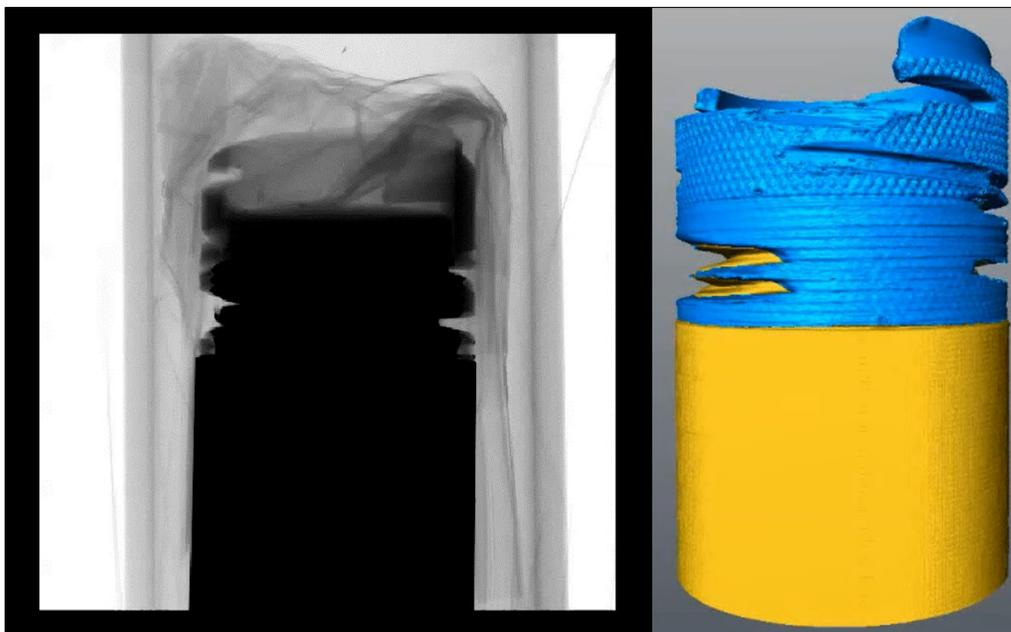
Figure 18: Tomographic Image (left) and False Color Image (right) of Tungsten Rod

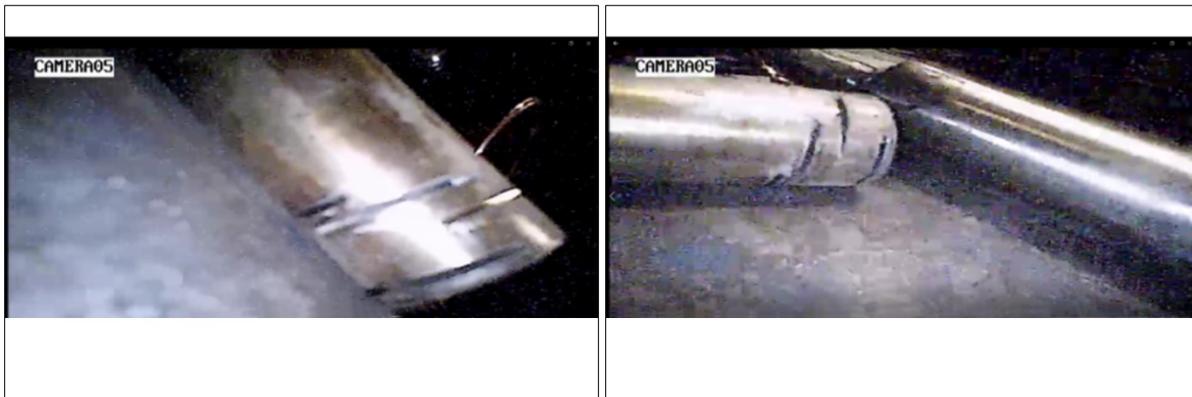
At 21:31 hrs., E1 removed the source capsule from the source tube, and performed a visual inspection of the source capsule. E1 confirmed “*scratches and one cut that appeared to breach the source capsule wall*” (Figures 19, 20, and 21). E1 continued evaluation of the situation at the controls.

Figure 19: Damage to Cesium-137 Outer Source Capsule
(screen captures from the MHC video)

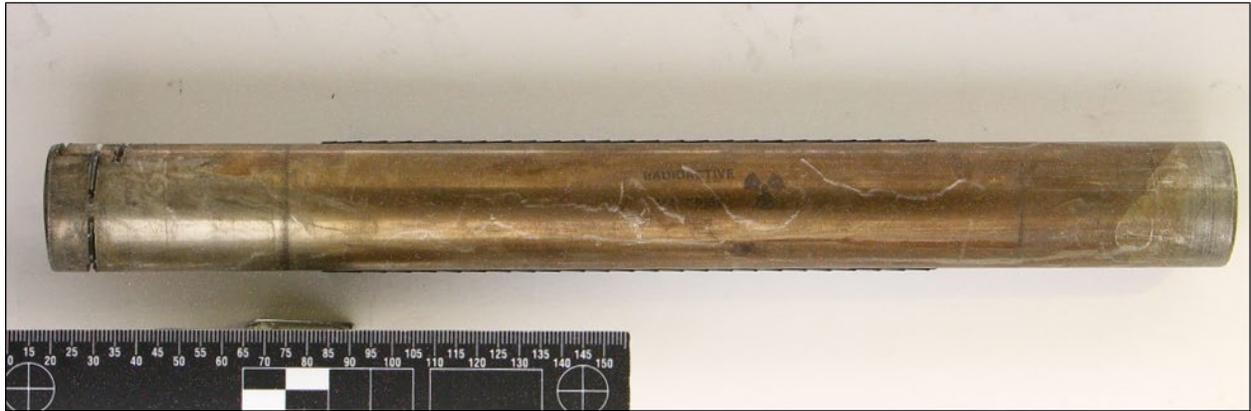
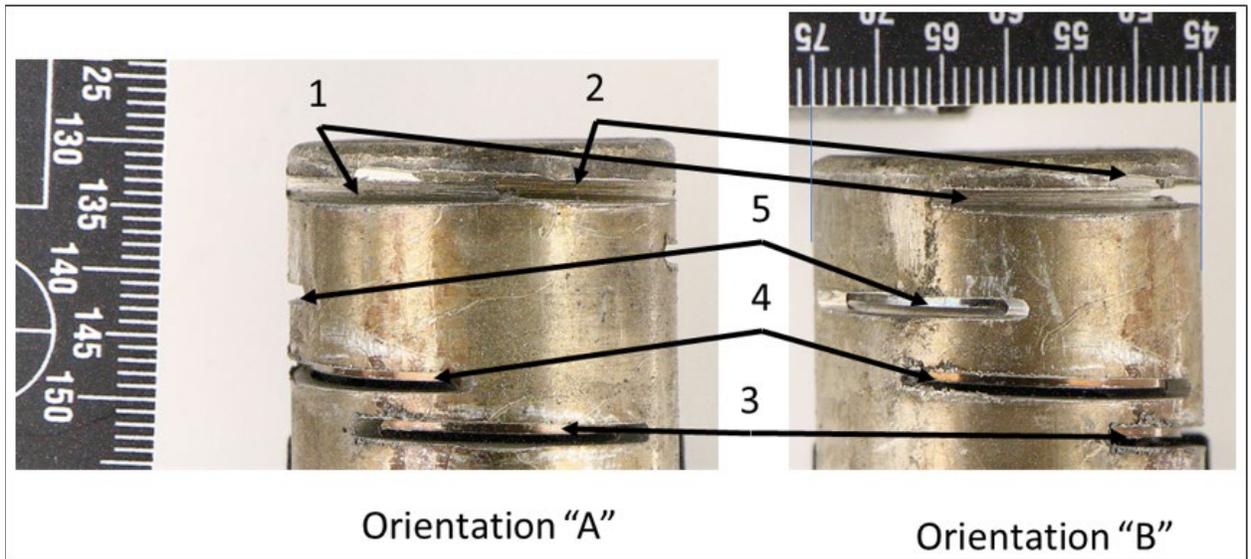
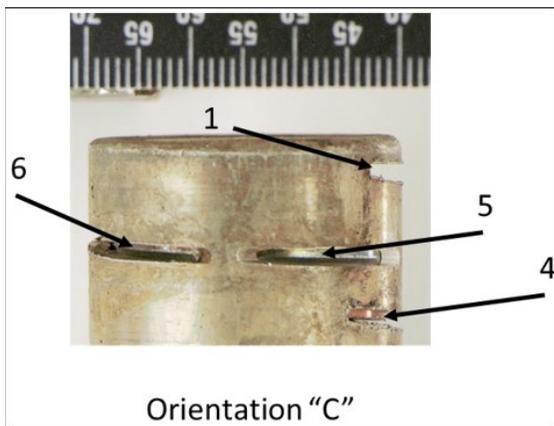
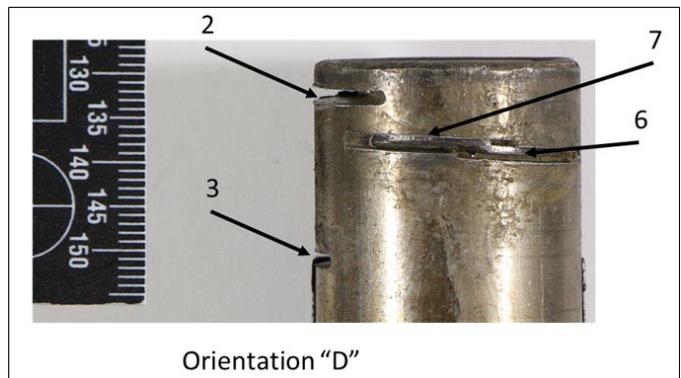
Figure 20: Damage to Cesium-137 Outer Source Capsule
(Forensic images – counterclockwise rotation views.)
(Numbers are references to identify the cuts into the outer source capsule)

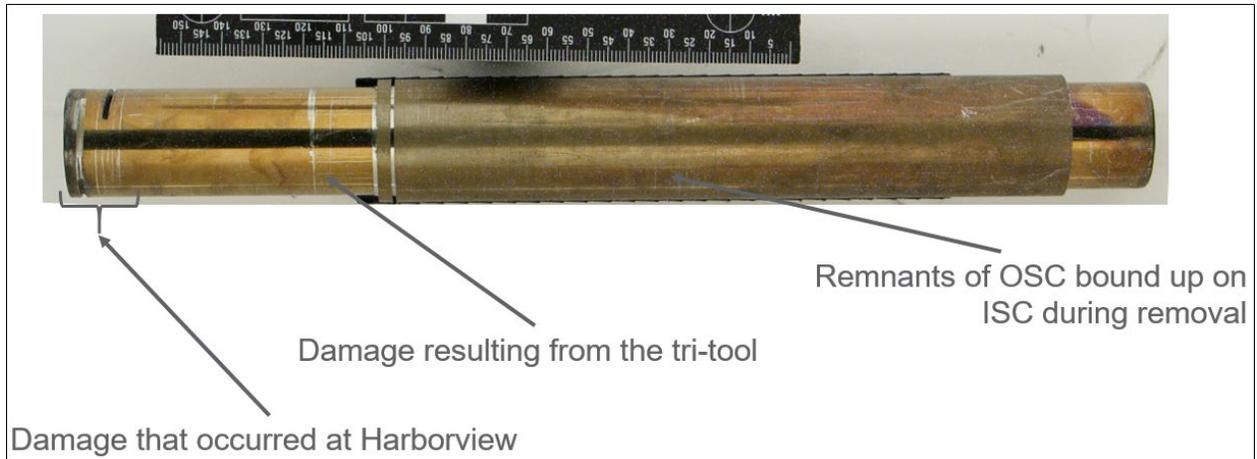
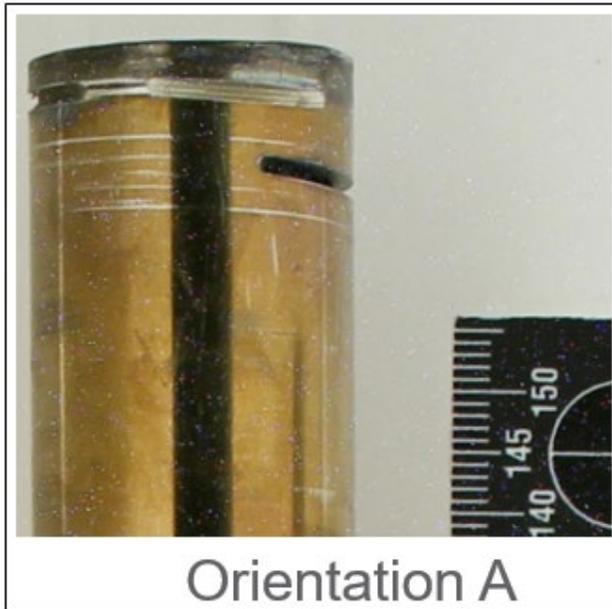
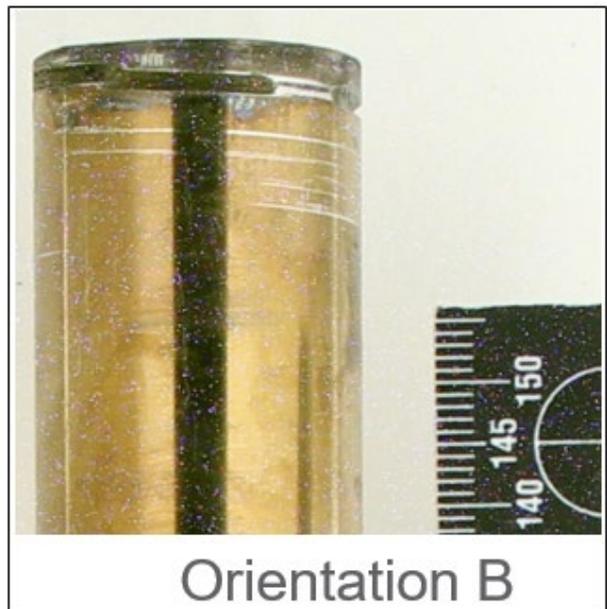
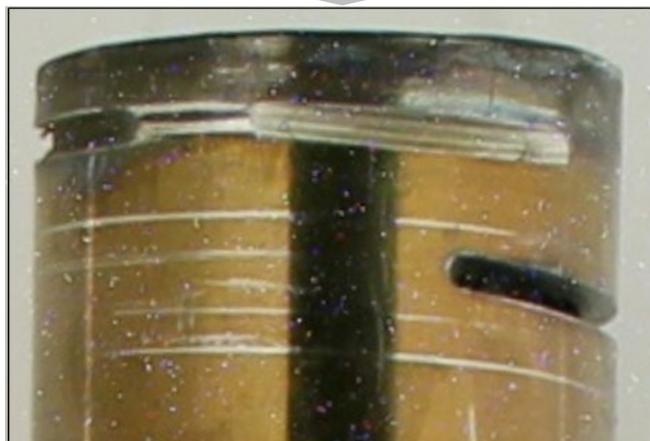
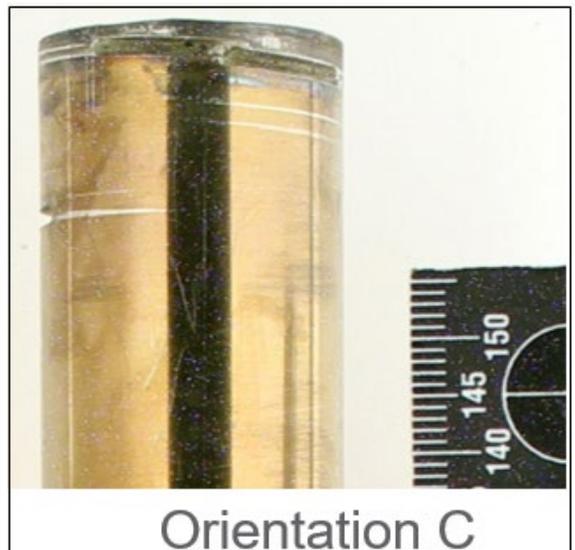
Figure 21: Damage to Cesium-137 Inner Source Capsule
(Forensic images – Close ups show damage during source recovery operations.)
(OSC: Outer Source Capsule; ISC: Inner Source Capsule)
