U.S. DEPARTMENT OF  
**ENERGY**

Legacy  
Management

## 2020 Annual Site Inspection and Monitoring Report for Uranium Mill Tailings Radiation Control Act Title II Disposal Sites

December 2020

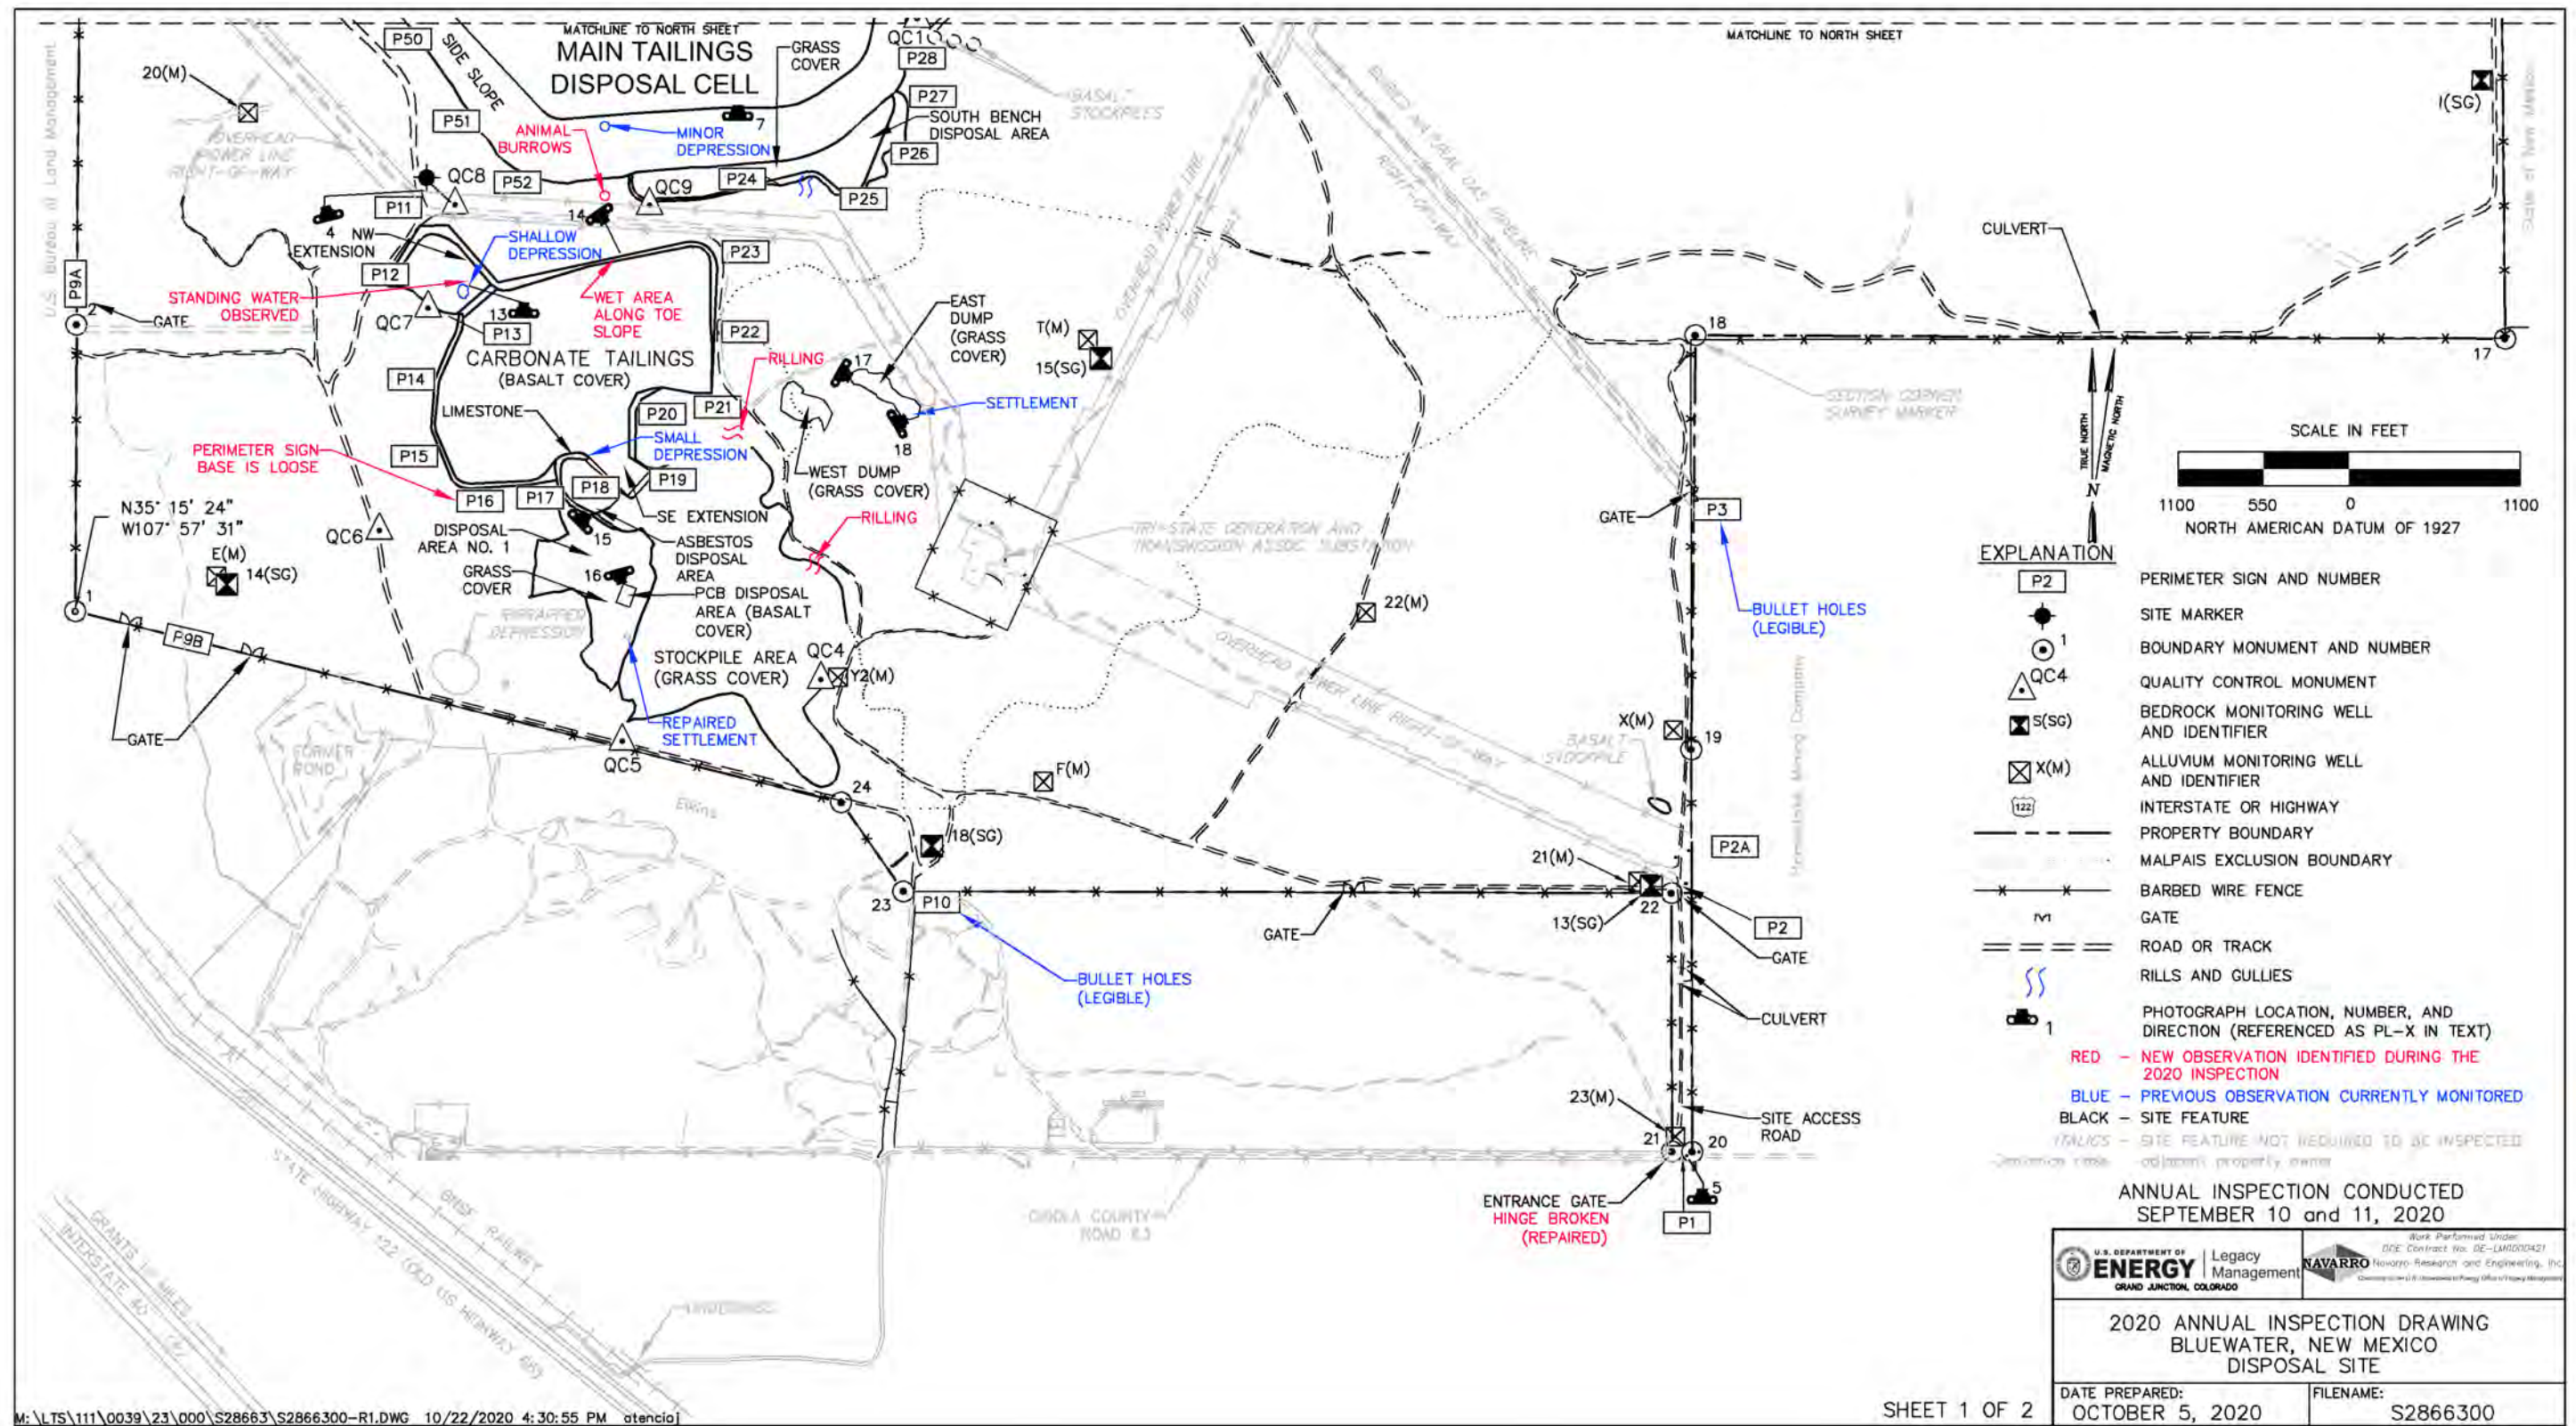
Figure 1-1. 2020 Annual Inspection Drawing for the Bluewater, New Mexico, Disposal Site (South Area)

Interior roads used to access LM assets consist of a dirt track covered at places with crushed basalt (PL-1). The roads are susceptible to erosion and are repaired when they become impassable. Erosion on the road northwest of the main tailings disposal cell continues to be an issue. In 2017 riprap was added to repair a gully intersecting this section of the road. Additional erosion was noted along the road paralleling the northern perimeter of the site. LM is planning to repair the roads in 2021 through the interagency agreement with USACE. Vegetation was also overgrown along the road paralleling the north perimeter of the site, which LM cut back in a subsequent visit in September 2020. No other maintenance needs were identified.

Inspectors also identified the need to repair erosion along the interior road. This work is proposed for 2021.

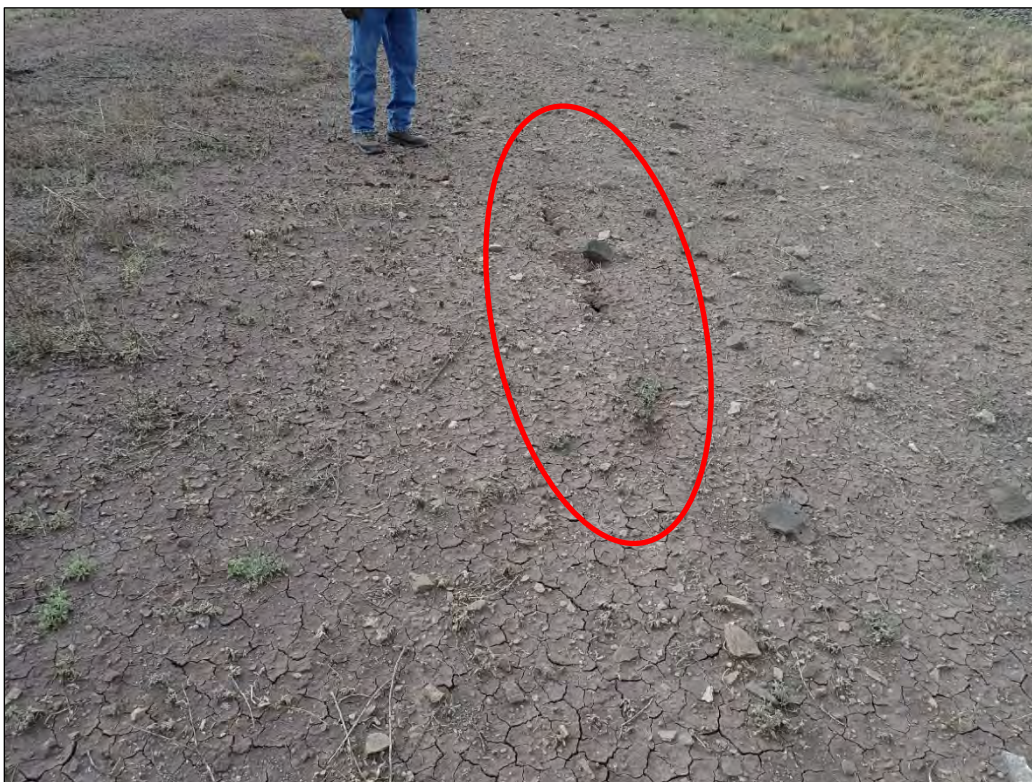
| Site | Chapter | Page | Issues and Actions |
|---|---|---|--|
| | | 1-7 | A linear desiccation crack was observed along the base of the east side slope of the disposal cell. |

*PL-12. Linear Desiccation Crack*

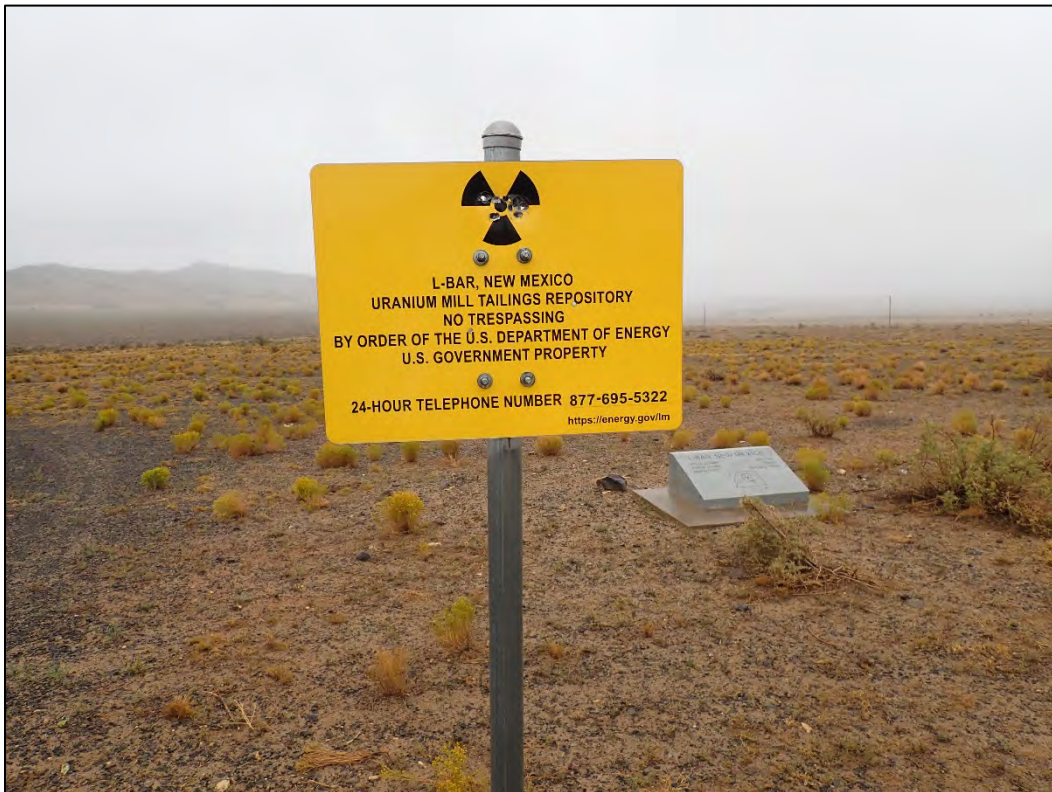
The entrance sign is on the main site access road near the site marker. It has several bullet holes but was legible (PL-2). Thirty-three warning or perimeter signs (PL-3) are attached to the barbed-wire fence that surrounds the disposal site structures and an area of excessive gully erosion in the southeast portion of the site. Perimeter sign P19 was found on the ground and was reattached to the perimeter fence during the September 30, 2020, maintenance activities.

*PL-2. Entrance Sign*

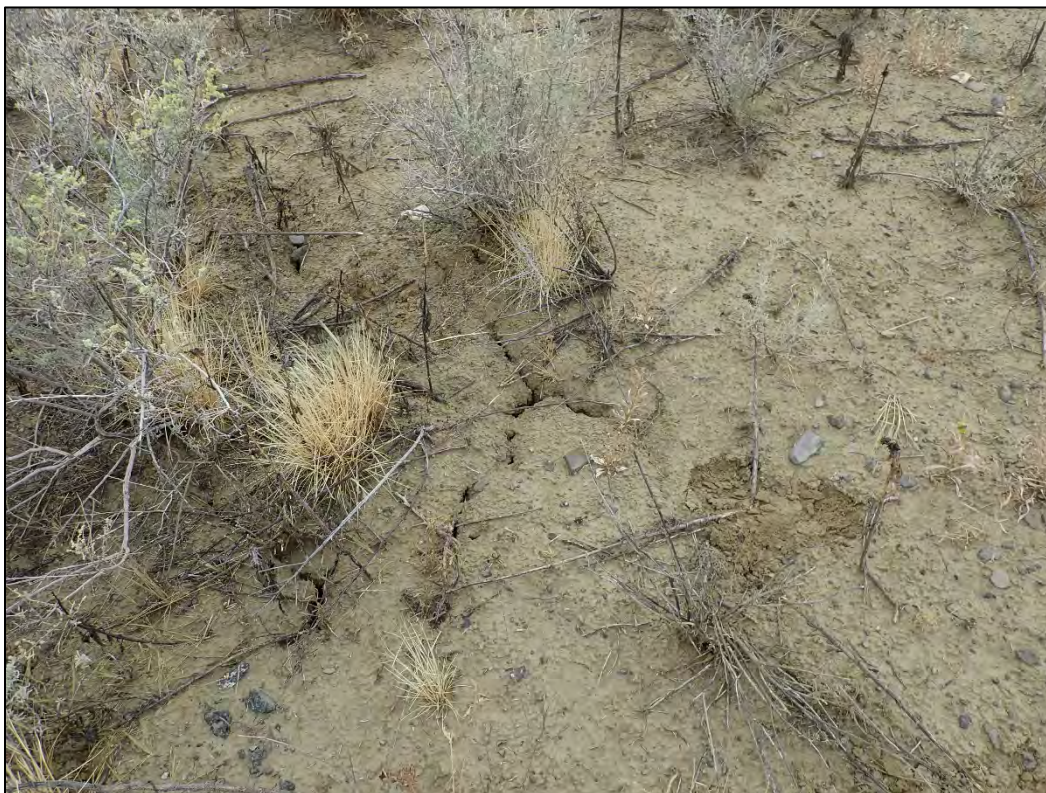
*PL-9. Desiccation Crack on Disposal Cell Top Slope*

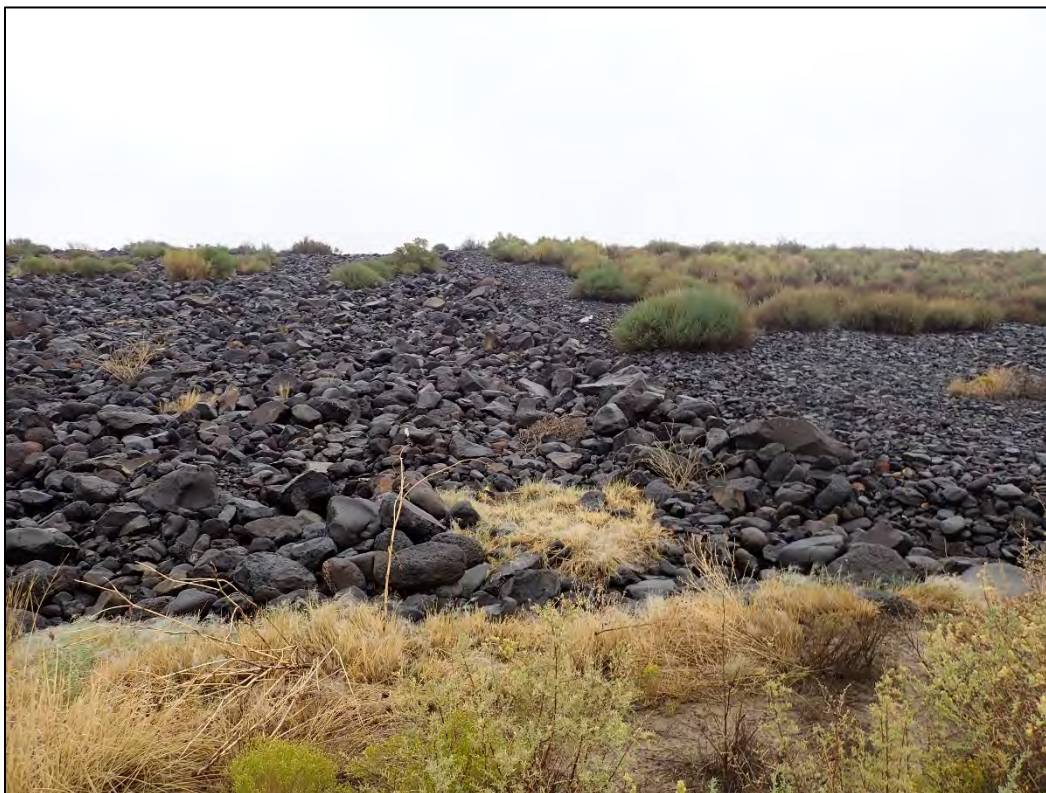
*PL-11. Potential Storm-Water Flow Path in Containment Dam Spillway*

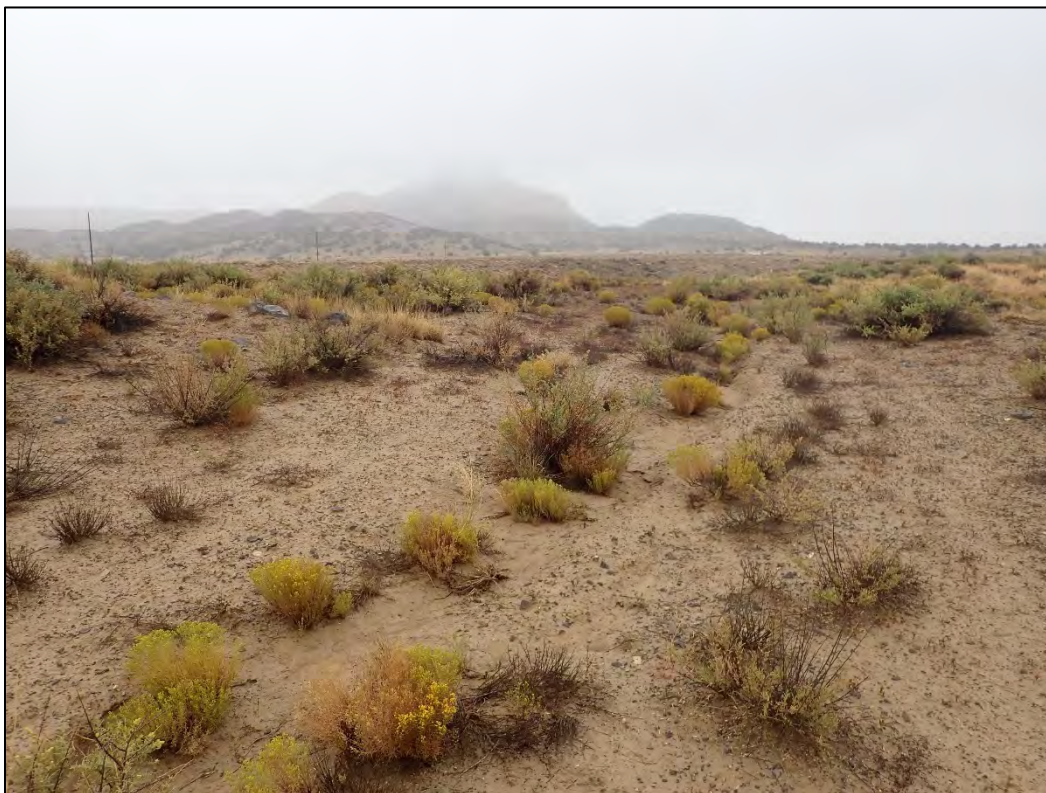
*PL-17. Minor Rilling Near North Channel Cutoff Wall*

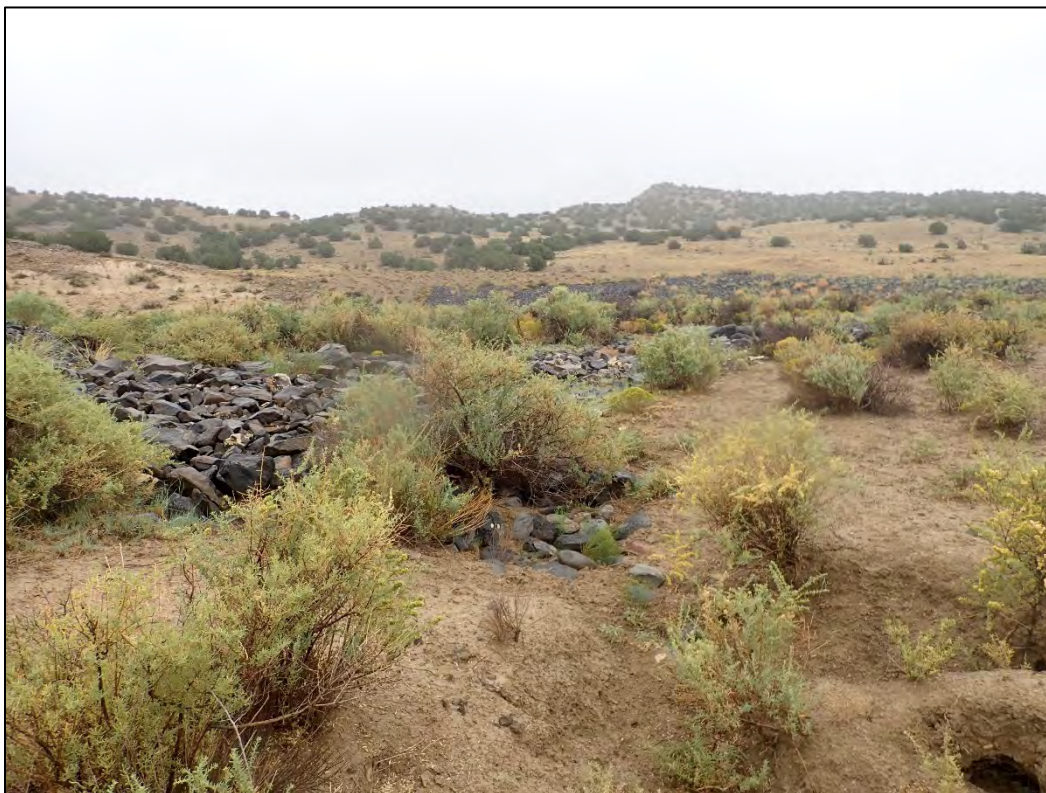
*PL-19. Gully Downgradient of South Channel Cutoff Wall*

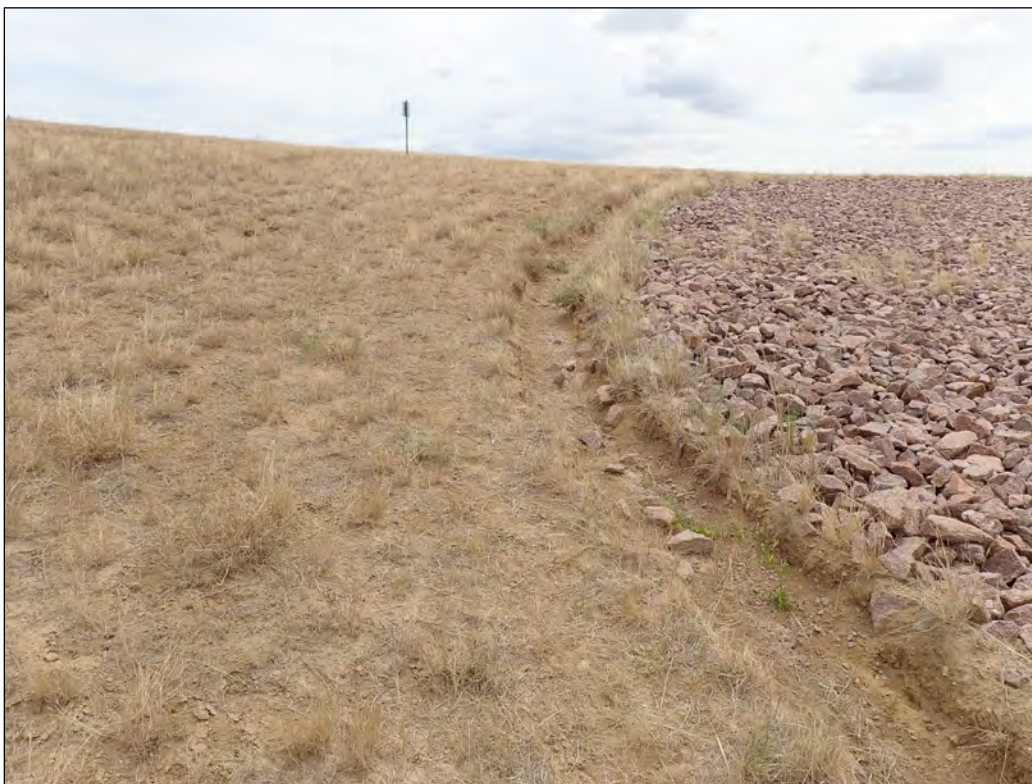
*PL-8. Cattle-Caused Path Along Riprap Near Perimeter Sign P13*
