# Deep Dive into Marine Energy Composites and Manufacturing

# Crevice Corrosion in Seawater Using CFRP Composite as Part of a Novel Crevice Former

F. Presuel-Moreno\*, B. A. Hernandez-Sanchez\*\*,

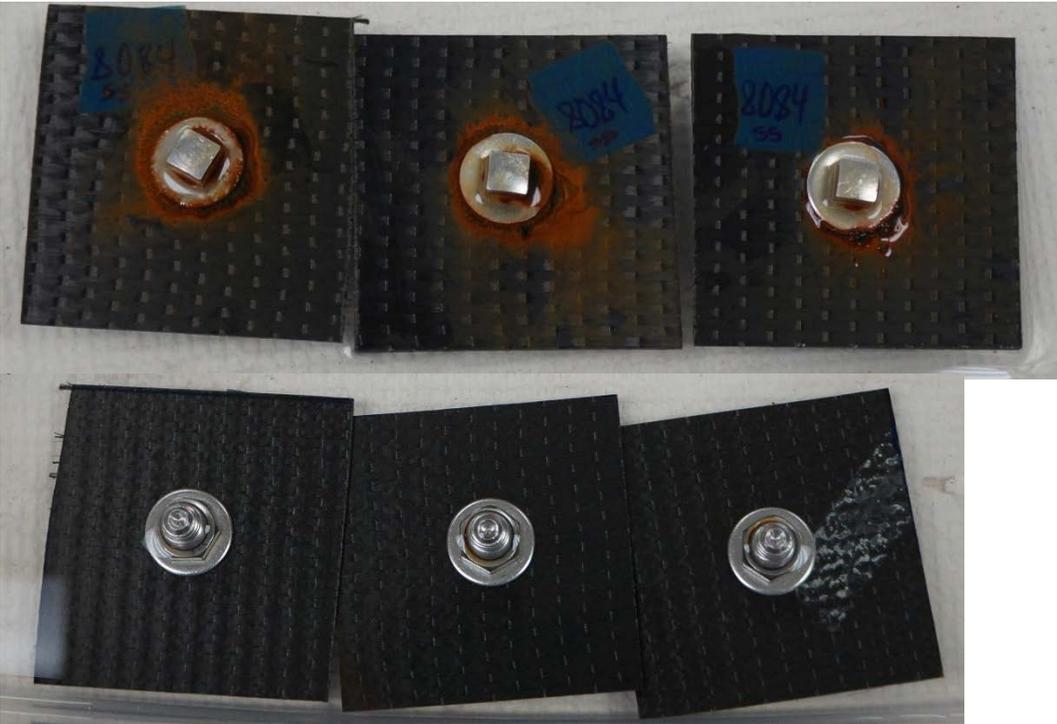
Observations after 55 days of immersion

# Stainless Steel/CFRP composite fastened samples

Room Temperature

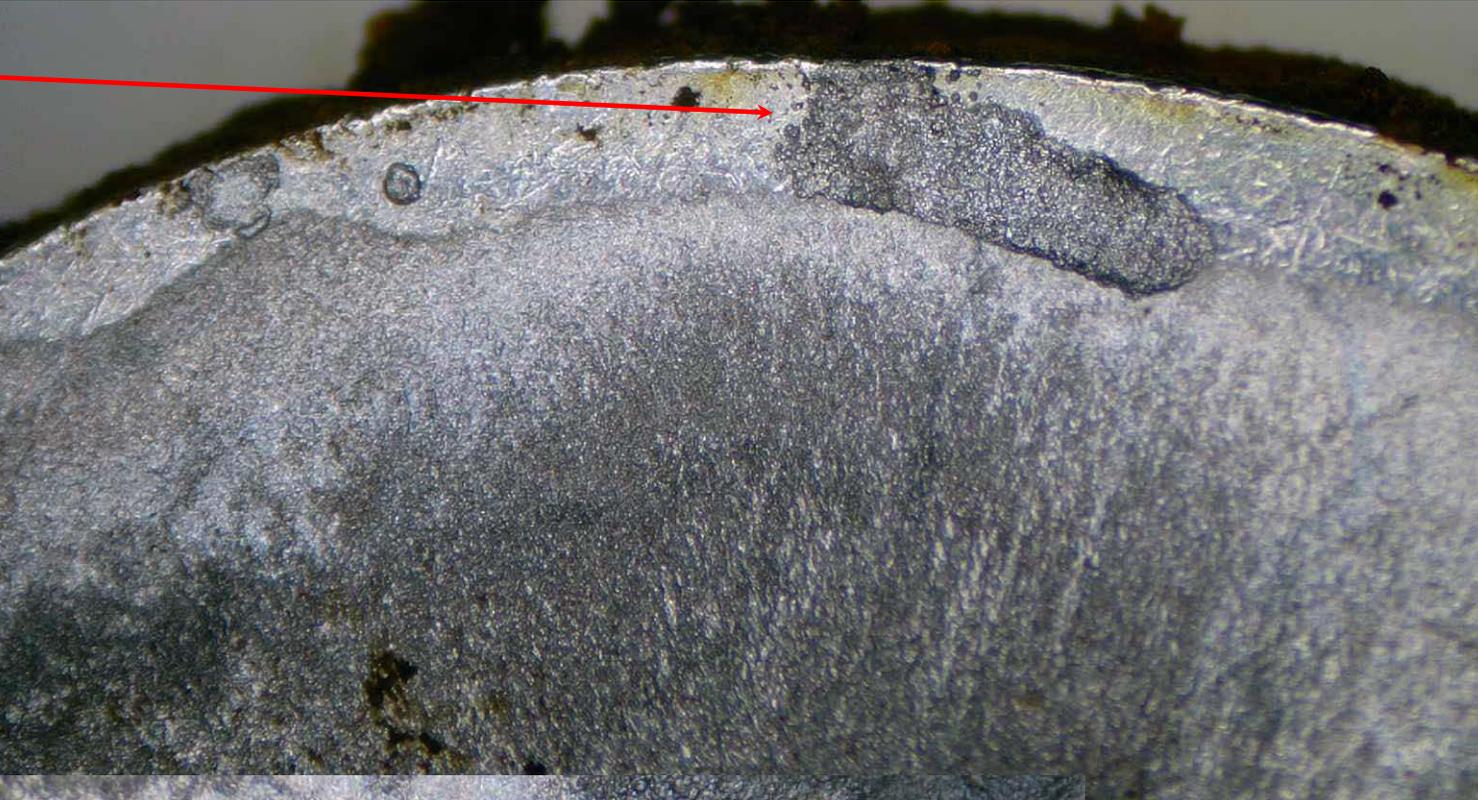
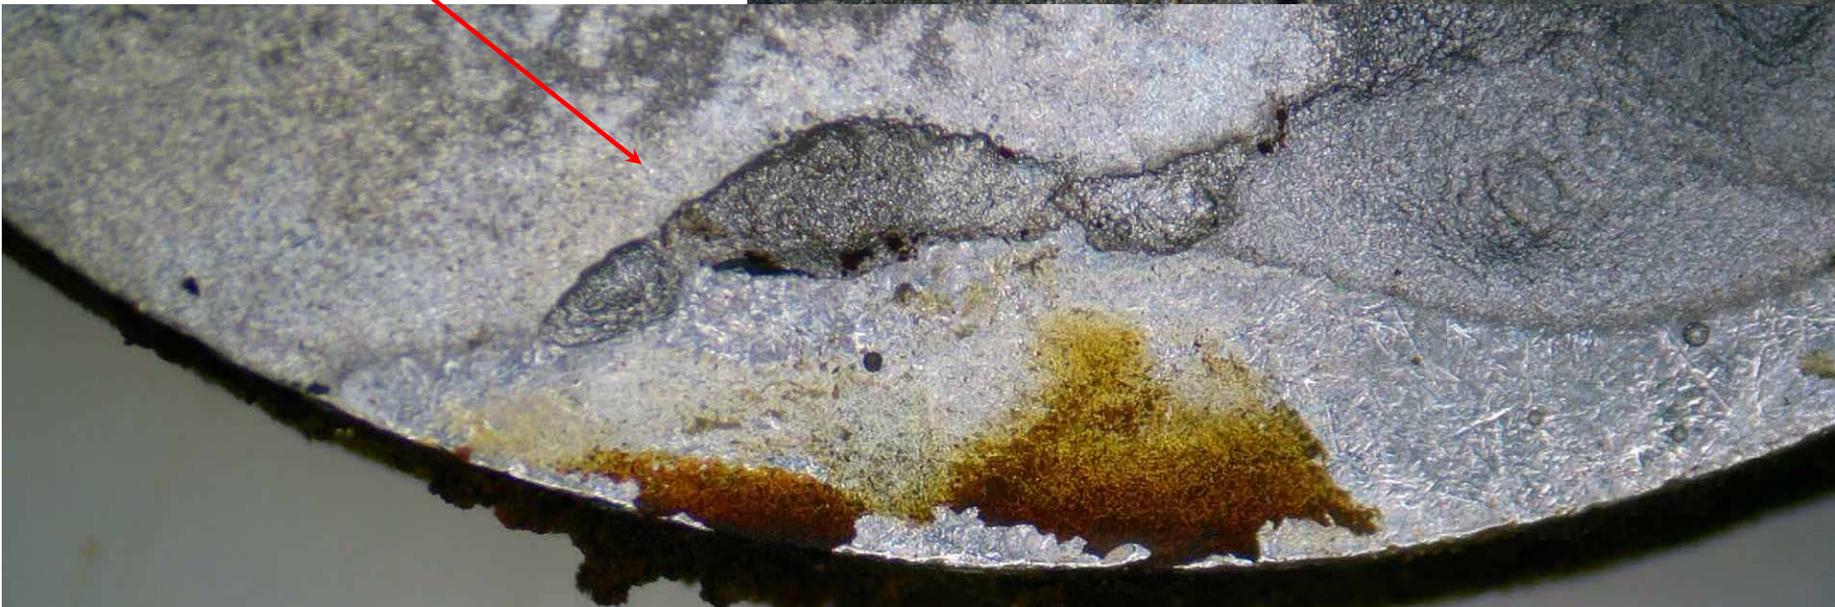
Stainless Steel Washers in contact with the CFRP composite, top row smooth side, bottom row rough side

806 days  
Washer in contact with  
smooth composite

Crevice Corrosion of type C1 and C2 were observed on Monel and Stainless steel washers.

C1 corrosion occurred with large surface coverage on stainless steel, and most corrosion products leached out.

C2 corrosion occurred as different sizes of pits on stainless steel and as brown corrosion products that flaked easily on Monel washers.

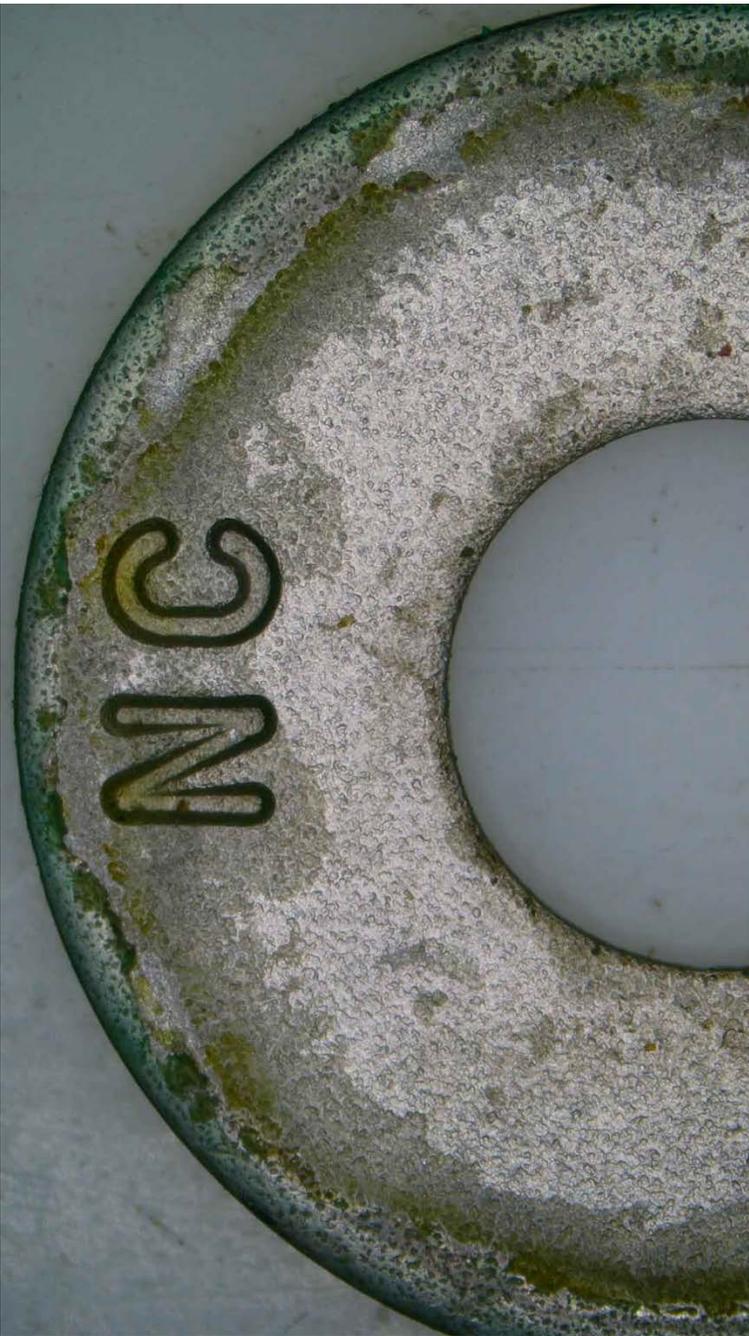
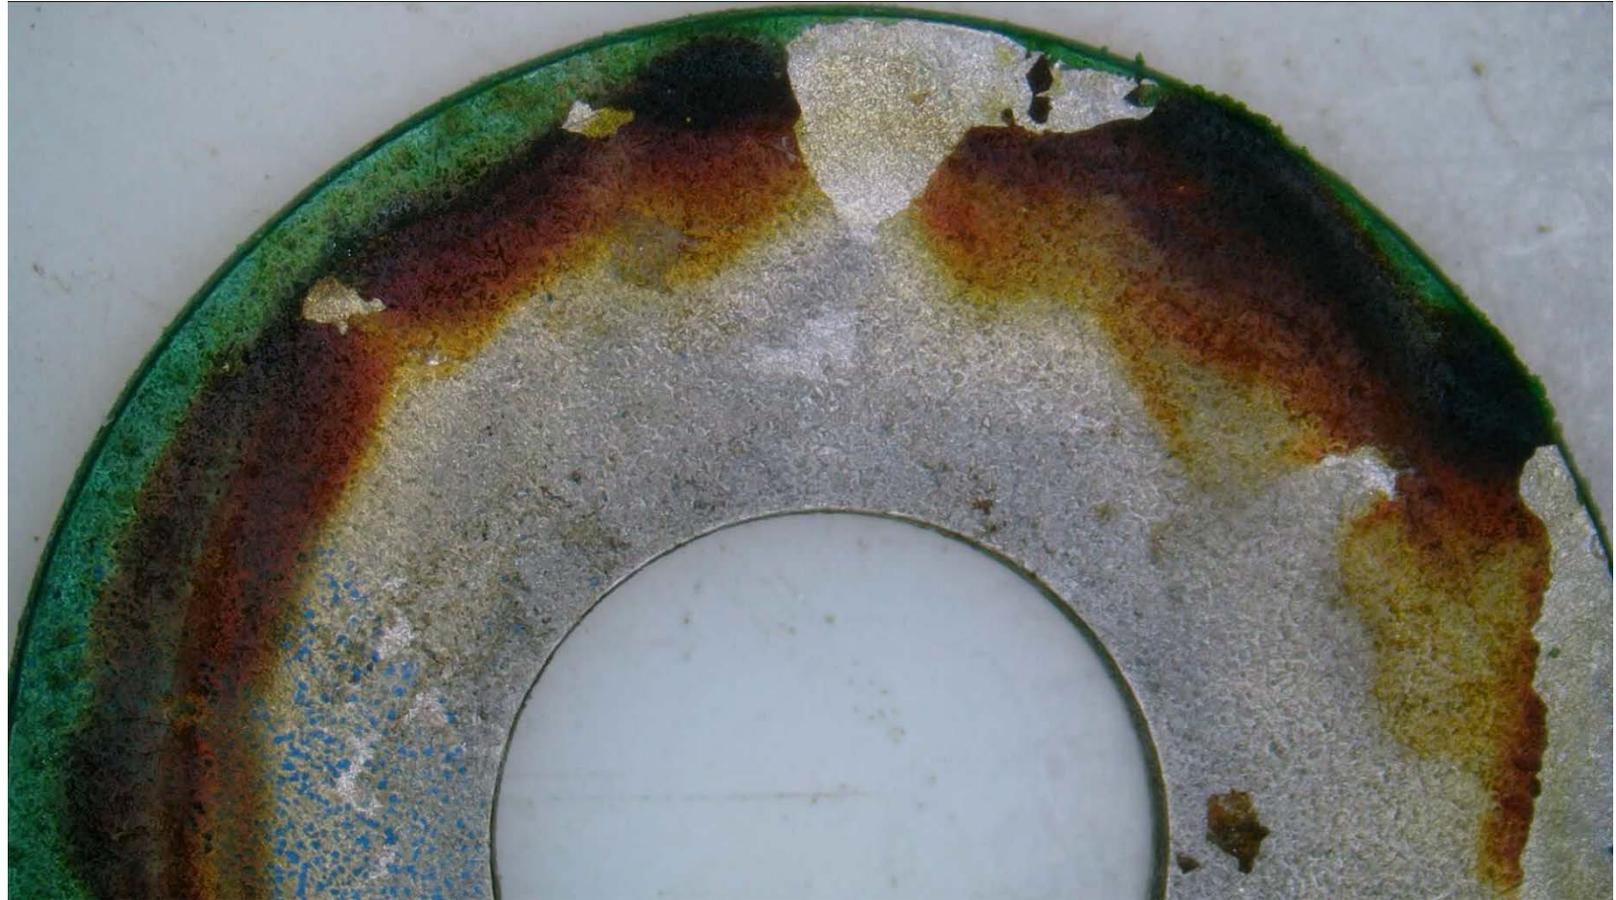
Monel washer surfaces in contact with the CFRP composite, top row smooth side, bottom row rough side

799 days, on the left in contact with smooth CFRP composite,  
below in contact with rougher CFRP composite surface

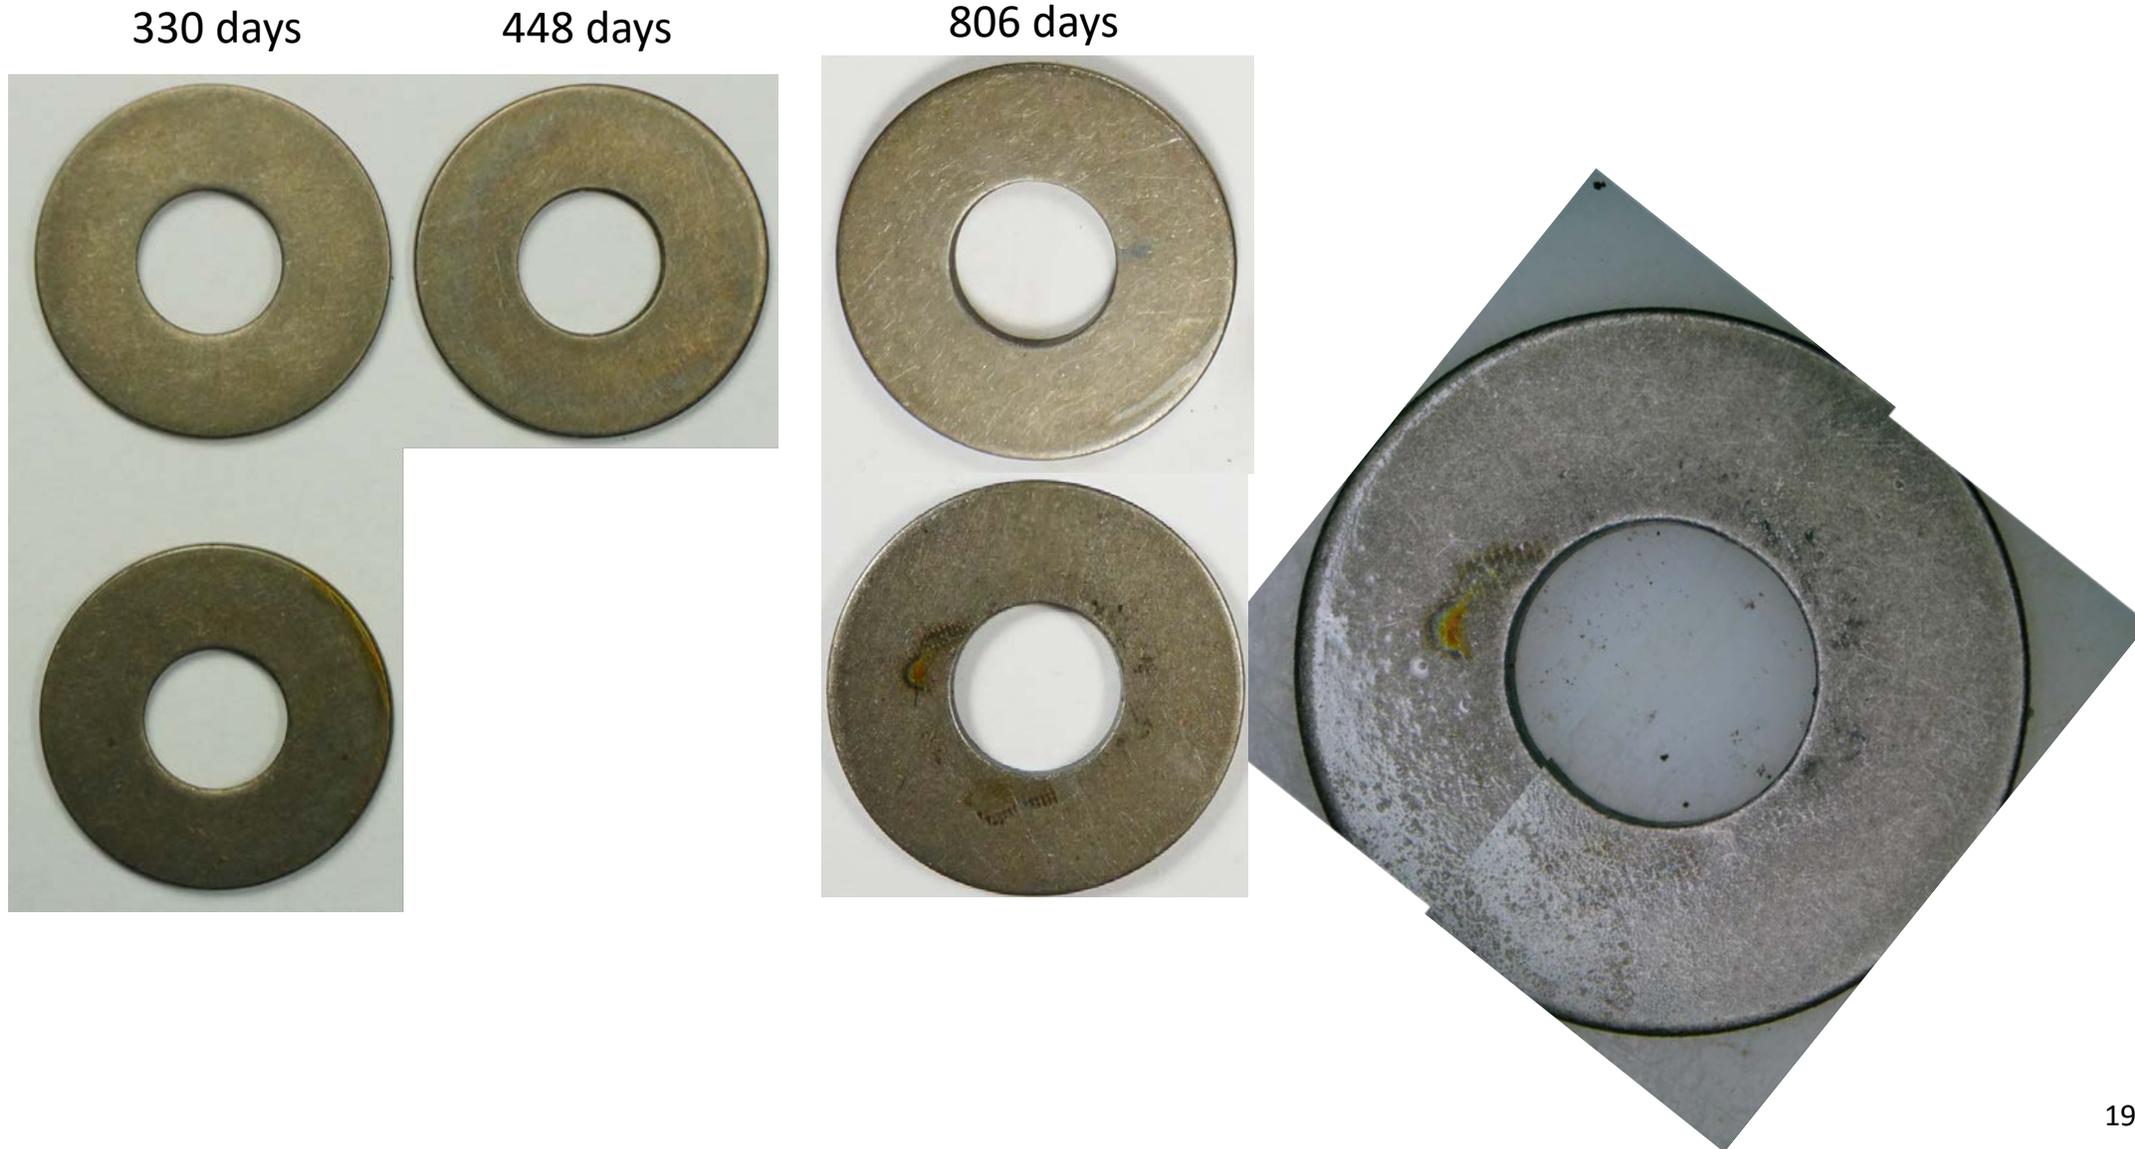
Ti washer surfaces in contact with the CFRP composite, top row smooth side, bottom row rough side

No corrosion took place on the Titanium washers within the time monitored

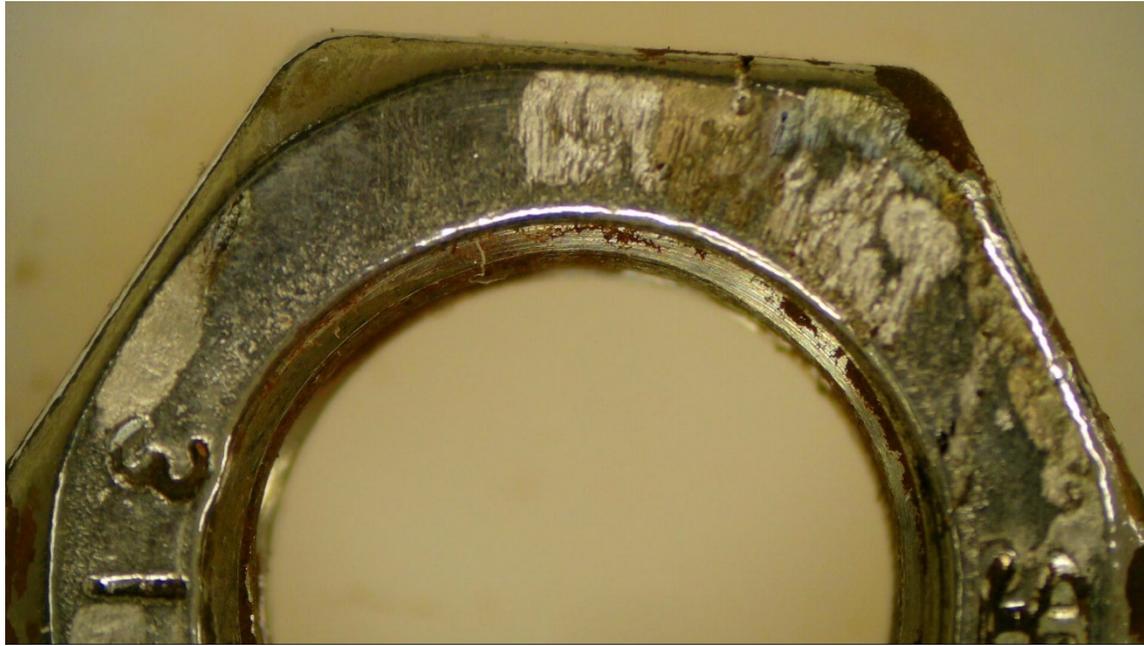
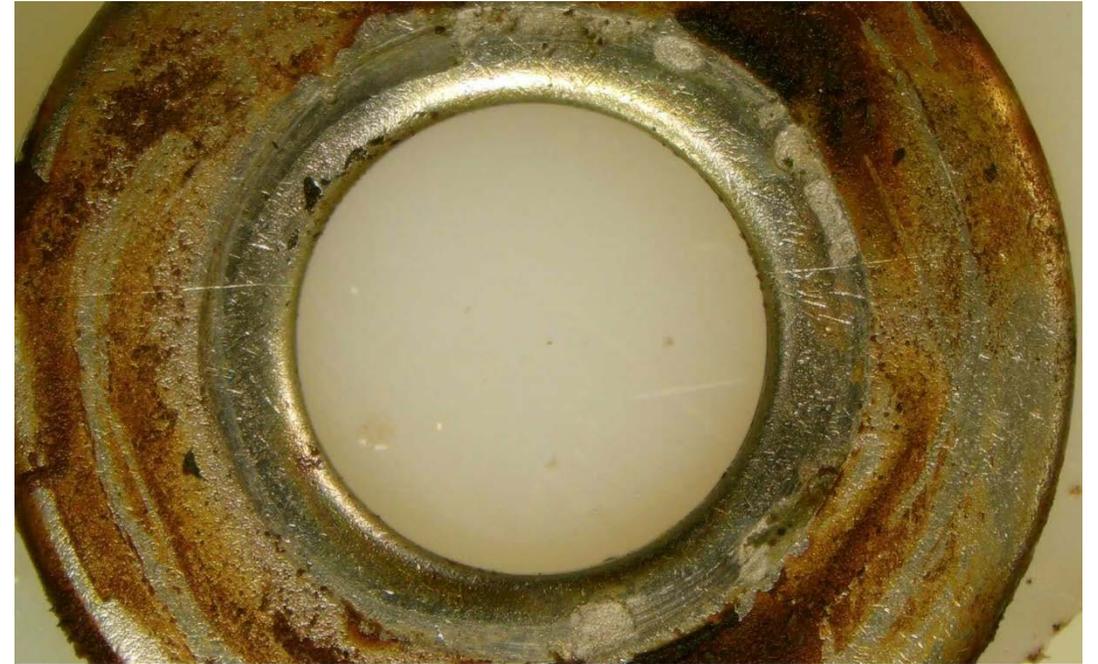
Example of a C3 site (crevice corrosion between nut and washer surfaces)

Nut side in contact with washer

Washer in contact with nut

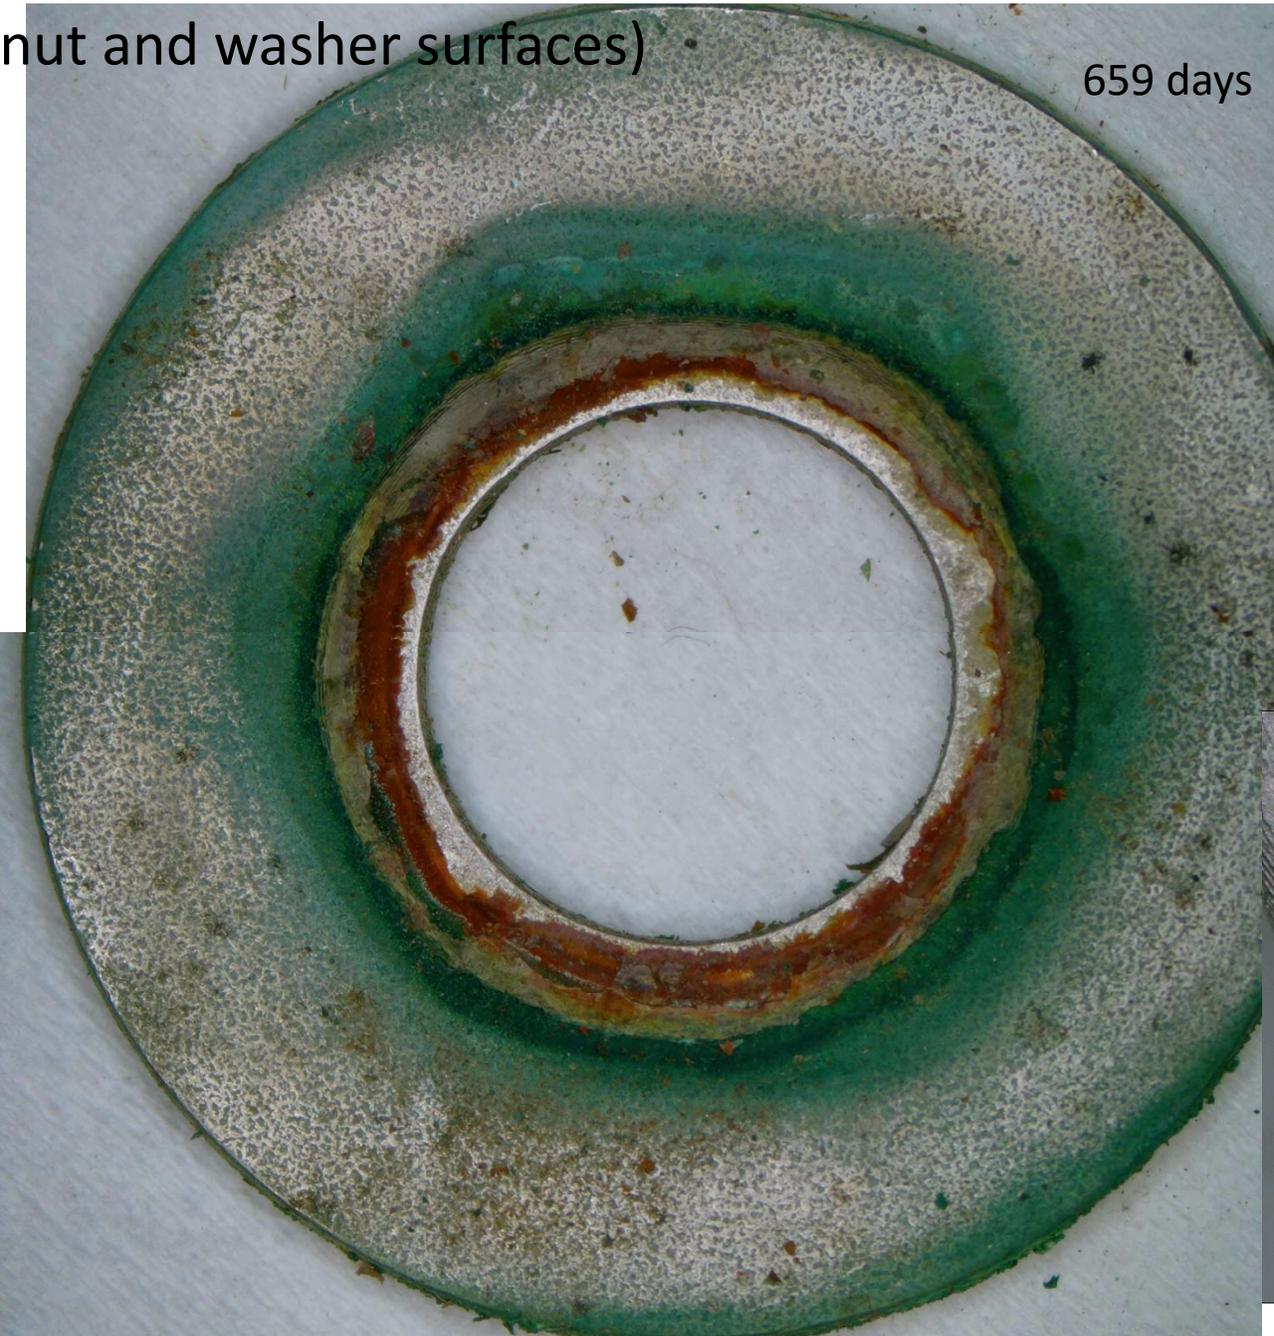
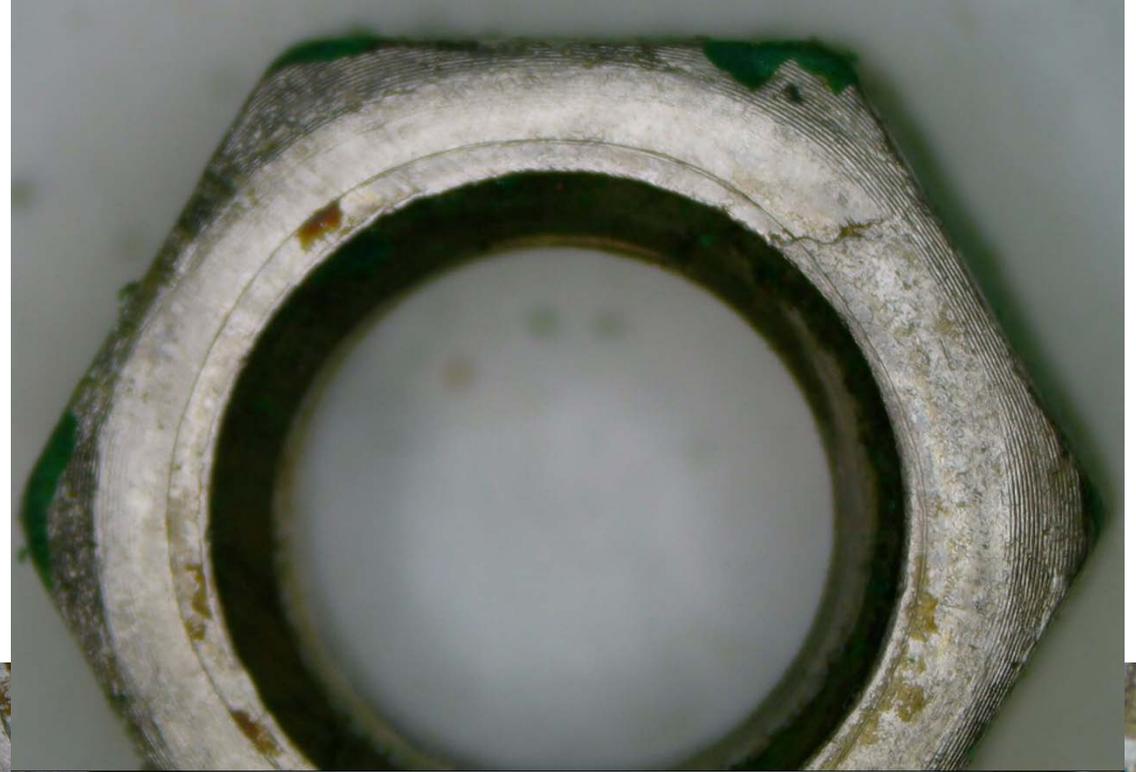
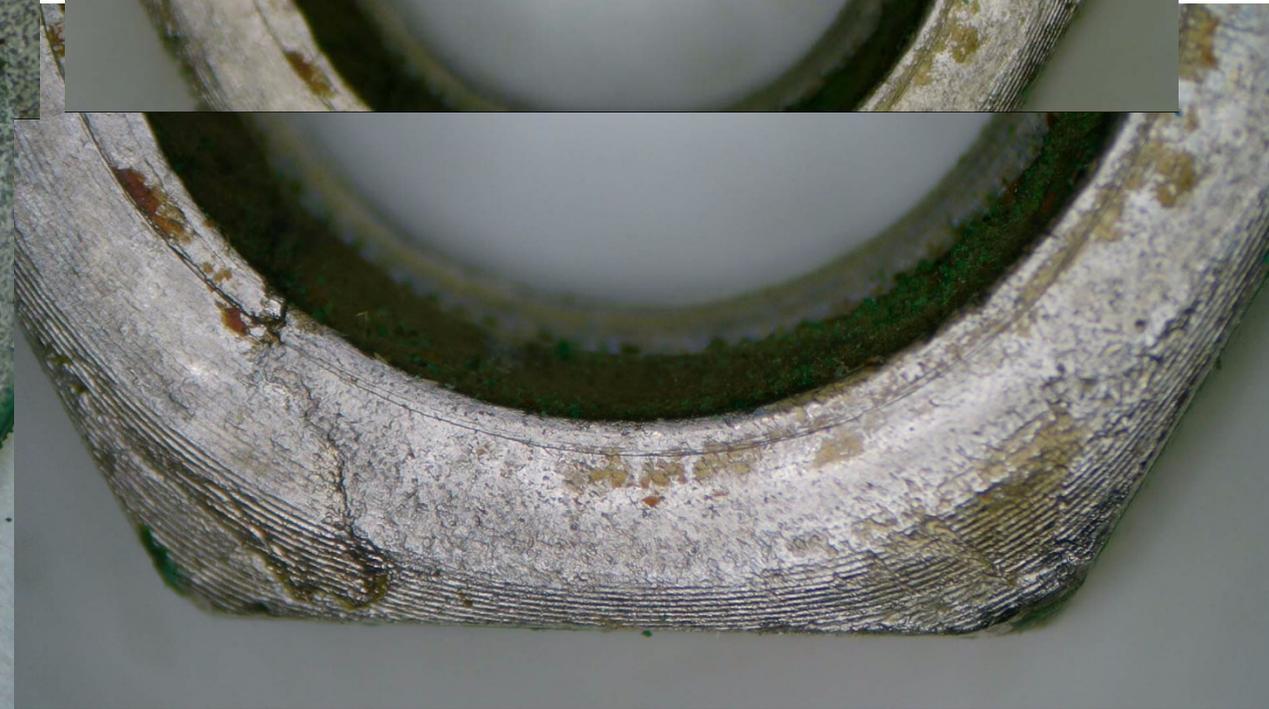
Example of a C3 site (crevice corrosion between nut and washer surfaces)

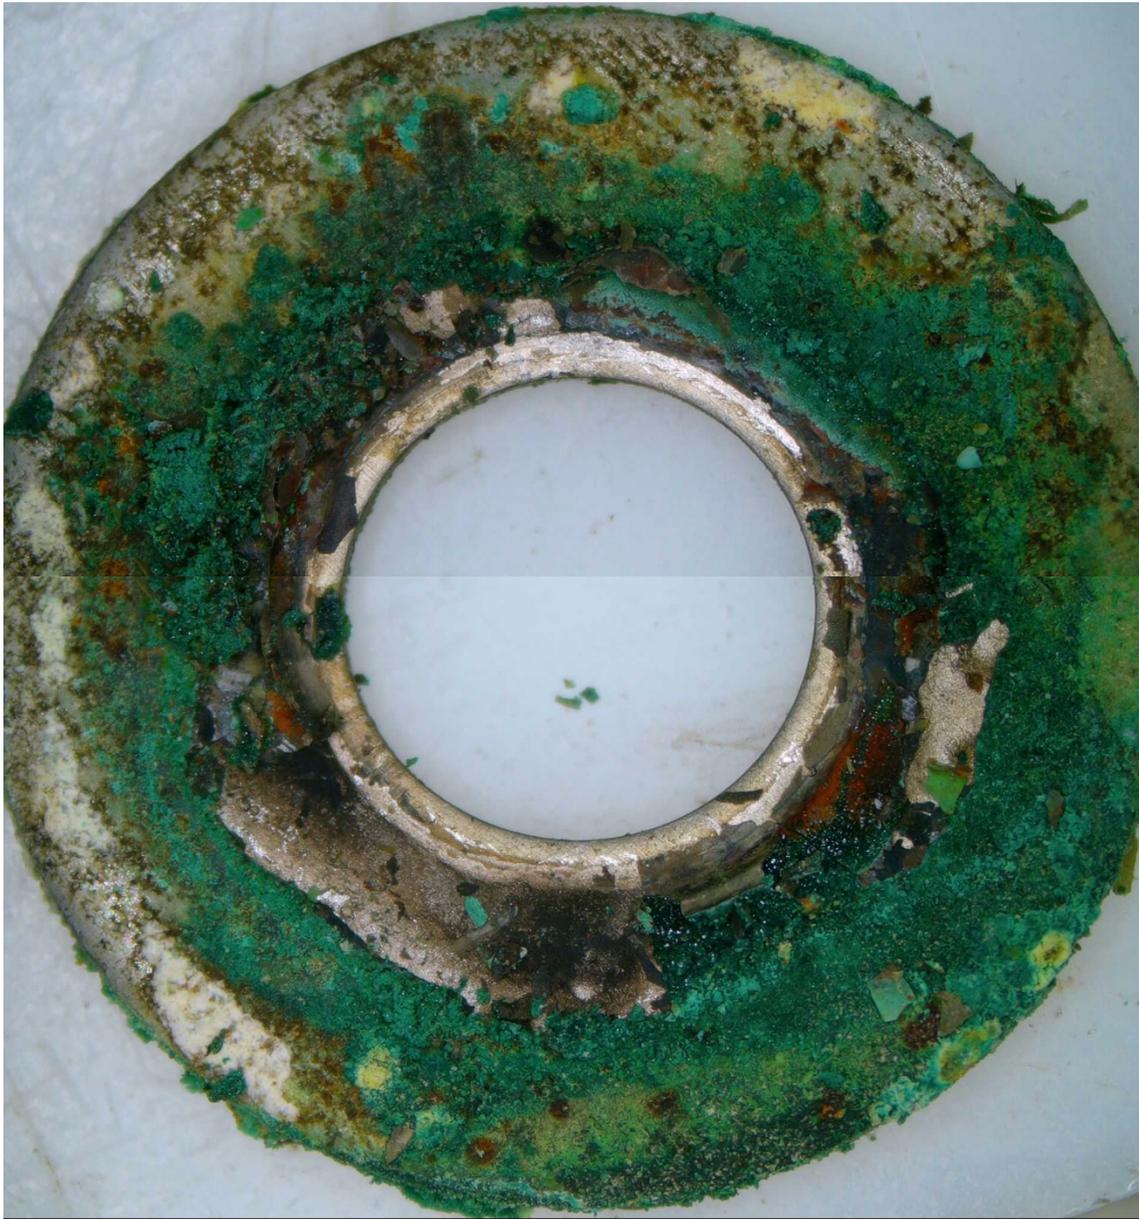
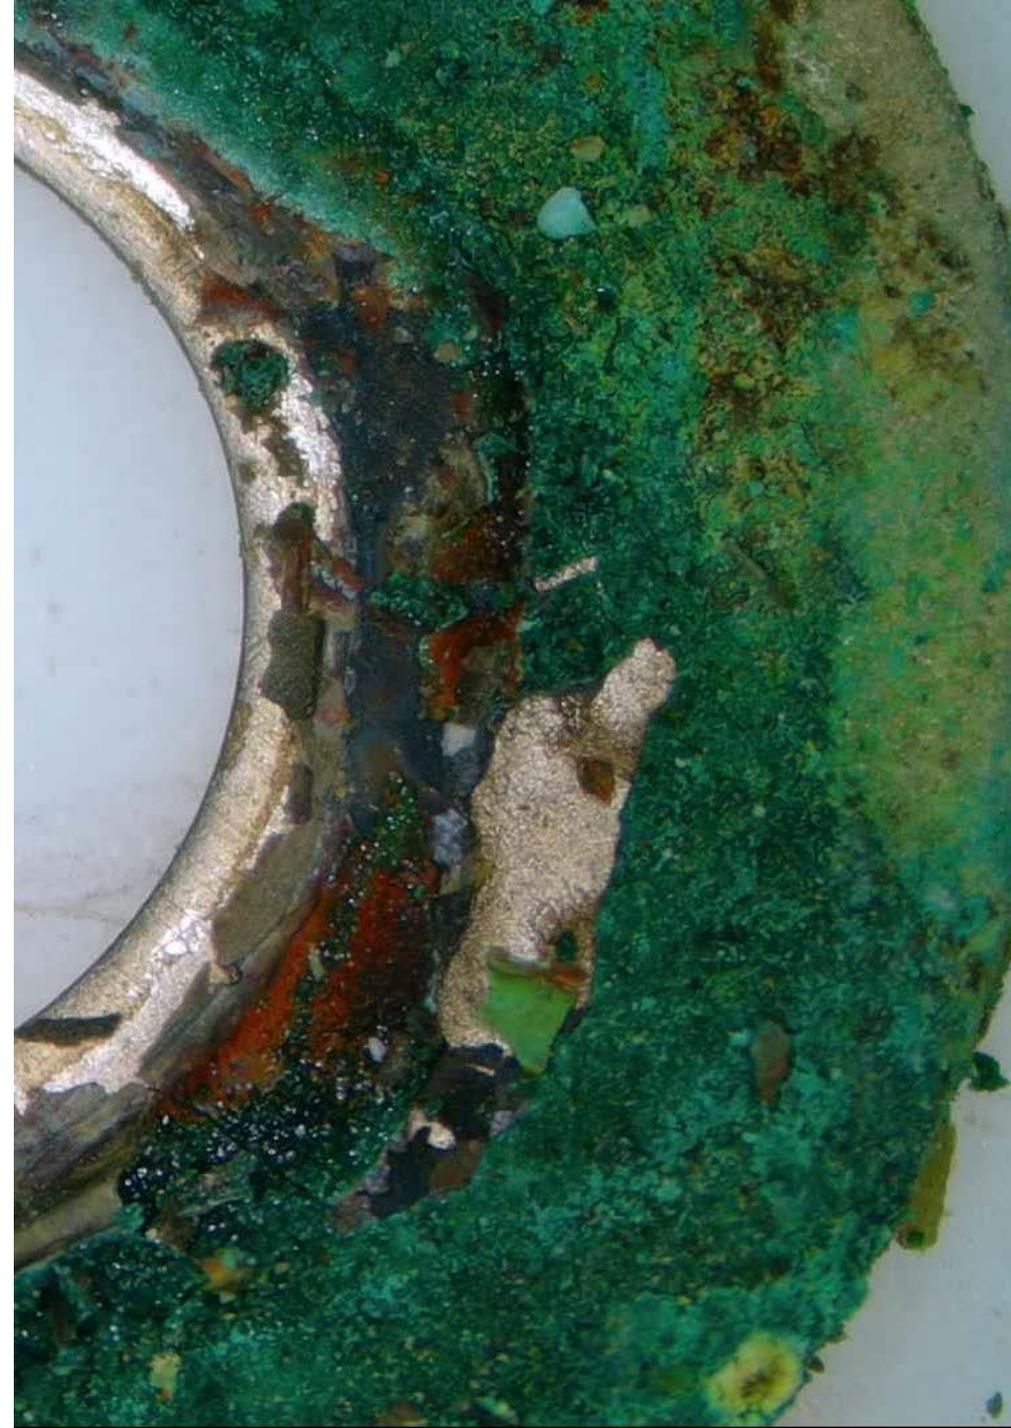
Example of a C4 site (crevice corrosion between bolt and washer surfaces)

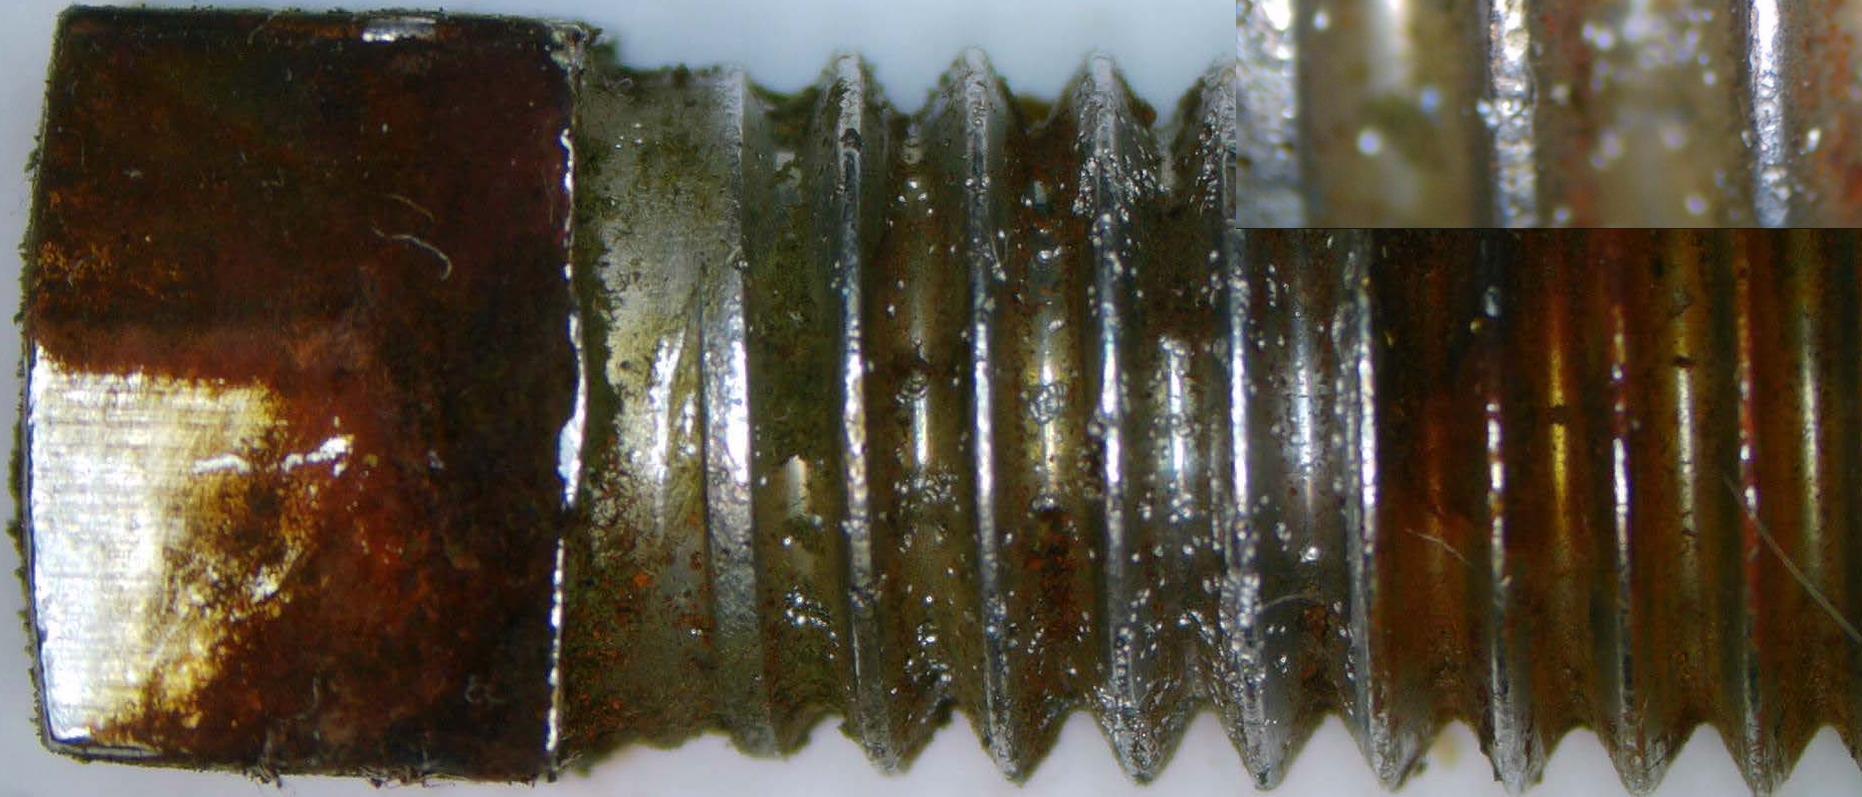
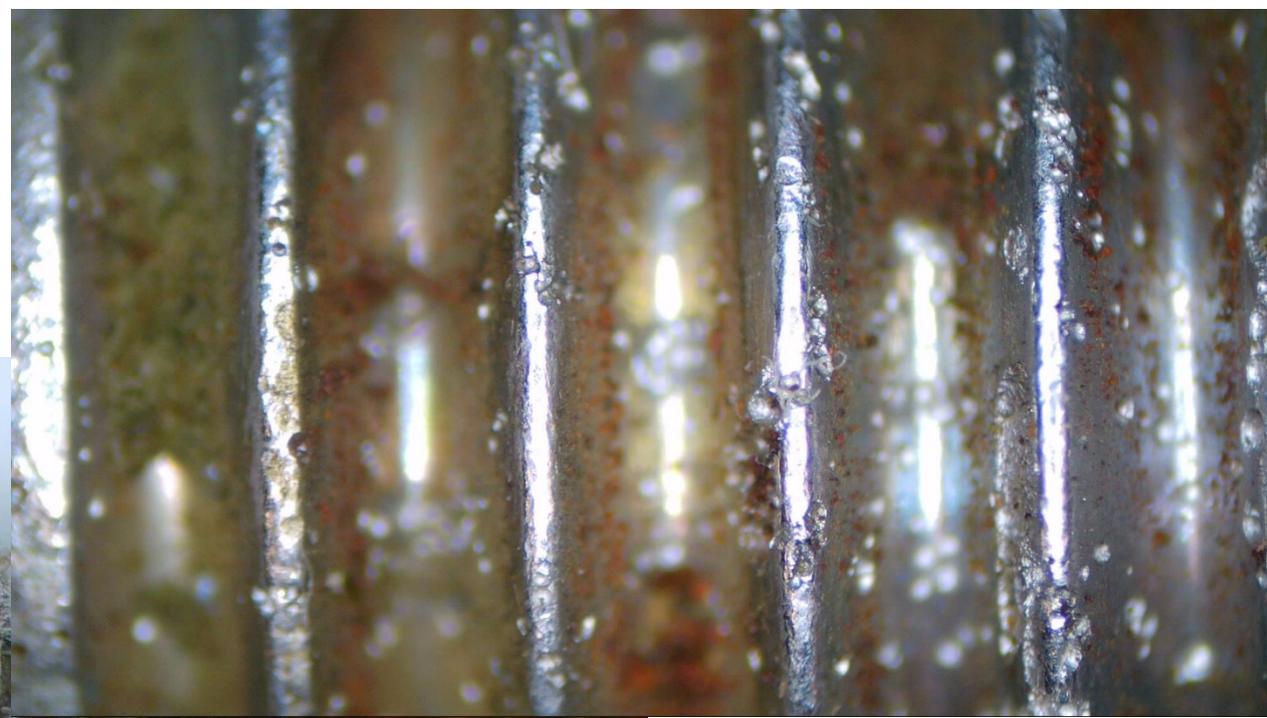
Example of a C5 site (crevice corrosion between threads of bolt and nut)

Elevated Temperature – Stainless Steel (652 days)

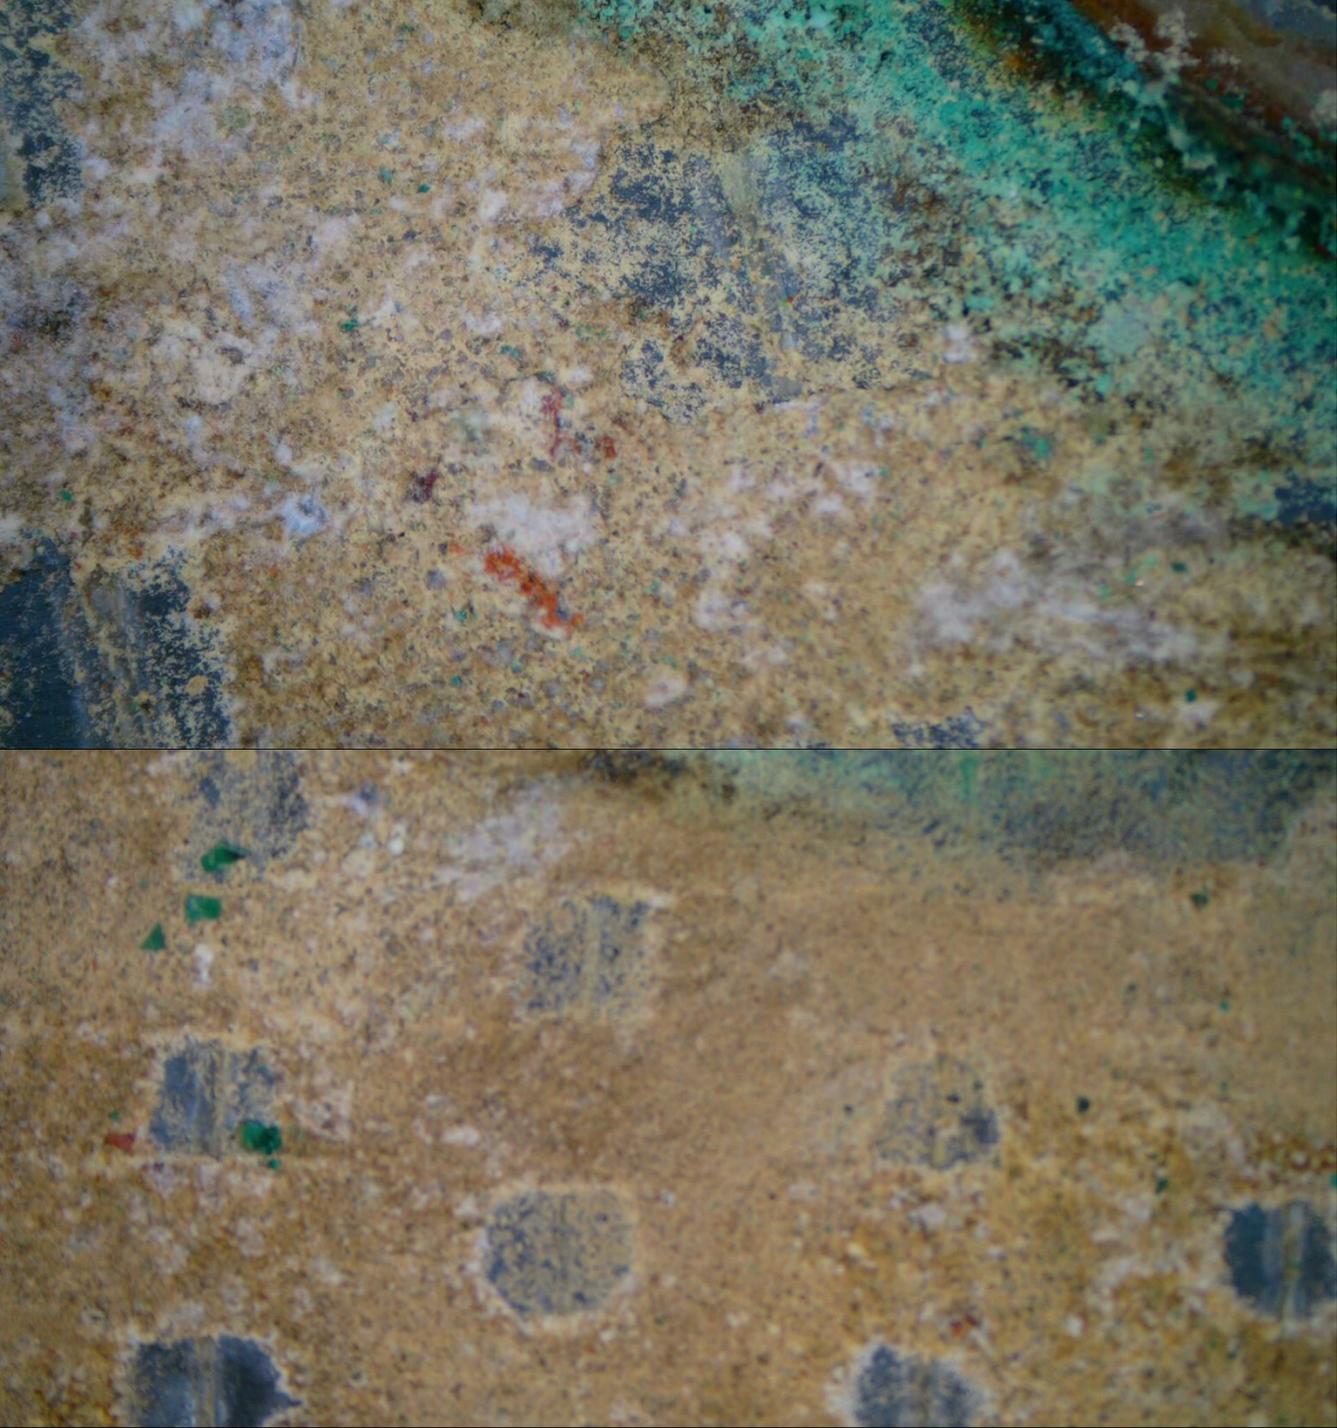
Pitting Corrosion
