U.S. DEPARTMENT OF
ENERGY

Legacy
Management

2020 Annual Site Inspection and Monitoring Report for Uranium Mill Tailings Radiation Control Act Title I Disposal Sites

March 2021

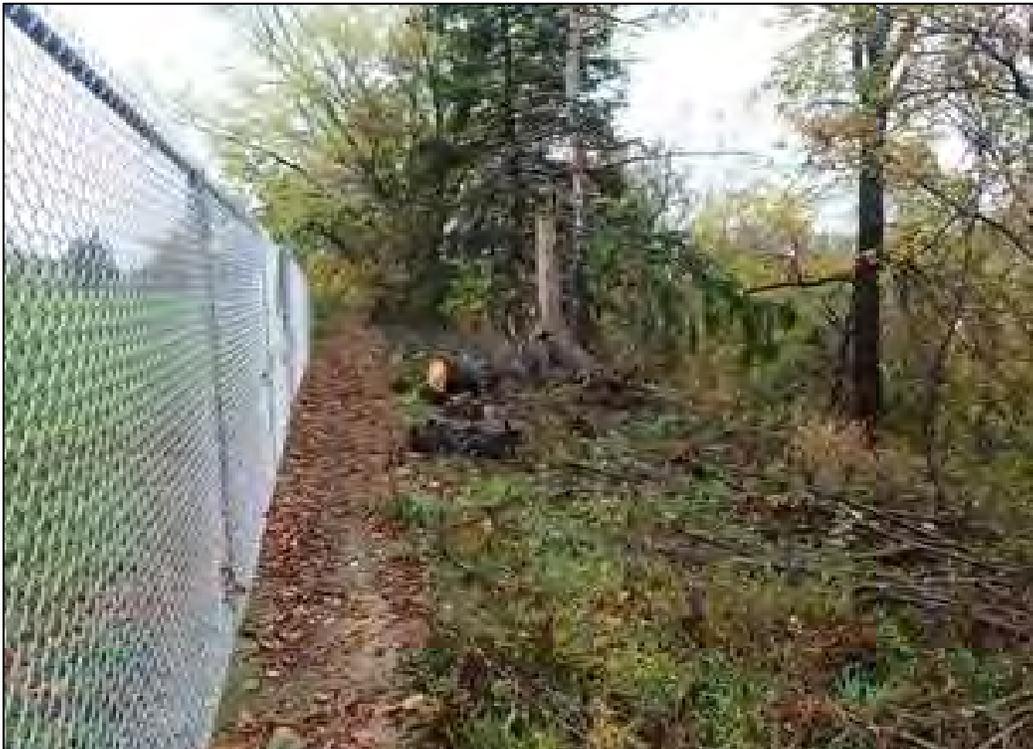
PL-2. Repaired Fence Line

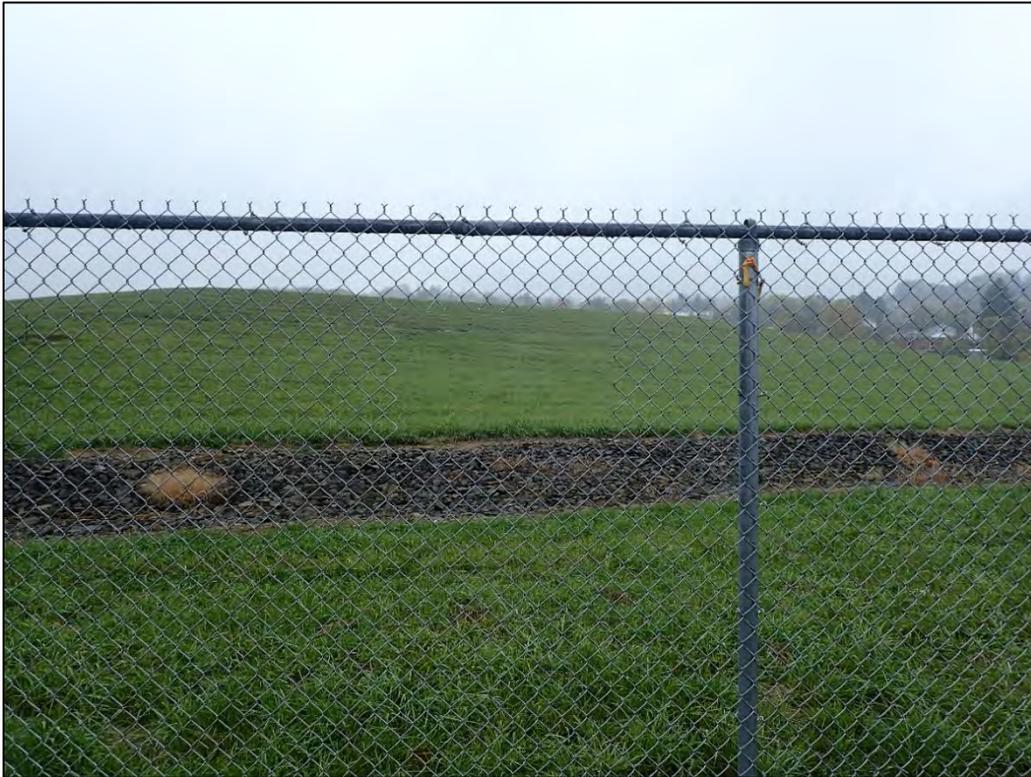
PL-3. Disposal Cell with Missing Perimeter Sign P1

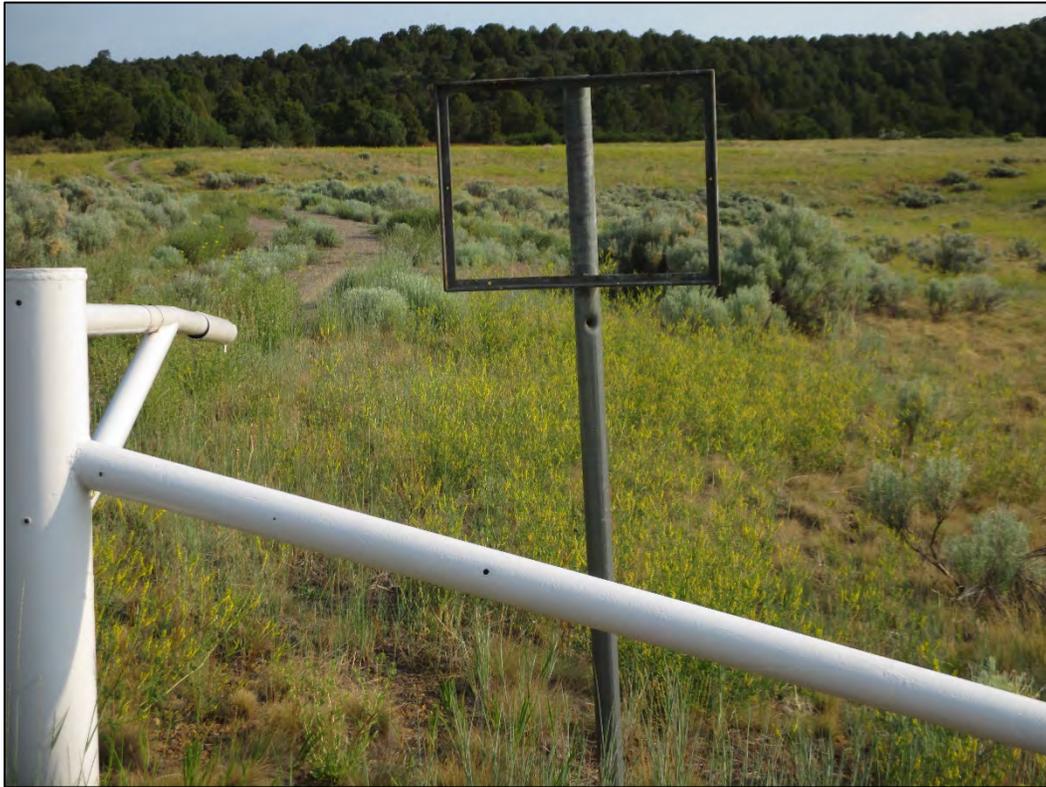
PL-1. Entrance Sign Missing

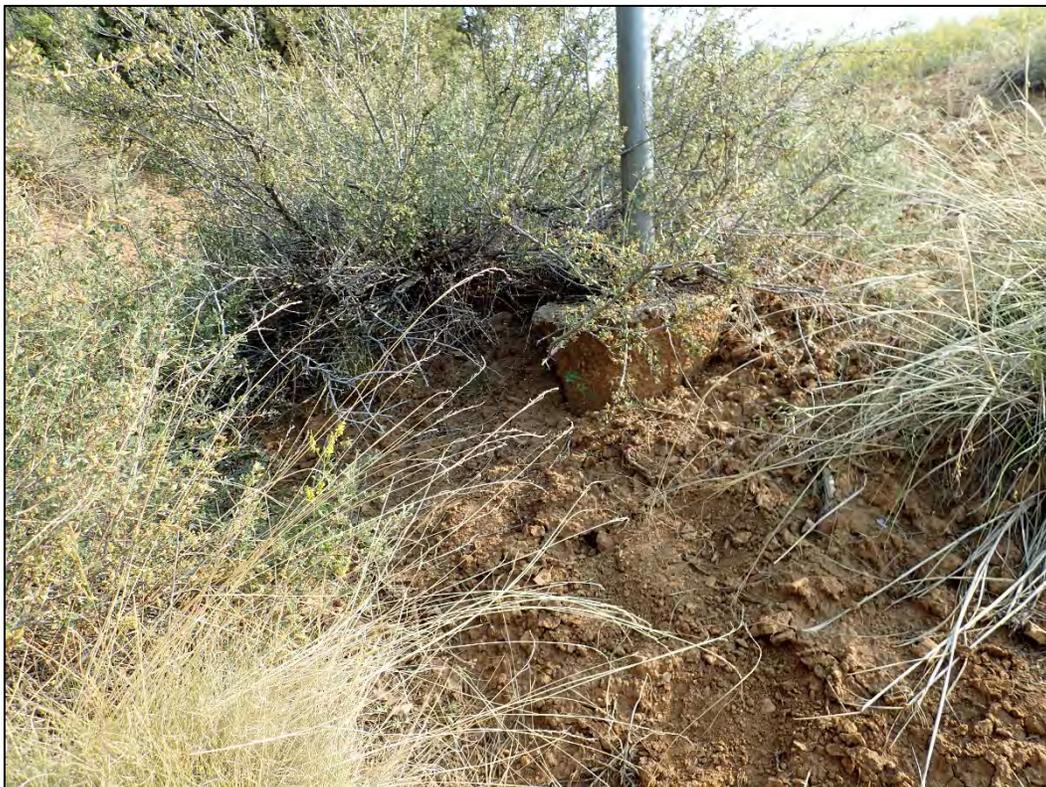
PL-2. Perimeter Sign P79 Undercut by Erosion

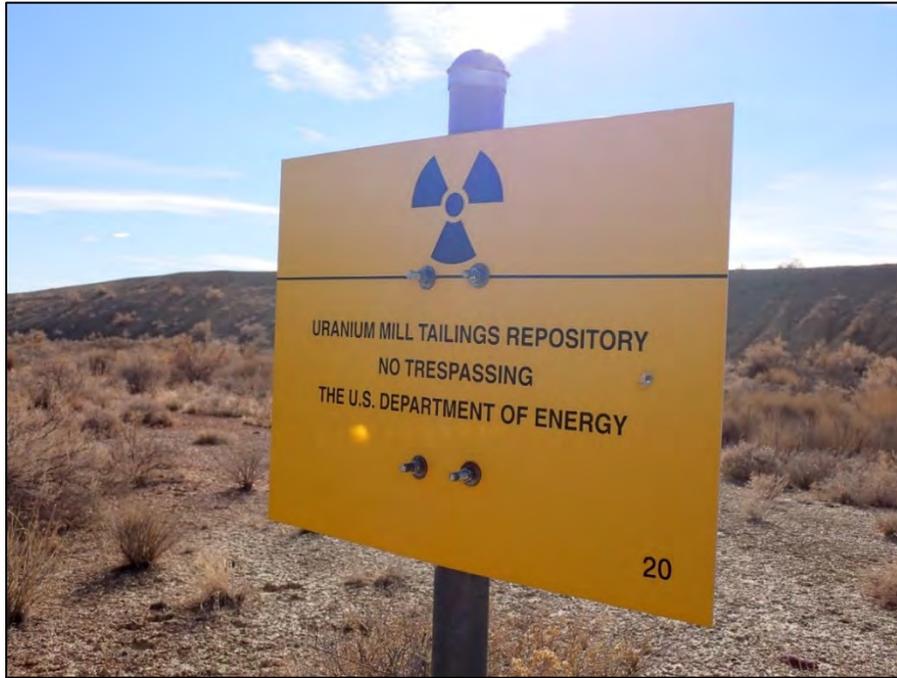
PL-5. Perimeter Sign P20 with Bullet Damage

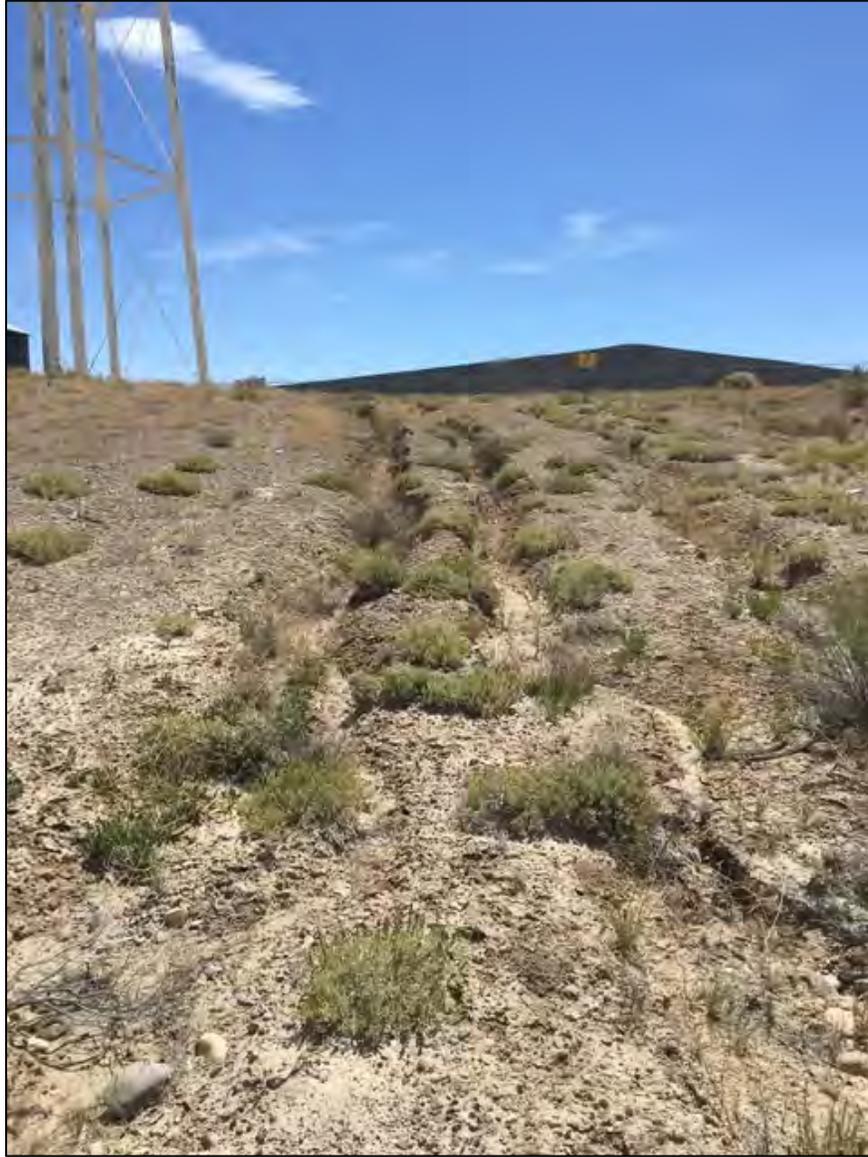
PL-11. Gullies Downslope of Water Tower (Offsite)

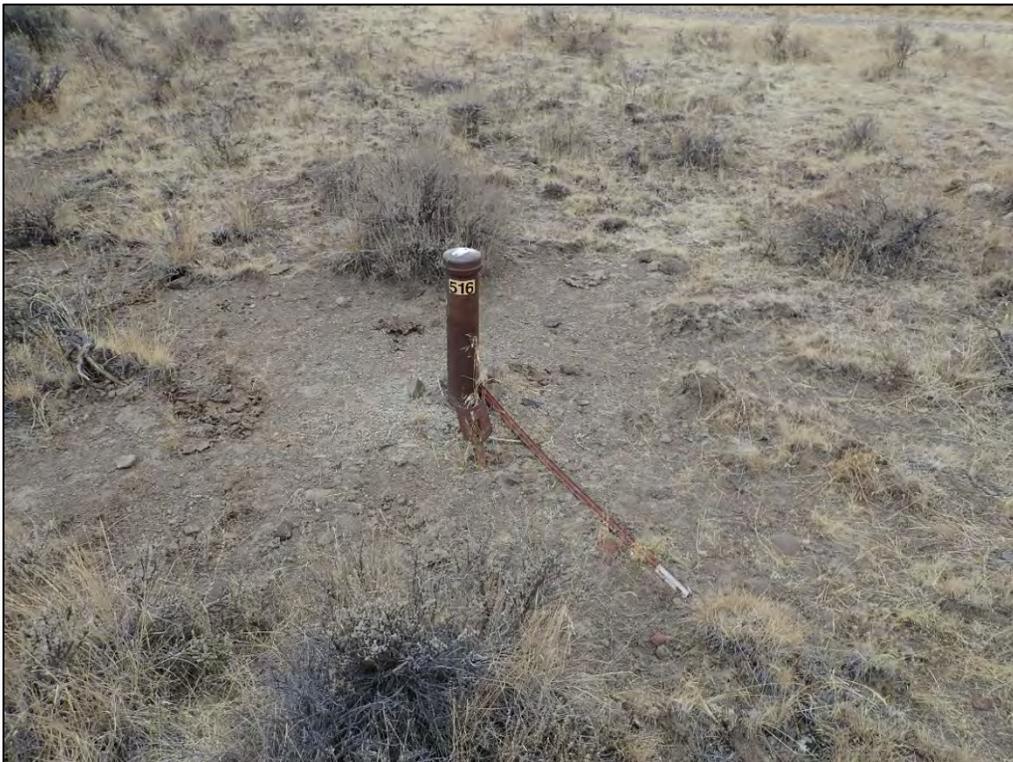
PL-6. Broken T-Post near Monitoring Well 0516

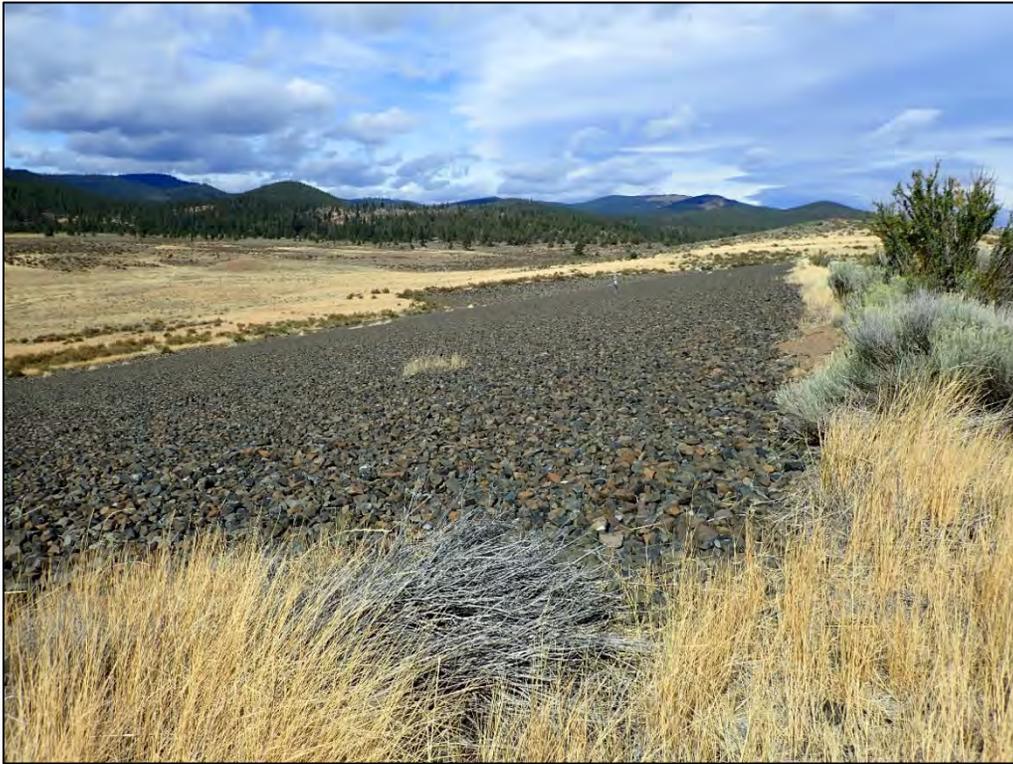
PL-7. Contact Boundary West Side Slope and South Top Corner with Encroaching Vegetation

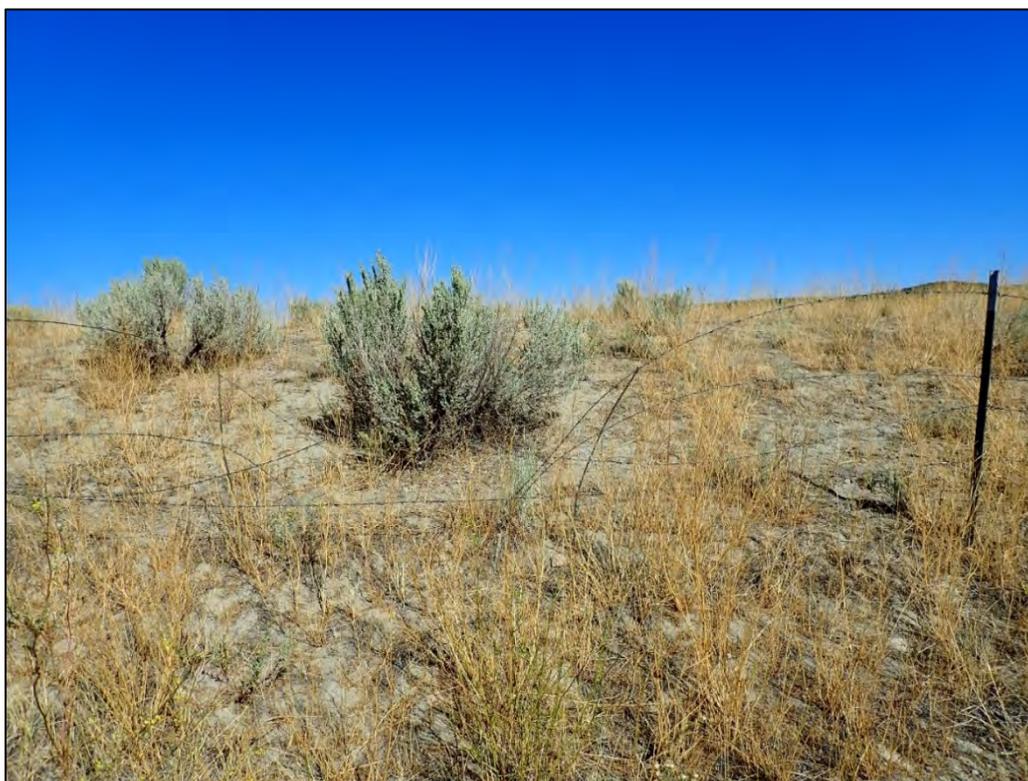
PL-2. Broken Fence Strands Along Northern Perimeter Fence

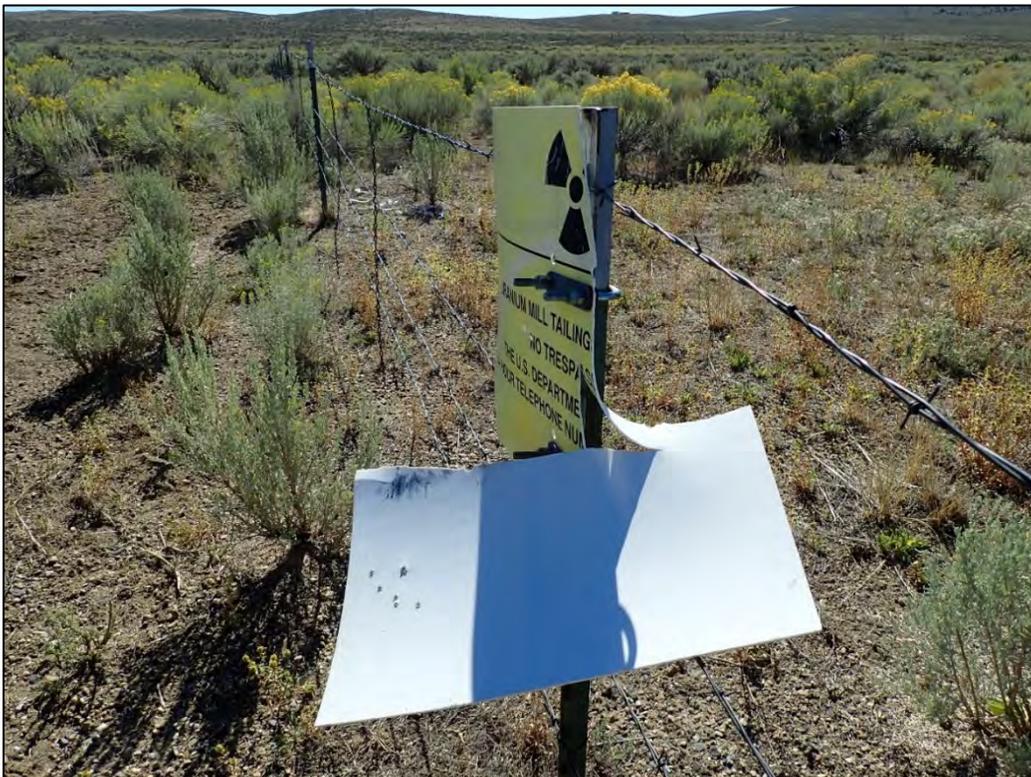
PL-4. Damaged Perimeter Sign P25

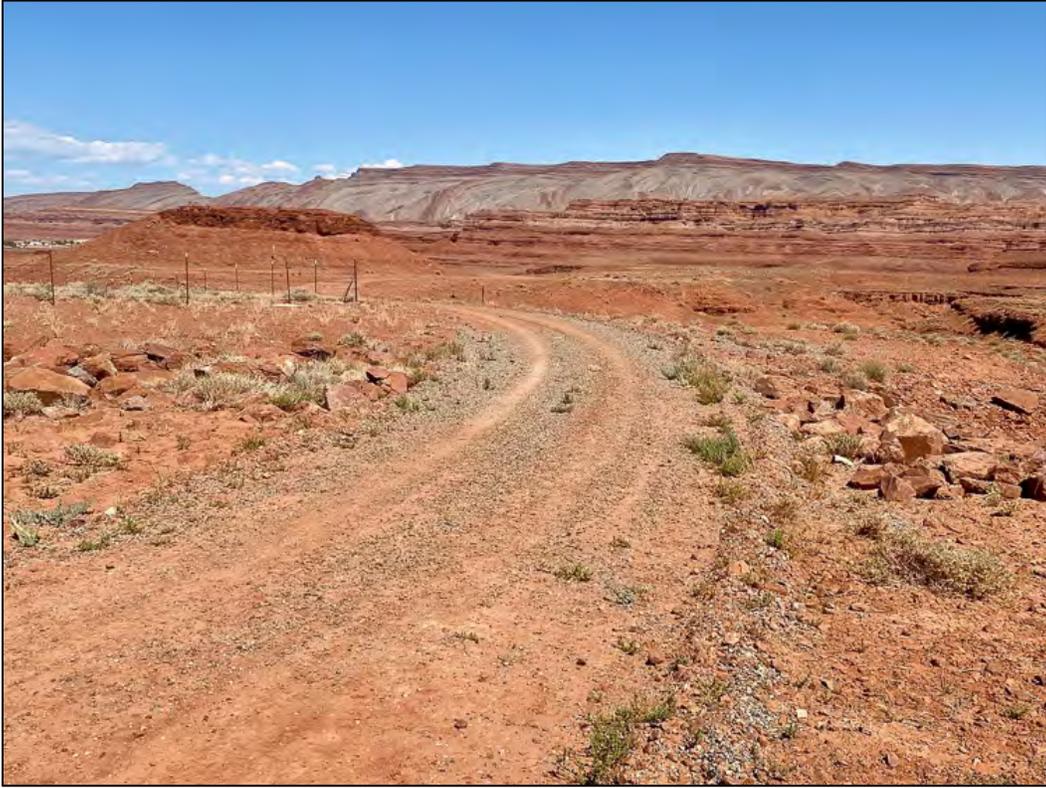
PL-13. Road Repair Area

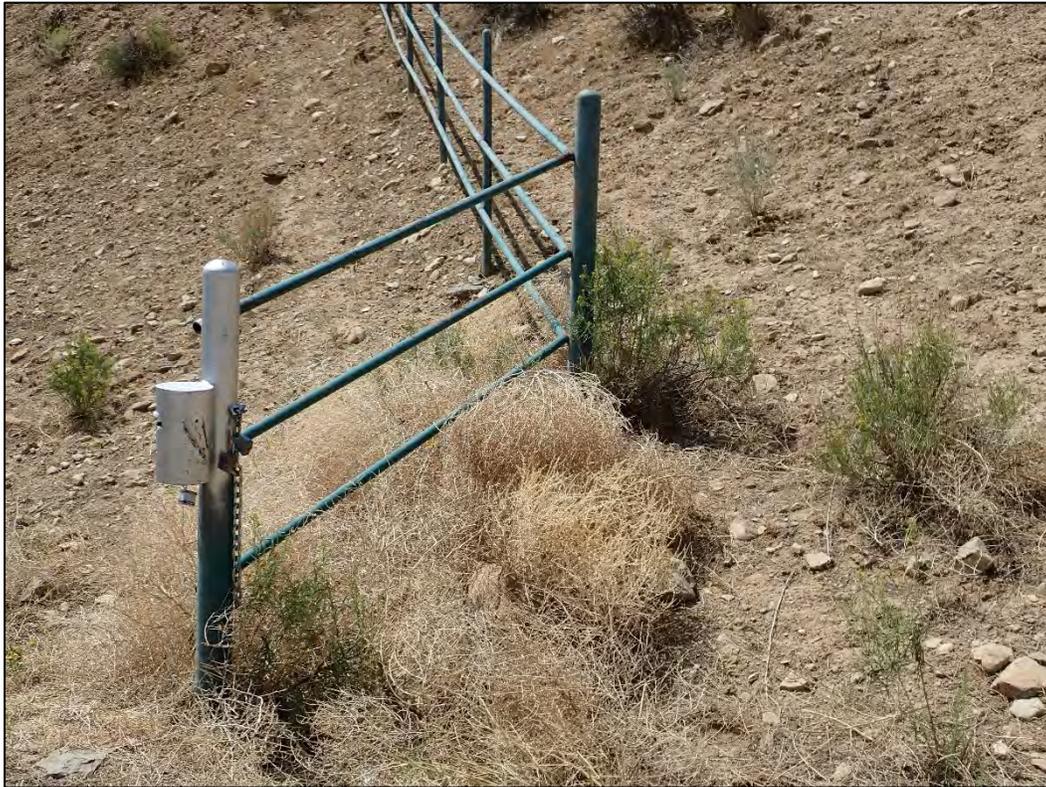
PL-1. Tumbleweed Accumulation Near Outer Gate

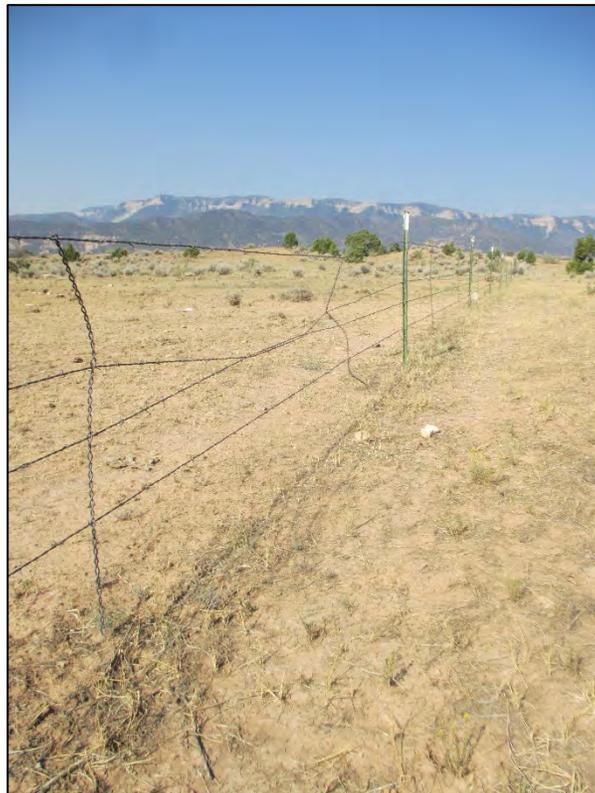
PL-2. Fence Damage

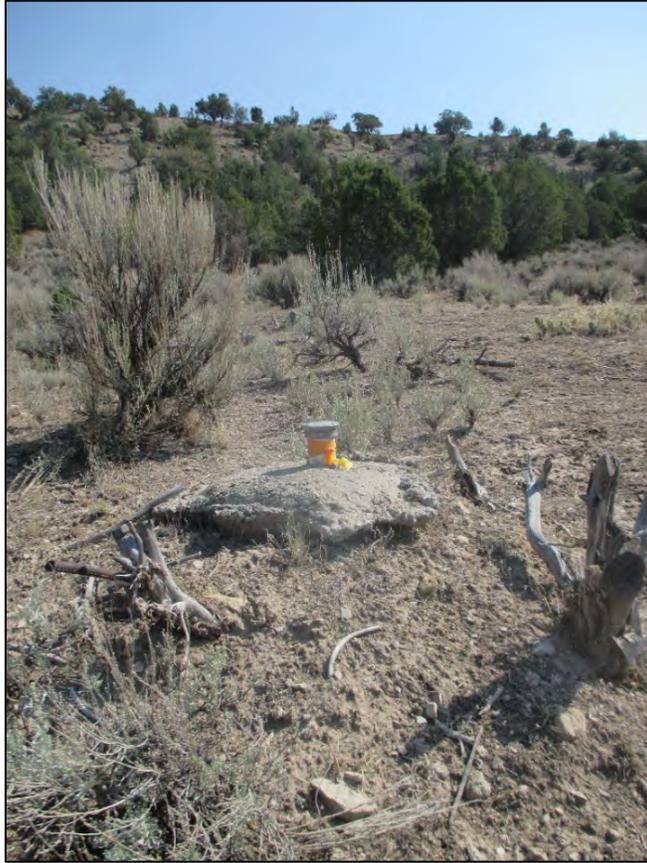
PL-3. Boundary Monument BM-18 with Undercutting

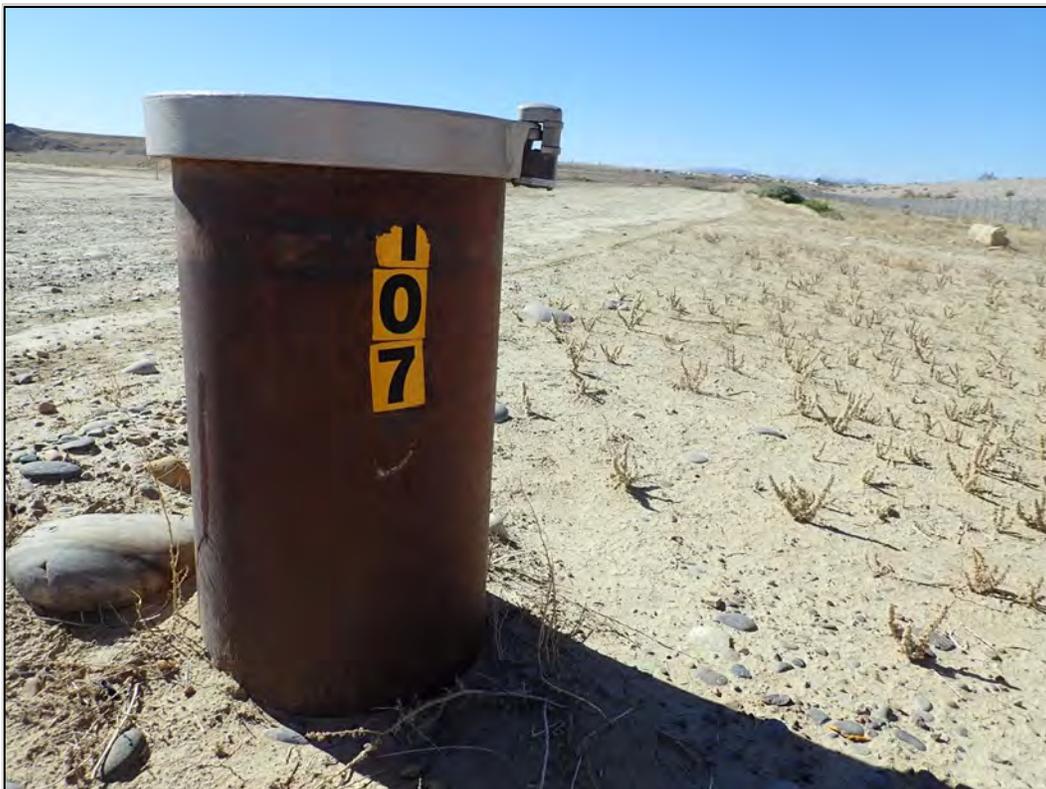
PL-8. Missing ID Stickers on Monitoring Well 1074
