# **Overview of the First Quarter 2021 Surveillance and Maintenance Report for the Rocky Flats Site, Colorado**

January – March 2021

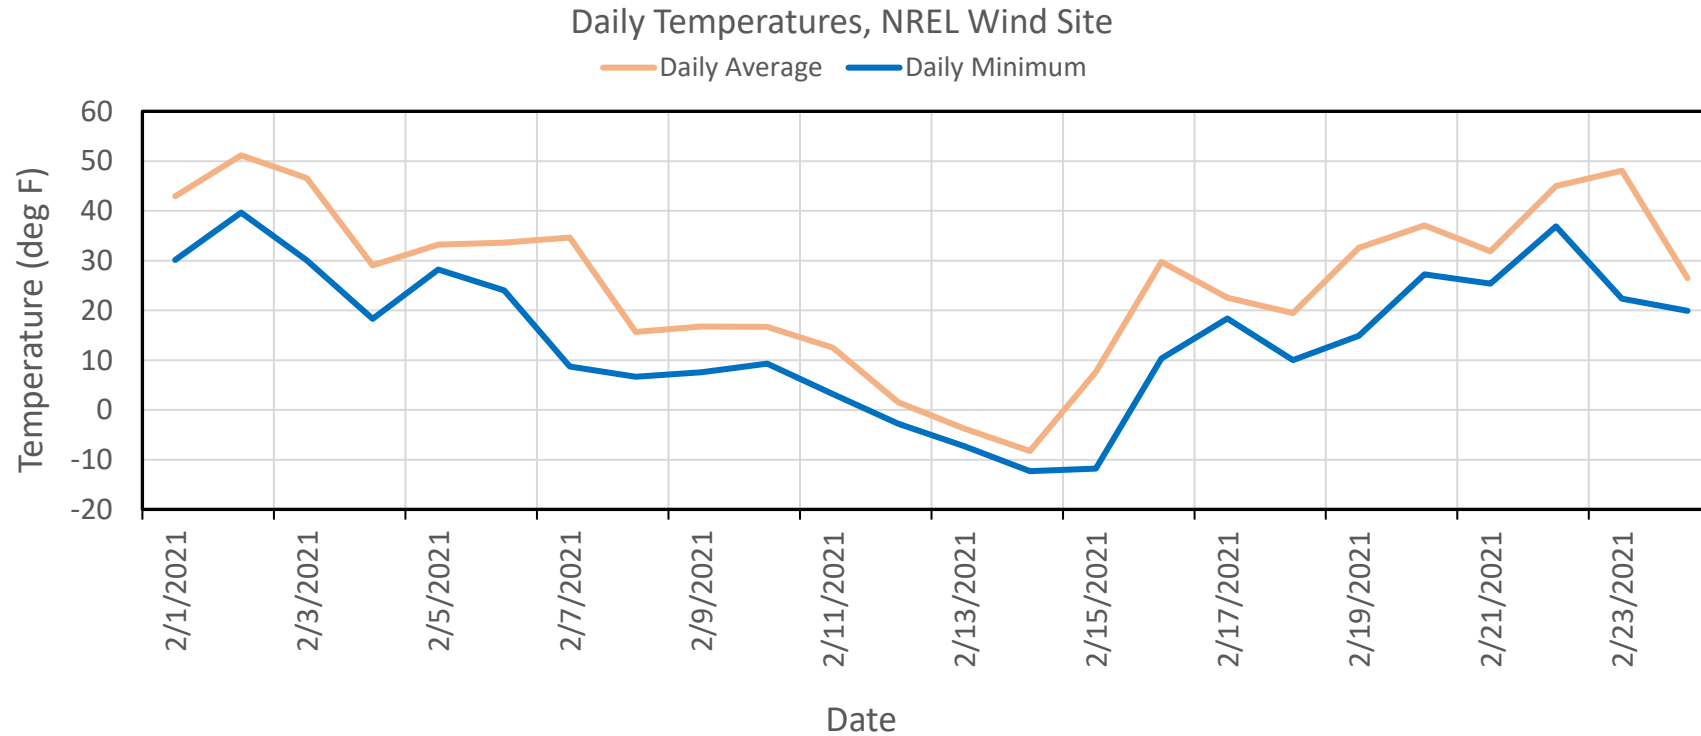
- ETPTS

- Parts exposed within a vault froze during period of extreme cold in February 2021
- Paused water transfer from MSPCS until frozen parts thawed and confirmed to be undamaged

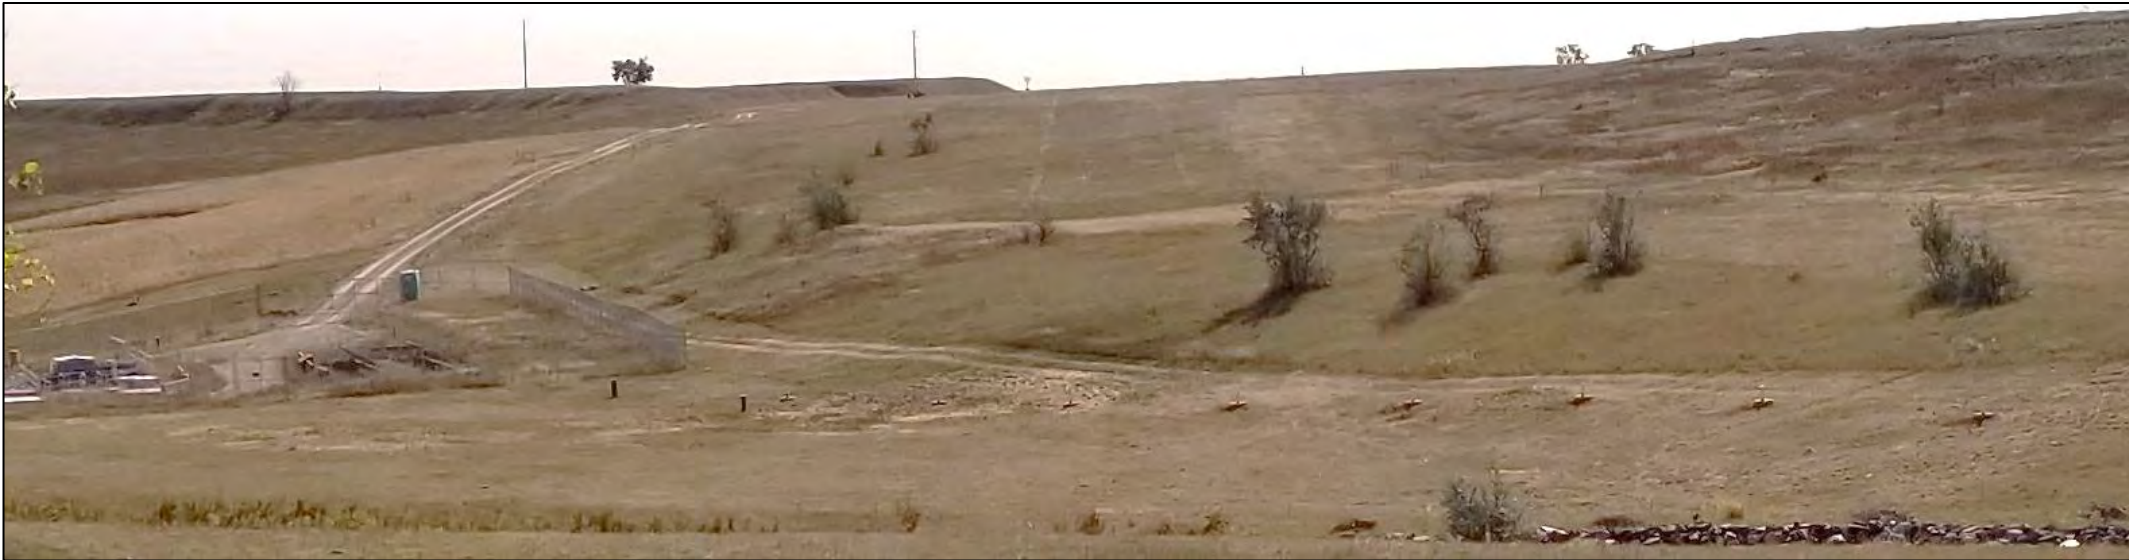
- SPPTS

- Replaced a sump pump in one of the vaults
- Continued seasonal adjustments to dosing, residence time
- Continued evaluating groundwater conditions west of existing collection trench

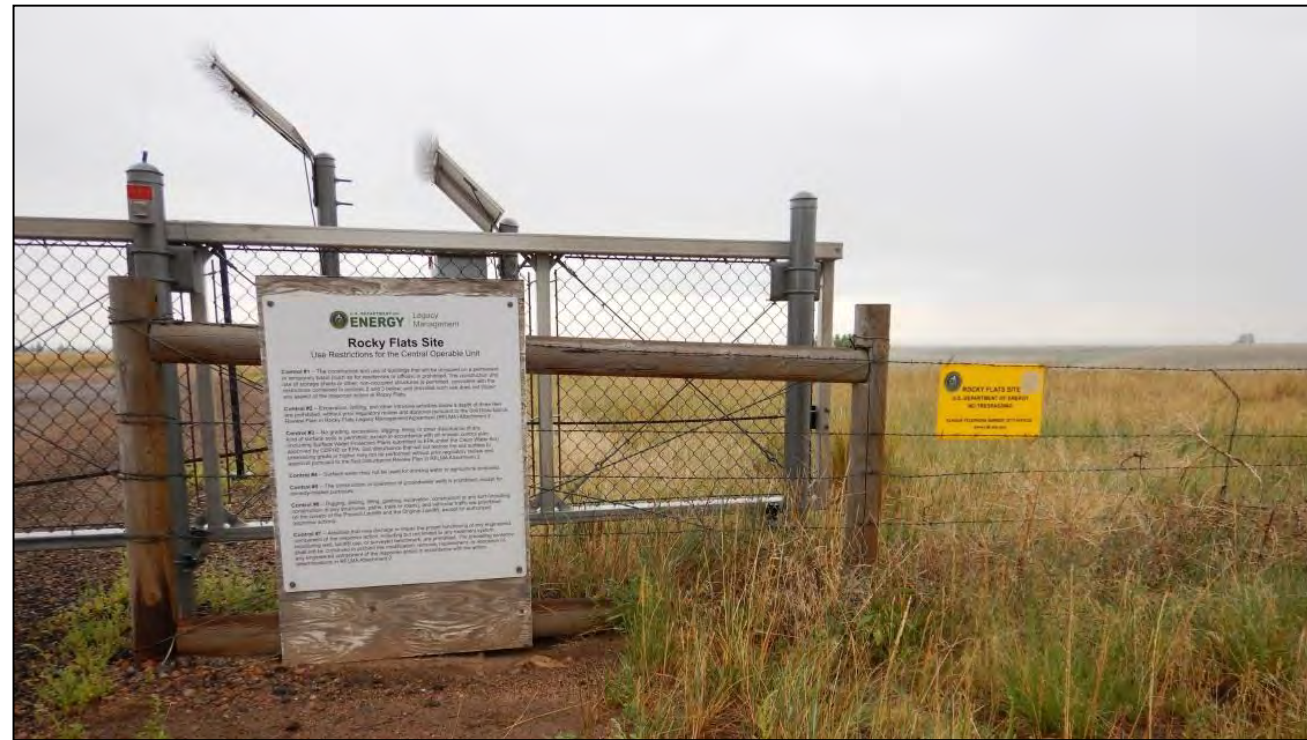
- RFLMA physical control
- Signs inspected on February 11, 2021
  - All signs in good condition and legible

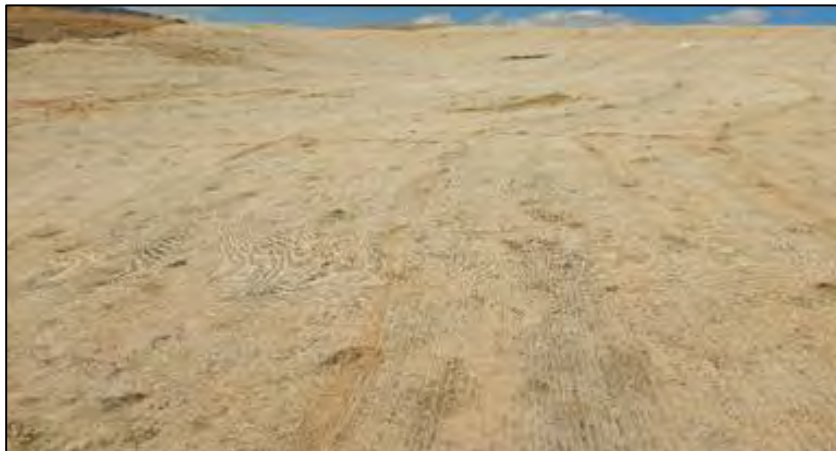
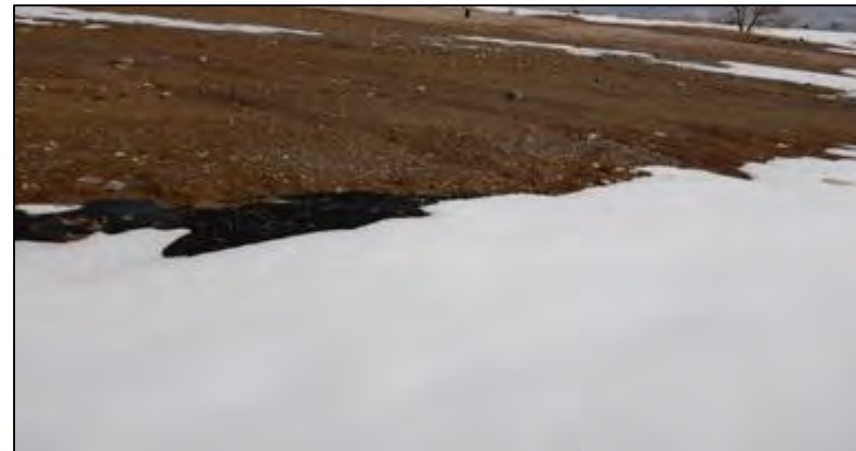
- Monthly inspections
  - January 22, February 24, and March 26, 2021
    - Coconut erosion matting displaced from high winds and elk migration throughout quarter
      - Re-staked, replaced, or wood straw spread as alternative
  - March 26 inspection combined with weather-related inspection following rapid melt of 10 inches of snow
    - Rills outside of waste footprint above Berms 5 and 6
      - Deposited 1 to 3 inches of sediment into Berm 5 and 6 channels
      - Rills removed using hand tools

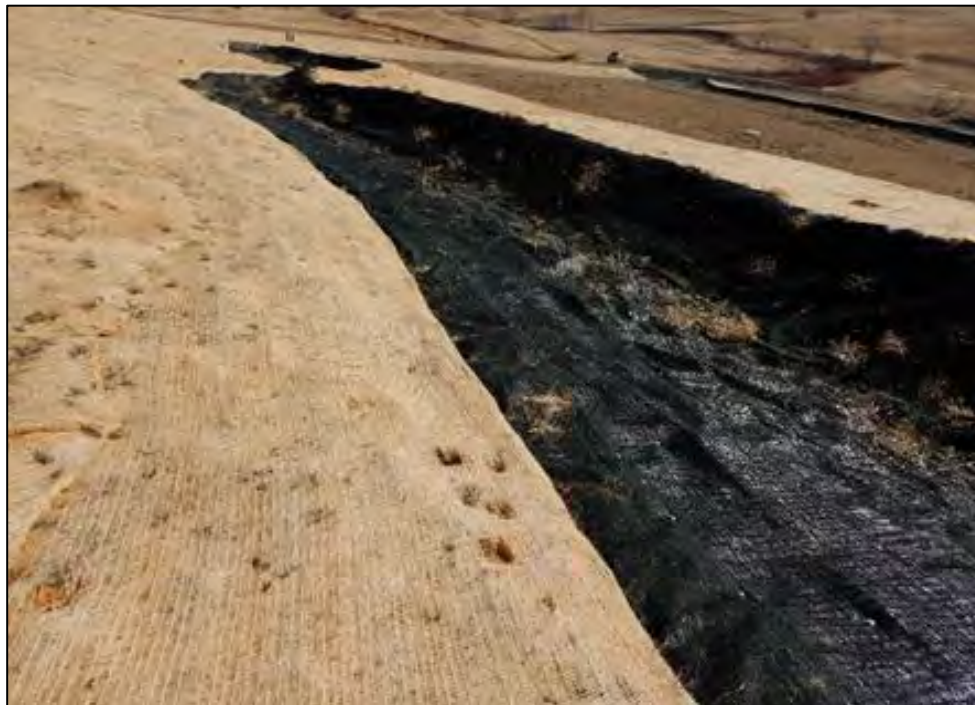
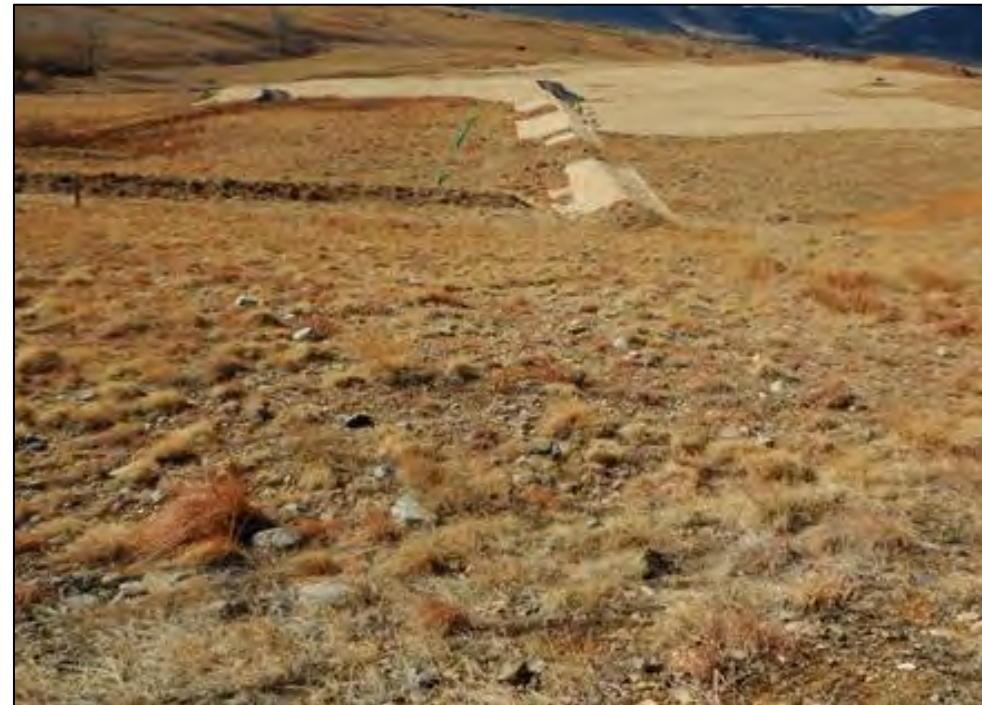
- Surveyed settlement monuments on March 1, 2021
  - Vertical settling was within design limits
  - Areas of stabilization activities remain stable and in good condition

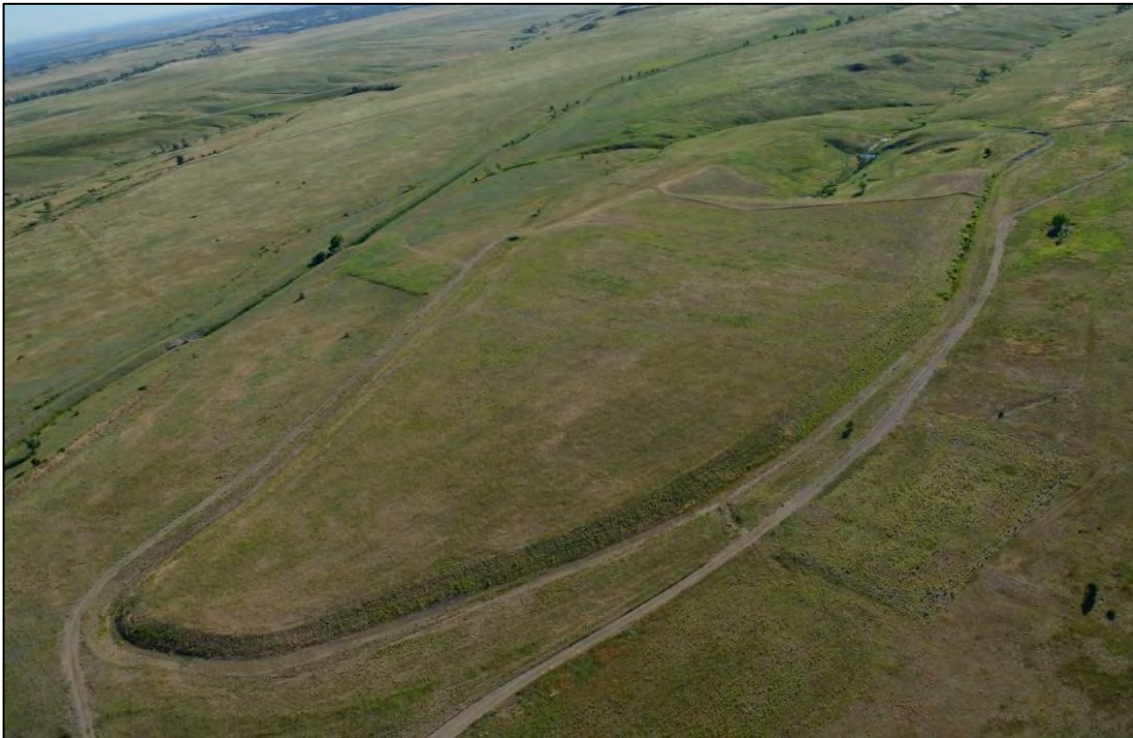
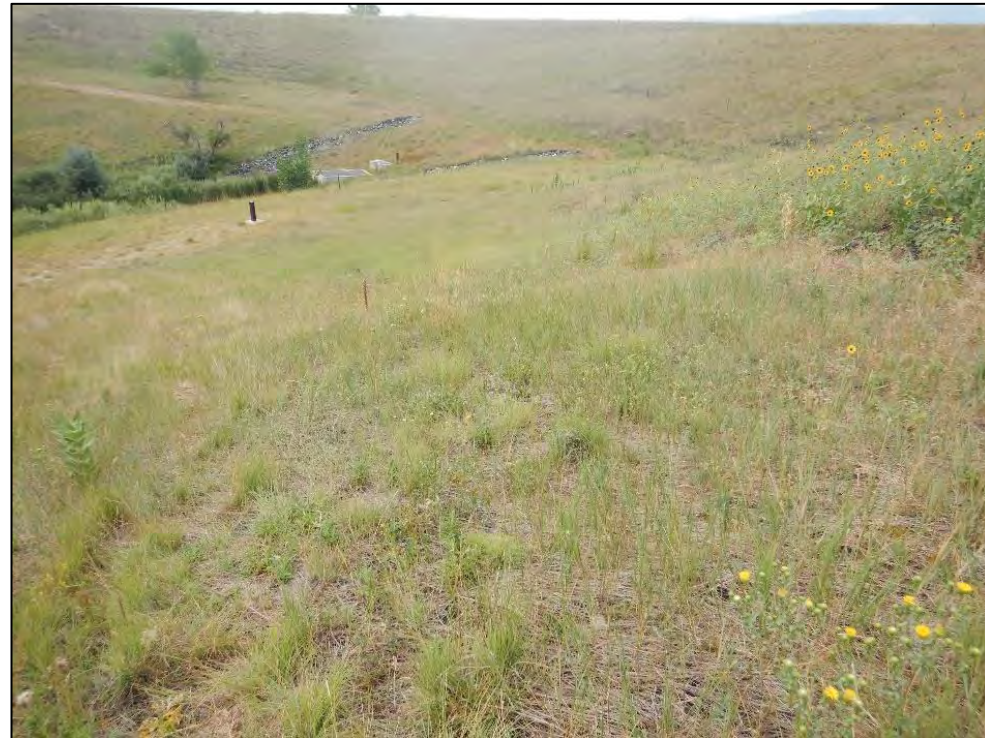
- Quarterly inspection performed on March 1, 2021
- Present Landfill is in good condition

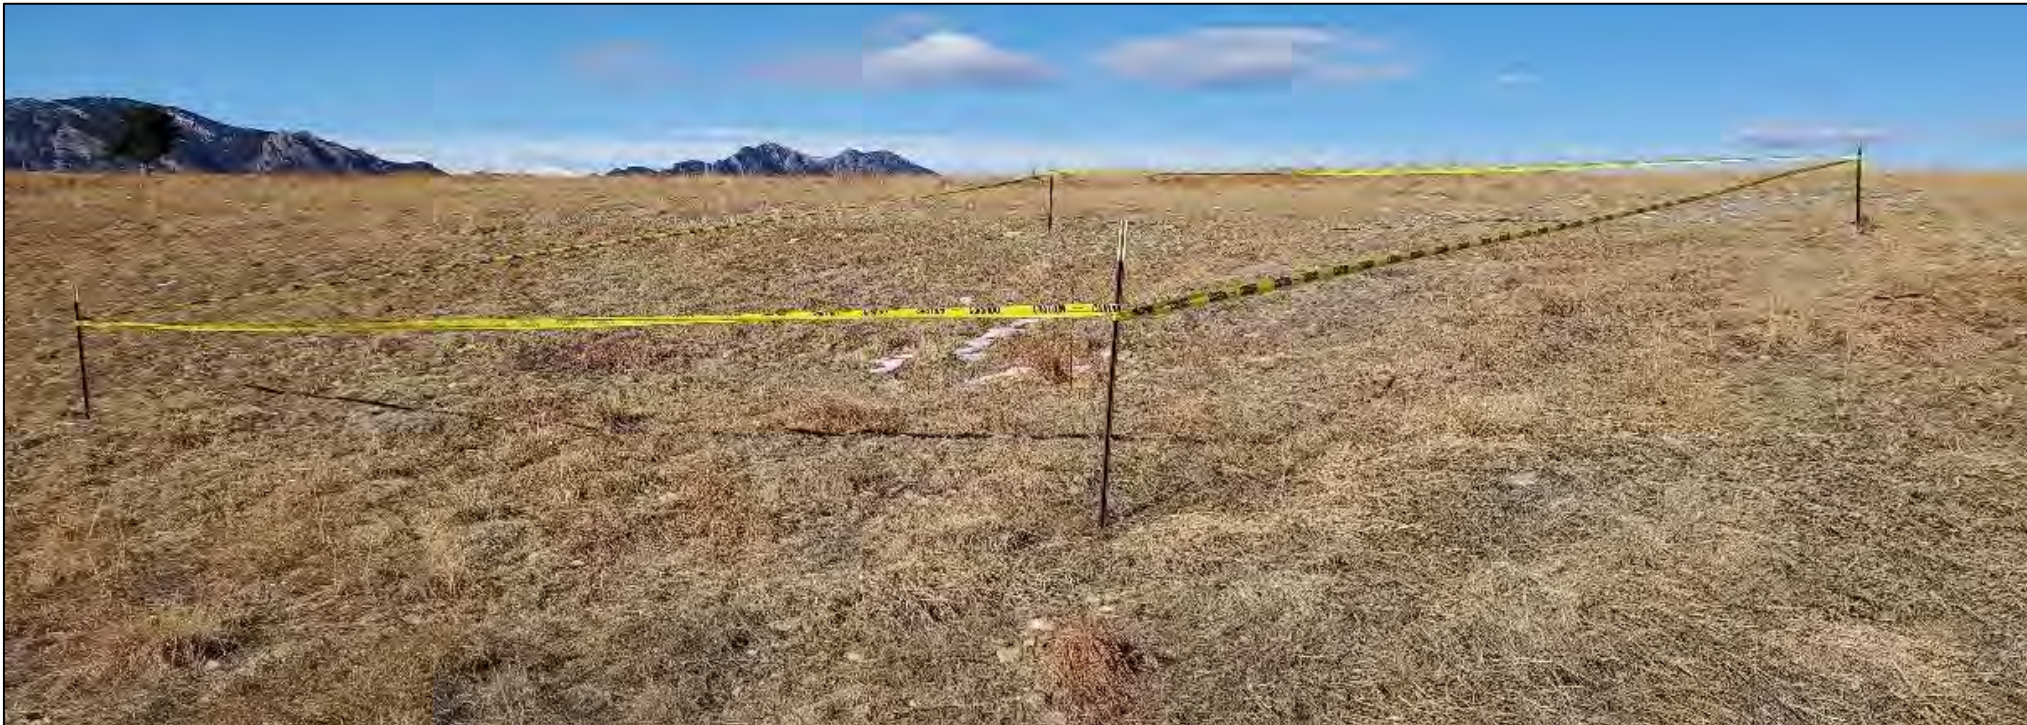
- Quarterly inspection of Former Building Areas 371, 771, 881, and 991 was completed on February 3, 2021
  - The depression located near the southeast corner of former building area 881 (December 2019) was backfilled on February 3, 2021
