### **Asbestos Abatement Project Closeout Report**

# **Asbestos Abatement Project Closeout Report for the Piqua, Ohio, Decommissioned Reactor Site**

## **September 2019**

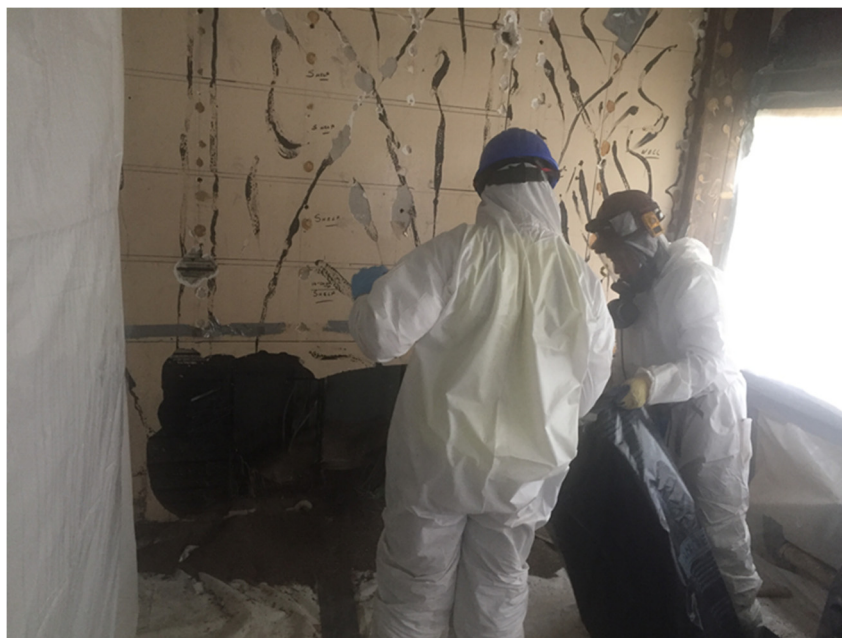
The abatement effort was proceeding as planned in early May 2019 when, during the abatement of the vermiculite in the plenum, an unforeseen discovery was made. The actual volume of 2224 square feet and widespread location of vermiculite within the plenum far exceeded the localized 155 ft<sup>3</sup> identified in the 2016 hazard assessment survey. The survey captured approximately one open bag of vermiculite from atop the spray-in insulation. As the plenum abatement proceeded, it became apparent that the entire plenum was filled with vermiculite hidden by the spray-in insulation.

Photo 8 shows two asbestos abatement workers in proper PPE and inside a containment area, shoveling vermiculite (that poured out from the Administration Building north wall area onto the floor) into asbestos disposal bags.

*Photo 8. Asbestos Workers Removing Vermiculite for Disposal*

In response, the LMS project lead, the Neuber project manager, and the Rii project manager discussed at great length the next steps to safely approach abatement in the plenum area given the widespread amount of vermiculite throughout. Specifically, the Piqua Project Team discussed an approach to establish containment for safely performing an exploratory search for vermiculite behind the first floor walls (i.e., in the office area and locker room that are directly below the plenum). On May 20, a new containment area was established for potential vermiculite. Additional vermiculite was discovered behind several walls on the first floor, and abatement proceeded.

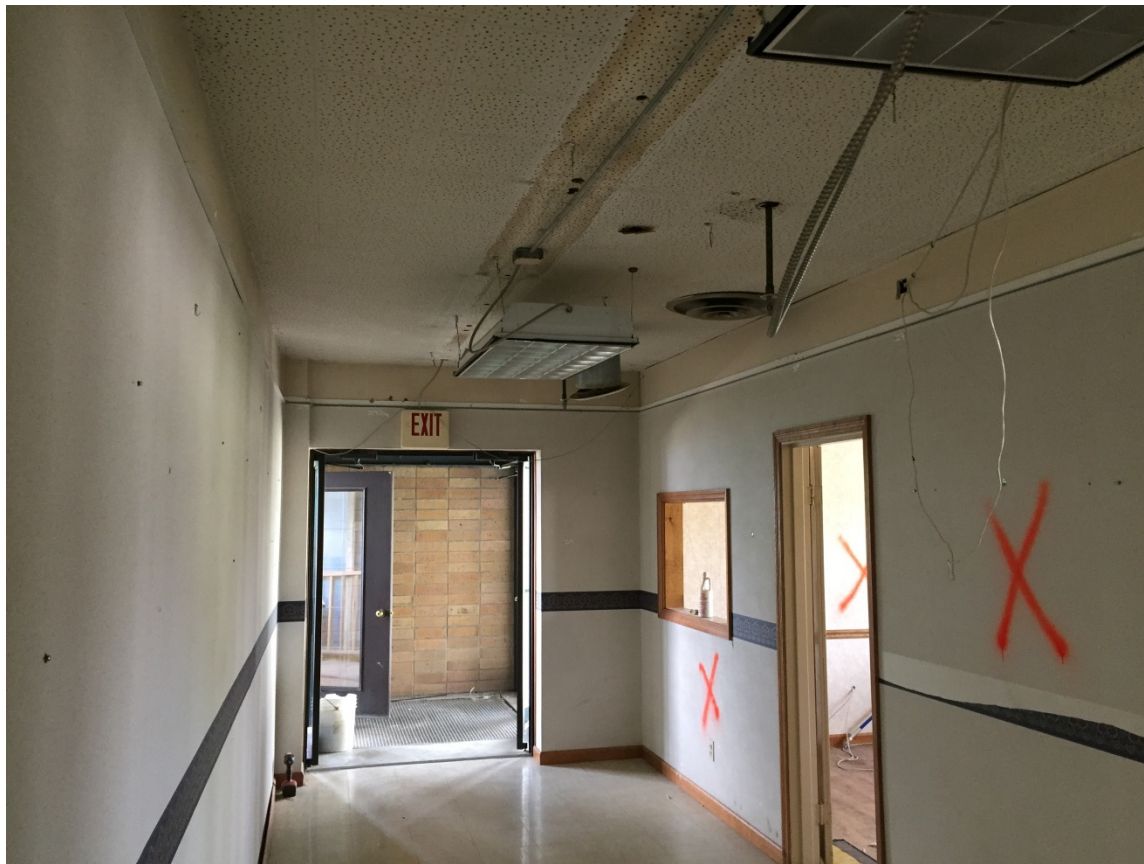
The Administration Building consists of three stories above grade and a full basement, and the floor space ranges from 5332 ft<sup>2</sup> at the basement level to 355 ft<sup>2</sup> at the third level, for a total of 11,718 ft<sup>2</sup> including stairways. The first and third floors required selective demolition of interior wall construction, and it took place after the decommissioning of the Reactor Building. In particular, new construction occurred on the first floor to include three new front offices, a redesigned conference room, and redesigned laundry area and locker room accommodations, all with dropped ceiling installed. Similarly, an office area was established on the third floor. Photo 9 shows the first floor front office area with walls marked for selective demolition, ACM floor tiles in hallway, and laminate flooring in an office. Photo 10 shows the same area after removal of vermiculite, selective demolition of walls, removal of ceiling tiles, and abatement of ACM floor tiles. Photo 10 also shows the removal of ACM piping that was tied to the wall-mounted radiator.

*Photo 9. Piqua Administration Building, First Floor Office Area, Before Abatement*

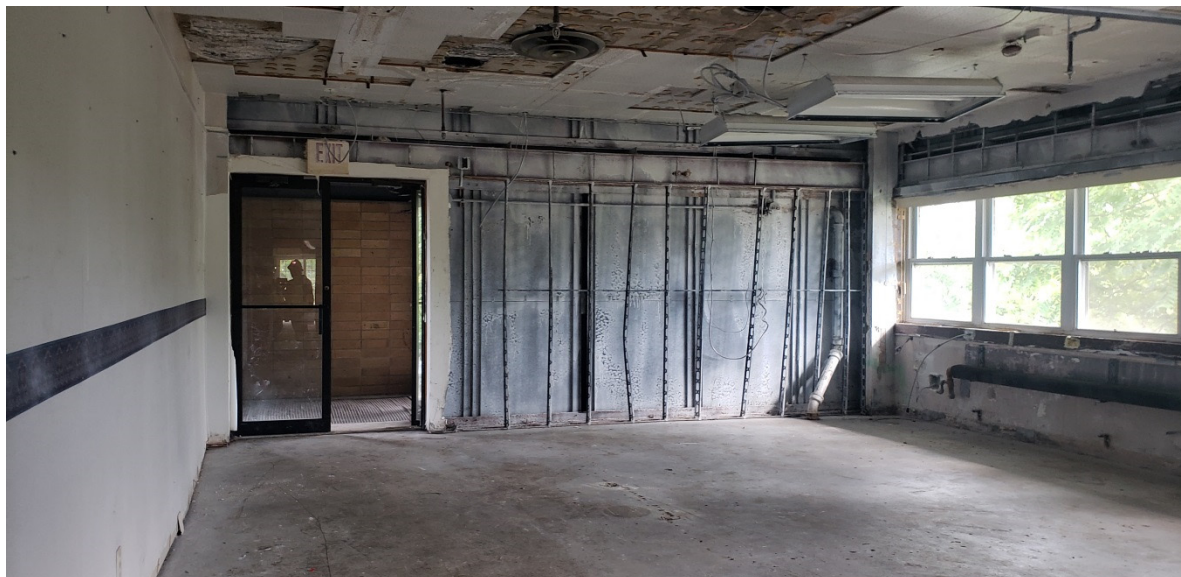
*Photo 10. Piqua Administration Building, First Floor Office Area, After Abatement*

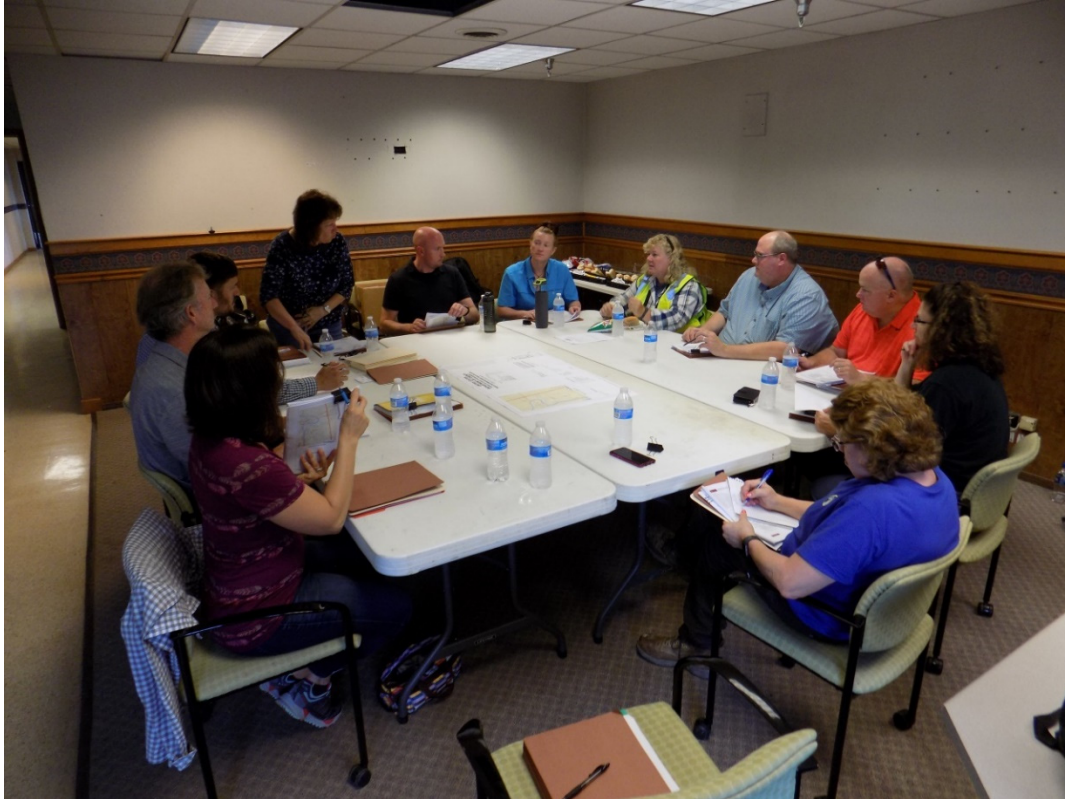
Photo 11 shows the first-floor Administration Building conference room before abatement. The area included false rear walls, a dropped ceiling, and carpeting. The room required selective demolition since the room had concealed ACM pipes, ACM floor tiles, and ACM mastic. Photo 12 shows the same room after selective demolition and abatement of those ACM materials.

*Photo 11. Piqua Administration Building, Conference Room, Before Abatement*

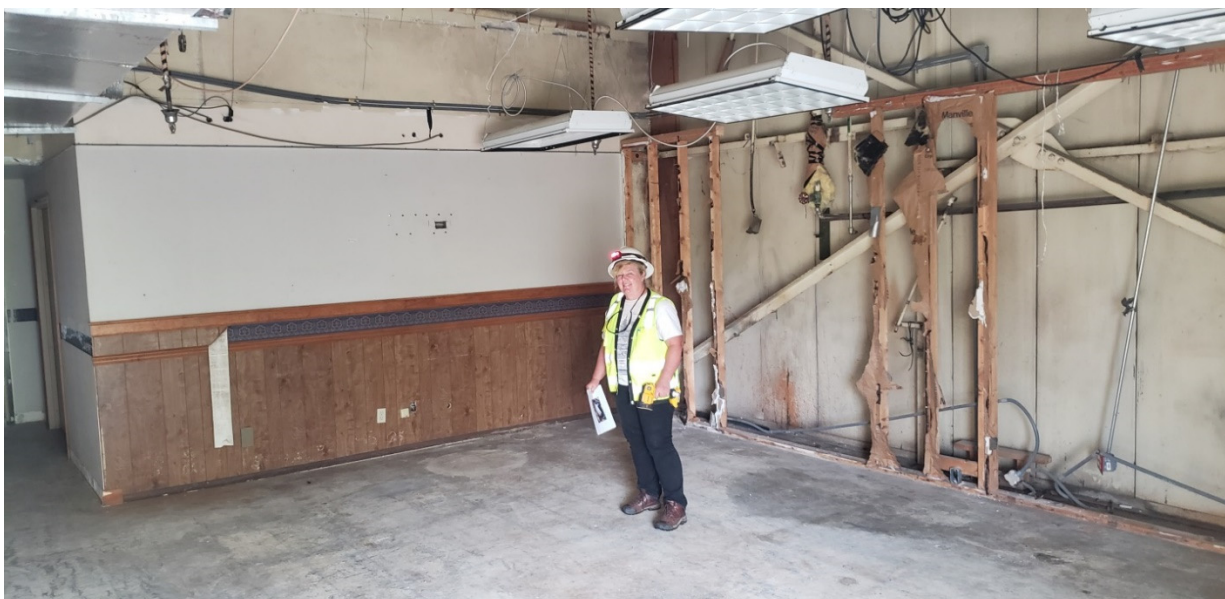
*Photo 12. Piqua Administration Building, Conference Room, After Abatement*

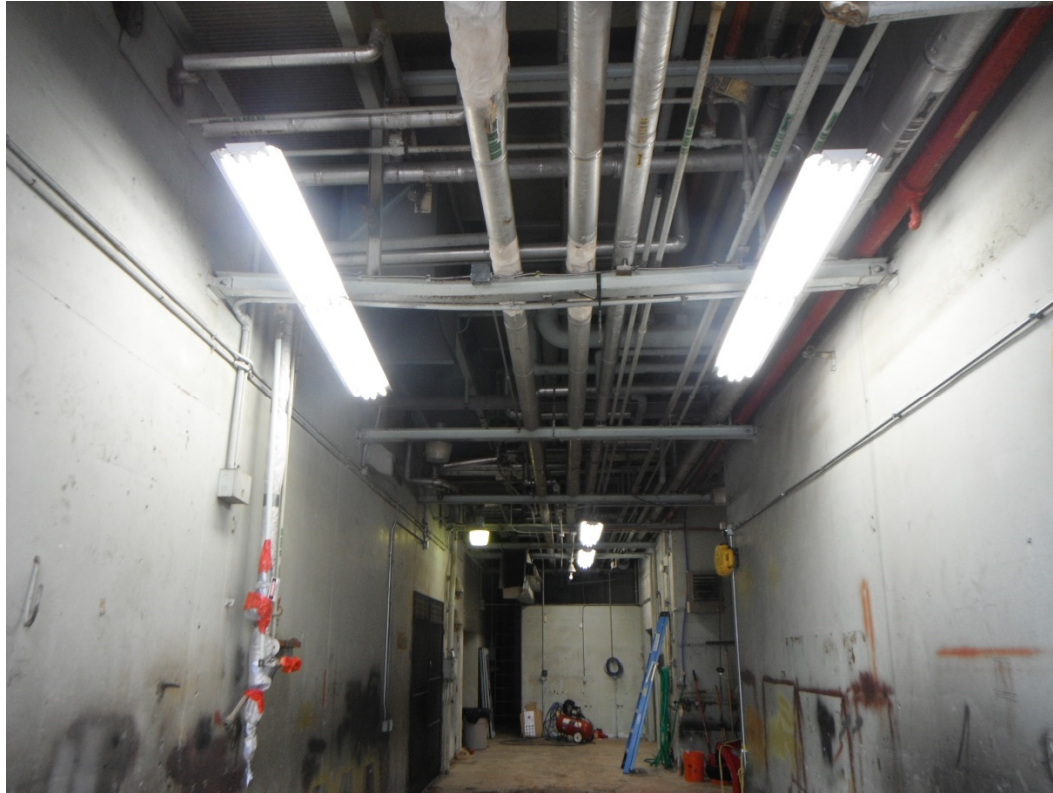
Photo 13 and Photo 14 are before and after images of the Administration Building basement level hallway. More than 2500 linear feet of ACM pipes were glove bagged, cut, and wrapped for disposal. This area required scaffolding and scissor lifts to access the pipes.

*Photo 13. Piqua Administration Building, Basement Level Hallway, Before Abatement*

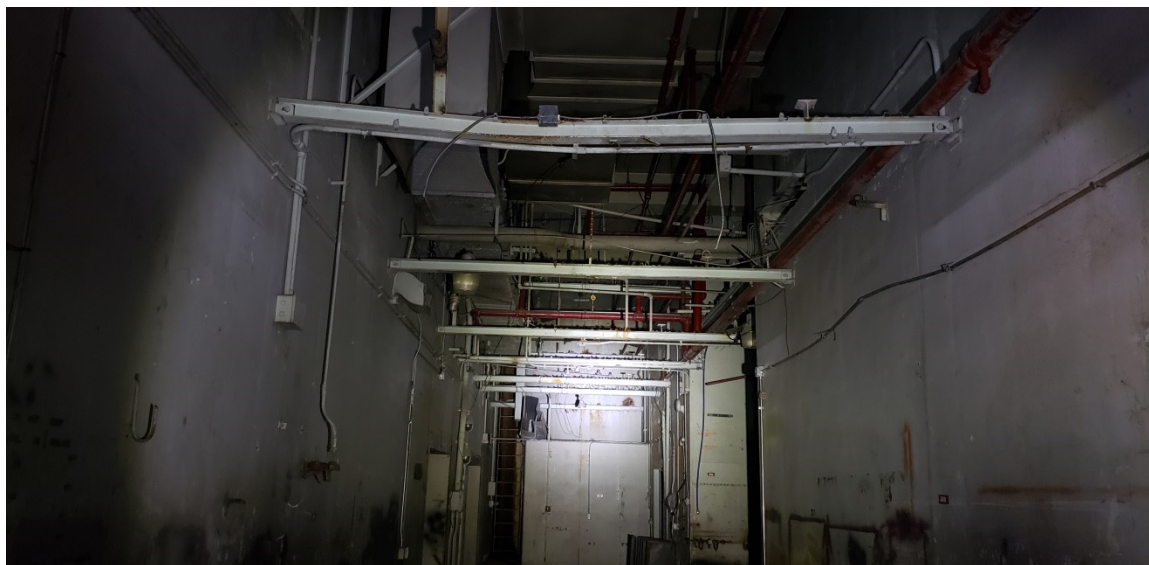
*Photo 14. Piqua Administration Building, Basement Level Hallway, After Abatement*

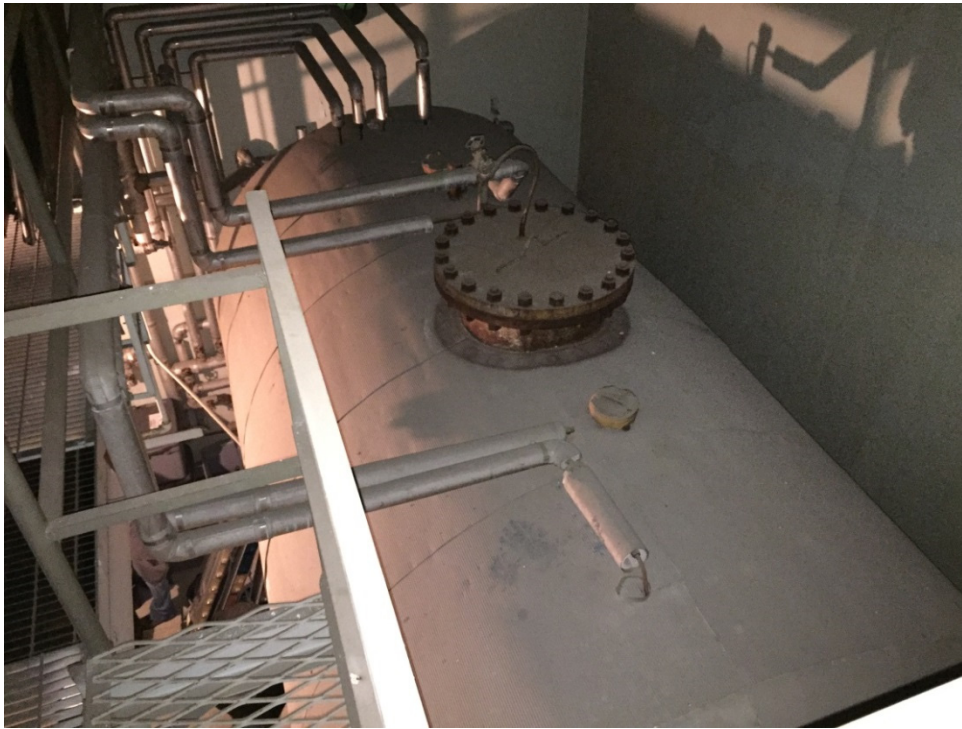
Photo 15 and 16 illustrate the large chemical tank inside the Administration Building before and after abatement. In Photo 15, the view is from above the tank that has metal-jacketed ACM. In Photo 16, the metal jacket and the ACM has been removed to reveal the heating coils on the tank.

*Photo 15. Administration Building, Basement, Large Chemical Tank Before Abatement*

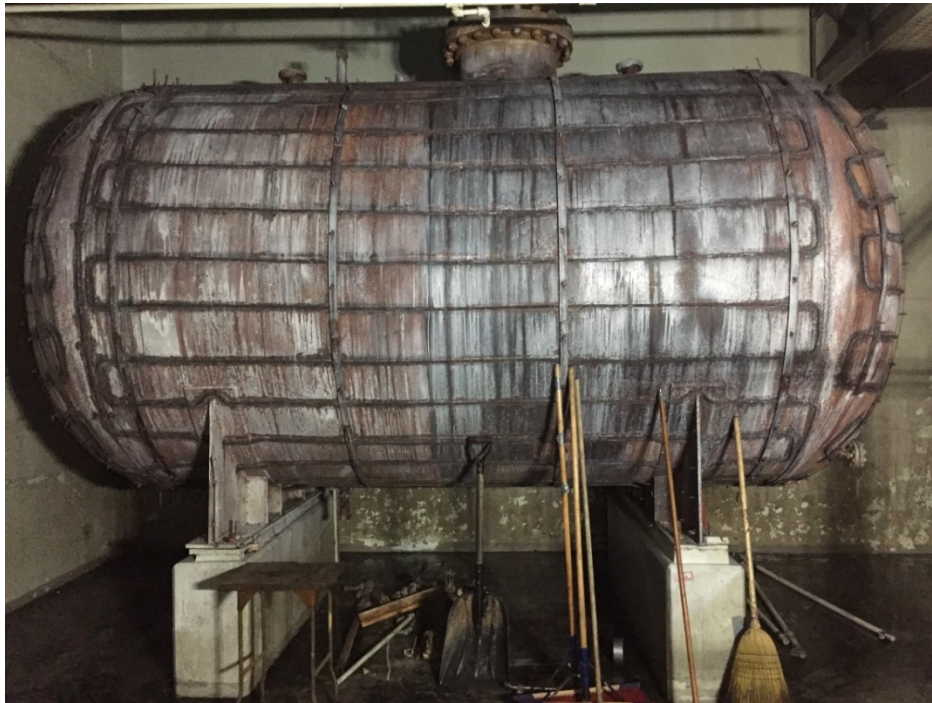
*Photo 16. Administration Building, Basement, Large Chemical Tank, After Abatement*

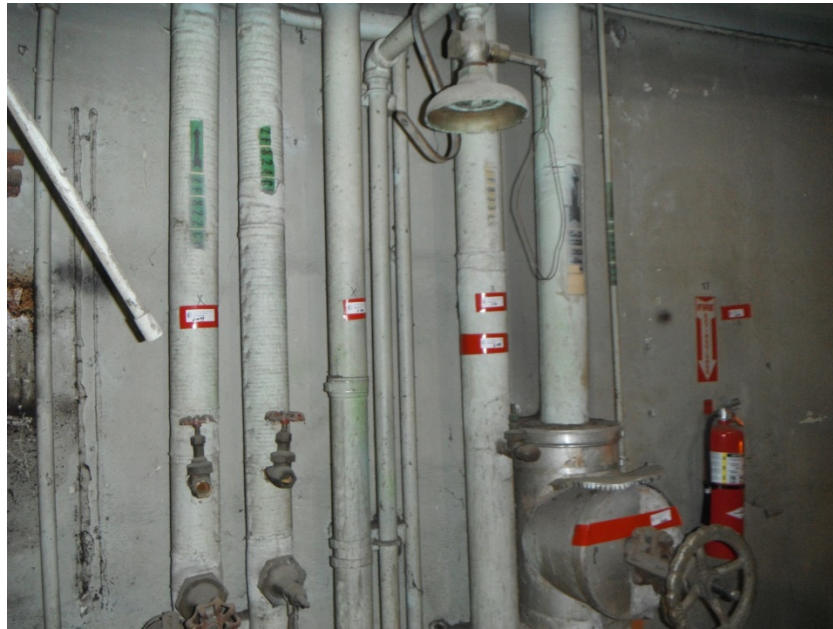
The 4380 ft<sup>2</sup> Reactor Building has an above-ground containment dome known as Level 100 that extends 68 feet high. The portion of the Reactor Building below grade has several levels and extends 44 feet below ground level. Photo 17 shows a section of ACM pipes requiring abatement located at Level 100 in the Reactor Building. Photo 18 shows the same area after the ACM pipes had been removed.

*Photo 17. Reactor Building, Level 100, Before Abatement*

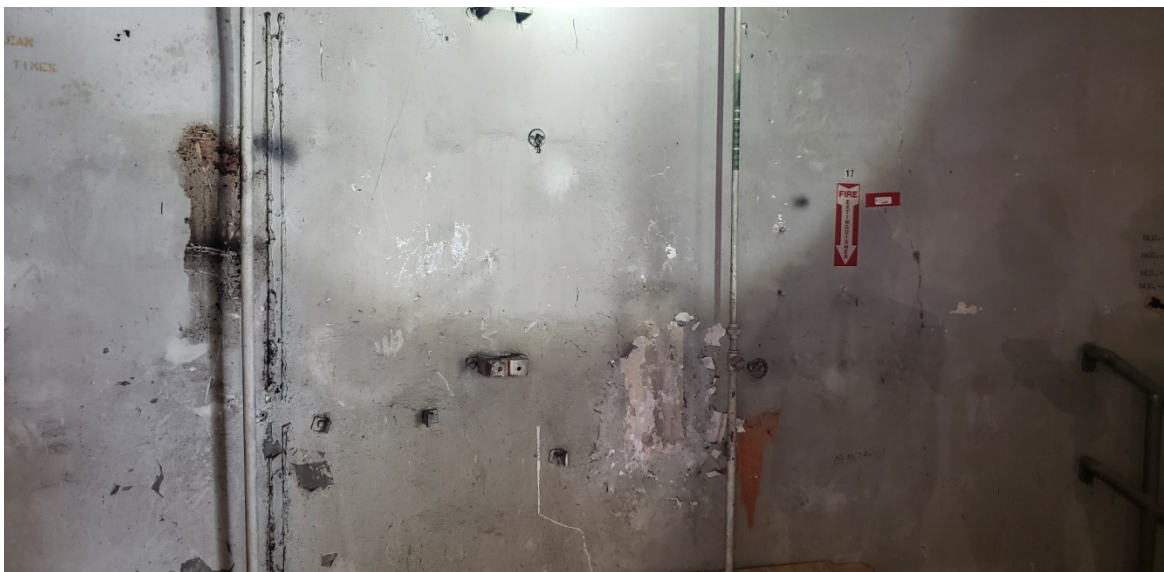
*Photo 18. Reactor Building, Level 100, After Abatement*

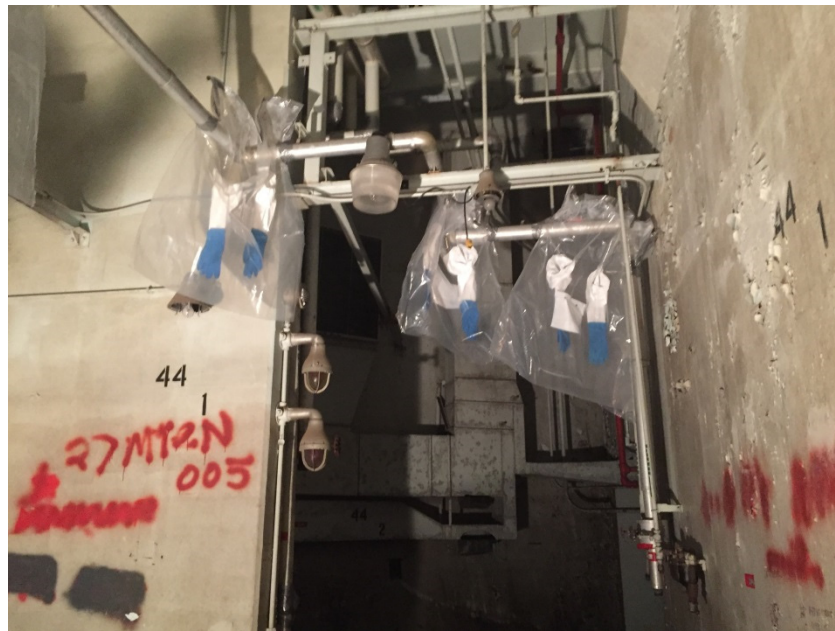
Photo 19 shows the placement of glove bags in preparation of removal of ACM pipes in an area on Level 56 in the Reactor Building, and Photo 20 shows the same area after the ACM pipes had been removed. That removal required the use of a scissor lift due to the area limitations and height of the pipes.

*Photo 19. Reactor Building, Level 56, Before Abatement*

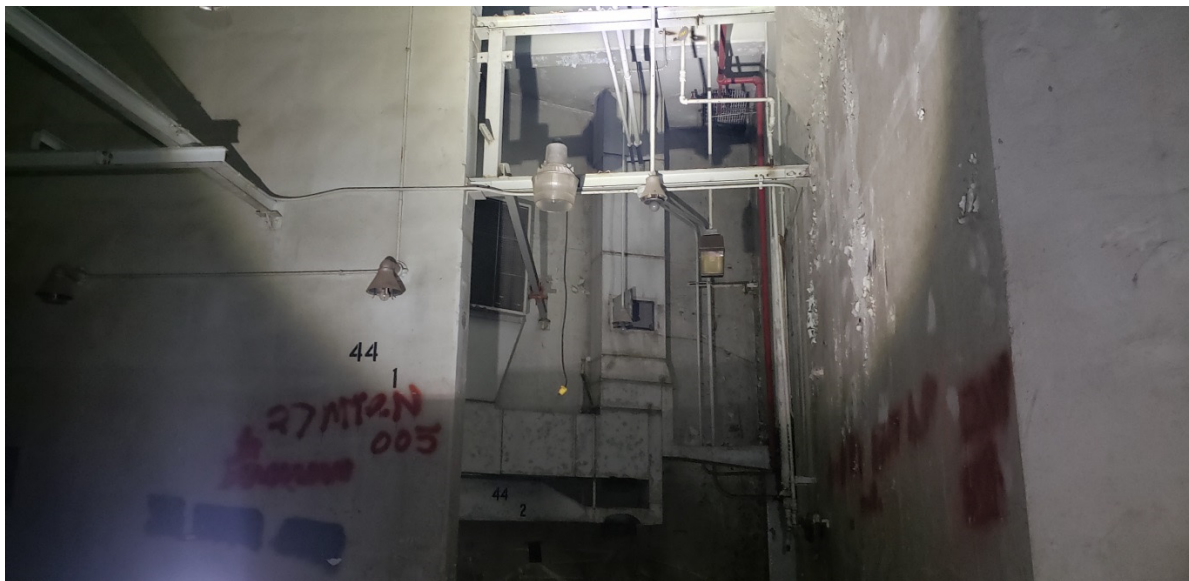
*Photo 20. Reactor Building, Level 56, After Abatement*

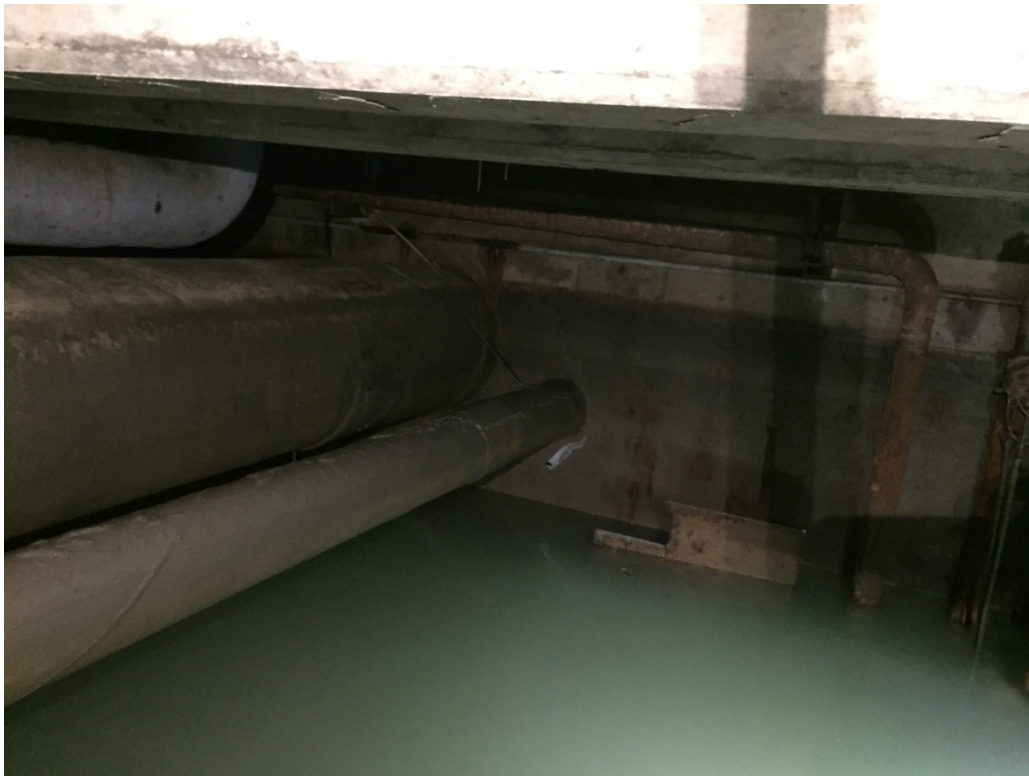
Photo 22 shows the north vault with standing water. Photo 23 shows the poor condition of the ACM pipes and ACM in the floor debris in the north vault after the pumping and before the abatement. Photo 24 shows the final condition of the north vault after abatement.

*Photo 22. Water in the North Vault, Before Abatement*

Each of the utility vaults had standing water that required pumping. Before the pumped water could be released to the environment, it was filtered through a micron filter because the vault contained ACM pipe insulation. The pipe insulation was deteriorated, which meant that asbestos was in the water and found friable in the floor debris. Once the standing water in the north vault was pumped down to floor level, workers discovered a lower tiered vault (i.e., a 20 × 20 room that was not identifiable on the original as-builts) directly below the north vault. The lower tiered vault was filled with 8 feet of water. That water had to be pumped out before anyone could enter the lower tiered vault, where workers determined ACM was present.

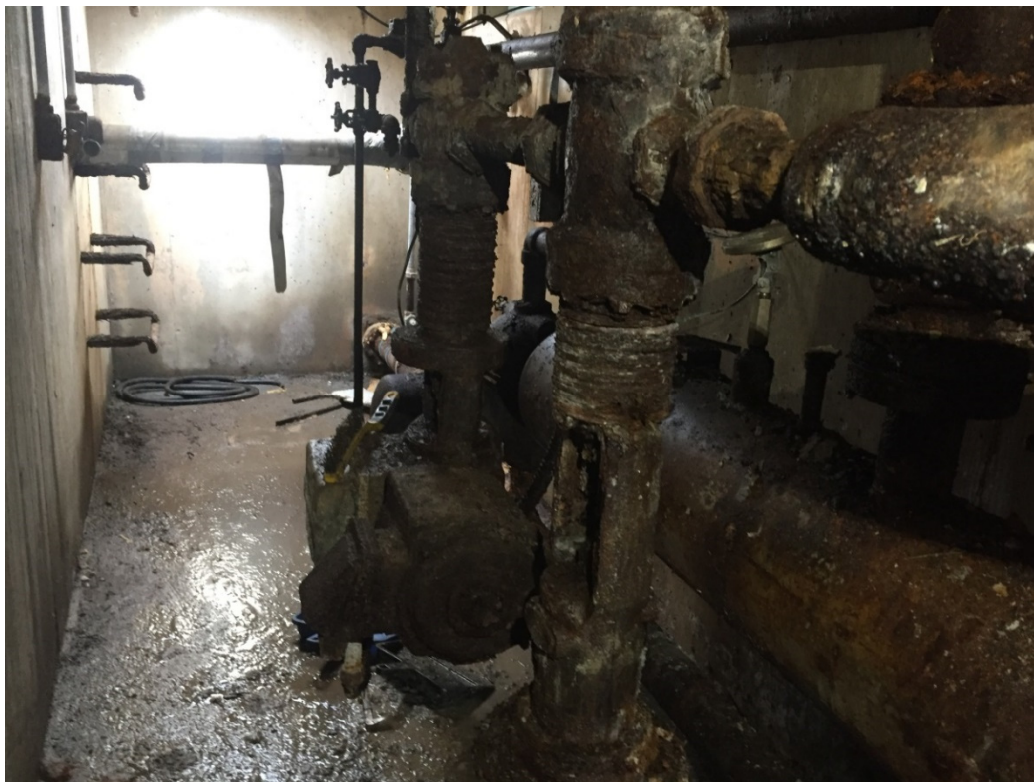
*Photo 23. North Vault After Pumping and Before Abatement*

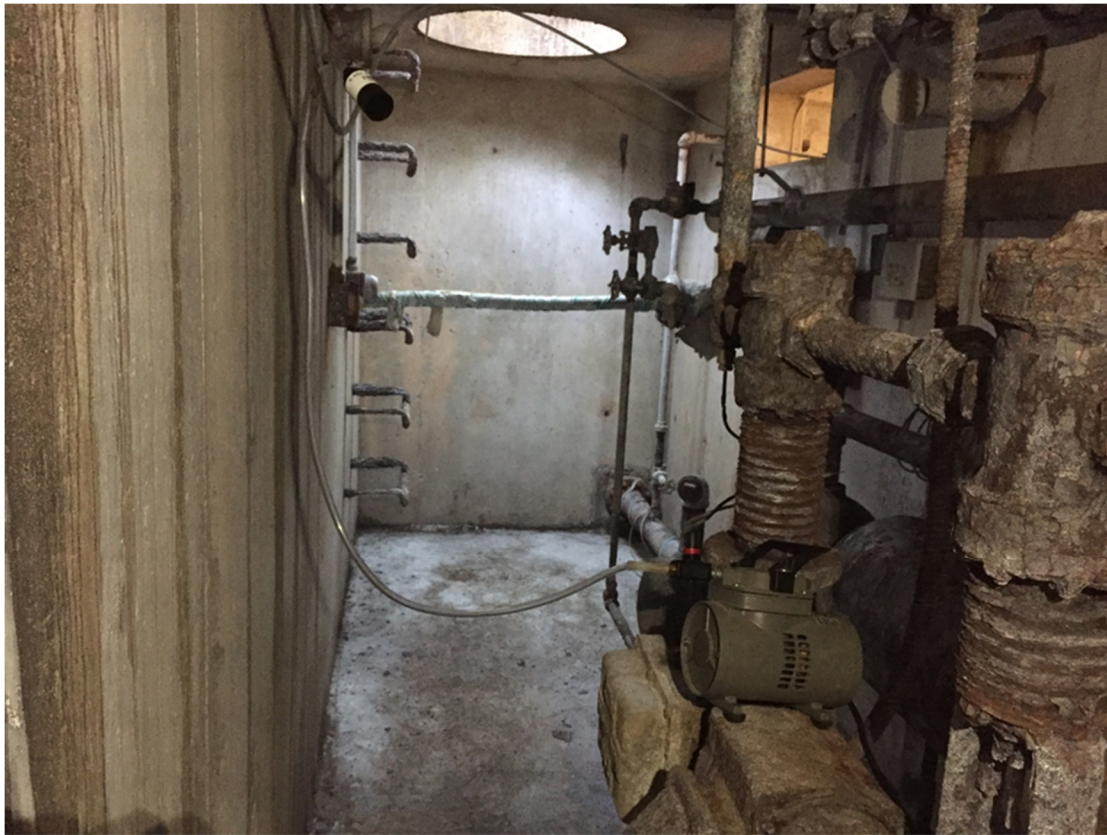
*Photo 24. North Vault Final Condition, After Abatement*
