Recipient Organization: Forest County Potawatomi Community

Project Title: Developing Residential Energy Usage Baselines and Energy Efficiency Options

Energy and Capital
Improvement Report for:
Forest County
Potawatomi
November 15, 2019

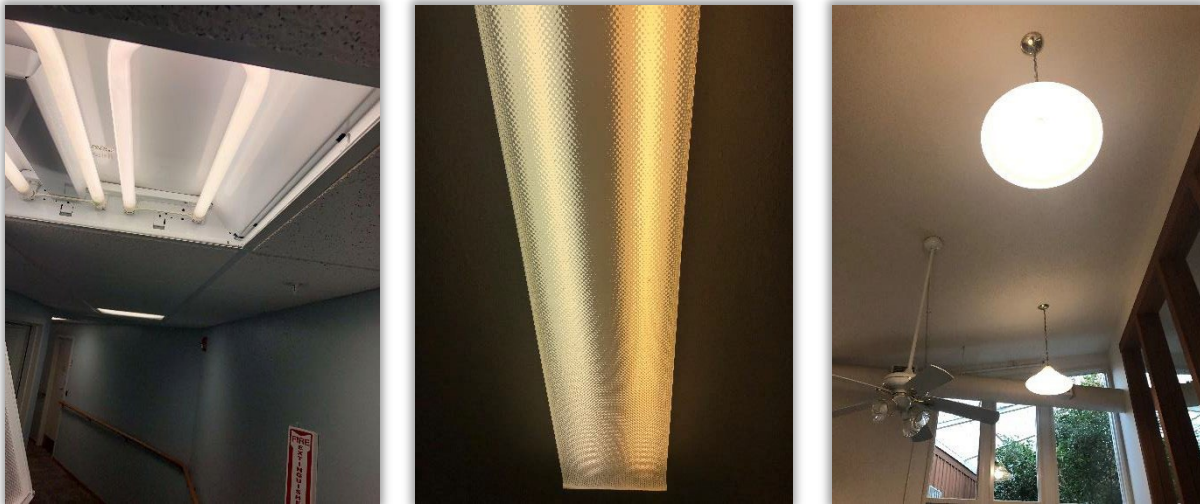
*It was noted that during the second site visit, incandescent bulbs in the main lobby area were being replaced with new incandescent bulbs.

Figure 19: Various Non-LED lighting viewed in Assisted

Lighting Replacements: It is recommended for quality of light, life of the light, and cost savings to consider LEDs as lights are replaced. New LED bulbs and four foot tubes are 11w and 15w, respectively, with the same light output. They do make a direct replacement LED bulb that can replace the fluorescent tubes; however, the existing ballasts would have to be compatible with the new LED bulbs. Replacing the fixture is always the best option and will provide the best distribution and quality of light, however, it is more expensive than just replacing the bulbs. LEDs come in all shapes and sizes and even flood lights and spotlights have LED replacement options. H&H recommends looking for an LED option for any bulb or fixture being replaced at Assisted living and any other buildings.

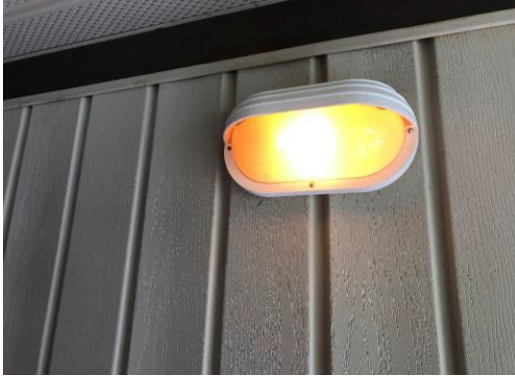
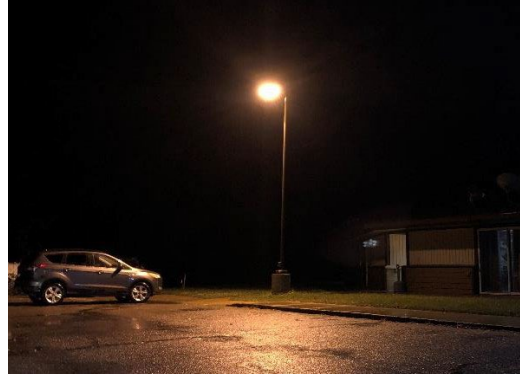
Exterior Lighting: The exterior lighting consists of four light poles approximately 20' tall, canopy lighting, and wallpacks at the two entrances. Two of the bulbs in the pole lights were replaced with LEDs and two appeared to still be high pressure sodium lights. The Pole lights operate on a manually adjusted timeclock. The entrance way lighting operates 24/7.

Figure 20: Assisted Living Existing Exterior Lights – Wallpack (left) and Pole Light (right)

Wallpack Replacements: Replace the existing wallpack lights with new LED wallpacks. The existing wallpack lenses have had a lot of yellowing reducing the light output. New wallpacks could be installed with photoeyes to turn off during the day instead of running 24/7. This would improve the amount of light provided, reduce energy costs, as well as reduce the reoccurring maintenance involved with replace the lights in that fixture.

Lighting Controls: Connect the outdoor lights into the centralized lighting control system for Potawatomi. This will automatically turn the lights on based on the dusk and dawn times each day. The canopies currently do not shut off, although they are LED and have a small energy cost, this would double the life of the existing LEDs installed, thus further pushing out the replacement cost.

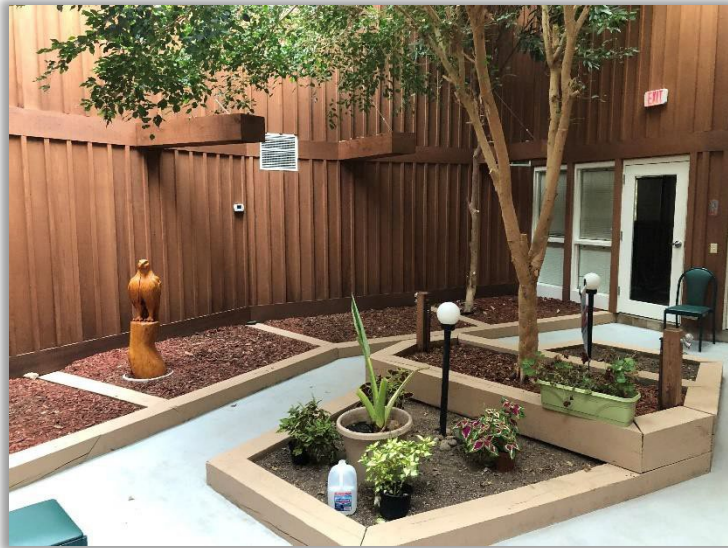
Tree: The existing center area is designed as a “greenhouse”, but the actual usage of the space is “undetermined.” It has two make-up air fans and two larger exhaust fans for the space. It is heated only by a single propane furnace with no outside air. Currently, only one exhaust fan and one make-up air fan run only when the space needs to be cooled. The make-up air is the only the only source of ventilation air in this space, meaning no mechanical ventilation is provided all winter long as the space does not need to be cooled. Another issue that could

Figure 21: Center Room Housing the

persist is that if the space needs to be cooled, the make-up air could actually heat the space when the outside temperature is above the space temperature.

Center Room Housing the Tree: The usage of the middle space should be determined and then the correct HVAC system can be determined. Changes are recommended but would vary based upon usage of the space.

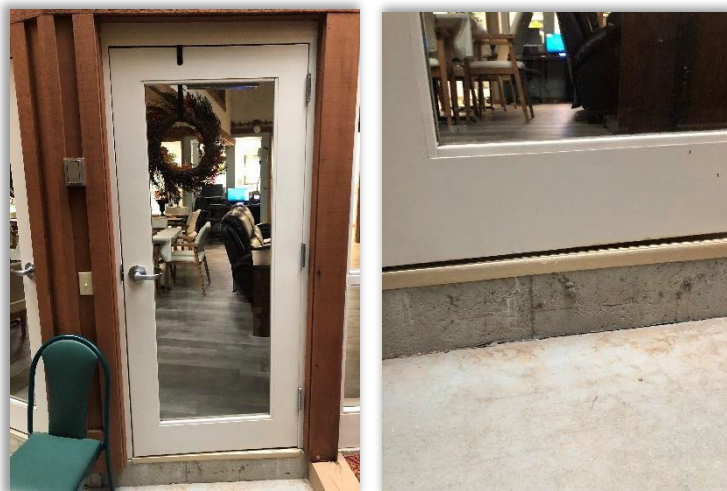
Doors all appeared to be in good shape with relatively good sealing weather stripping. The main two exterior doors had new weatherstripping, but light could be seen between the weather stripping which indicates some air leakage. After viewing the attic, the blown

Figure 22: Door to Center Room Housing the Tree (left) and its lack of weatherstripping (right)

Windows and Doors: When windows and doors are replaced in the future, it is recommended to go with a higher quality double or triple pane commercial window. The existing windows and doors do not warrant replacement but a higher quality window with a better thermal break will improve occupant comfort, last longer, and provide better energy savings.

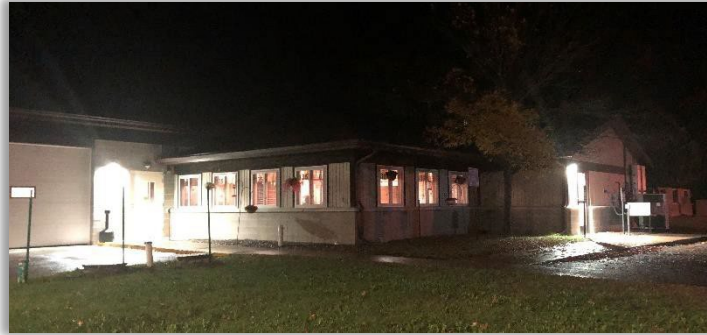
LED Wallpacks: The exterior lights all appear to be LED wallpacks of relatively new age. They are controlled via a photoeye but were unfortunately were observed on at 10:12 am.

Figure 23: Night view of Caring Place with Exterior Lights

Photoeye Adjustment: Because the photoeye did not turn off the wallpack at 10:12 am, it indicates the photoeye needs to be adjusted. Adjusting the photoeye positioning or sensitivity will help ensure the outdoor lights are off during the daytime hours and come on near dusk. Although they are LED with limited energy impact, extended use will reduce their life and prompt a sooner replacement.

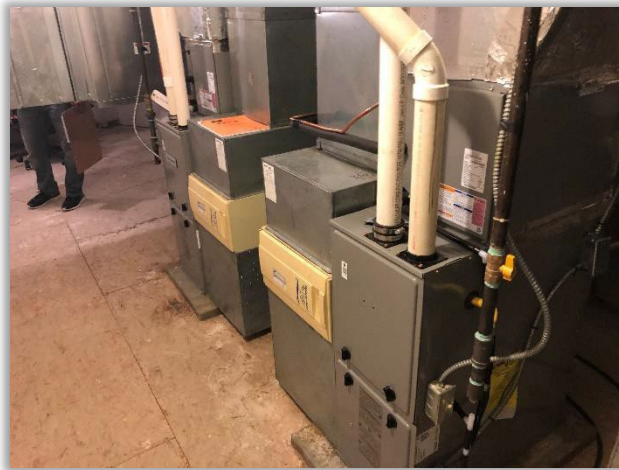
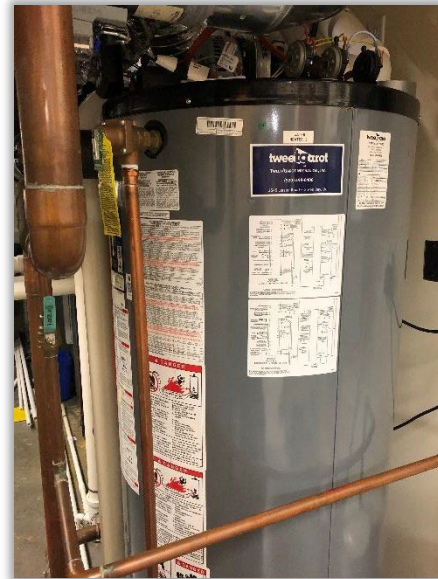
New Wing of Building: There are two separate wings of the building. The new section has four propane furnaces and four condensing units serving the space. There is one ERV serving this zone as well. Each zone operates independently with a single thermostat controlling the zone. Because each zone consists of multiple rooms, the thermostat in one room does not accurately display the temperatures in the other rooms which can cause temperature complaints. The furnaces have two high efficiency condensing hot water heaters set to 140 degrees that supply the domestic hot water.

Figure 24: Caring Place Furnaces (left) and Water Heater

Water Temperature Set Point: If the building is registered as “healthcare” the water temperature would need to be set to 140 degrees to minimize the growth of legionella or other microorganisms. If this is pursued, mixing valves would need to be added to the fixtures in order to prevent scalding water temperatures. A burn can happen after being in contact with 140 degree water for 6 seconds. It is especially important to monitor this temperature closely as some occupants may not have the sensory ability to determine or react if the water is too warm. However, 120 degrees is good for every savings, it just might not be the right temperature selection for the facility.

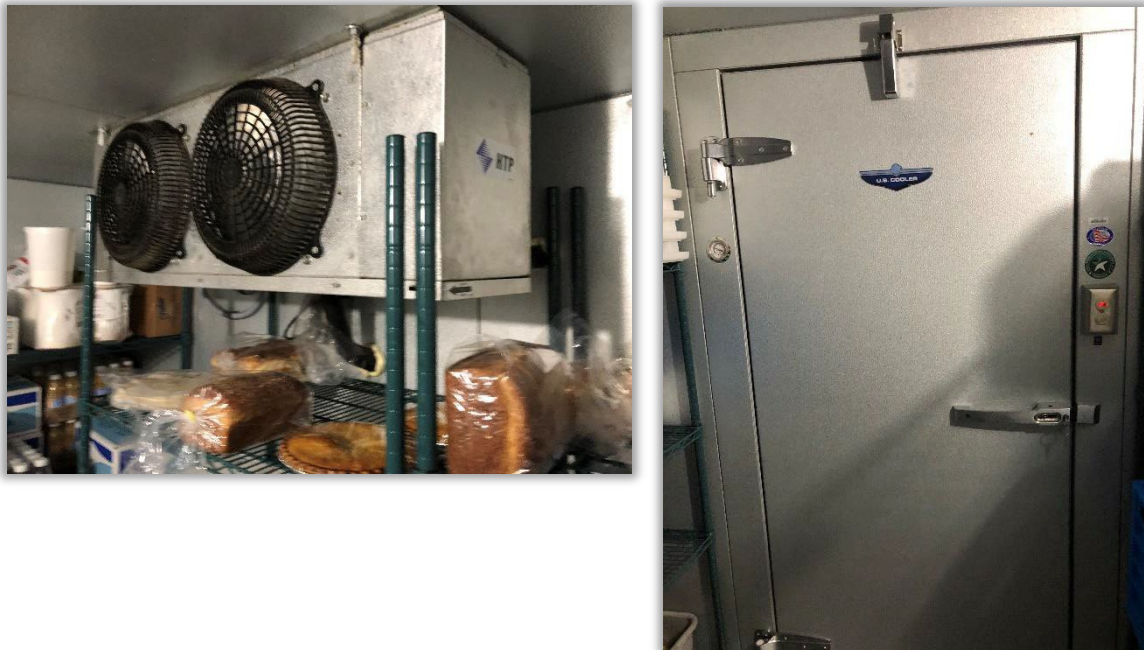
Walk-in Cooler and Freezer: There is one walk in cooler and one walk in freezer in the kitchen. The walk-in cooler has an evaporator with two 1/15 hp shaded pole motors with no controls. The walk-in freezer has an evaporator with two 1/15 hp shaded pole motors. No controls were present besides a timeclock labeled defrost which ran three times per day. It is assumed that these motors run continuously.

Figure 25: Caring Place Walk-in Cooler Shaded Pole Fan (left) and Walk-in Freezer Door (right)

ECM Motors: Replace the shaded pole motors with ECM motors in the walk in cooler and freezer with controls. The controls will slow down the fans based upon the demand and automatically run defrost cycles. Although the motors are only 1/15 hp nameplate, the new motors will provide a 60% kW reduction. This would save around 1,700 kWh per year.

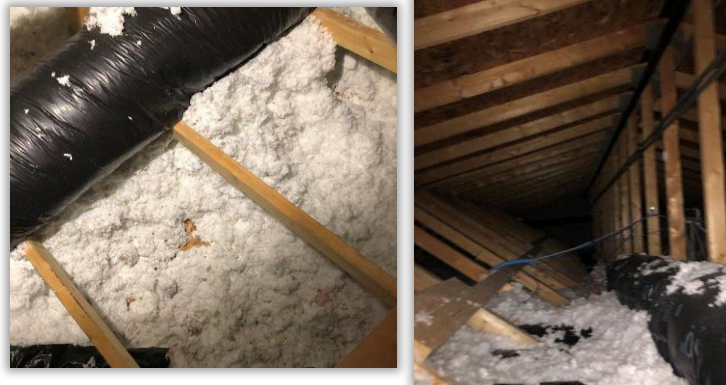
Figure 26: Caring Place Blown-In Insulation

Attic Insulation: Redistribute the blown in insulation in the attic. There appeared to be some high and low spots that could be leveled out for optimal thermal performance.

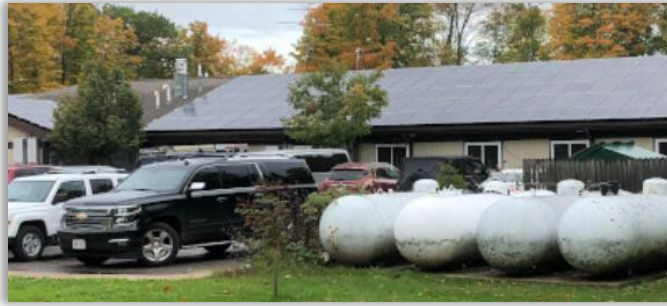
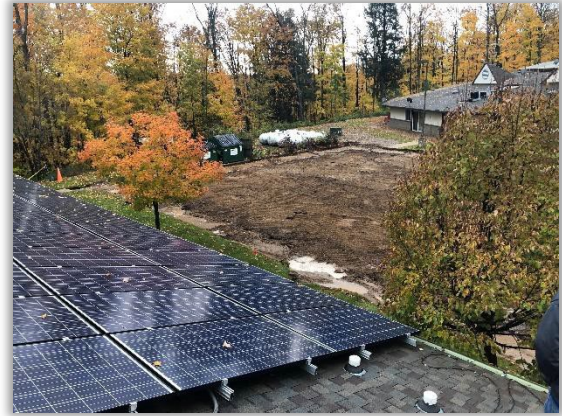
Solar System: The solar system was observed to be in good condition on the roof. However, it was noted that two trees are growing near a large set of panels and will cast large shadows over the panels over the next 20 to 25 years depending on how fast they grow. Currently, the trees are minimally affecting solar production as they are about approximately only 15 - 20 feet tall.

Figure 27: Caring Place Solar with Trees

Removing the Trees: Unfortunately, allowing the trees to grow to full maturity in their current positions will negatively affect solar panel production. If the trees each grow to be 25 feet, it can be estimated that the trees shade can cause an annual reduction of 2,200 kWh of solar production. This would increase the utility bills by roughly \$176 annually. As the trees grow taller, the effect on energy loss will grow. When the trees grow to be 35 feet, it can be estimated they would reduce annual production by 9,600 kWh and cost \$768 per year. While the trees are not affecting the solar production right now, removing them and replanting them in another location would positively benefit the solar system production over the next 20 to 30 years. Depending on how fast or slow these trees grow, the production effect can be markedly higher or lower than estimated for this report.

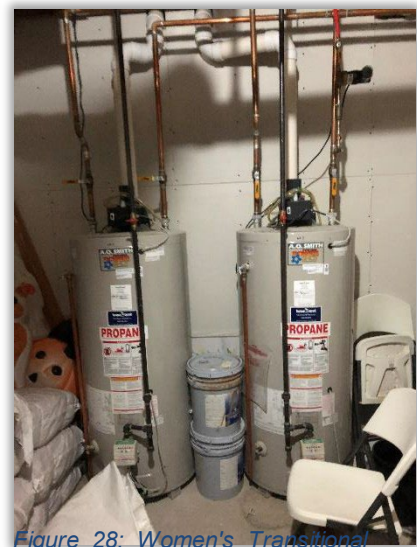
Figure 28: Women's Transitional Living Water Heaters

Water Heater Insulation: The water pipes should be insulated to prevent heat loss, especially within the first 30' of piping.

Water Heater Setpoint: Verify that the water temperature is set to 120 degrees.

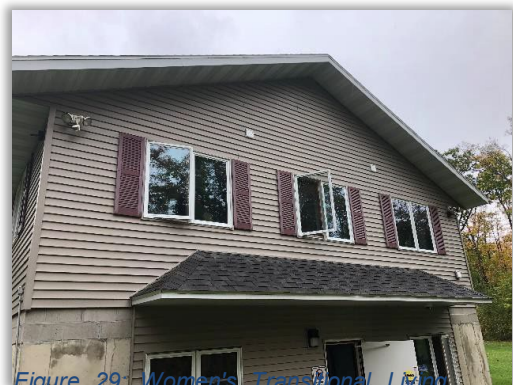
Figure 29. Women's Transitional Living Facility's Windows are Open

Setback Temperature: Install a setback thermostat for the unit without the setback capacities. Utilize the setback feature at night as possible. Turn off the units when the windows are open.

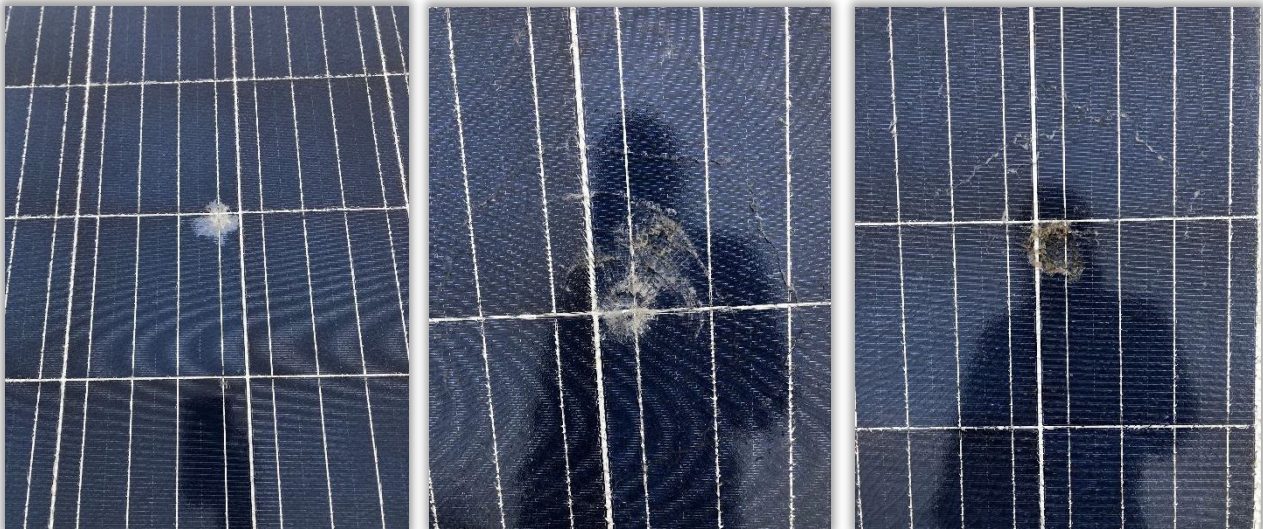
Figure 30: Women's Transitional Living Damaged Solar

Replace Damaged Panels: These damaged panels were conservatively estimated to result in a loss of roughly 5,800 kWh. This equates to roughly \$586 in annual losses in production. By placing these panels through the solar panel warranty, the solar production can be increased over the life of the solar project.

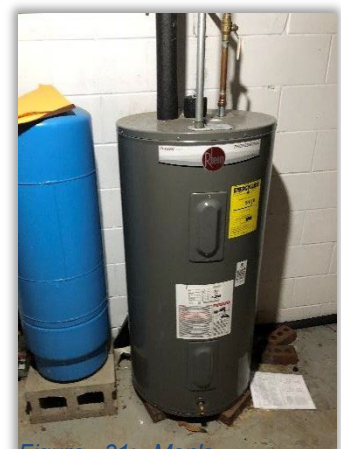
Figure 31: Men's Transitional Living Water Heater

Water Heater insulation: The water pipes should be insulated to prevent h loss, especially within the first 30' of piping.

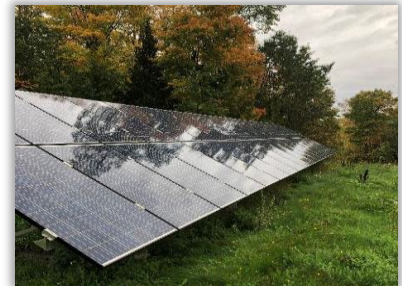
Figure 33: Men's Transitional Living Solar PV system

Solar PV System: No immediate action necessary as the units appear to be operating well.
