## **Appendix C**

### **Ecological Restoration**

## C.1.0 Ecological Restoration Monitoring

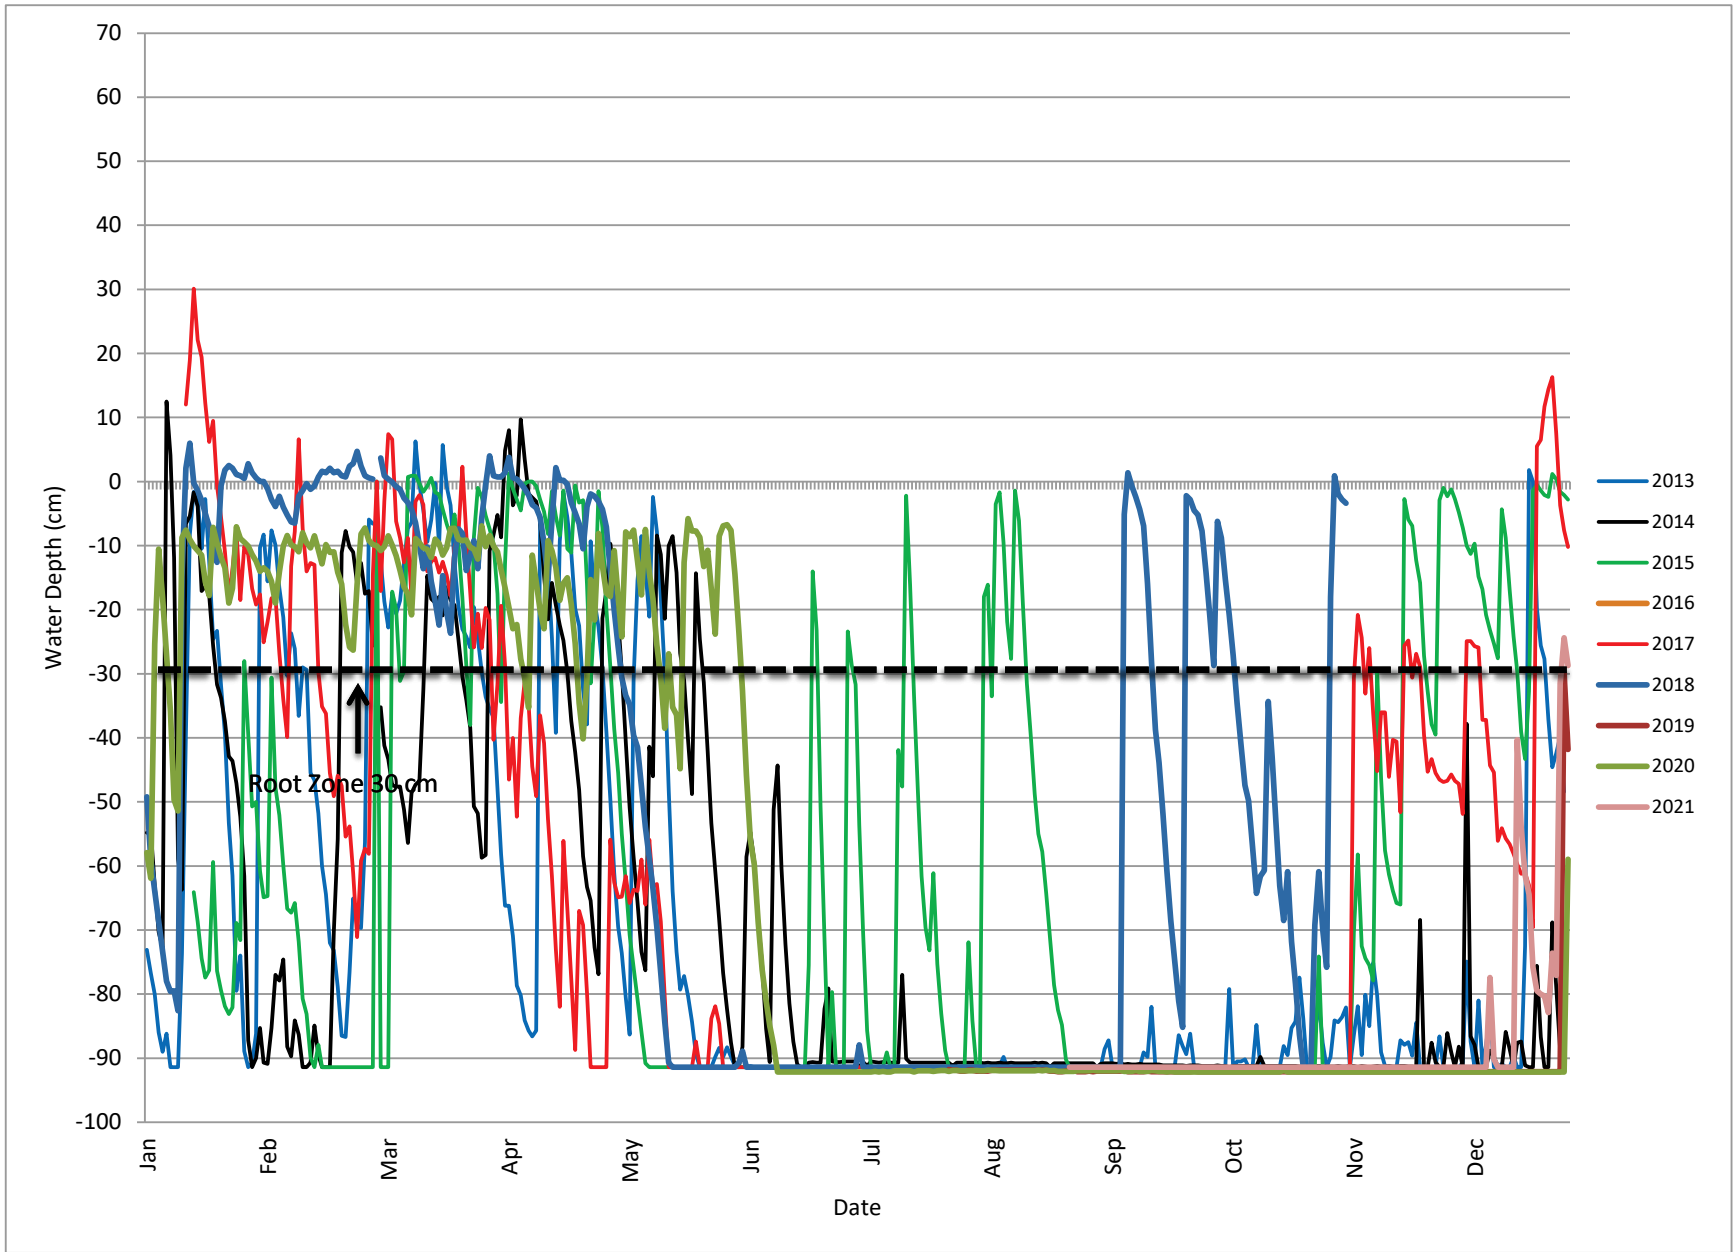
Figure C-2A. Wetland Area PRTW1-PZ1 Hydrograph

Recorded results were incomplete in 2021. No data was collected in any of the piezometers in three of the historically wettest months of the year (January through March). Additionally, PRTW1-PZ1 also failed through August. However, based on a review of 12 years of historical water level patterns in the piezometers, it is likely that PRTW1-PZ2 and PRTW1-PZ3 would have met the days of water in the root zone performance standard. Both piezometers showed a pattern similar to that of previous years, with saturated conditions observed through the winter and spring, followed by drier conditions in the summer and fall; however, water persisted in the root zone later into the summer than seen most other years. Saturated conditions returned somewhat later than typical in the fall and winter, as shown in Figure C-2B and C-2C. These findings are also similar to those at other emergent wetlands in Ohio. The influence of surface water is evident, as spikes in water elevations are usually observed (Mack et al. 2004) following precipitation events in summer months. Additionally, vegetation and amphibian monitoring results presented above indicate that the Paddys Run Tributary project area is indicative of a quality wetland. DOE proposes to eliminate hydrologic monitoring beginning in 2022 with regulatory and stakeholder approval.

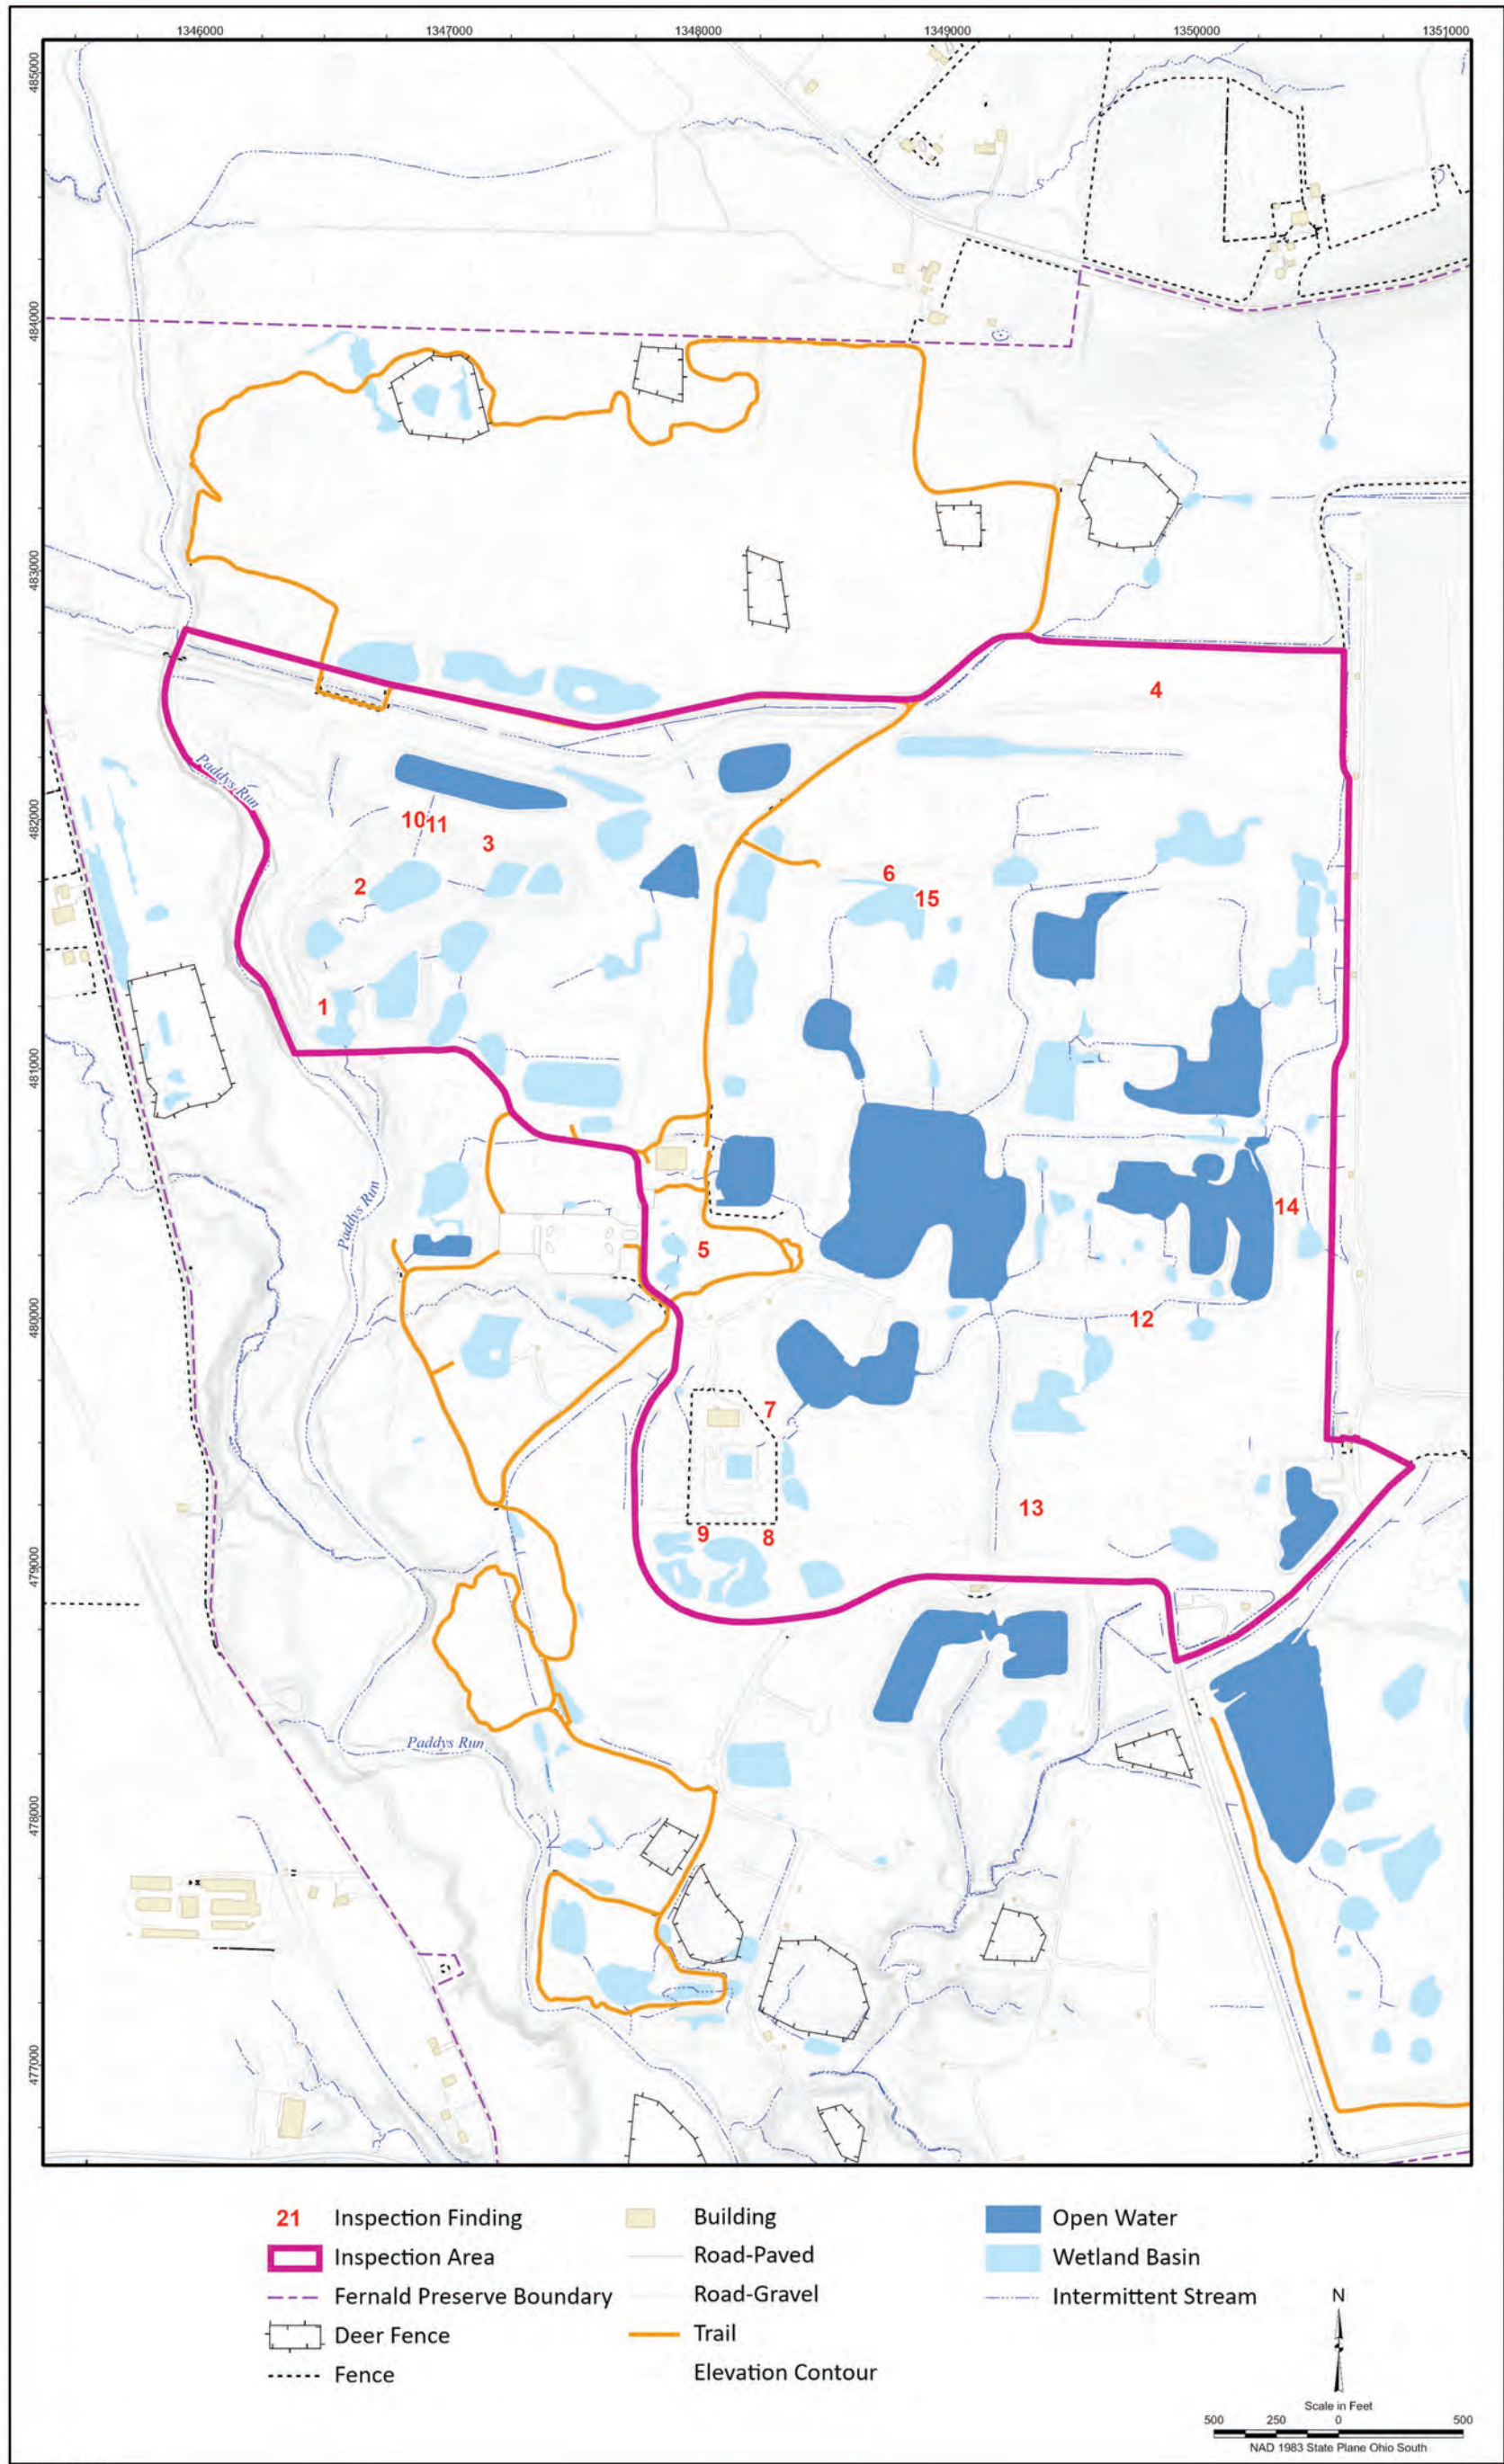
Figure C-3A. Central Quadrant Site Inspection Findings, January 2021

Map Number	Inspection Finding	Finding Resolution or Path Forward	Date Resolved
1	Pear trees	To be addressed	3/31/2022
2	Teasel	Herbicide applied	8/17/2021
3	Bird box hanging upside down	Bird box replaced	6/21/2021
4	Metal rod	Metal rod removed	6/21/2021
5	Broken post	Metal post removed	6/21/2021
6	Pear tree	To be addressed	TBD
7	Pear tree	To be addressed	TBD
8	Several pear trees	To be addressed	3/31/2022
9	Several pear trees	To be addressed	3/31/2022
10	Concrete	Free released and disposed	4/13/2021
11	Erosion	To be addressed	TBD
12	Erosion	To be addressed	TBD
13	Asphalt	Free released and disposed <sup>b</sup>	4/13/2021
14	Concrete	Free released and disposed <sup>b</sup>	4/13/2021
15	Metal cages and posts	Metal cages and posts removed	6/22/2021

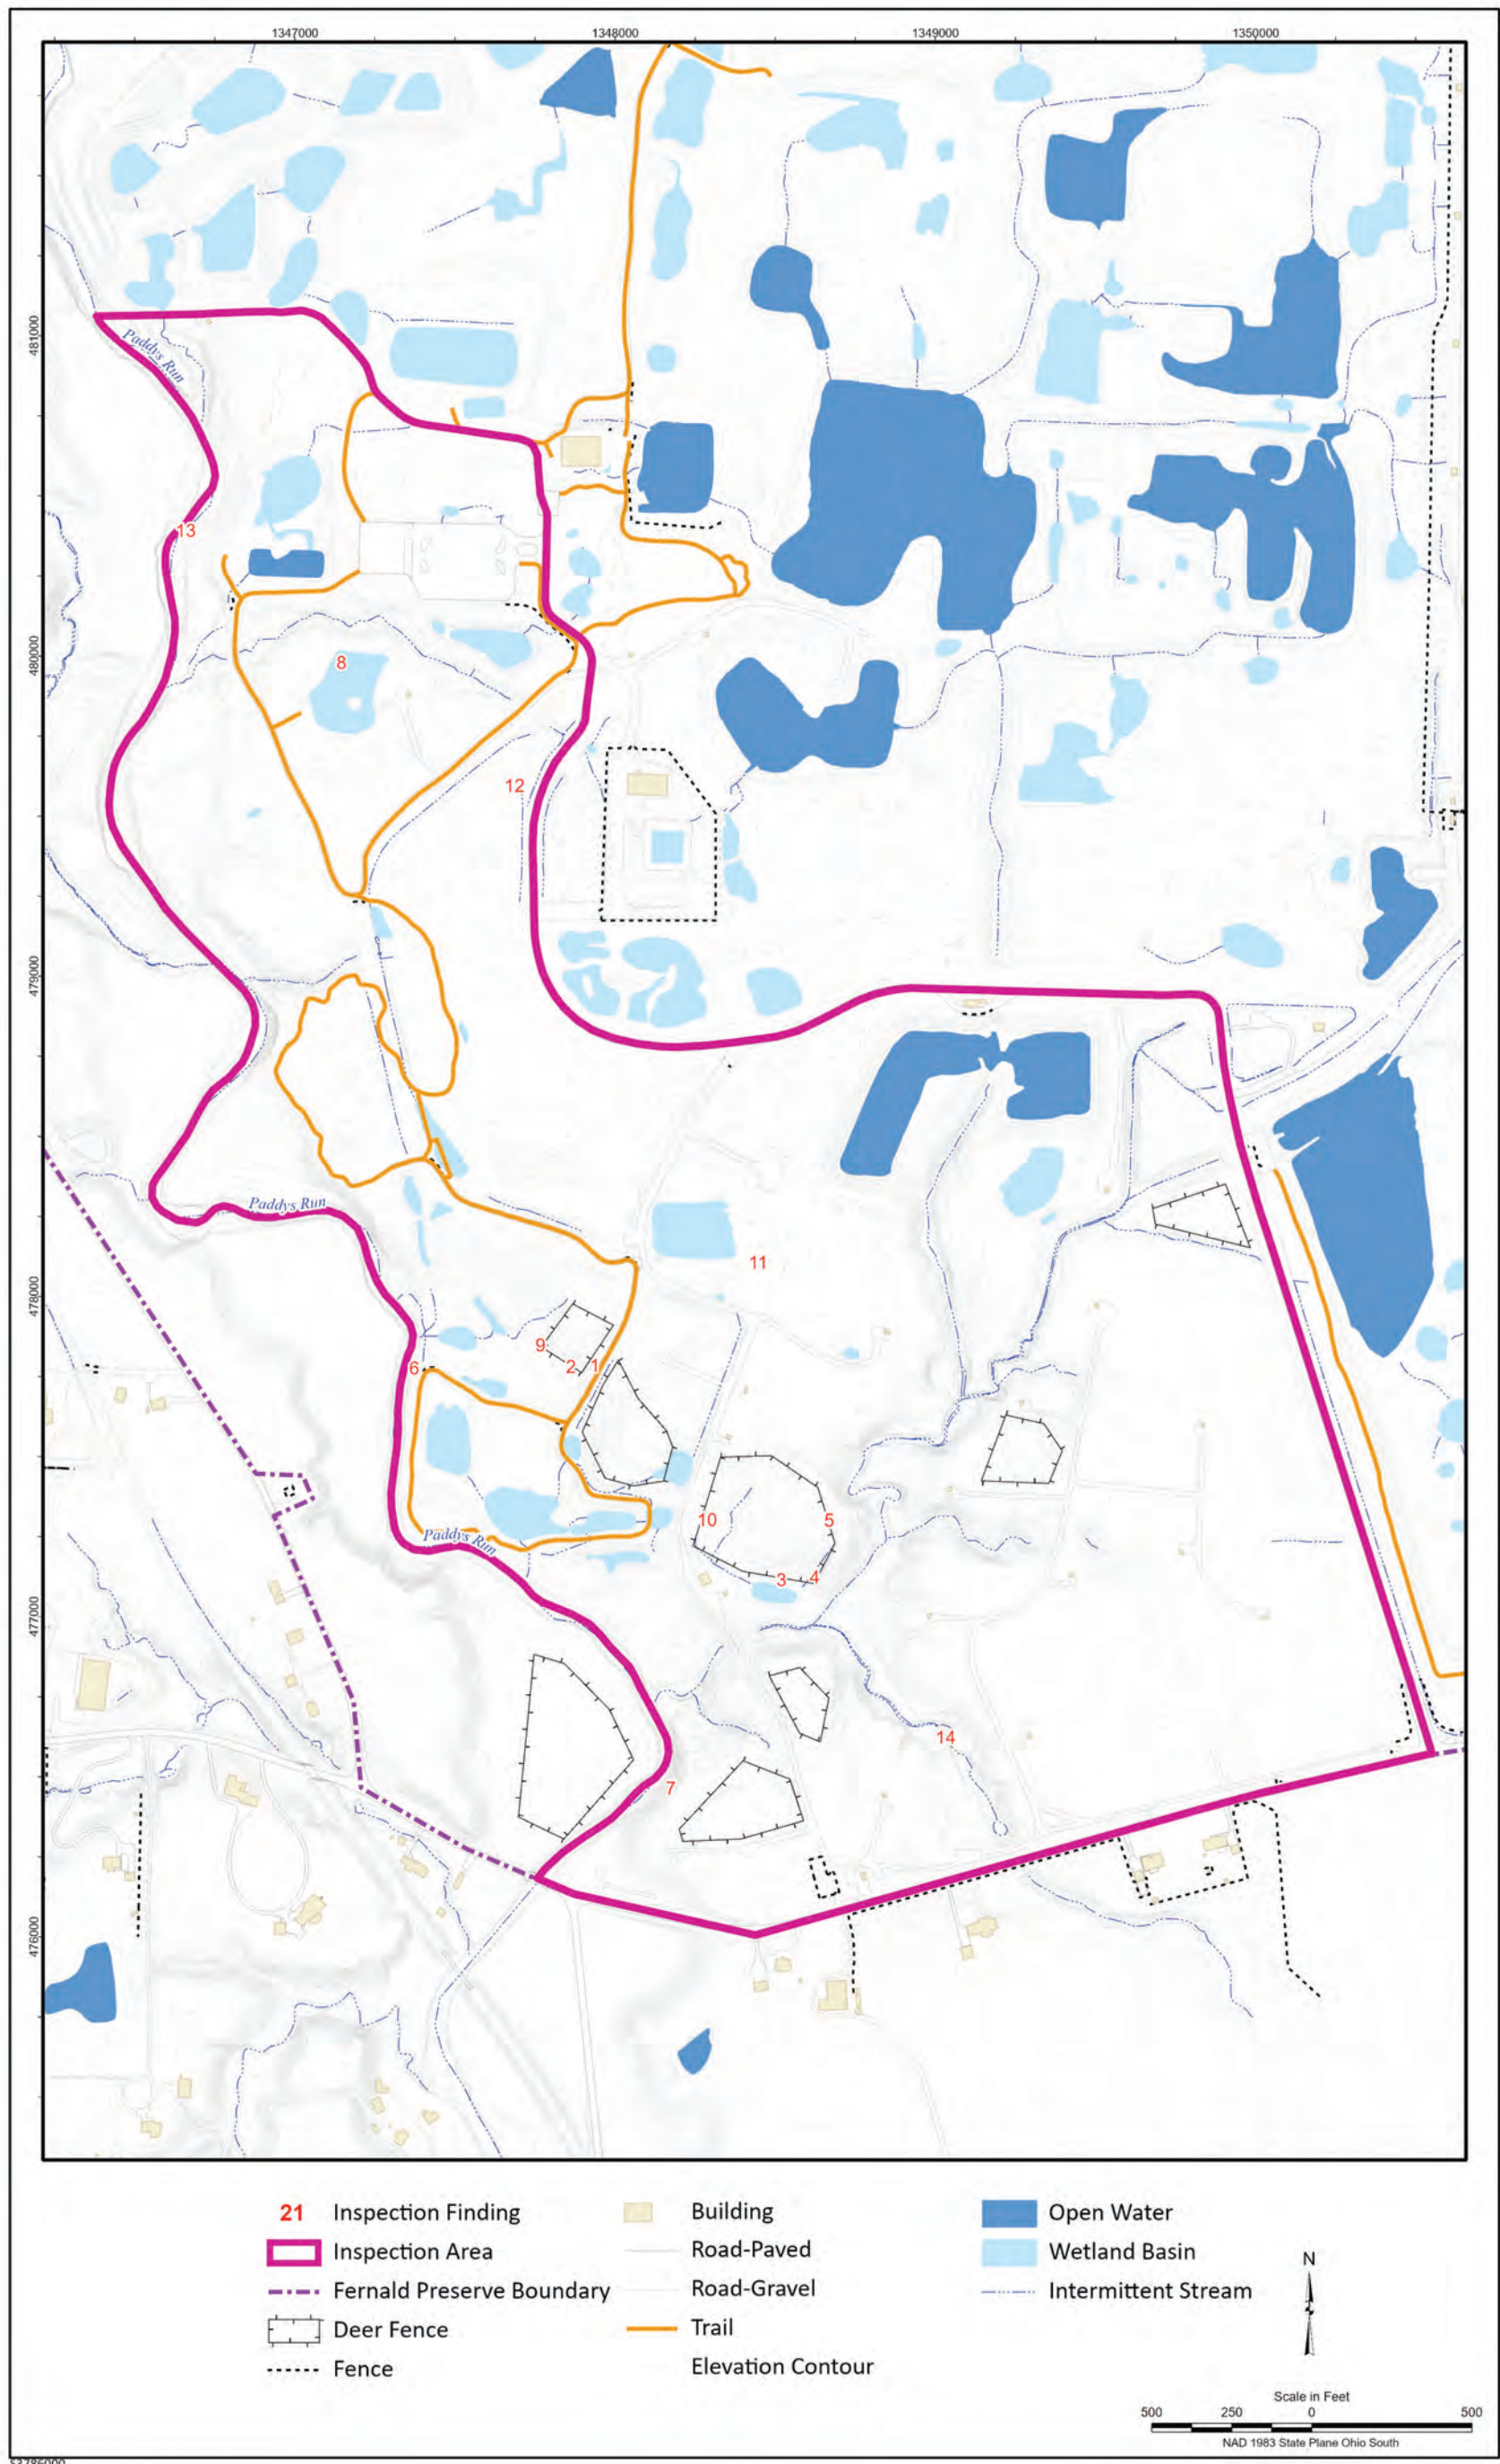
Figure C-3B. South Quadrant Site Inspection Findings, March 2021

Map Number	Inspection Finding	Finding Resolution or Path Forward	Date Resolved <sup>a</sup>
1	Hole in deer fence	Deer fence repaired	9/1/2021
2	Hole in deer fence	Deer fence repaired	9/1/2021
3	Hole in deer fence	Deer fence repaired	1/27/2022
4	Top panel of deer fence down	Deer fence repaired	1/27/2022
5	Top and bottom of deer fence torn	Deer fence repaired	1/27/2022
6	Path to creek	No action required; vegetation has grown and obscured any trail	12/8/2021
7	Concrete	To be addressed	TBD
8	Phragmites	Herbicide applied	8/5/2021
9	Deer fence separating	Deer fence repaired	9/1/2021
10	Hole in deer fence	Deer fence repaired	1/27/2022
11	Metal wire on ground	Metal wire removed	8/31/2021
12	Top of bird box is coming off	To be addressed	TBD
13	Concrete riprap washed away	To be addressed	TBD
14	Old drum and concrete	Drum free released <sup>b</sup> and disposed	3/9/2021

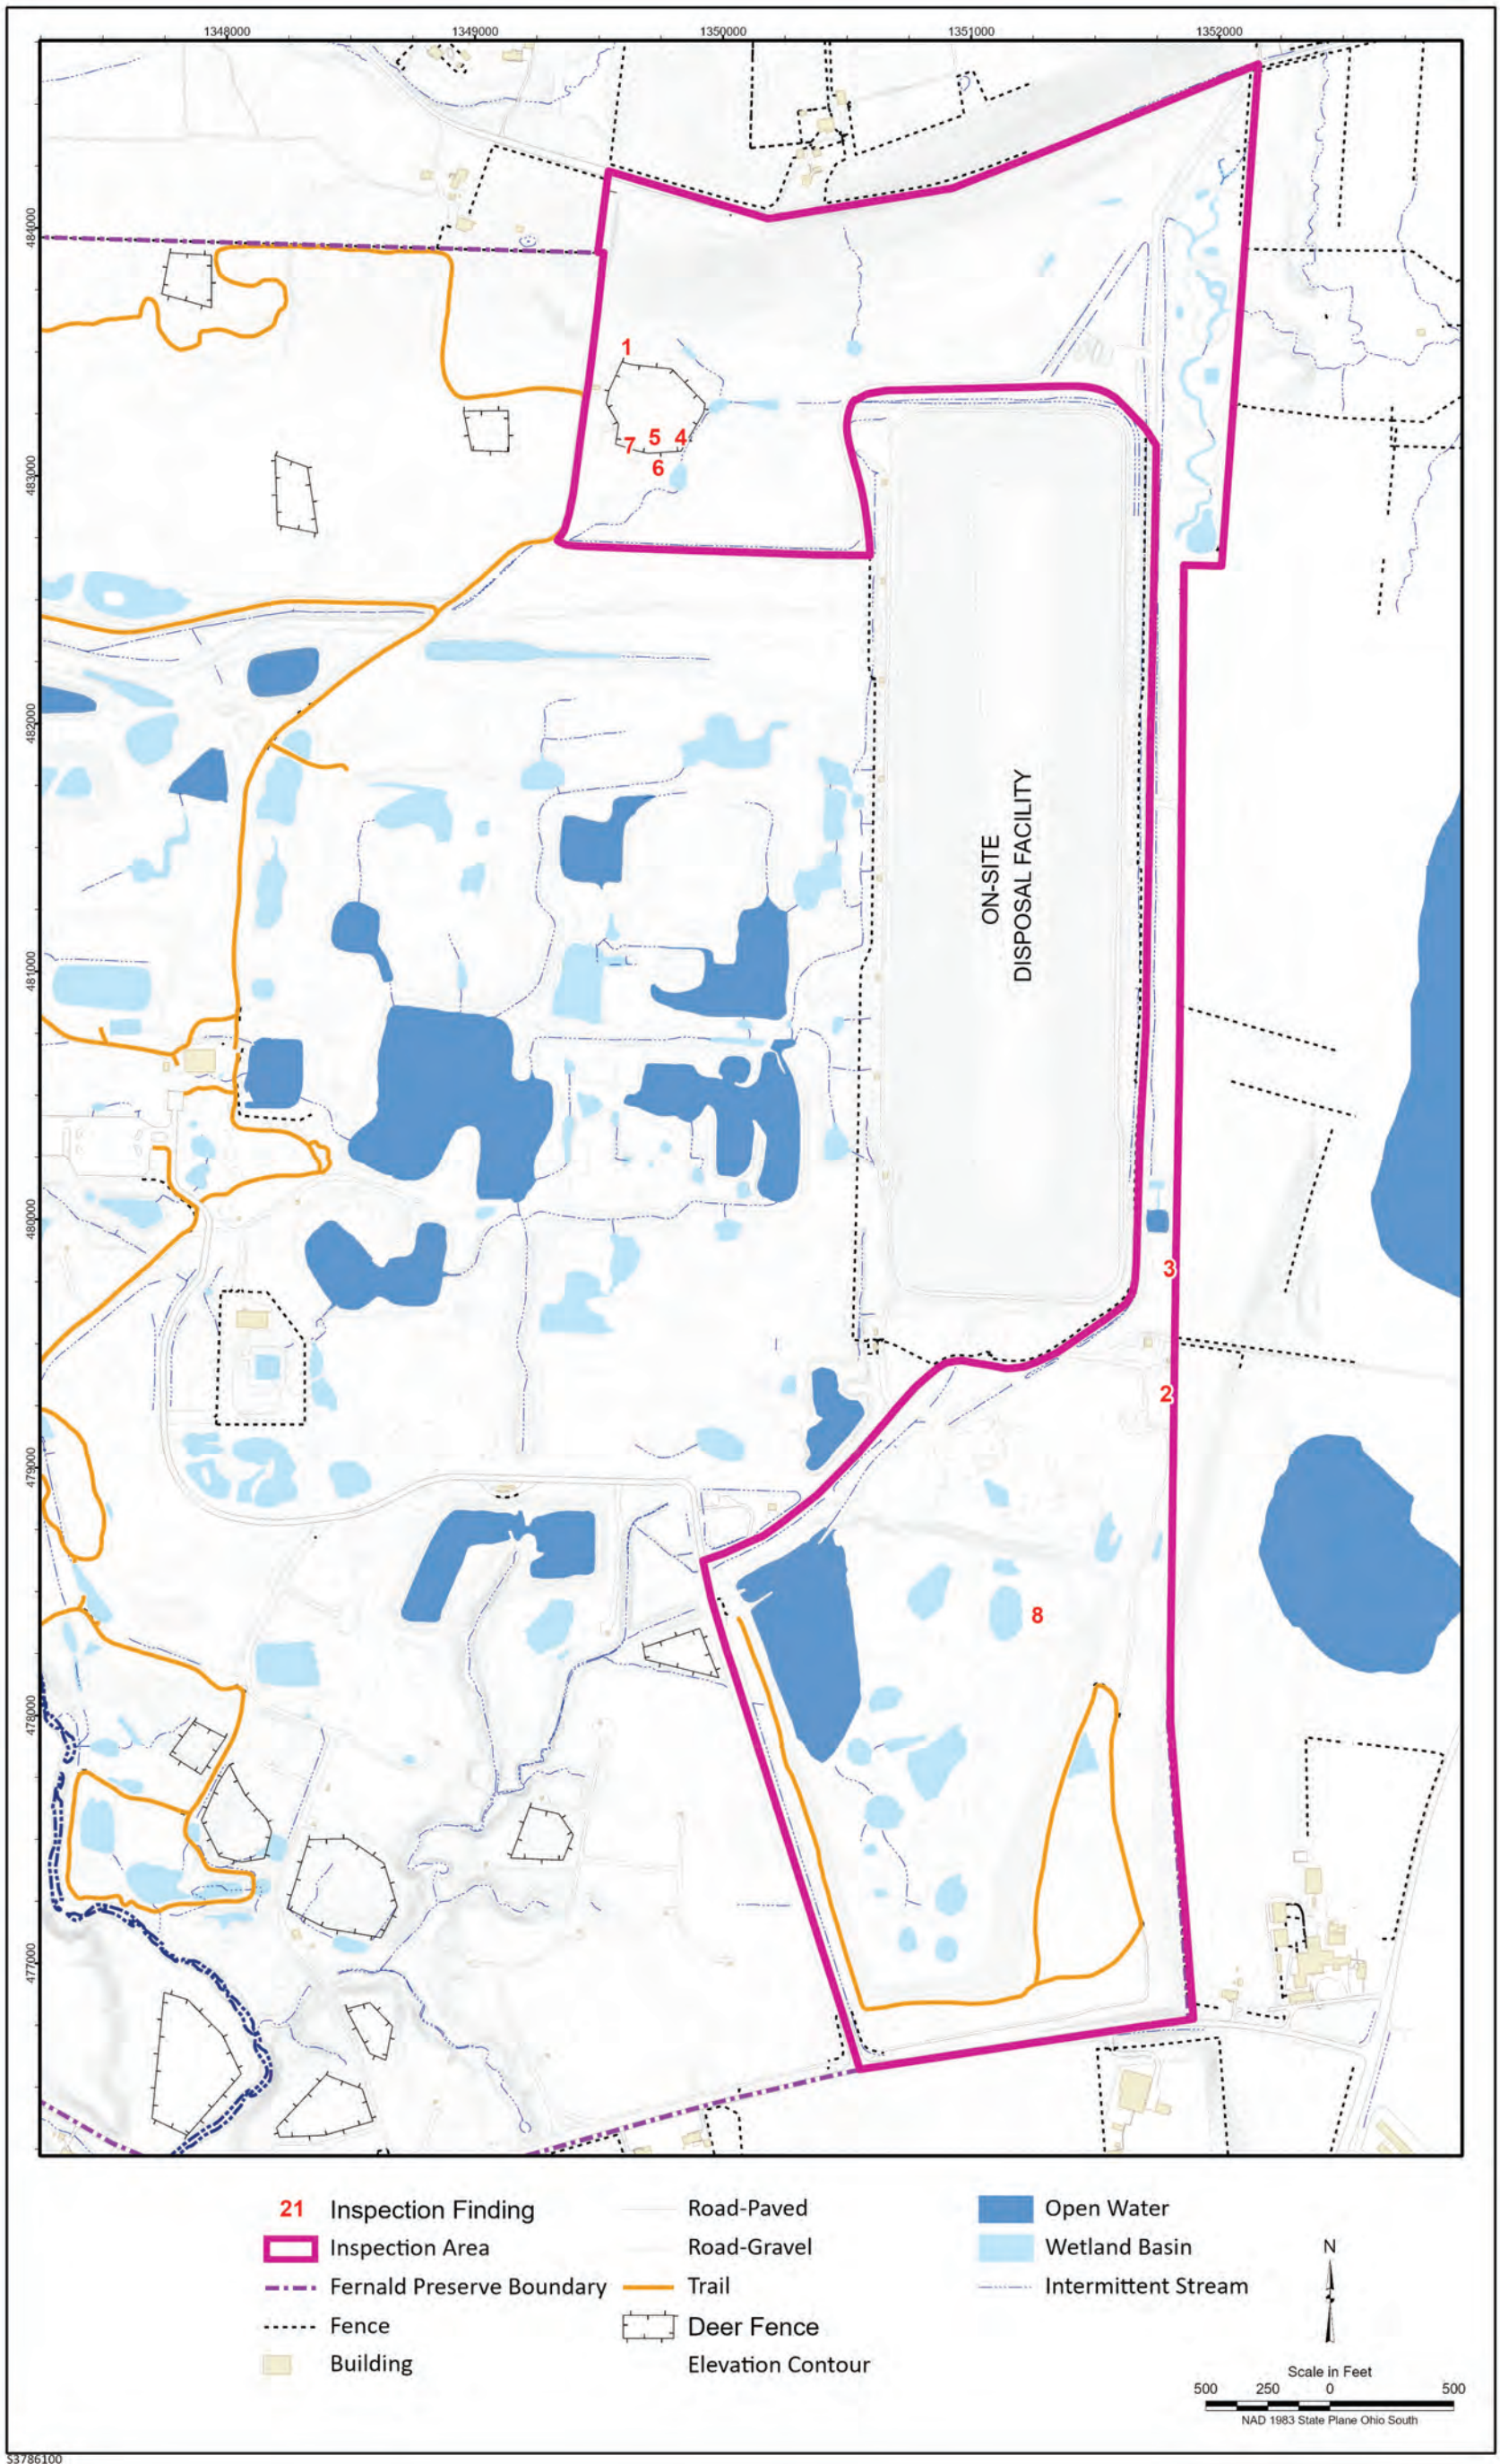
Figure C-3C. East Quadrant Site Inspection Findings, March 2021

Map Number	Inspection Finding	Finding Resolution or Path Forward	Date Resolved <sup>a</sup>
1	Hole in deer fence	Deer fence repaired	8/26/2021
2	Aerial utility marker	Marker disposed	3/16/2021
3	Pear trees	To be addressed	3/31/2022
4	Hole in deer fence	Deer fence repaired	8/26/2021
5	Hole in deer fence	Deer fence repaired	8/26/2021
6	Hole in deer fence	Deer fence repaired	8/26/2021
7	Hole in deer fence	Deer fence repaired	8/26/2021
8	Tree cage	Tree cage removed	8/31/2021

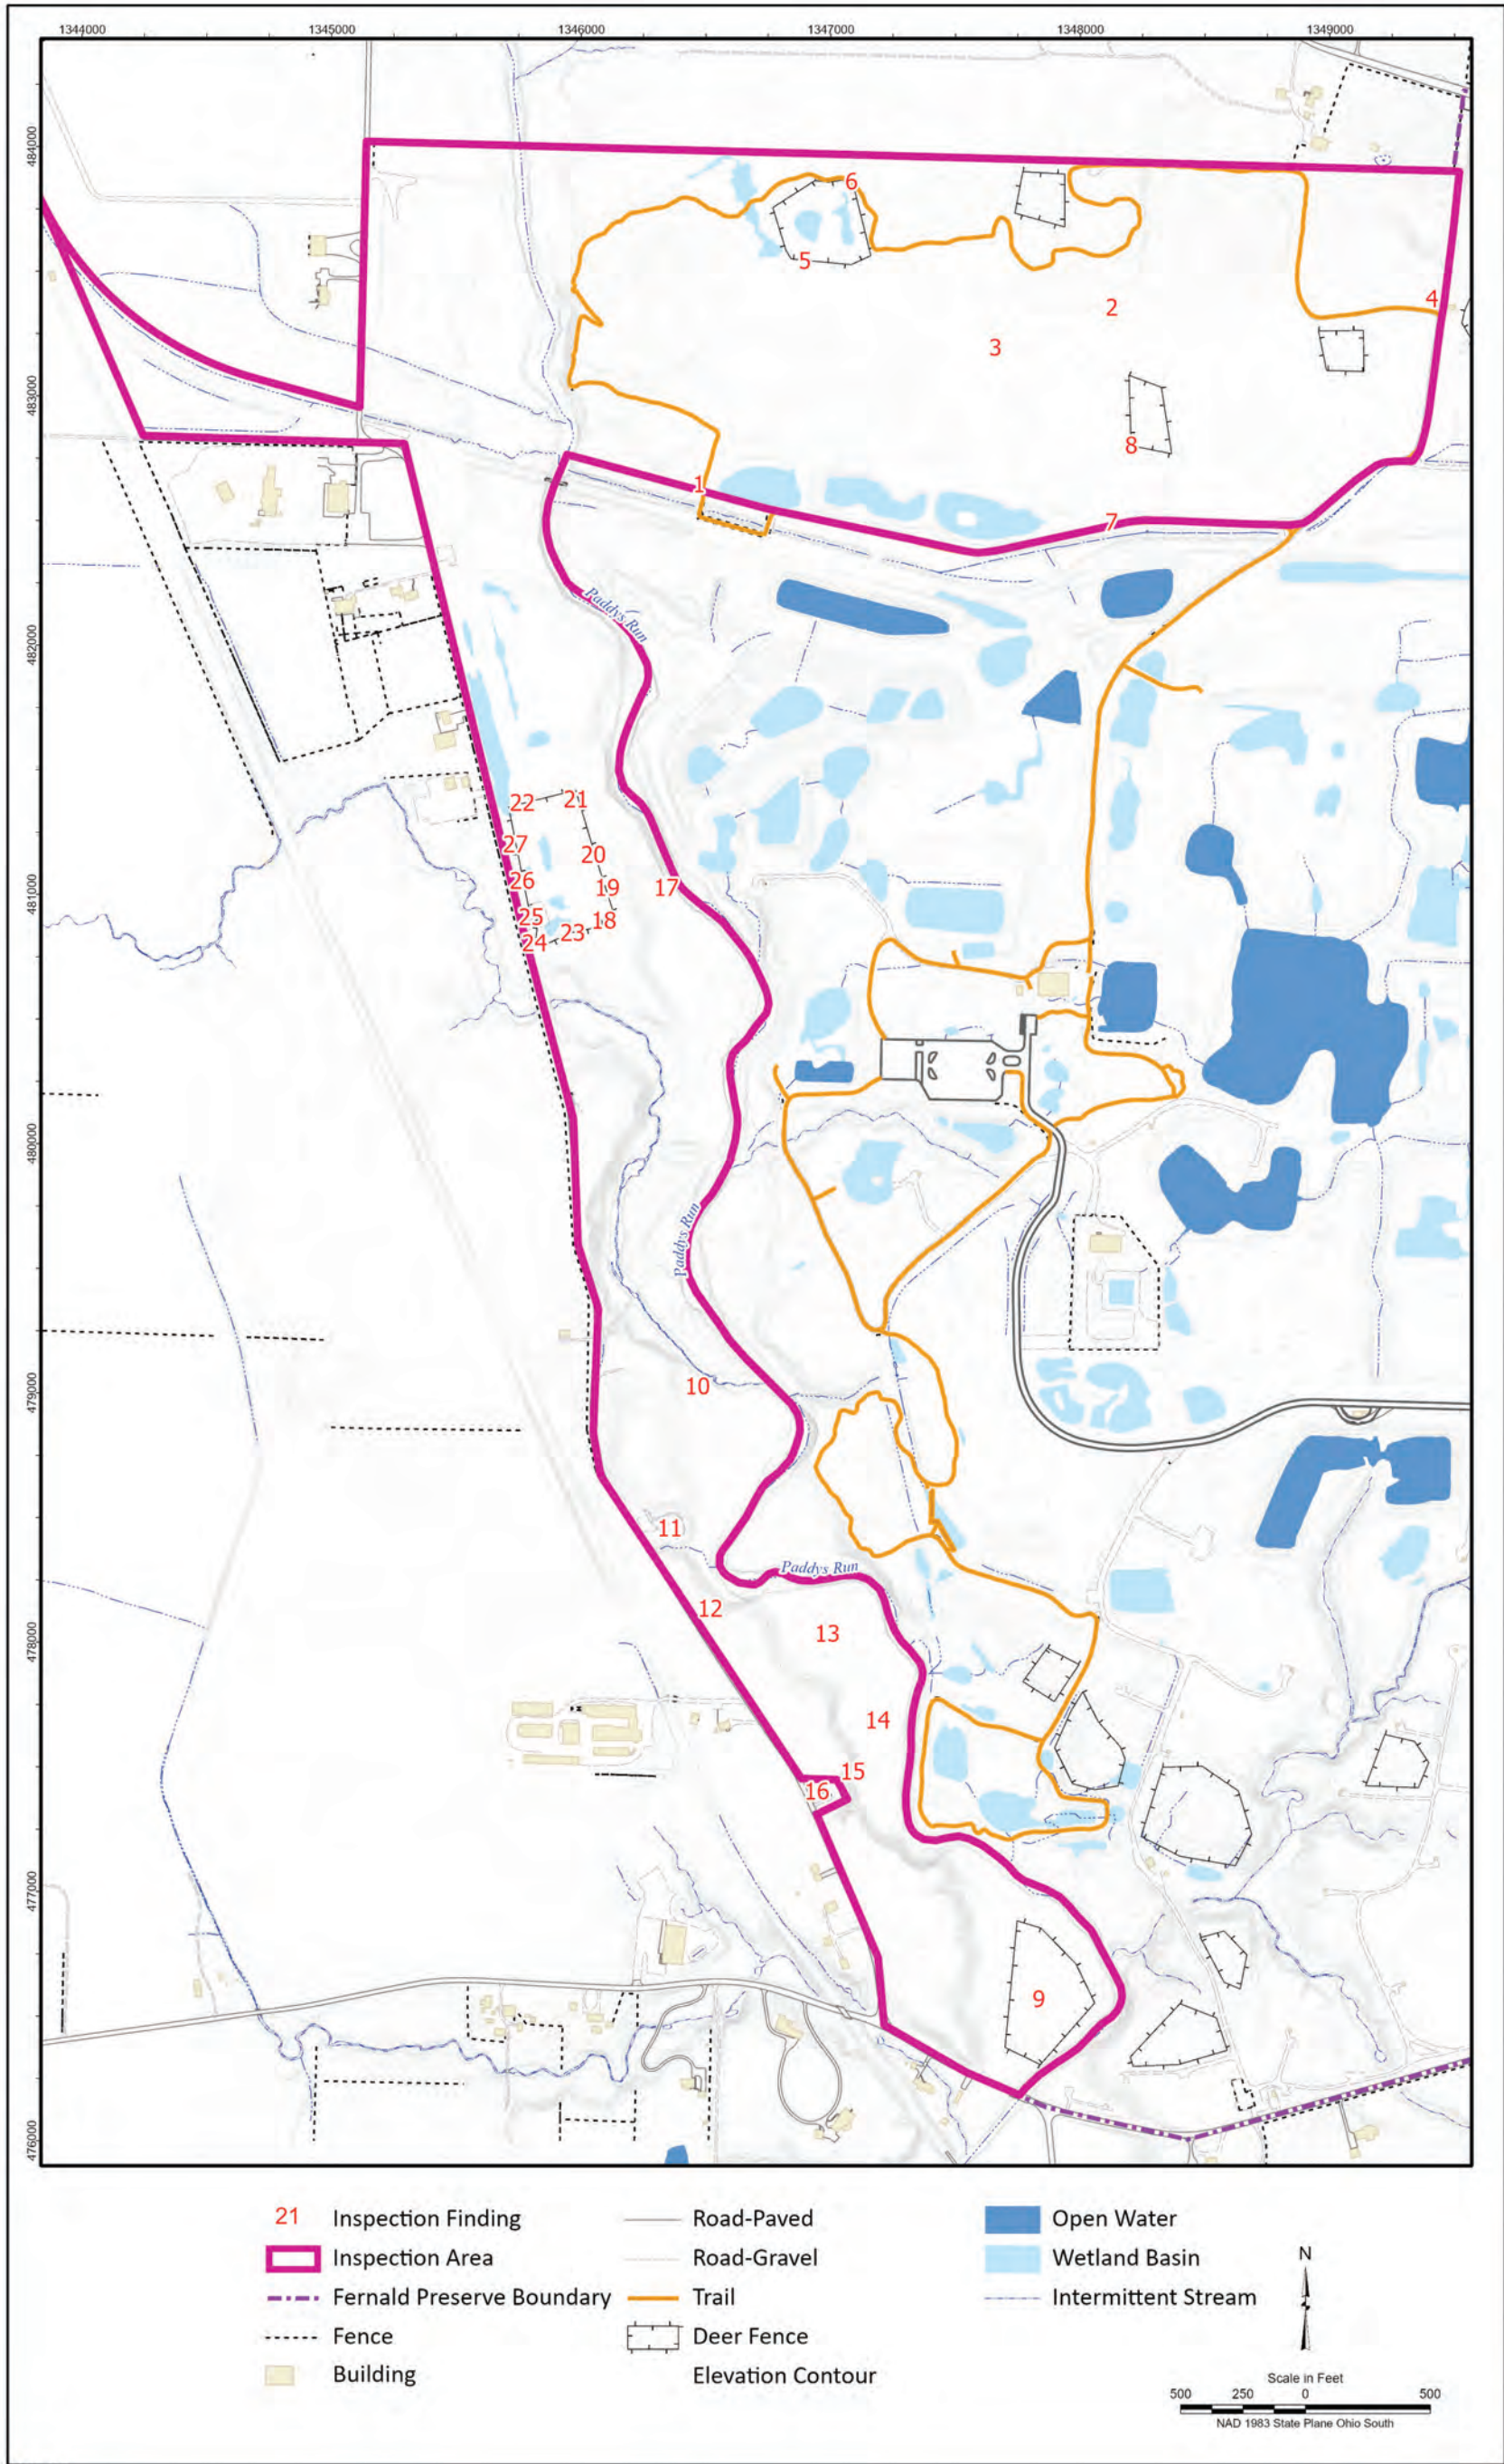
Figure C-3D. West Quadrant Site Inspection Findings, December 2021

17	Fencing without trees inside	To be addressed	TBD
18	Broken cable and plastic ties	Deer fence repaired	1/20/2022
19	Broken plastic ties and rings missing	Deer fence repaired	1/25/2022
20	Broken top cable	Deer fence repaired	1/25/2022
21	Broken plastic ties	Deer fence repaired	1/25/2022
22	Hole in deer fence	Deer fence repaired	1/25/2022
23	Hole in deer fence; fence falling down	Deer fence repaired	1/20/2022
24	Hole in deer fence	Deer fence repaired	1/20/2022
25	Hole in deer fence	Deer fence repaired	1/19/2022
26	Hole in deer fence	Deer fence repaired	1/19/2022
27	Hole in deer fence	Deer fence repaired	1/19/2022

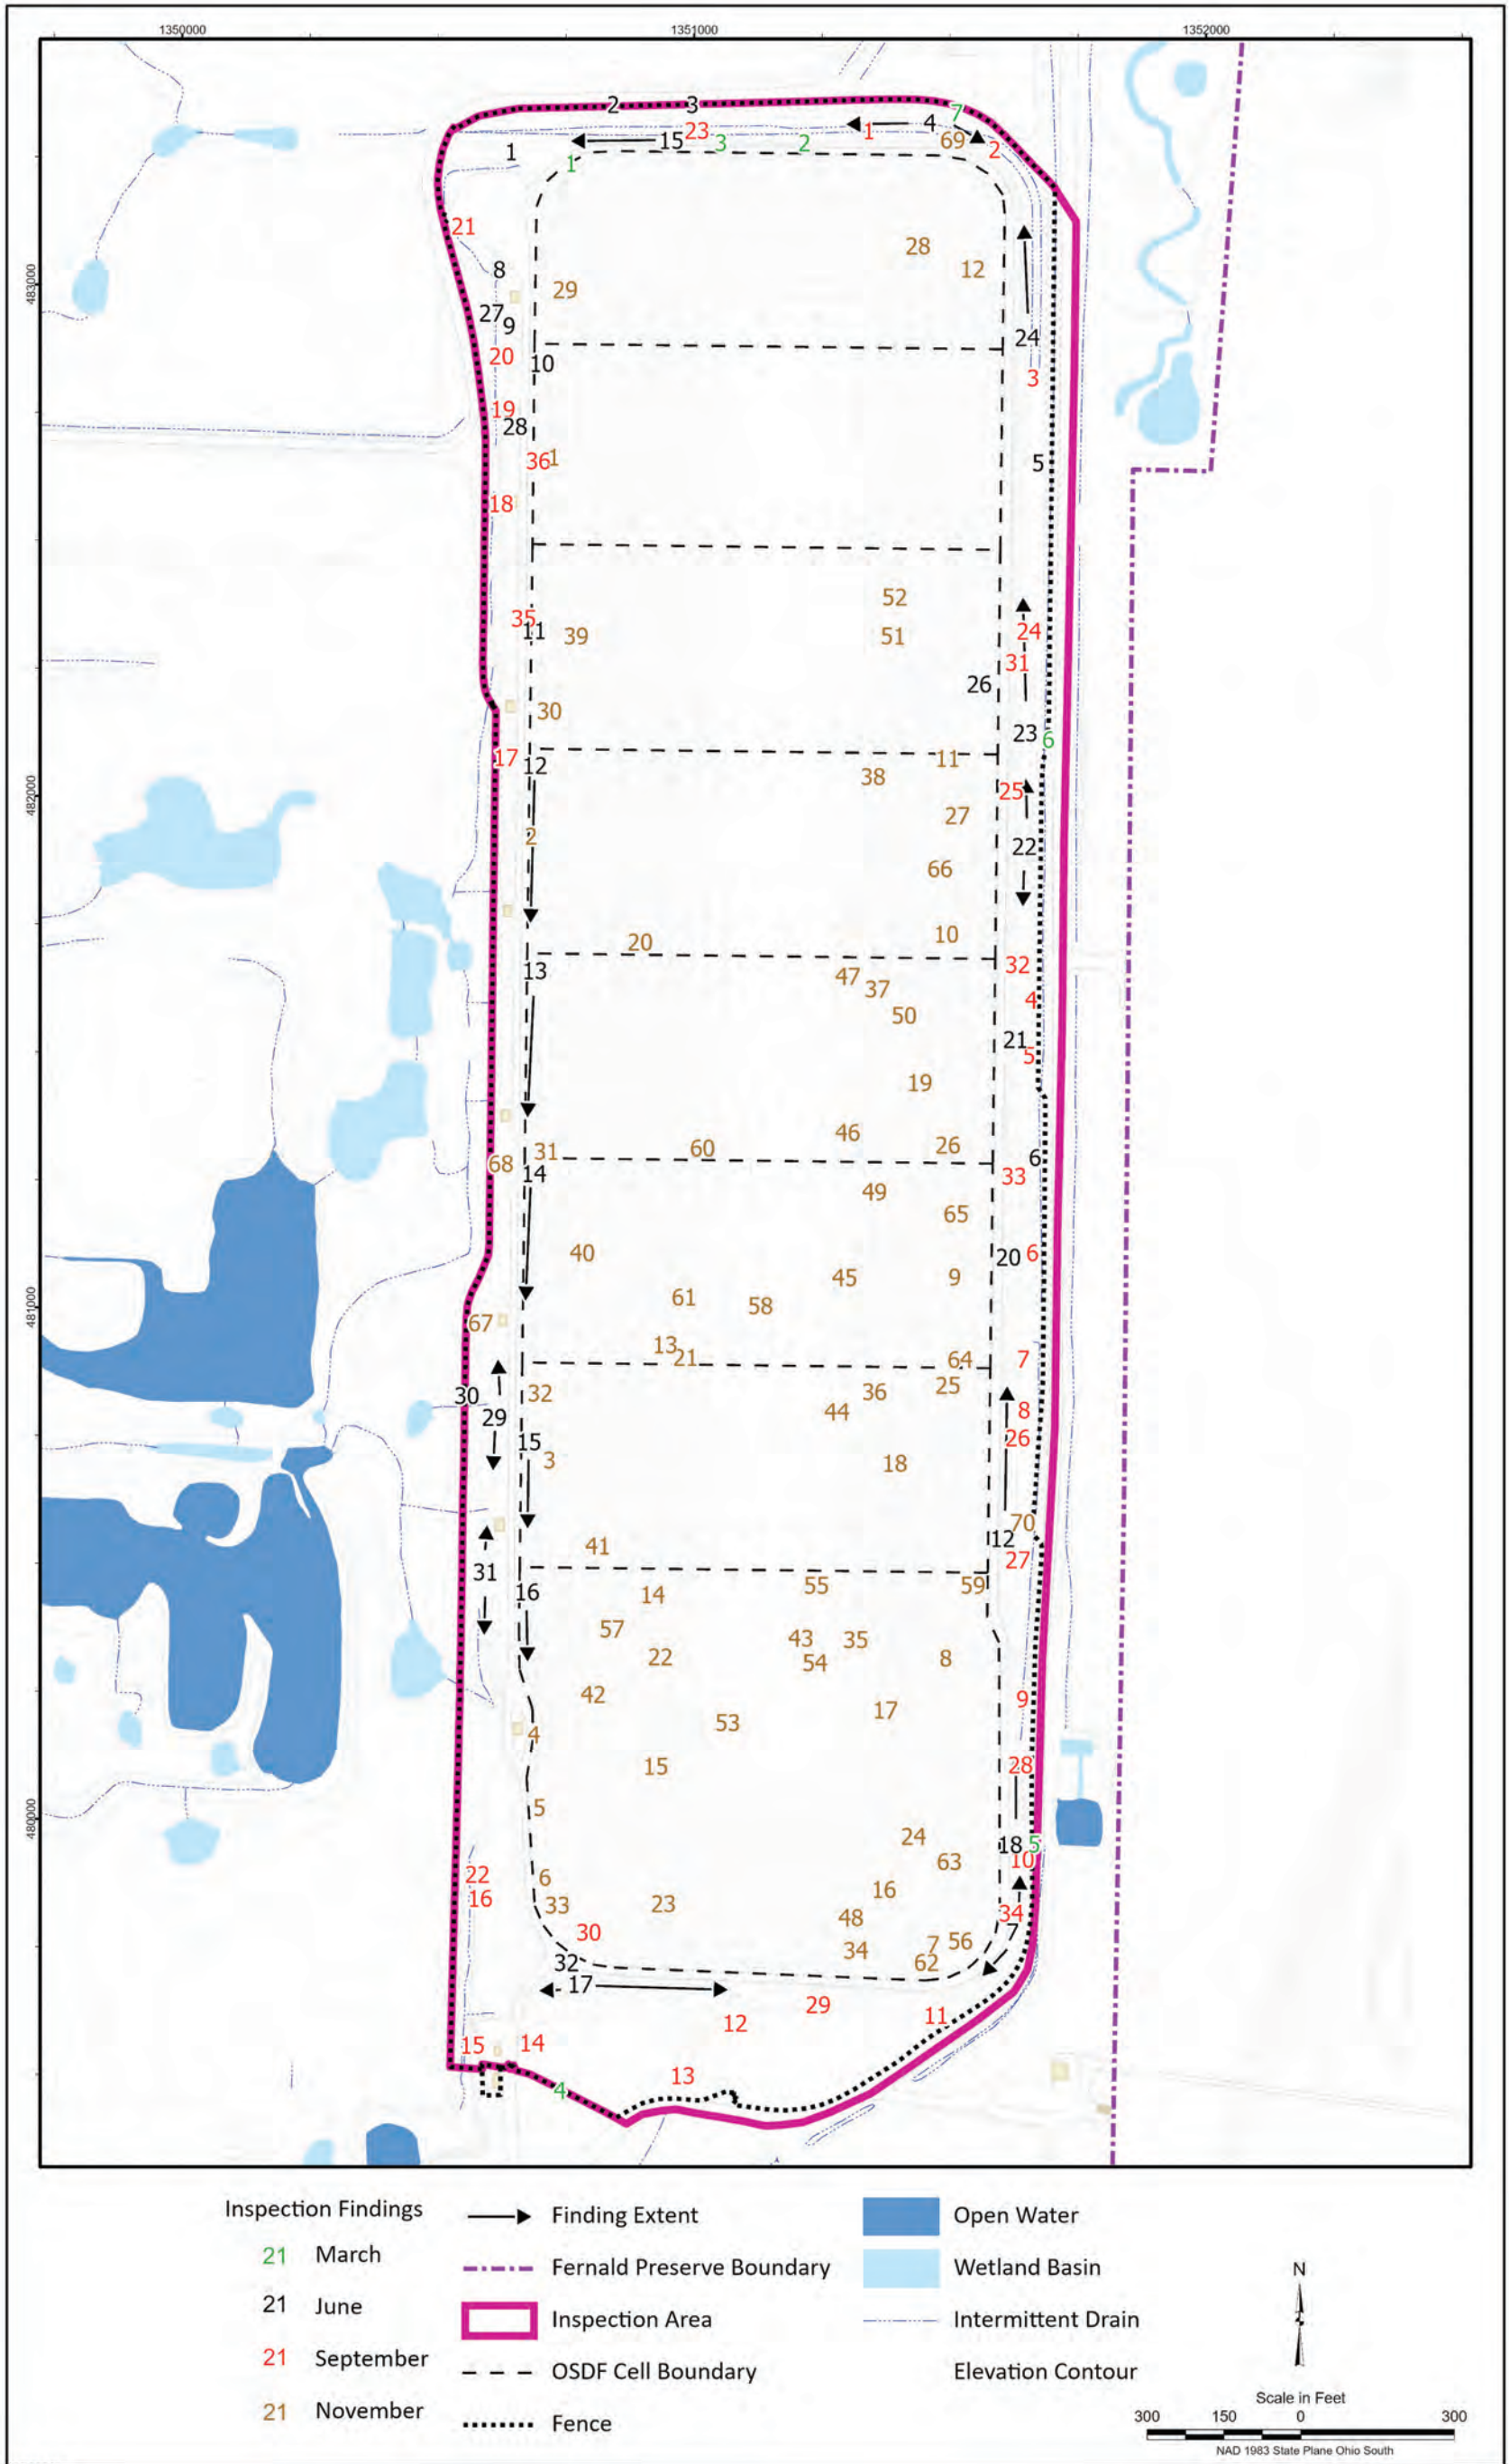
Figure C-3E. 2021 OSDF Inspection Findings

OSDF inspections consist of a quarterly walkdown around the perimeter of the OSDF and an annual walkdown of the vegetated cap. Erosion rills, animal burrows, noxious weeds, woody vegetation, settlement cracks, and other indications that there may be an issue with the proper functioning of the cap are identified and repaired. Tables C-11 through C-14 provide the 2021 OSDF findings, resolution detail, and date of resolution, and Figure C-3E identifies the approximate location of each listed finding. In 2021, there were no signs that the integrity of the cap had been compromised. As in previous years, findings consisted mainly of woody vegetation, noxious weeds, and animal burrows. Callery pear (*Pyrus calleryana*) and other woody vegetation continue to invade the OSDF cap. Field personnel physically remove or apply herbicide to woody vegetation to keep trees from becoming established on the cap.

Table C-11. OSDF Inspection Findings Including Post-Prescribed Burn Inspection Findings, March 2021

55	Pear trees	Vegetation cut and herbicide applied	1/31/2022
56	Woody vegetation	Vegetation cut and herbicide applied	1/20/2022
57	Animal burrow	Animal burrow filled in	12/9/2022
58	No description provided	Unable to locate	1/31/2022
59	Trash	Trash picked up	1/31/2022
60	Woody vegetation	Vegetation cut and herbicide applied	1/24/2022
61	Woody vegetation	Vegetation cut and herbicide applied	1/24/2022
62	Woody vegetation	Vegetation cut and herbicide applied	1/20/2022
63	Woody vegetation	Vegetation cut and herbicide applied	1/31/2022
64	Woody vegetation	Vegetation cut and herbicide applied	1/31/2022
65	Woody vegetation	Vegetation cut and herbicide applied	1/31/2022
66	Woody vegetation	Vegetation cut and herbicide applied	1/27/2022
67	Exposed landscape fabric	Covered exposed fabric with riprap	1/20/2022
68	Bent fence post	Fence post is secure	1/20/2022
69	Bent fence post	Fence post is secure	1/20/2022
70	Sign attachment broken	Sign reattached	12/8/2022
