Unalakleet Microgrid Optimization & Typhoon Merbok Impacts

US Department of Energy –
Office of Indian Energy
Annual Program Review
Denver, CO
November 16, 2022

Effects on Airport

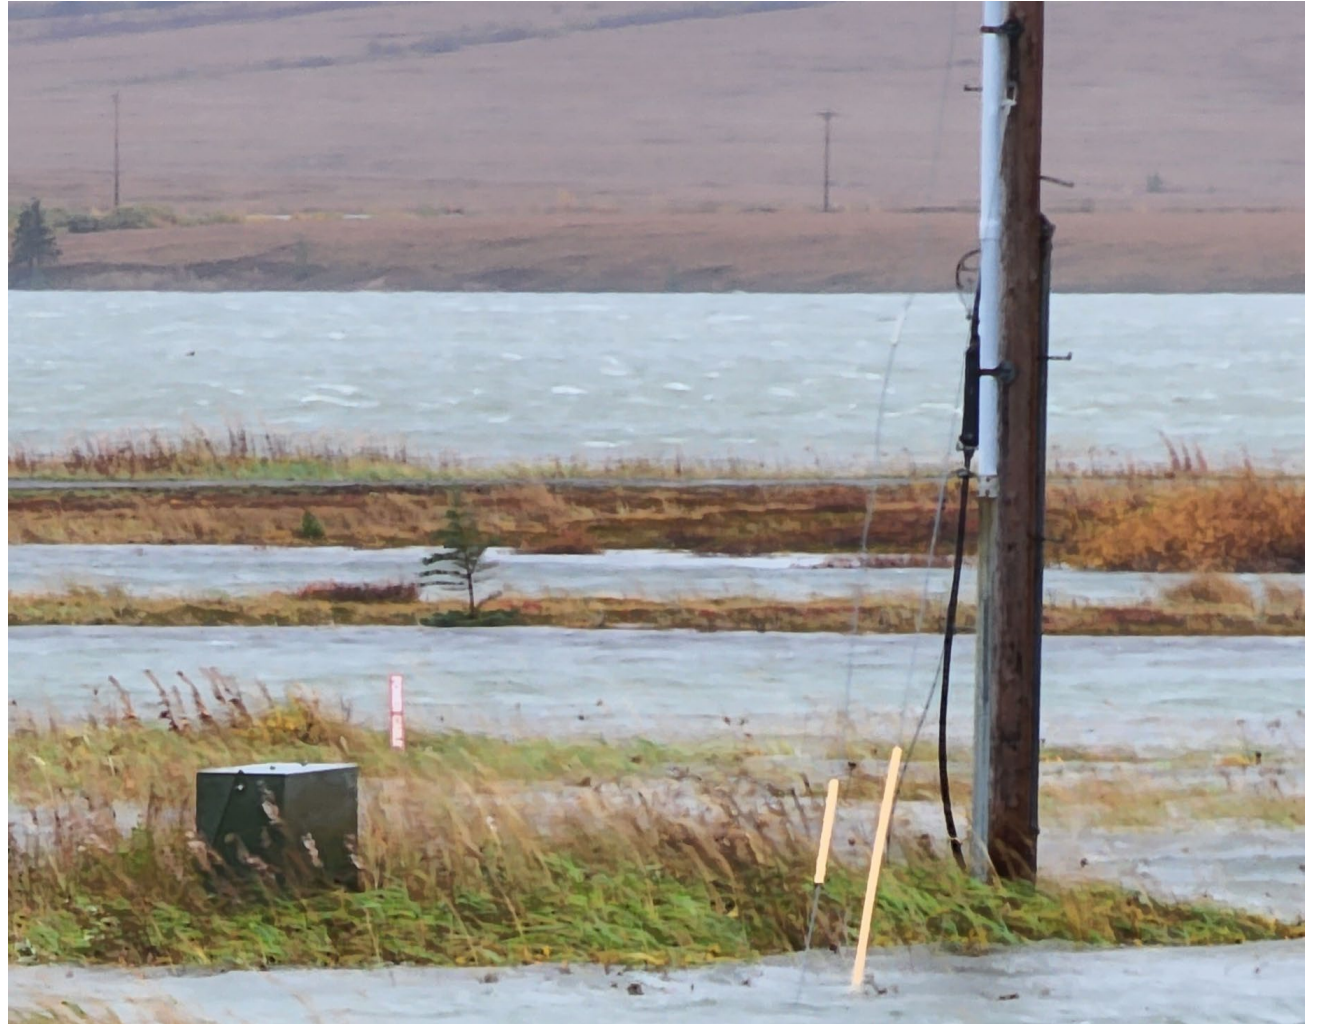
Sectionalizer

Flooded. Must be raised.

Overhead riser at East-West Runway.

THIS IS THE WORST LOCATION.

3-phase. Fed from Happy Valley/North Loop

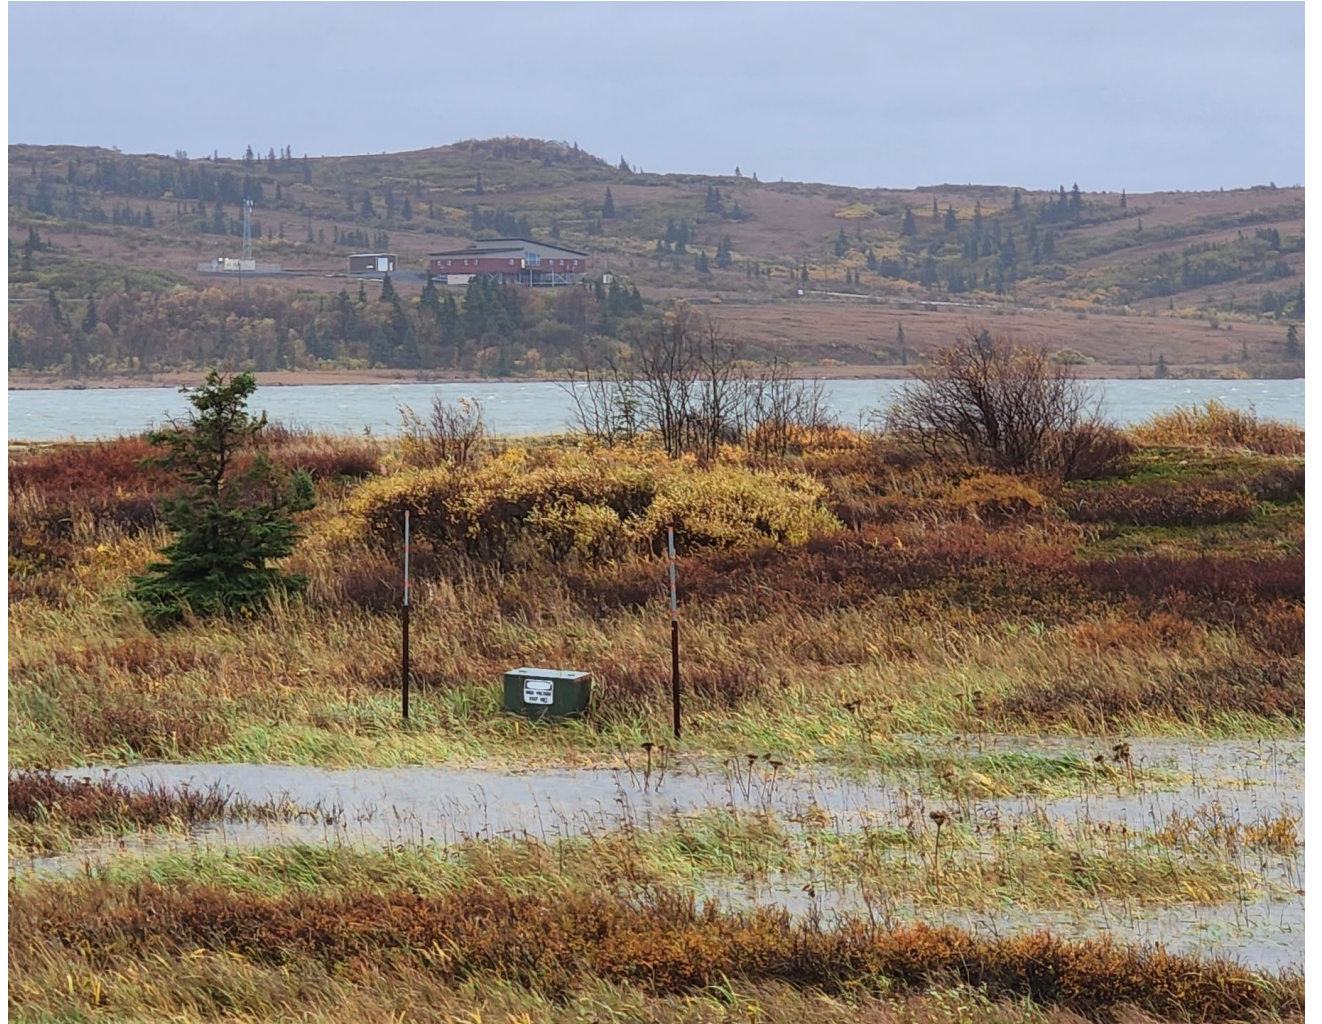
Junction Box

Flooded. East side of North-South Runway.

Must be raised.

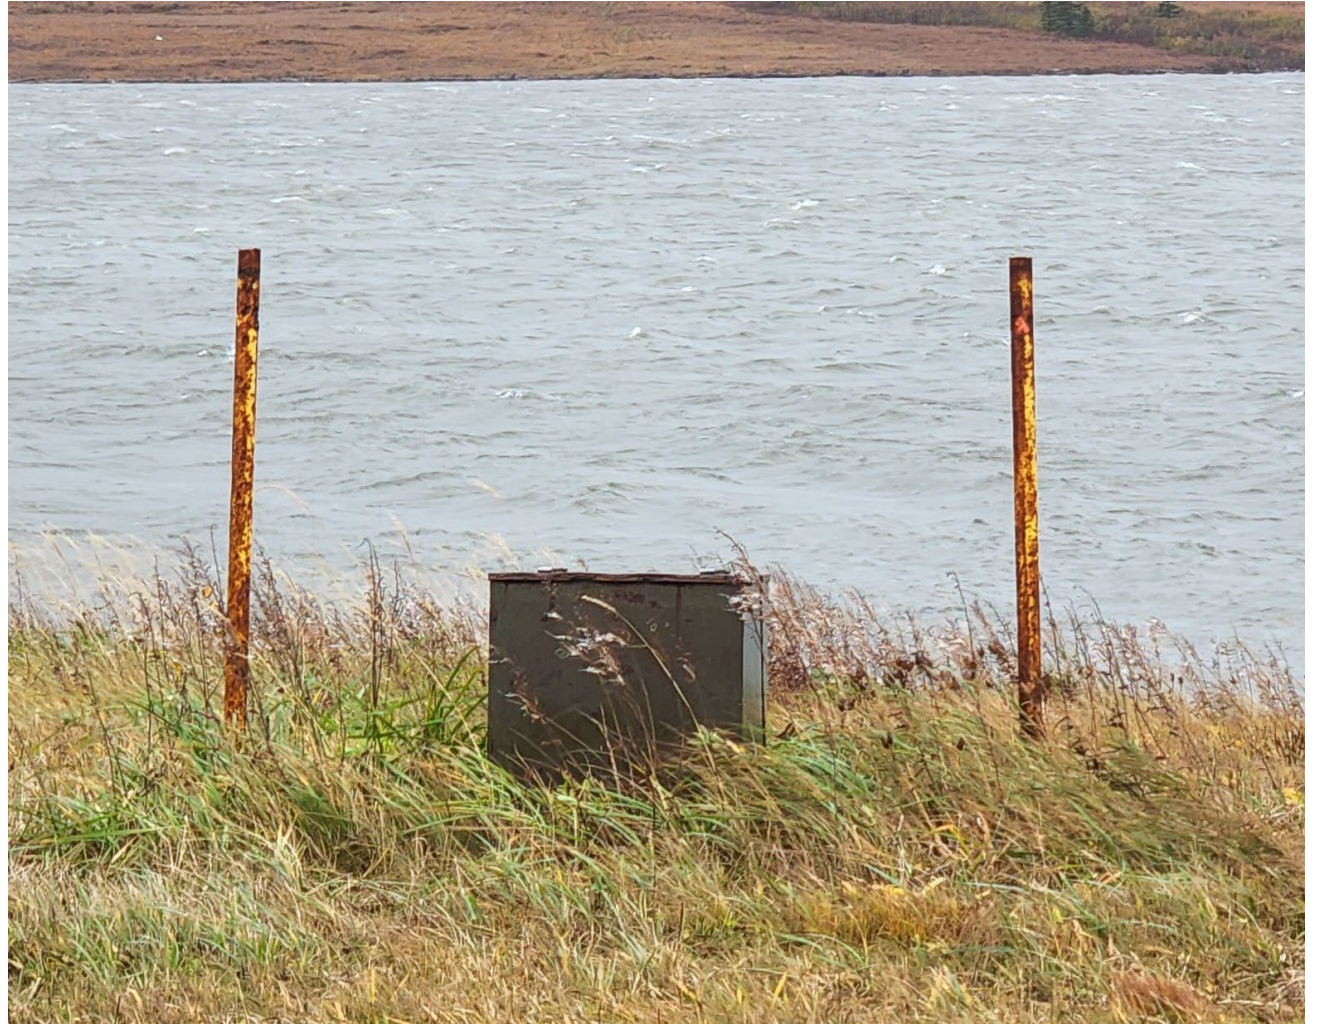
Junction Box

Not Flooded. At-risk.

East side of North-South Runway. Located north of windsock.

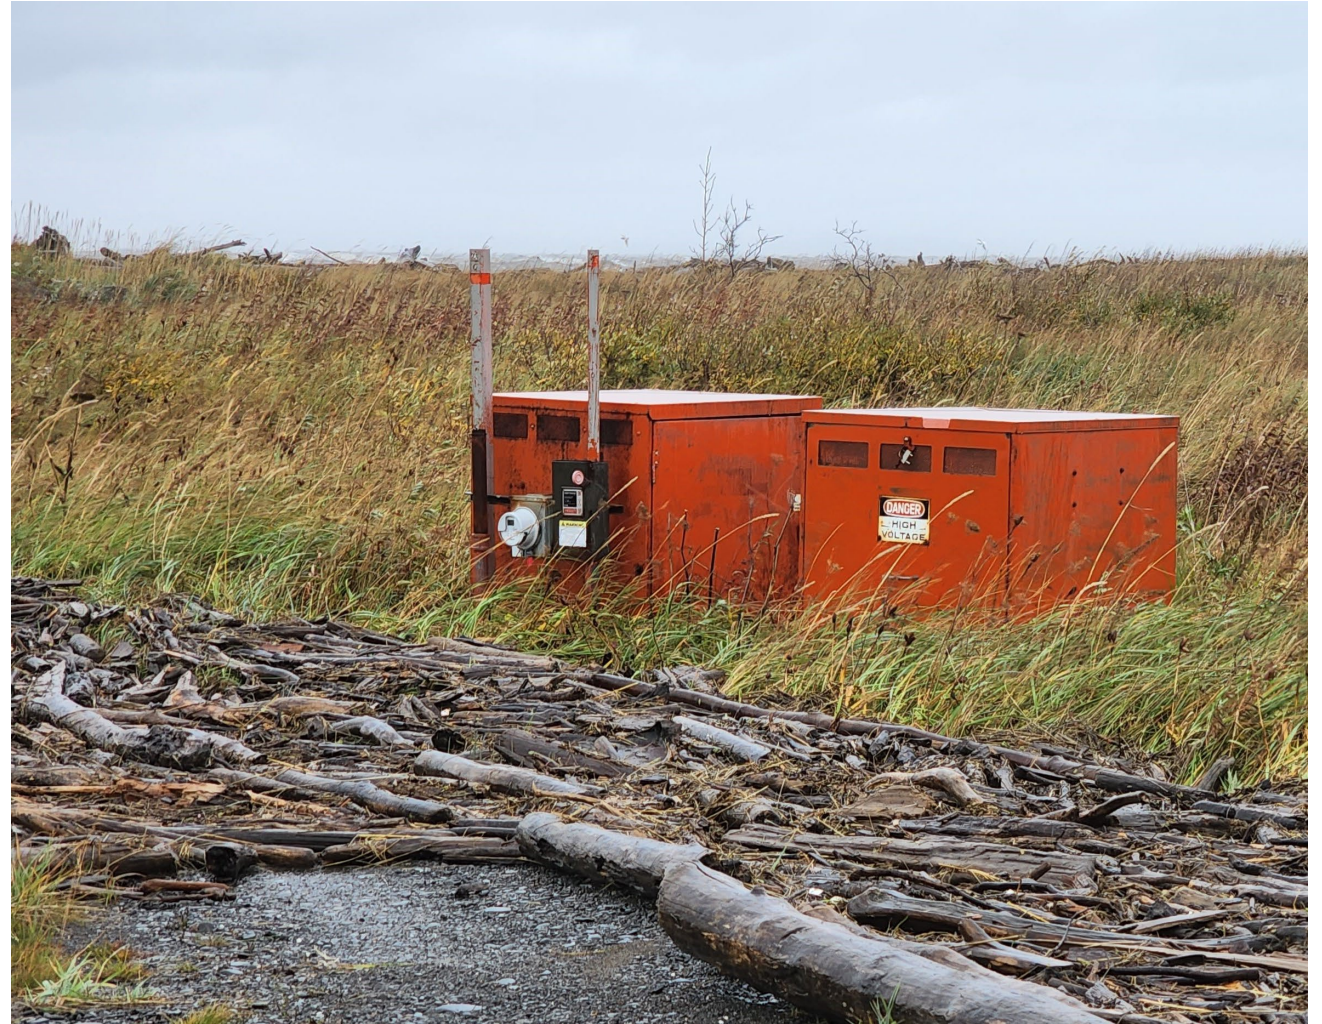
Sectionalizer and Transformer

Flooded. Must be raised.

Oceanside near DOT sand pile.

THIS IS THE SECOND WORST LOCATION.

Fed from West Loop or North Loop (under the north-south runway)

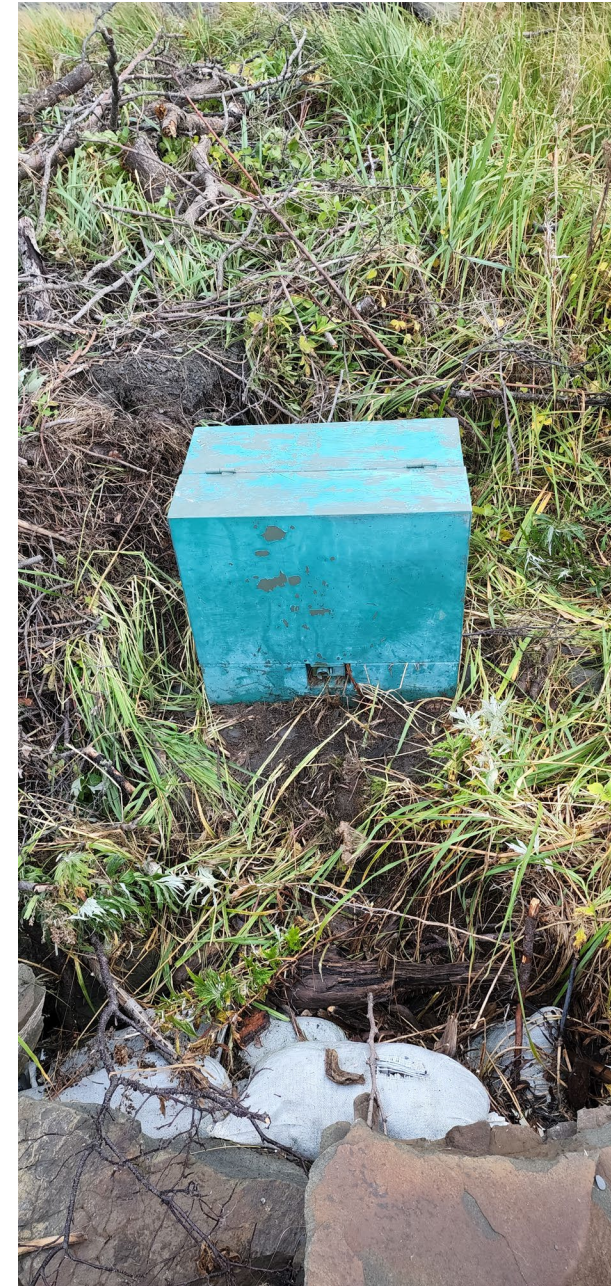
Sectionalizing Cabinet N1

Flooded. Raise/relocate.

Rocks on ocean side. Sand bagged prior to storms.

First j-box north of airport gate.

Contains bypass lines (under barge landing road.)

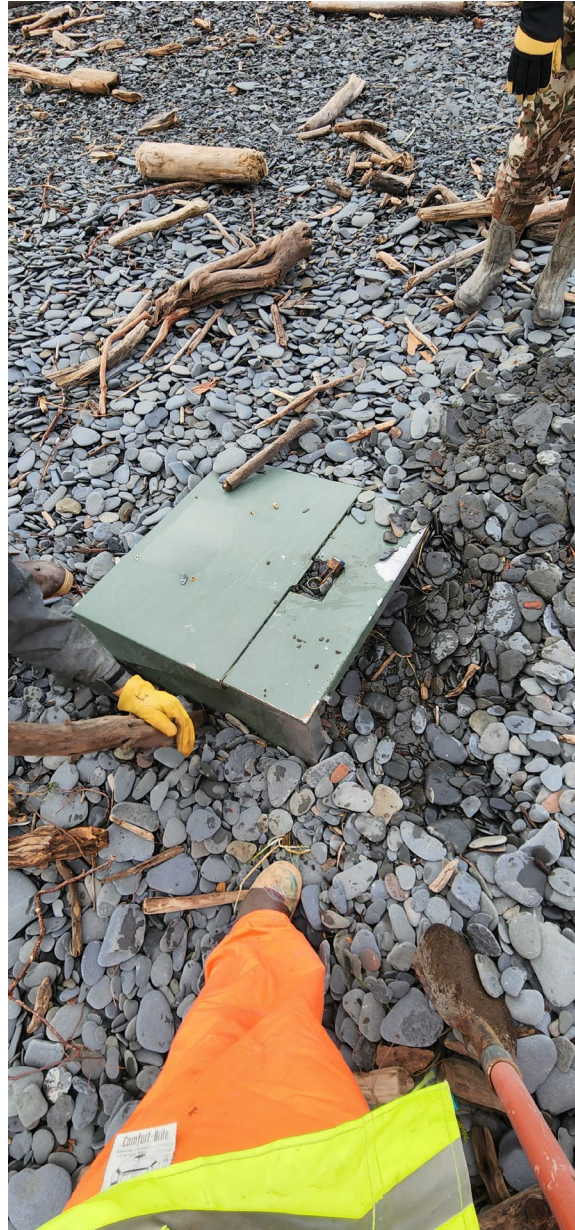
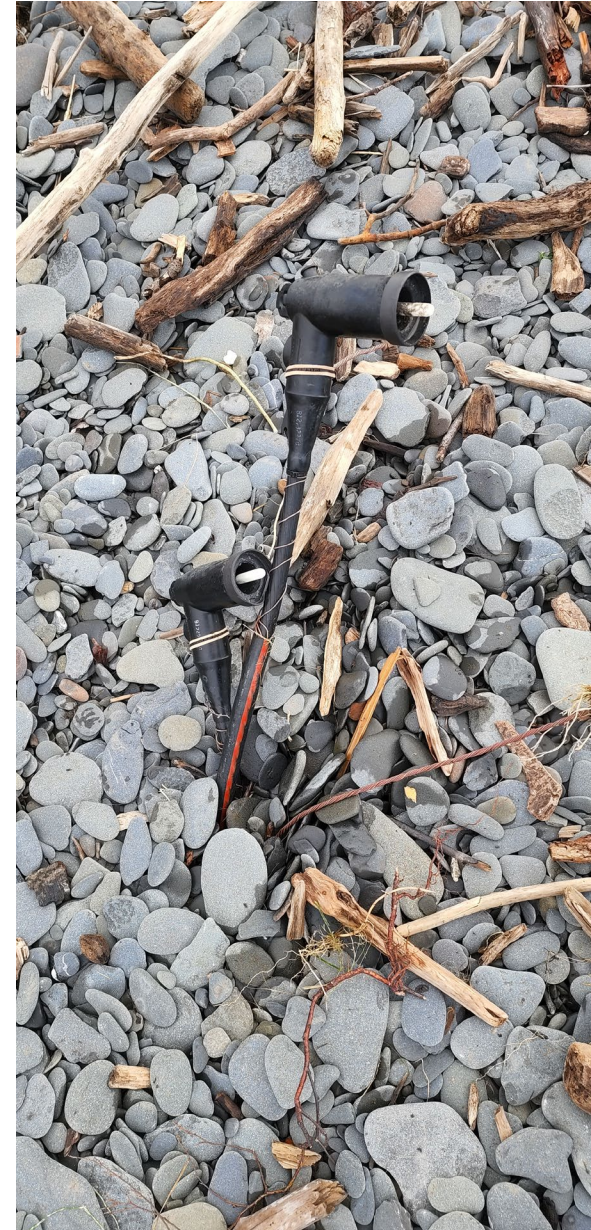
Junction Box N2

Flooded. WASHED OUT.

Destroyed by high surf.

Second junction box north of airport gate.

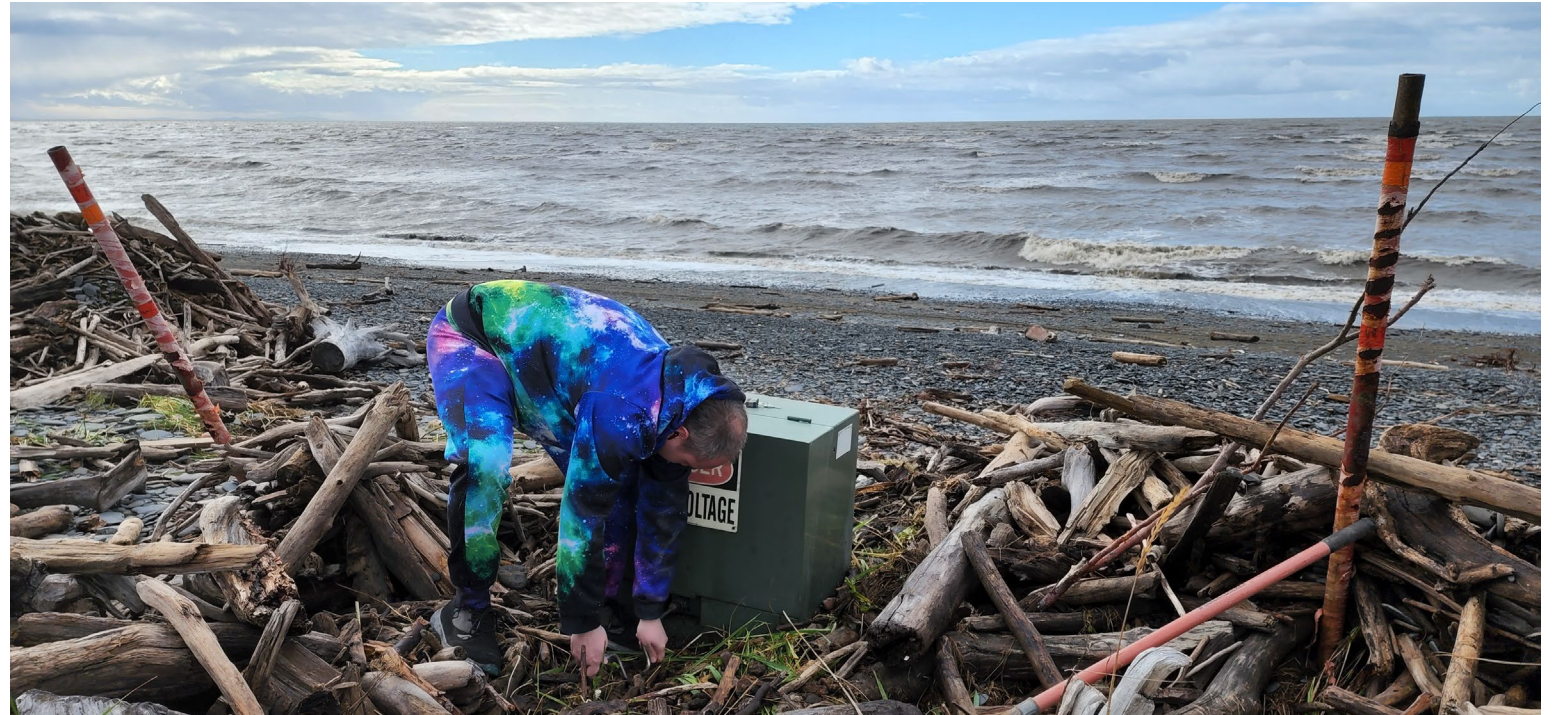
Junction Box N3

Buried by debris. Raise/relocate.

Third junction box north of airport gate.

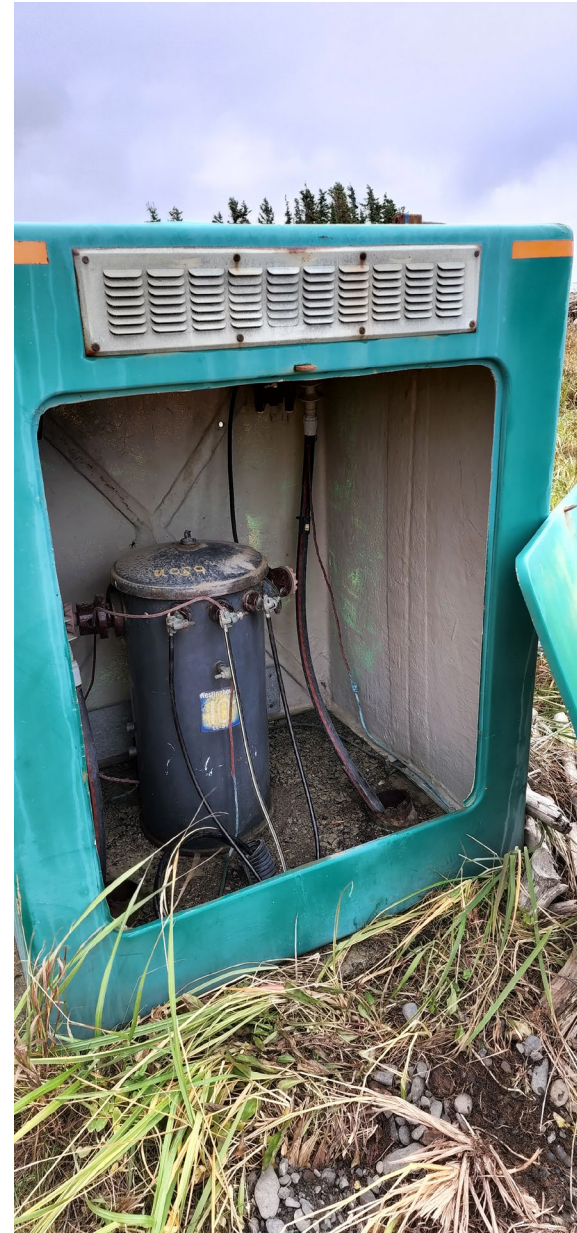
Transformer N4

Heavy spray. Potential tipping hazard if struck by debris/waves. Raise/relocate.

Transformer located at R. Lockwood driveway and turn to Pumphouse.

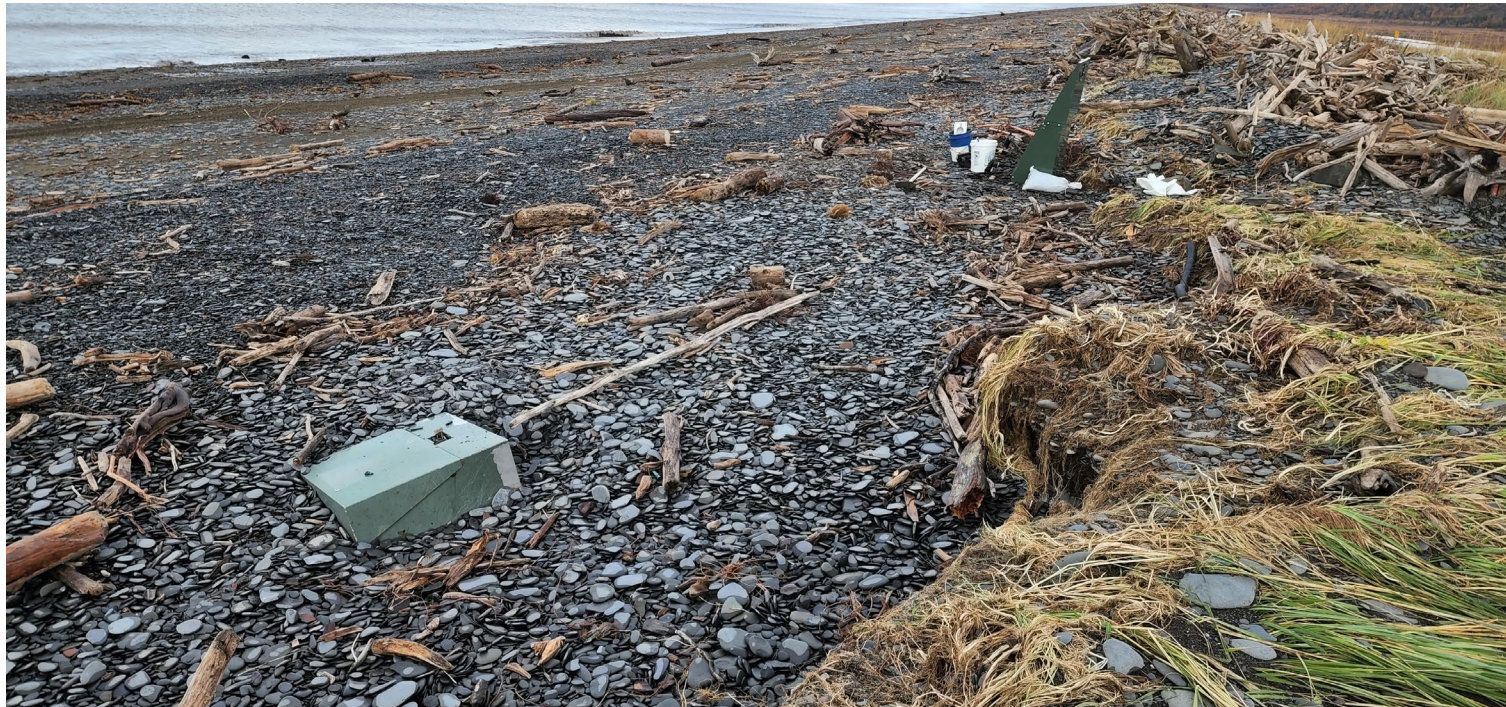
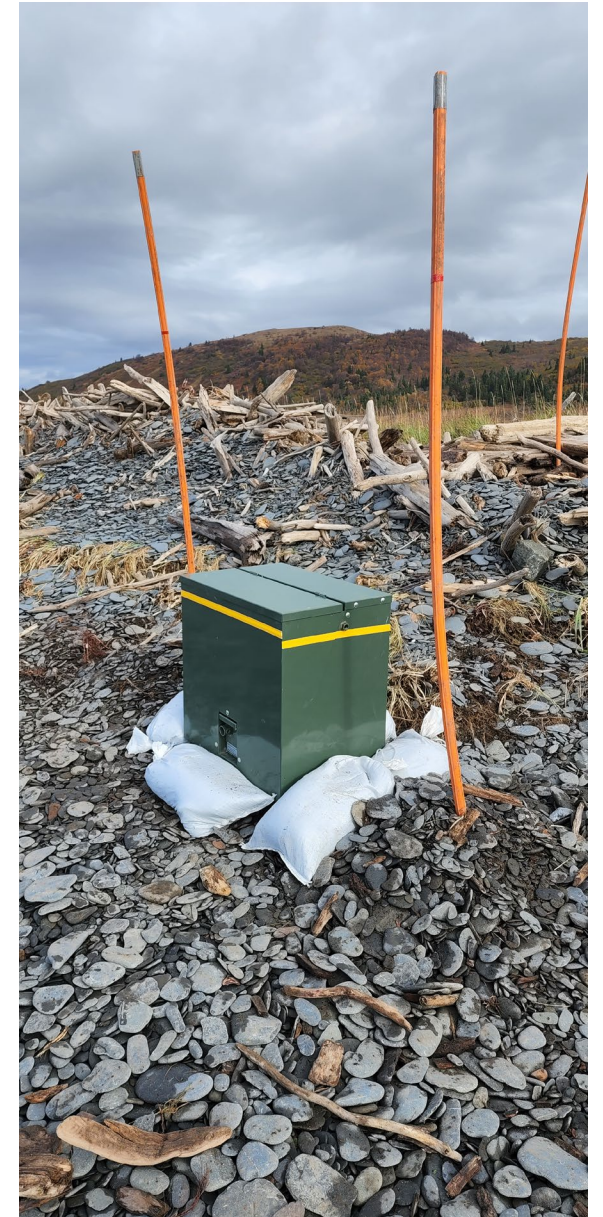
Junction box N2

Replaced. **Still susceptible to storms.** Raise and protect with rock, or relocate. This is a temporary fix.
