# TA-53 Arc-Flash Accident Joint Accident Investigation Team (JAIT) Report

Prepared by a joint team representing both NNSA and Los Alamos National Laboratory

An interdisciplinary, learning-focused, and joint Federal and Laboratory team investigated the causes of an electrical accident at Technical Area (TA) 53 at Los Alamos National Laboratory. This event affected nine Los Alamos employees, two of whom required hospitalization. The Joint Accident Investigation Team (JAIT) determined the direct cause of the accident to be cleaning fluid sprayed into the air gap between an energized switchgear bus and the grounded enclosure. The aerosolized fluid created a path to ground, resulting in an arc-flash. The root cause was less-than-adequate management of control implementation. This report identifies relevant facts; determines direct, contributing, and root causes; provides detailed analysis; and establishes conclusions and judgments of need to prevent recurrence.

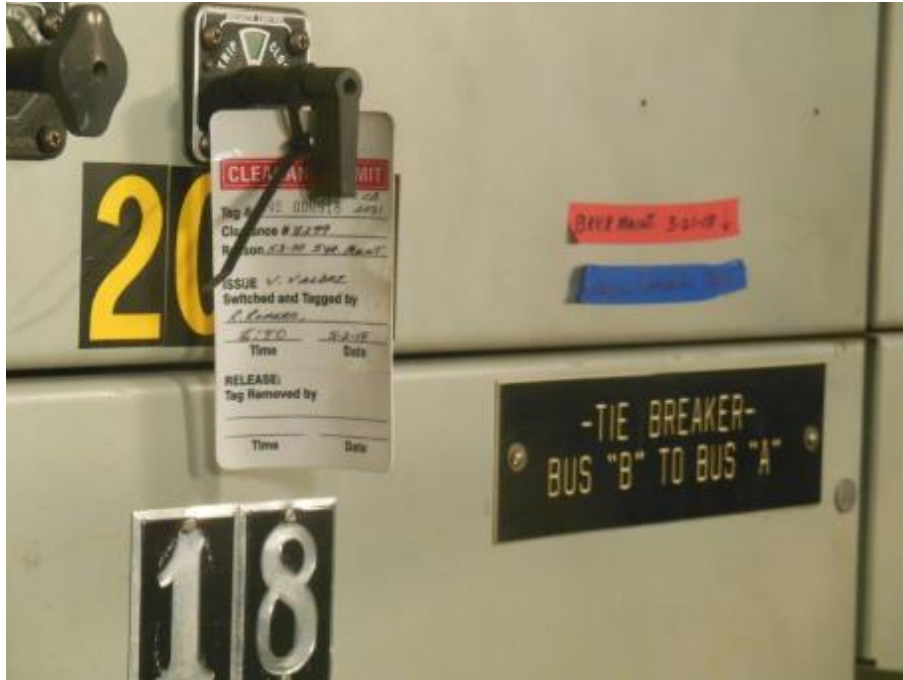
*Figure. 2-3. The Clearance Tag hangs from the cubicle 18 tiebreaker.*

At approximately 1100, E1 walked past the clearance tag that was fixed to cubicle 18 and opened the door to cubicle 17, which was part of the energized Bus B segment. E1 was wearing personal protective equipment (PPE) consisting of nitrile gloves and an arc-rated (AR) shirt, and other clothing including non-arc-rated overalls, and a baseball cap.

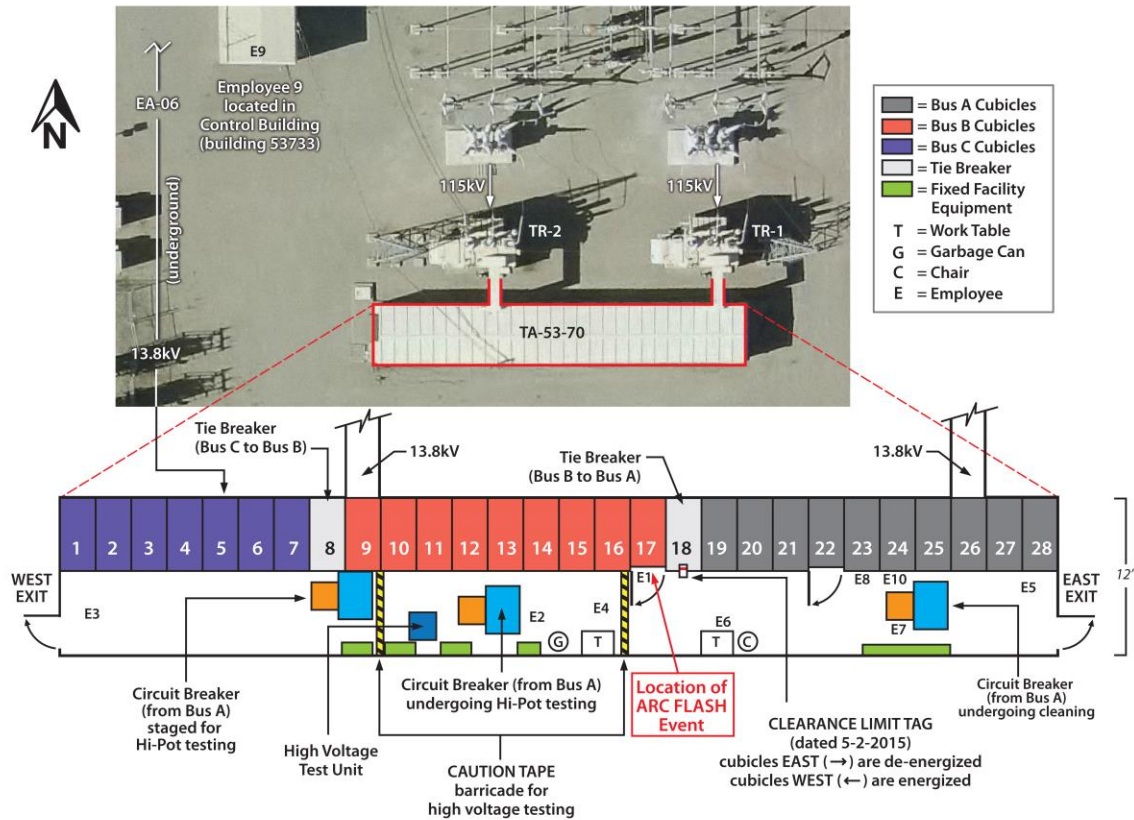
Bus B and Bus C were energized at the end of the shift on the previous day, so the action of E1 unbolting and removing these protective covers inside this cubicle exposed the energized bus bars. Based on physical evidence at the scene and system-monitoring data, at 1108 E1 hand sprayed a commercial liquid cleaner into the air gap between the energized switchgear bus and the grounded enclosure inside cubicle 17 (Figure 2-5).

Figure 2-4. Substation TA-53-0070 configuration at time of accident on Sunday, May 3, 2015

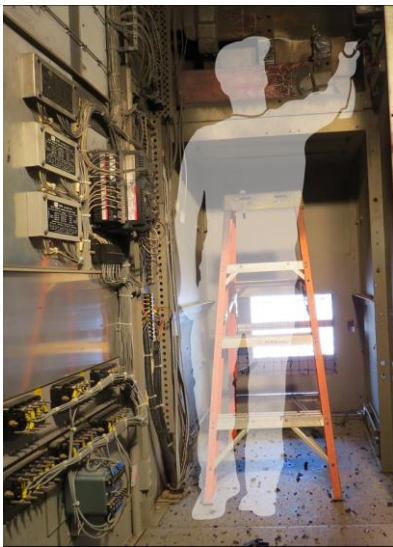
E1 positioned a four-foot fiberglass stepladder along the inside of cubicle 17 (Figure 2-5.). He removed the side-by-side internal steel protective-cover panels to expose the bus bars and associated switchgear, apparently to allow cleaning of the internal surfaces, components, and assemblies.

Figure 2-5 Position of E1 just before the accident.

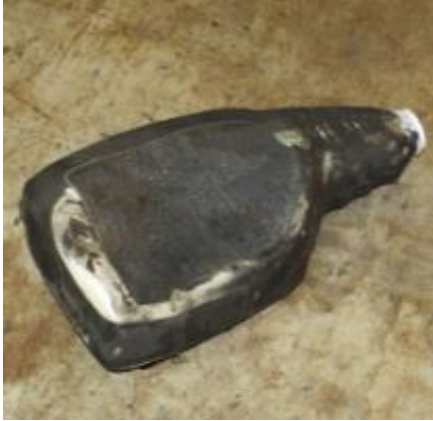
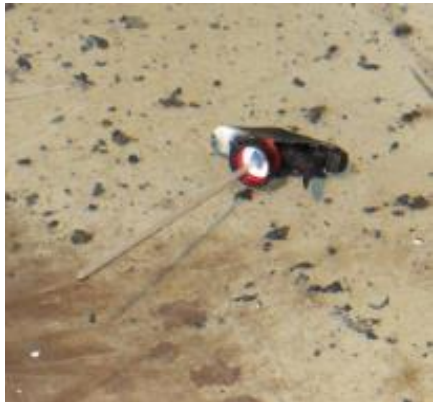
The JAIT verified this assumption based on the post-event condition of the spray container, which indicated that it had been extremely close to a high heat source (Figure 2-6). In addition, post-event waveform analysis of the arc-flash event supports the conclusion that the liquid was sprayed in very close proximity to the energized C-phase bus. The initial fault measured as a C-phase-to-ground arc transitioning quickly to a B-phase-to-ground arc, followed by multiple phase-to-phase faults as plasma flooded the cubicle.

The spray cleaner used is a commercially available household cleaner with no established dielectric characteristics, which means it has no insulating properties to prevent the conducting of electrical current. This spray's intended use for this application was to clean non-energized surfaces.

**The presence of this conductive, aerosolized fluid in the dielectric airspace between the energized bus bar components and the grounded cubicle sidewall surface resulted in an immediate arcing fault, which rapidly transitioned to an arc-flash event.**

*Figure 2-6. Post-event condition of the spray bottle's bottom (top image) and sprayer (bottom image) on the floor outside cubicle 17.*

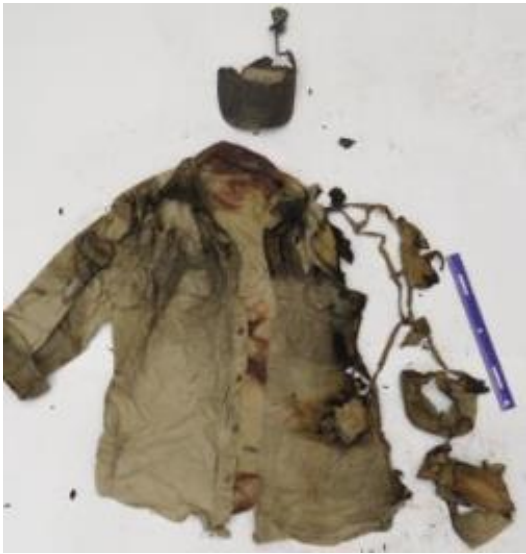
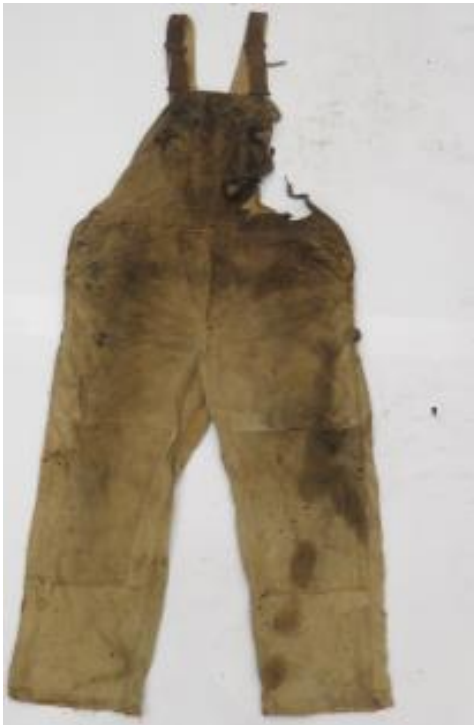
Post-event analysis of E1's clothing (Figure. 2-8) indicates no sign of combustion below chest level.

*Figure 2-8. Clothing recovered from E1 after the arc-flash event.*

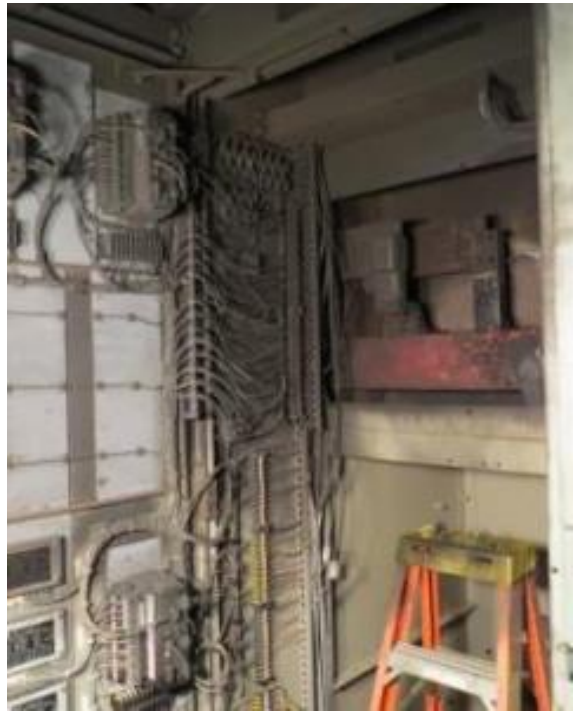
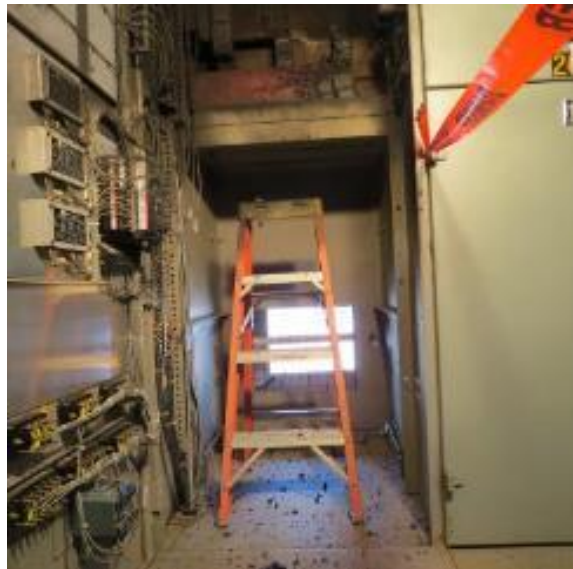
The above conclusion is based on the waveforms captured from the monitoring systems and the physical damage on the cubicle wall and bus bars. The low-current leader of the fault is hidden by the very high currents following the initial flash, with the arc fault sustained by the establishment of highly conductive plasma. This energy discharge burned the bus bars and vaporized the copper and other metal parts in the vicinity, resulting in an arc-blast.

*Figure 2-9. What cubicle 17 looked like after the arc-flash event.*

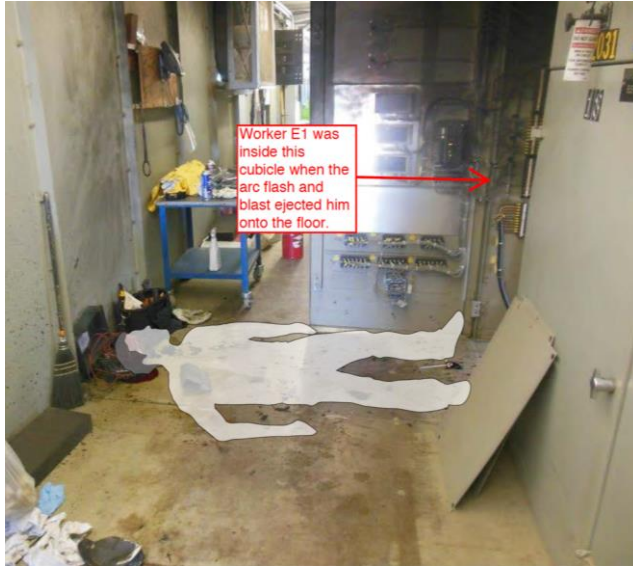
**The rapid release of thermal energy from the flash event resulted in serious burns to E1's hands, forearms, chest, face, head, and left rear upper torso. The subsequent pressure wave forced him backward and downward onto the floor, where his head struck a micro-ohm testing instrument.**

*Figure. 2-10. Position of E1 after the arc-flash event.*

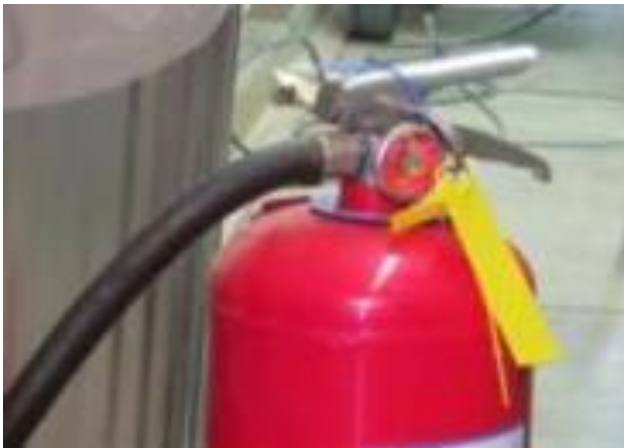
*Figure. 2-11. This fire extinguisher was brought to the scene but not used to extinguish the fire on E1 at the arc-flash accident scene.*

Immediately following the accident, E2 and E3 responded to assist E1, who was initially responsive. E2 patted E1 down and extinguished the fire that was on E1's clothing. At the same time E3 went to get a fire extinguisher but it was not needed. E1 became unresponsive and was revived by E2 who helped E1 remove burnt clothing, applied cool wet rags to E1, and assisted E1 out of TA-53-0070 while E3 went and called 911. Other individuals on the scene also called 911.

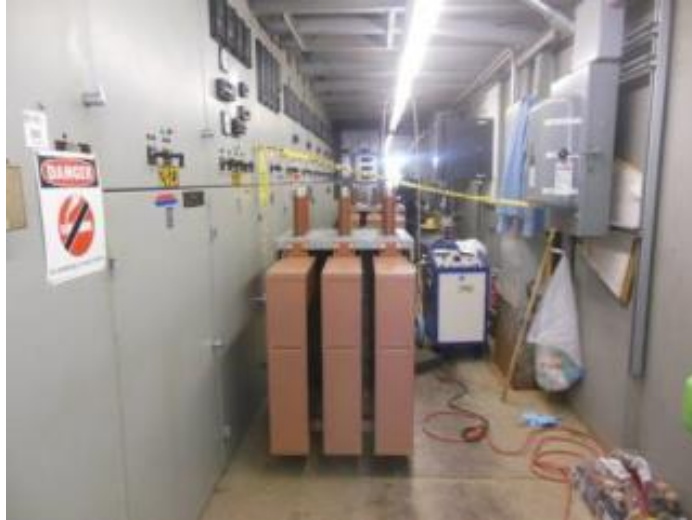
*Figure 3-1. This photo shows the area in front of energized Bus B and Bus C, both of which power the LANSCE area. Note how close the breakers under test were set to the operating equipment. There is an open cubicle door on the operating area. The blue device is the hi-pot test set. The area is so crowded that it almost blocks the east side exit door.*

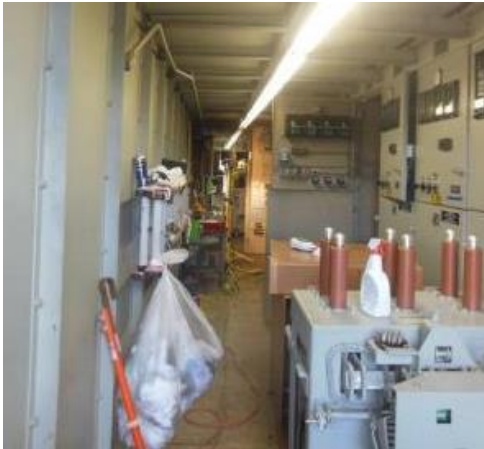
*Figure 3-2. This photo shows the front of de-energized Bus A. Note the one air breaker on the floor, as well as a bench, trash, and extension cord, and scattered tools.*

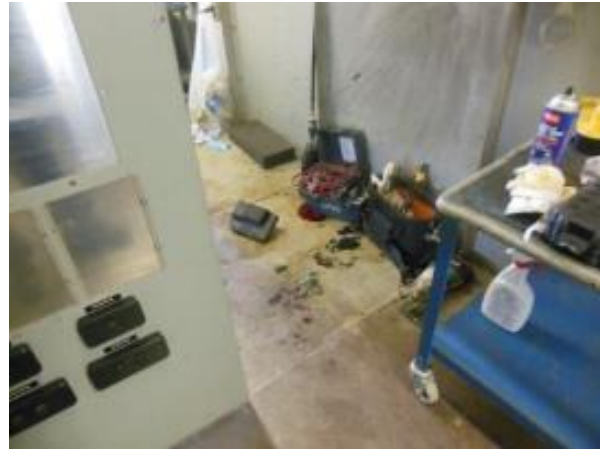
The JAIT found a half-burned cigarette on the floor in front of cubicle 17 (Figure 3-3). *Danger-No Smoking* signs were visible in the switchgear. There is no evidence that this cigarette was from E1, or even that it had been deposited on the day of the accident.

*Figure 3-3. This close-up shot shows the area in front of cubicle 17. Note the "ductor" test set, tools, a class-2 glove, a cigarette butt, and a bench.*

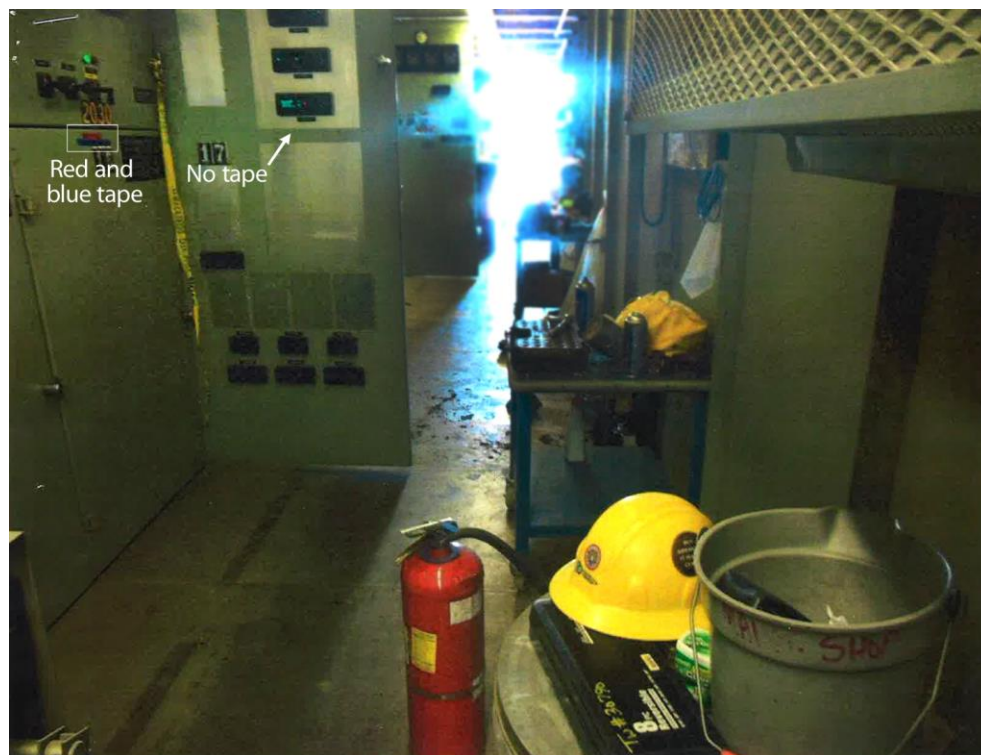
Cubicle 17 (where the accident took place) should have been marked with blue tape only, as it contains no breaker, and it had been cleaned on Saturday.

**Photographic evidence (Figure 3-4) and subsequent JAIT inspection revealed that cubicle 17 did not have tape of any color on it and there had never been any colored tape placed there.**

*Figure. 3-4. No tape was found on cubicle 17.  
Note the red and blue tape on the adjacent cubicle.*

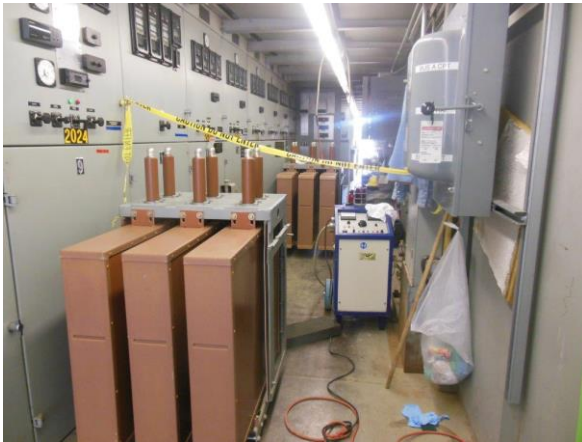
Figure. 3-5. *Yellow caution tape was used as a barrier for hi-pot testing.*

The work carried out on May 3 involved a significant number of people (8-9) and equipment in a relatively confined space. Yellow caution tape—identified after the accident—was used as a barrier for the hi-pot testing. The tape (Figure 3-5), along with a verbal protocol, was used to establish an exclusion zone while testing took place. This process was clearly stated and understood at the pre-job brief.

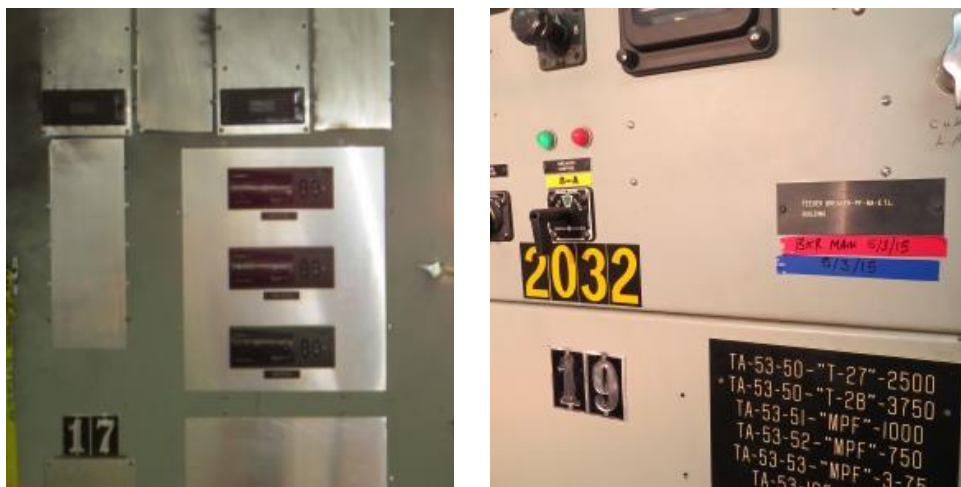
An informal process was used with red and blue tape to identify when work is complete (Fig. 3-6). Red tape on the cubicle indicates the breaker is finished and the blue tape means that the cubicle is clean. This process is not documented or developed in formal job planning. While a process is helpful to prevent duplication and provide visual status of work, if it is not well understood and formalized, it can cause errors. The cubicle where the event took place should have had blue tape, as it was cleaned on Saturday.

*Figure 3-6. Cubicle 19 showing both the breaker testing and cleaning is complete, in contrast to Cubicle 17 with no tape on Sunday, even though Cubicle 17 is on a re-energized bus.*

However, because the process was informal, there was no verification step to ensure all cubicles cleaned Saturday were labeled. The absence of tape may have caused confusion among the crewmembers. Cubicle 17 has no breaker so the door would not have red tape, which may have also confused E1 when looking at the door to determine what work was left to complete.

**JON-4: LANL needs to effectively implement human-performance error-prevention tools in work planning and hazard analysis.**
